London Avenue Canal Load Test – Small Load Test Site Selection

By Noah Vroman (ERDC), Dr. Thomas Brandon (VPI), and Neil Schwanz (MVP) Objectives:

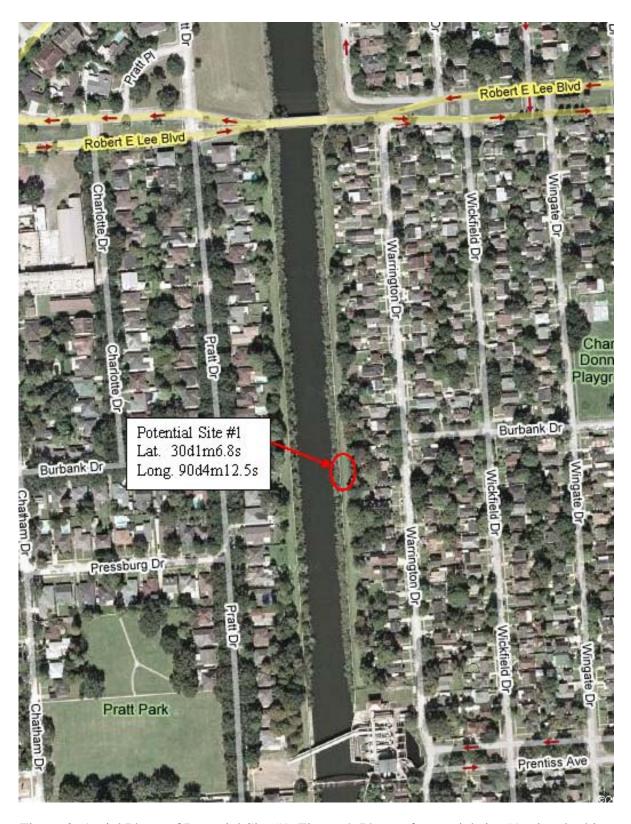
Figure 3. Aerial Photo of Potential Site #1. Figure 4. Photo of potential site #1, view looking south. Figure 5. Photo of potential site #1, view looking south.

The site of interest in this reach is located at a vacant lot @ GDM station 111+00. This site is shown in the photographs below (Figures 4 through 8). The vacant lot is appealing as it allows easier access with equipment and instrumentation to the levee. The property line (fence line) throughout this reach is at the protected side toe of the levee.
