UNITED STATES AIR FORCE
AIRCRAFT ACCIDENT INVESTIGATION
BOARD REPORT

CV-22B, T/N 06-0032

LOCATION: Near Hurlburt Field, Florida

DATE OF ACCIDENT: 13 June 2012

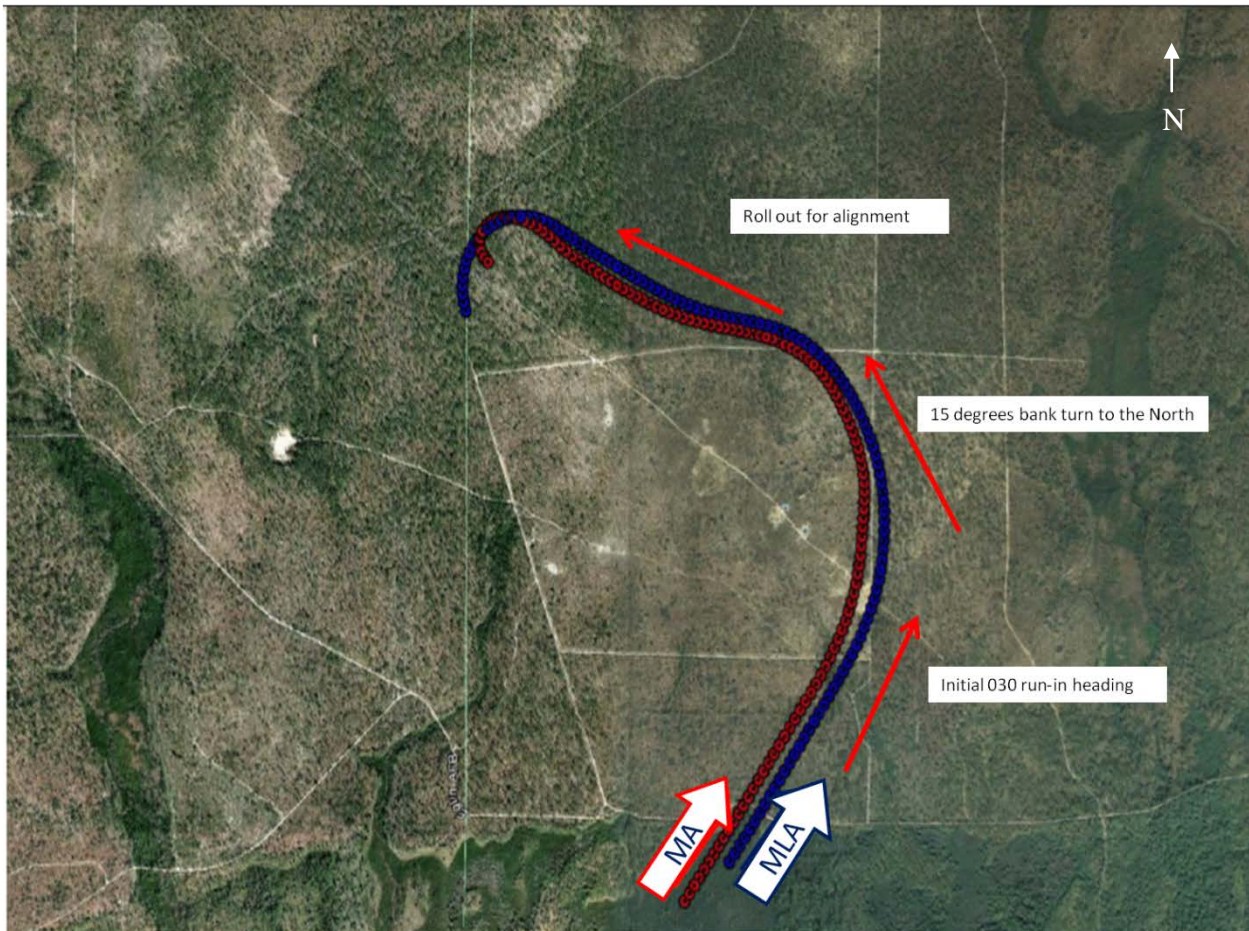
Figure 6. MF Ground Track

The MLP continued on a northeast heading of approximately 030 degrees and descended the MF to 300 feet AGL (approximately 350 feet mean sea level (MSL)) (See Figure 6) (Tab AA-10 to

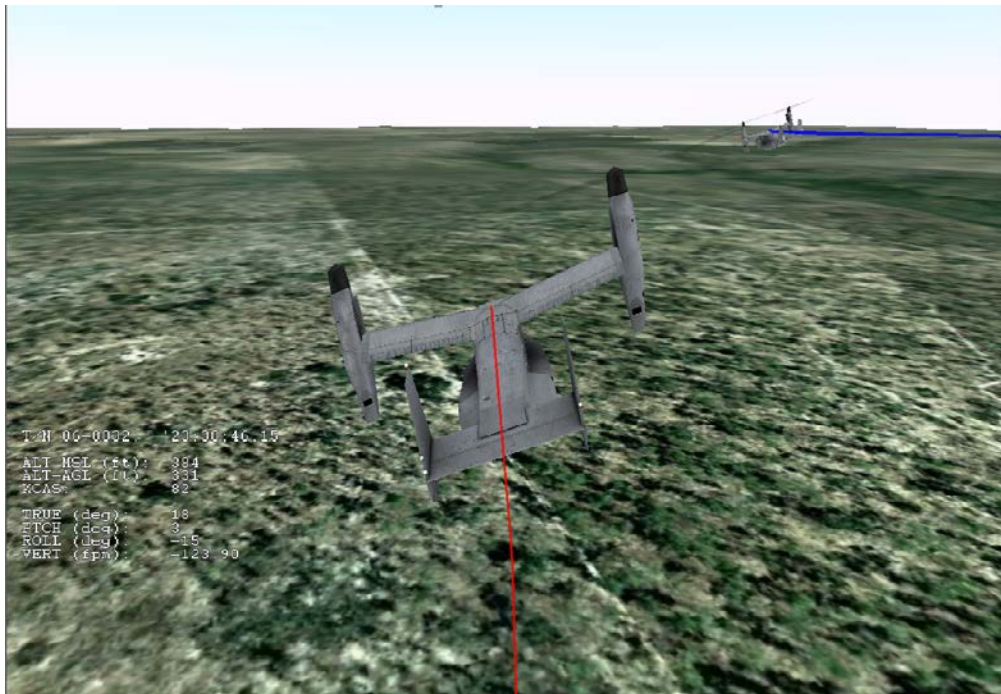
Figure 7. MF's 15-degree Angle of Bank Turn to Heading 310

AA-11). The MF overflowed the southeast corner of A-78 and, at 2338Z, executed a left turn at 15 degrees of bank to the northwest on a heading of 310 degrees to finish the clearing pass (See Figures 7 and 8) (Tabs V-2.6, AA-10 and AA-12). The MF confirmed A-78 was clear of all people and animals and that the MF was safe to begin live-fire operations (Tab V-9.3). Flight data gathered from the MA and MLA flight data recorders (FDR) shows that at the completion of the clearing pass, the MA was 0.2 nautical miles (NM) behind the MLA at the 7 o'clock position (aft of the MLA and 30 degrees left of the MLA's center line) (See Figure 4) (Tab AA-23).

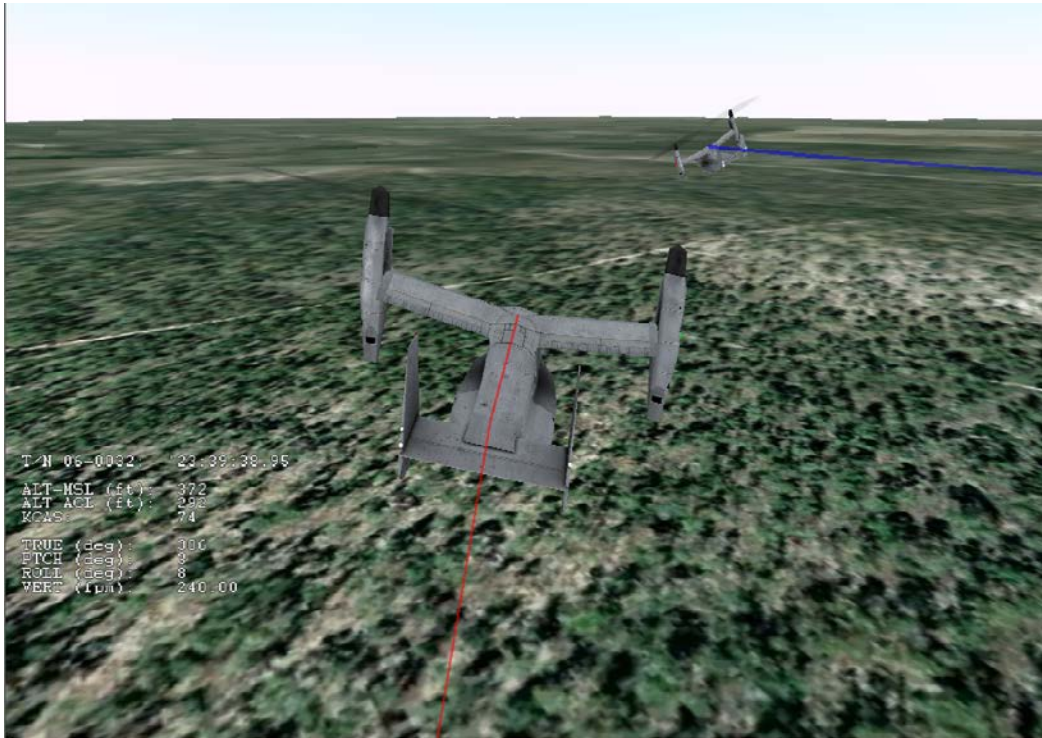
Figure 9. MA Begins Turn for Spacing

Following the clearing pass, the MLA began a left 180-degree turn at 30 degrees of bank to bring the MF to the briefed 130 degree heading (southeast) for the initial firing pass. As the MLP began his turn, the MCP began a brief right turn to fall behind the MLA, followed immediately by a 30-degree bank, left turn to maintain separation (See Figure 9) (Tabs V-2.6, AA-10 and AA-14). Although this maneuver never took the MA to the MLA's actual 6 o'clock position, the

MA did cross the MLA's turning flight path and the MLA's wake (See Figures 10 and 11) (Tab AA-15 to AA-16).

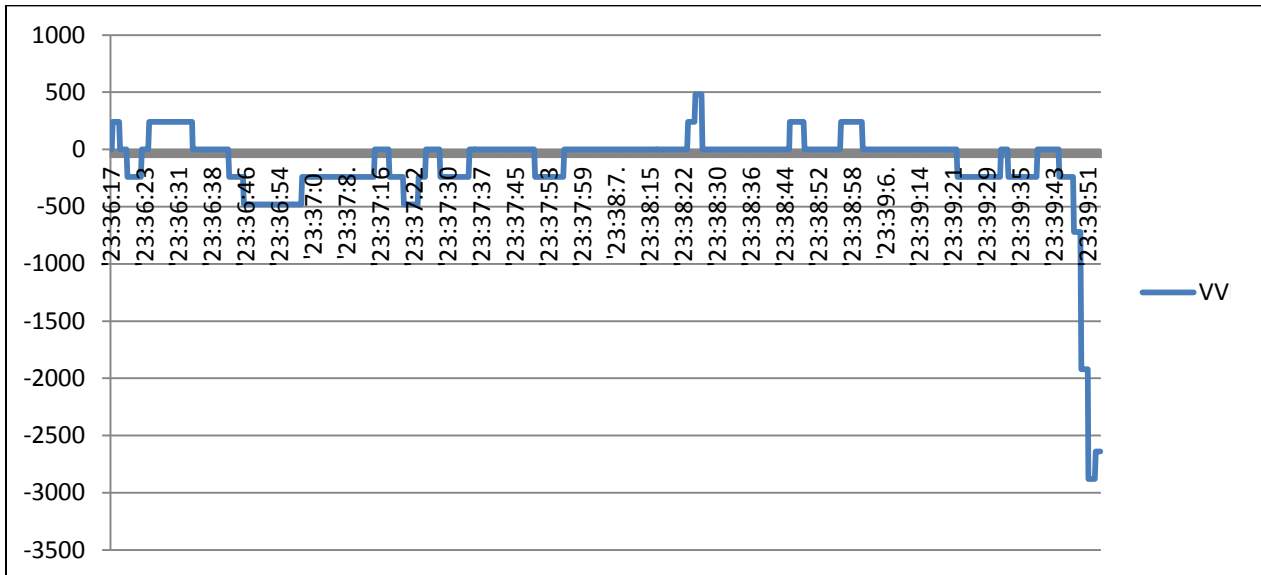
Figure 14. MA's Vertical Velocity (feet per minute)

Once the MA's left proprotor entered the MLA's wake, the MA immediately began an uncommanded roll to the left reaching a maximum of 63 degrees left bank, 23 degrees nose-low attitude and 2,880 feet per minute descent (See Figures 13 and 14) (Tab AA-21 to AA-22). The MP placed his hands on the flight controls and both he and the MCP attempted to recover the MA by immediately applying full right cyclic and then full thrust control lever (TCL) (Tabs V-1.6, V-2.7 and AA-26). The MC began to regain lateral control authority of the MA after they were clear of the MLA's flight path; however, the MA was still descending at a rate of 2,600 feet per minute (Tabs V-1.6, V-2.7 and AA-22). The MC stabilized the MA in a wings-level flight condition prior to impact but was unable to arrest the descent rate before the MA entered the 80- to 100-foot trees on the range (Tabs S-6 to S-7, V-1.6 and V-2.7).
