NTSB/SIR-12/01
PB2012-917003

Highway Special Investigation Report

Wrong-Way Driving

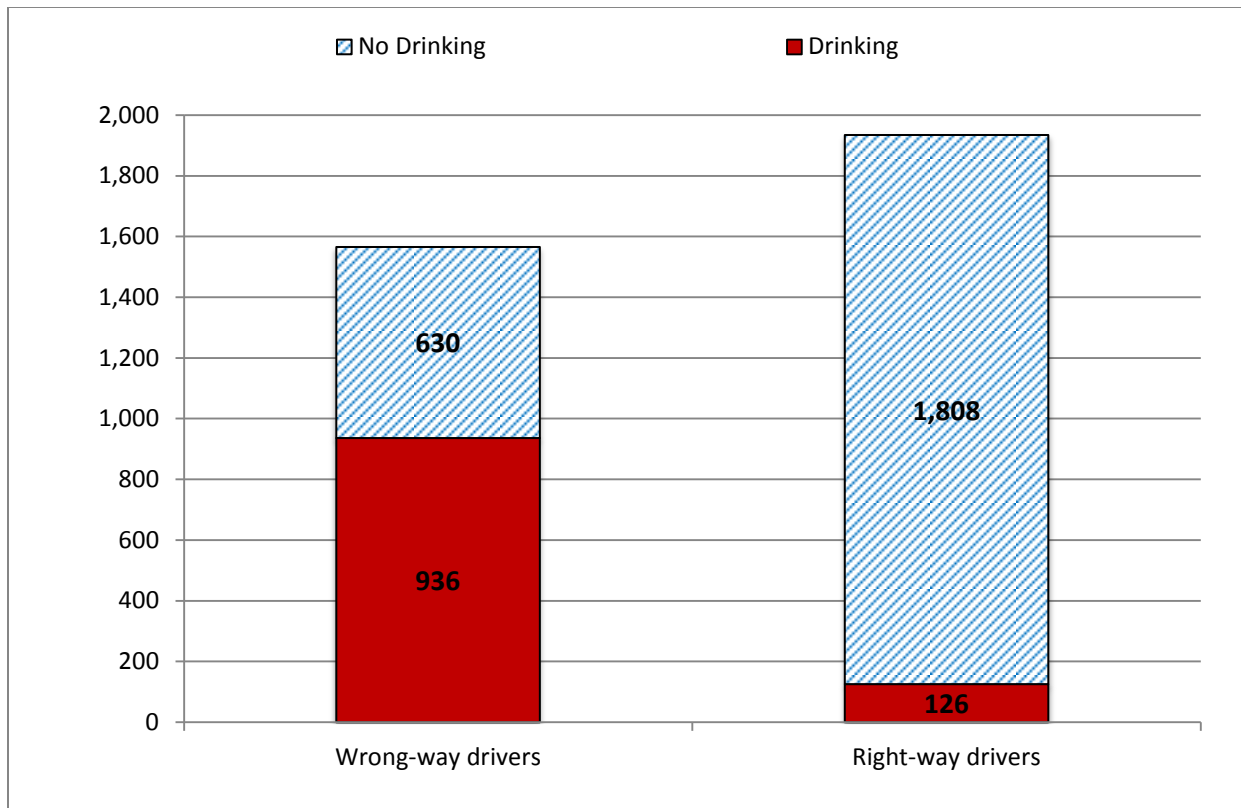
To determine the extent of alcohol impairment among wrong-way drivers, the NTSB examined drivers' blood alcohol concentration (BAC) levels and police officer assessments of alcohol impairment.²⁵ There were 1,566 wrong-way drivers in the multiyear FARS data set; of these, 936 wrong-way drivers (60 percent) had indications of alcohol involvement. By comparison, only 126 other drivers (6.5 percent) in the same fatal wrong-way crashes (referred to in figure 2 [see below] as "right-way drivers") had alcohol involvement. (Note: For the purpose of the analysis, the right-way drivers are those traveling in the legal direction of traffic flow and involved in the collision with the vehicle traveling in the wrong direction. These right-way drivers represent a random sample of drivers operating on controlled-access highways at the time of the collision.)

Figure 2. FARS data indicating drivers involved in fatal wrong-way collisions on divided highways who showed indications of alcohol use; comparison between wrong-way and right-way driver drinking data (2004–2009). (Note: The larger number of right-way drivers reflects the fact that a wrong-way driver may collide with more than one vehicle.)

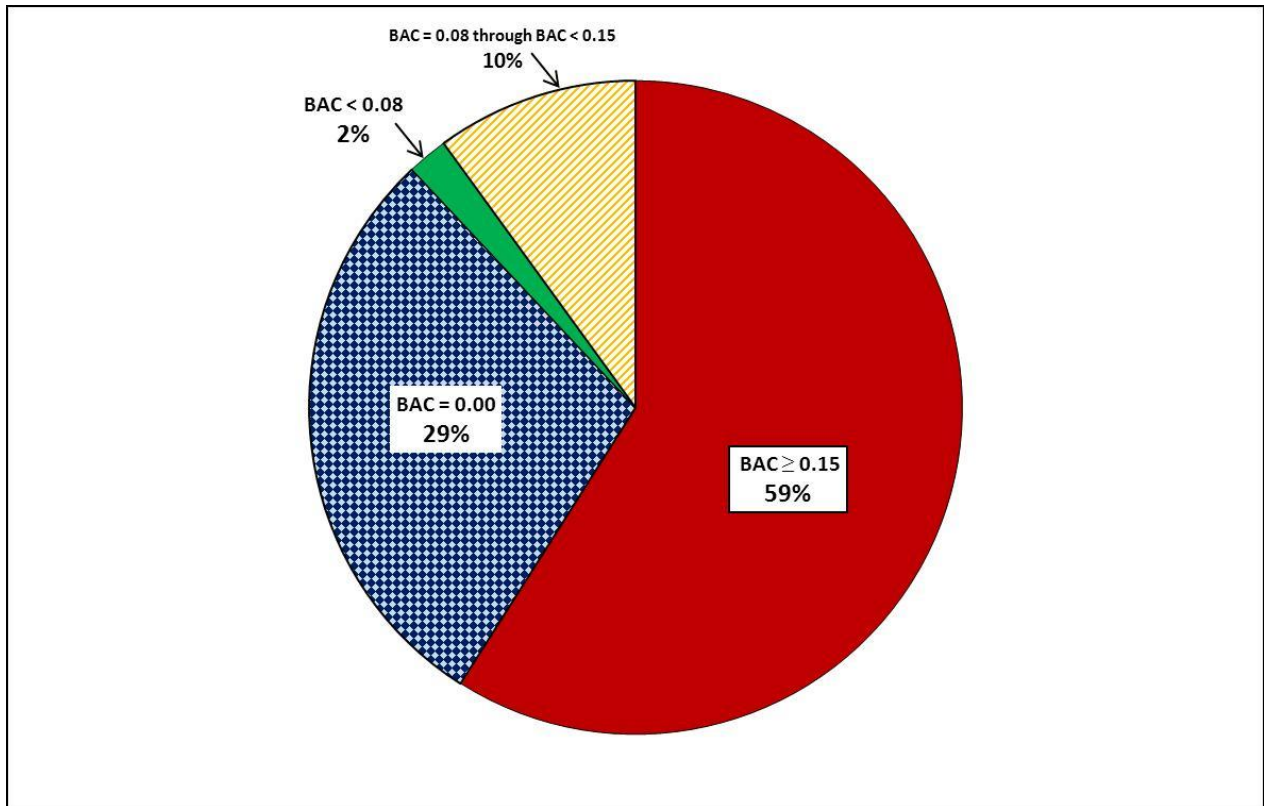
Although specific state laws and penalties vary, all states define alcohol-impaired driving based on a BAC at or above 0.08 percent. For the 1,150 drivers whose BAC was reported, 114 (10 percent) had BACs between 0.08 and 0.15, and 684 (59 percent) had a “high BAC” at or above 0.15.²⁶ (See figure 3.)

Figure 3. NTSB analysis of FARS data (2004–2009) showing reported BAC levels of wrong-way drivers.

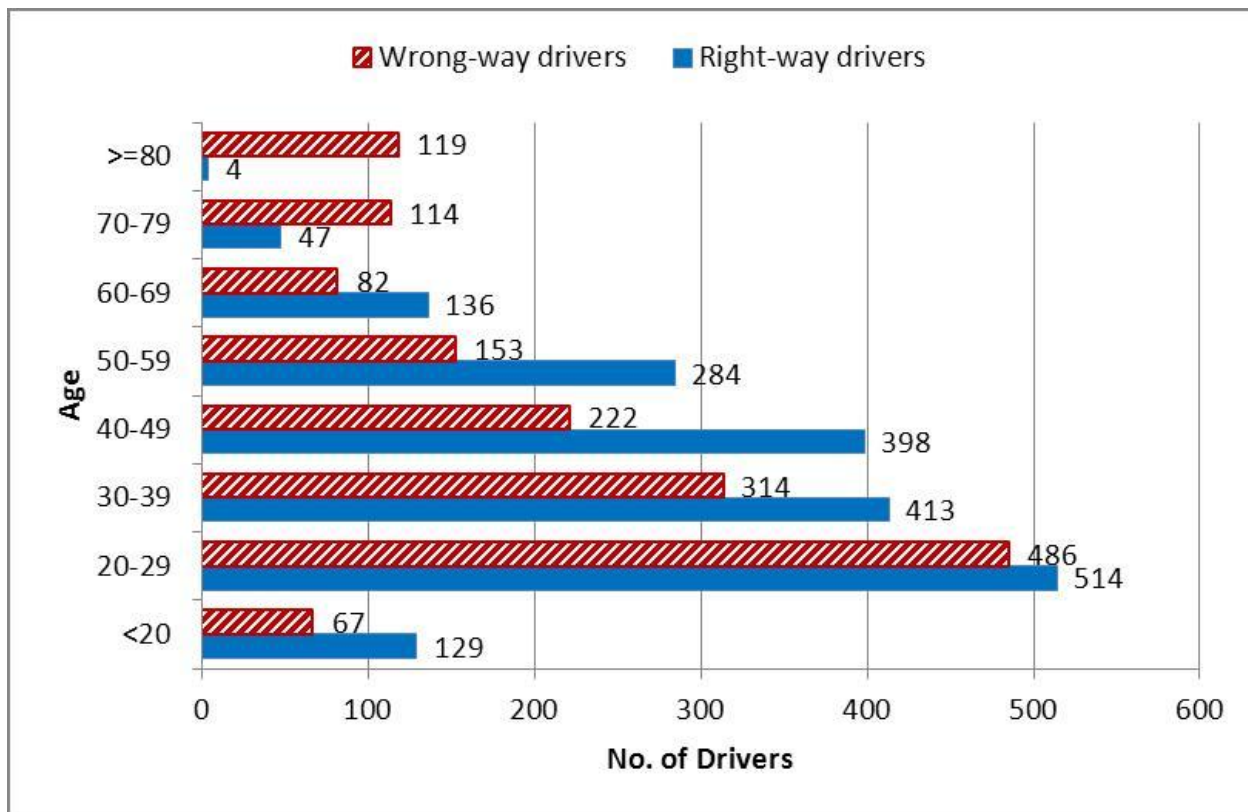
Figure 4. Ages of drivers involved in fatal wrong-way collisions on divided highways; comparison between wrong-way and right-way driver ages (2004–2009). (Note: The larger number of right-way drivers reflects the fact that a wrong-way driver may collide with more than one vehicle.)

The majority of wrong-way drivers were between the ages of 20 and 50. There were fewer wrong-way than right-way drivers in every 10-year age category below age 70. In the age categories above 70, however, the opposite was true, and the number of wrong-way drivers greatly exceeded the number of right-way drivers; there were almost 2 ½ times more wrong-way drivers for ages 70–79, and almost 30 times more for ages above 80.

The NTSB's FARS analysis determined that drivers over the age of 70 are over-represented in fatal wrong-way crashes. Figure 4 in section 1 of this report shows the ages of wrong-way drivers involved in fatal collisions (2004–2009) and, as a comparative sample, looks at right-way drivers who were involved in those collisions. The bar chart shows that right-way drivers over the age of 70 represent less than 3 percent of all right-way drivers involved in fatal wrong-way collisions, while wrong-way drivers over the age of 70 account for about 15 percent of the wrong-way drivers involved in such collisions.

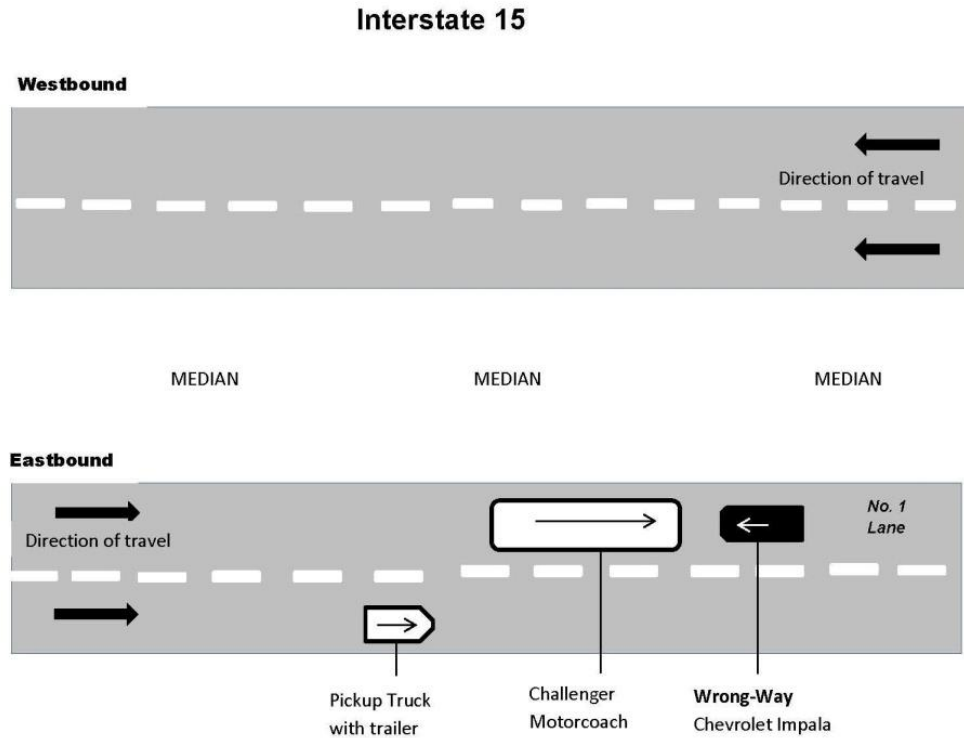
Figure A-1. Highway and vehicle elements of Baker, California, wrong-way collision. (Note: Diagram is not based on accident mapping or drafted to scale.)

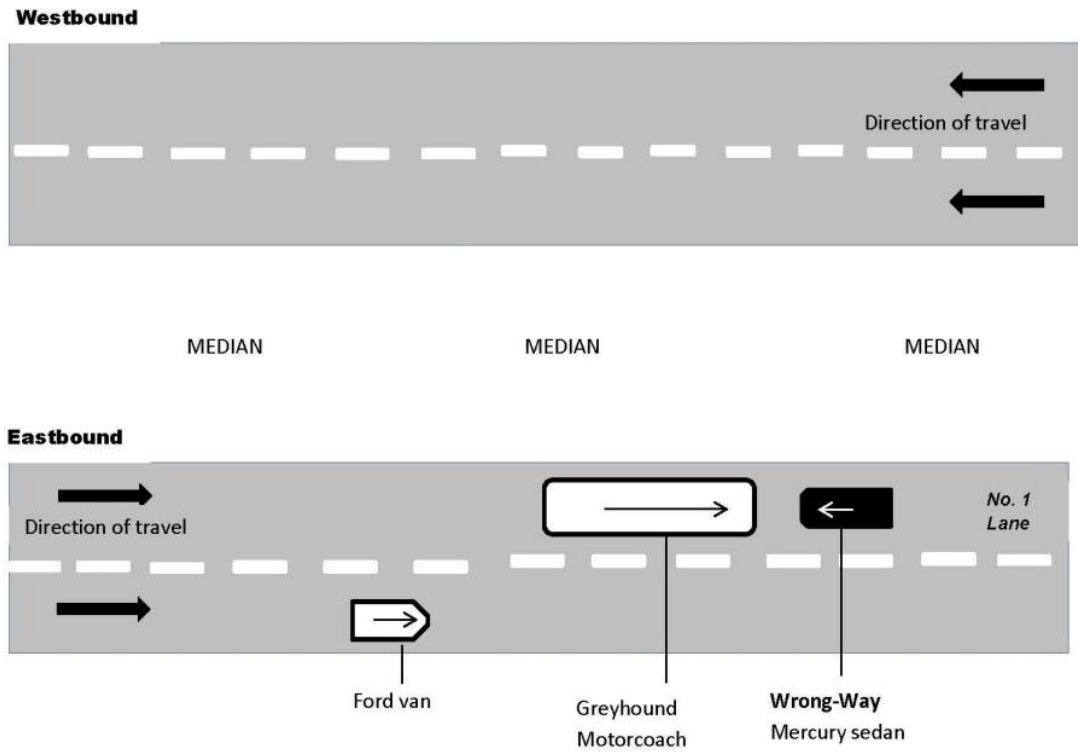
Dulles, VA, Airport Access Road

Figure A-2. Highway and vehicle elements of Dulles, Virginia, wrong-way collision. (Note: Diagram is not based on accident mapping or drafted to scale.)

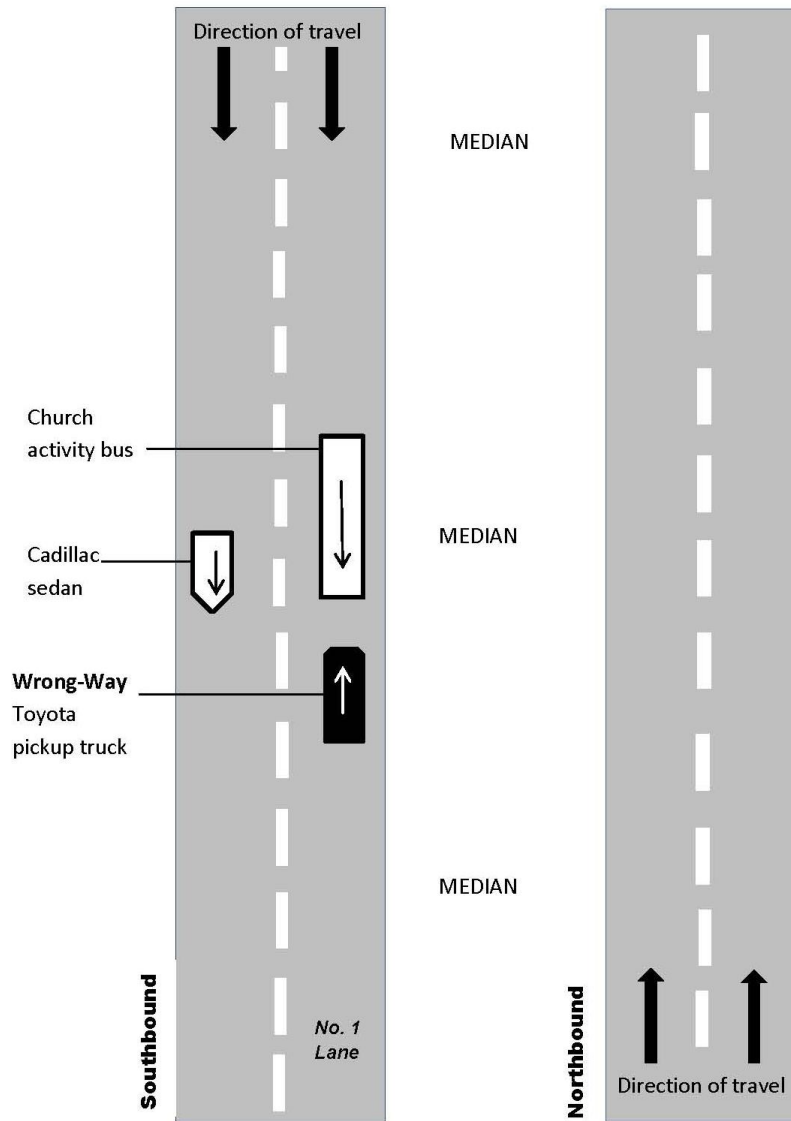
Interstate 71

Figure A-3. Highway and vehicle elements of Carrollton, Kentucky, wrong-way collision. (Note: Diagram is not based on accident mapping or drafted to scale.)

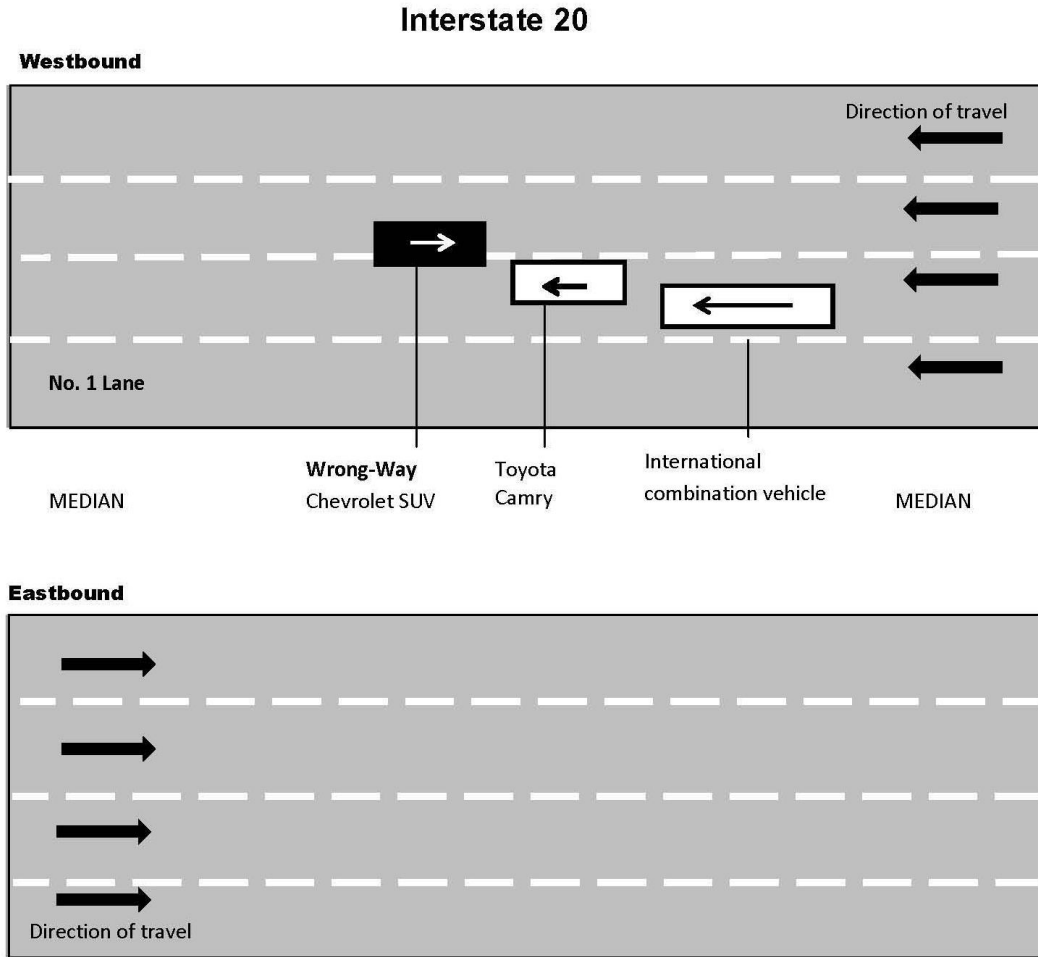
Figure A-4. Highway and vehicle elements of Arlington, Texas, wrong-way collision. (Note: Diagram is not based on accident mapping or drafted to scale.)

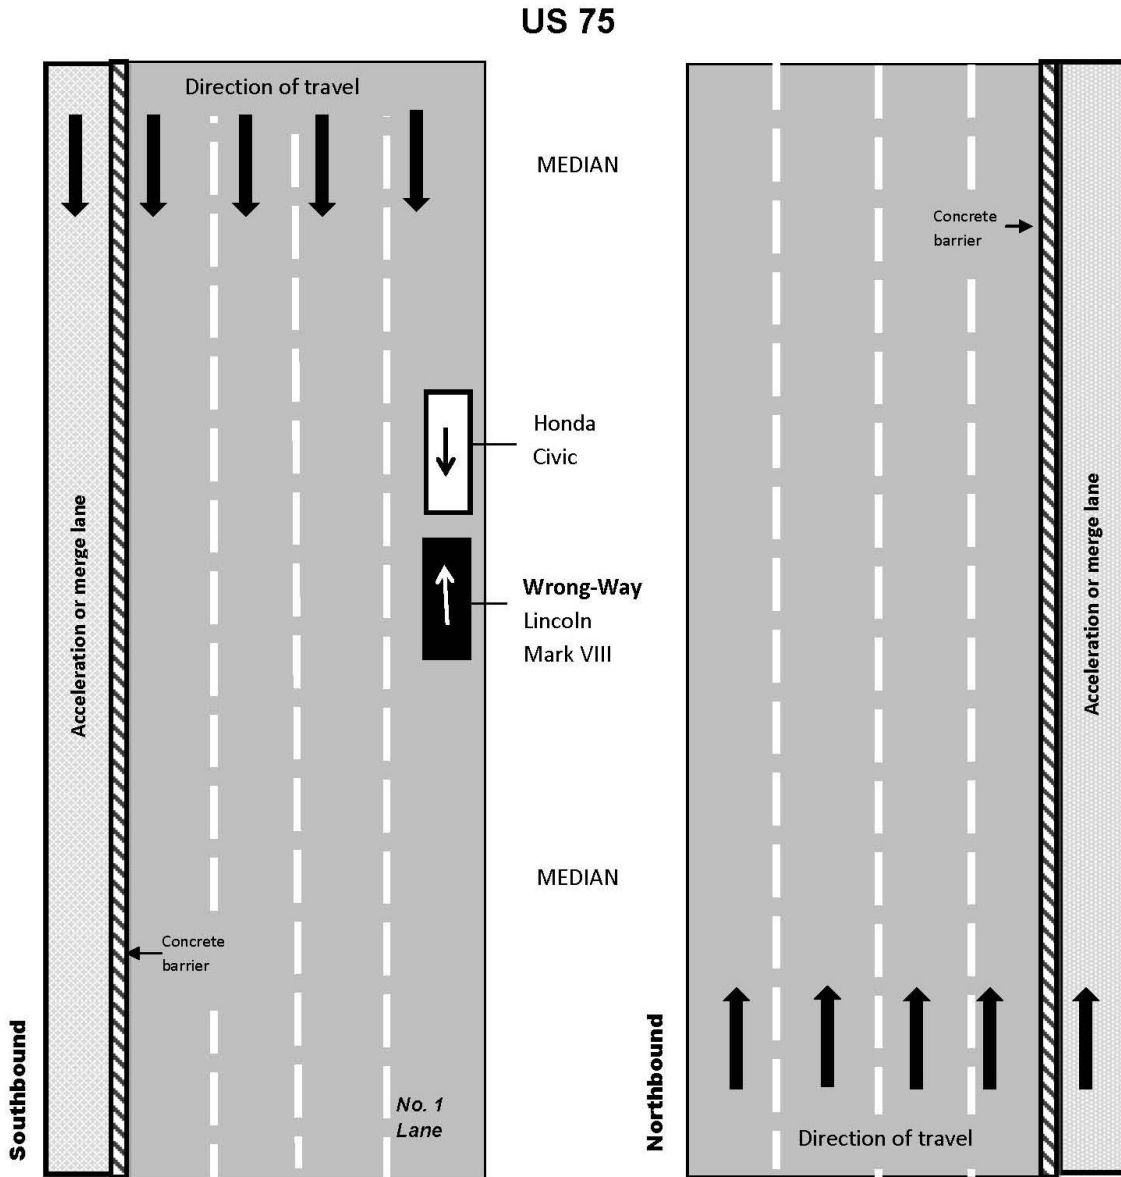
Figure A-5. Highway and vehicle elements of Dallas, Texas, wrong-way collision. (Note: Diagram is not based on accident mapping or drafted to scale.)

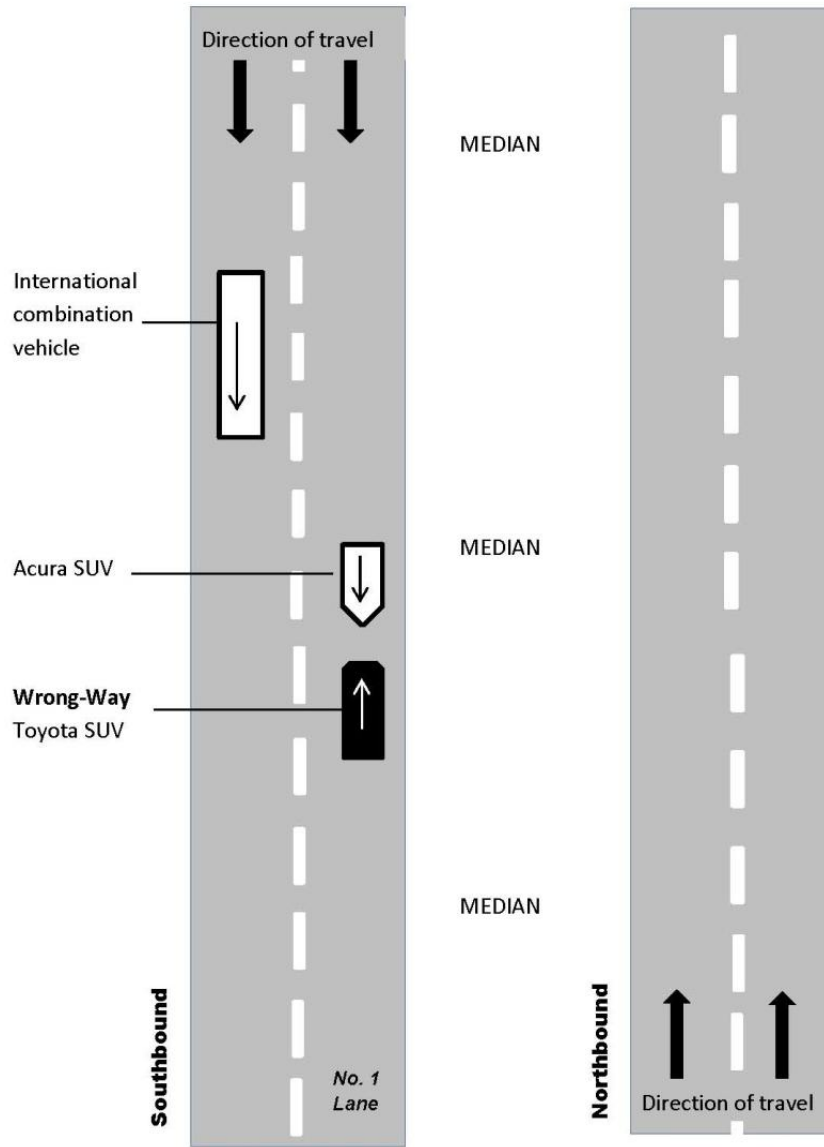
Interstate 25

Figure A-6. Highway and vehicle elements of Fountain, Colorado, wrong-way collision. (Note: Diagram is not based on accident mapping or drafted to scale.)

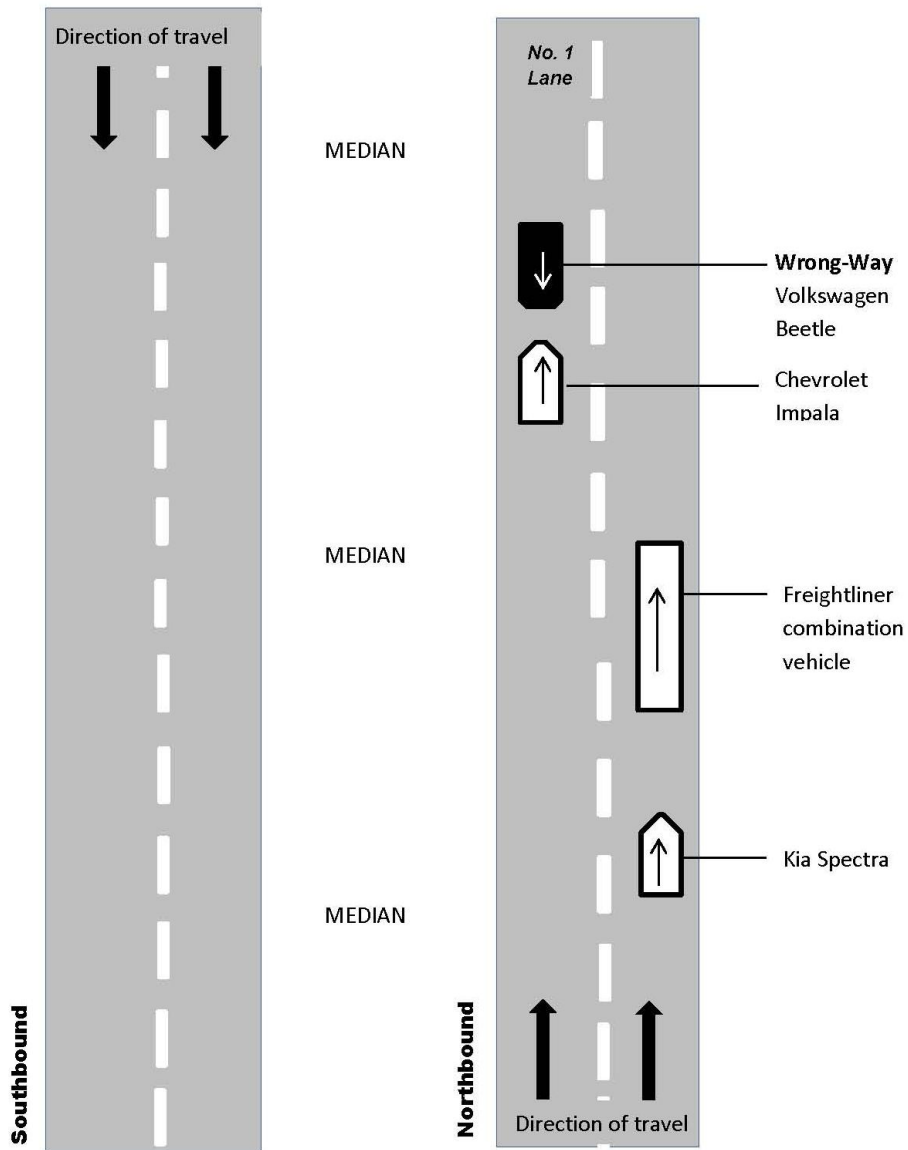
Interstate 43

Figure A-7. Highway and vehicle elements of Beloit, Wisconsin, wrong-way collision. (Note: Diagram is not based on accident mapping or drafted to scale.)

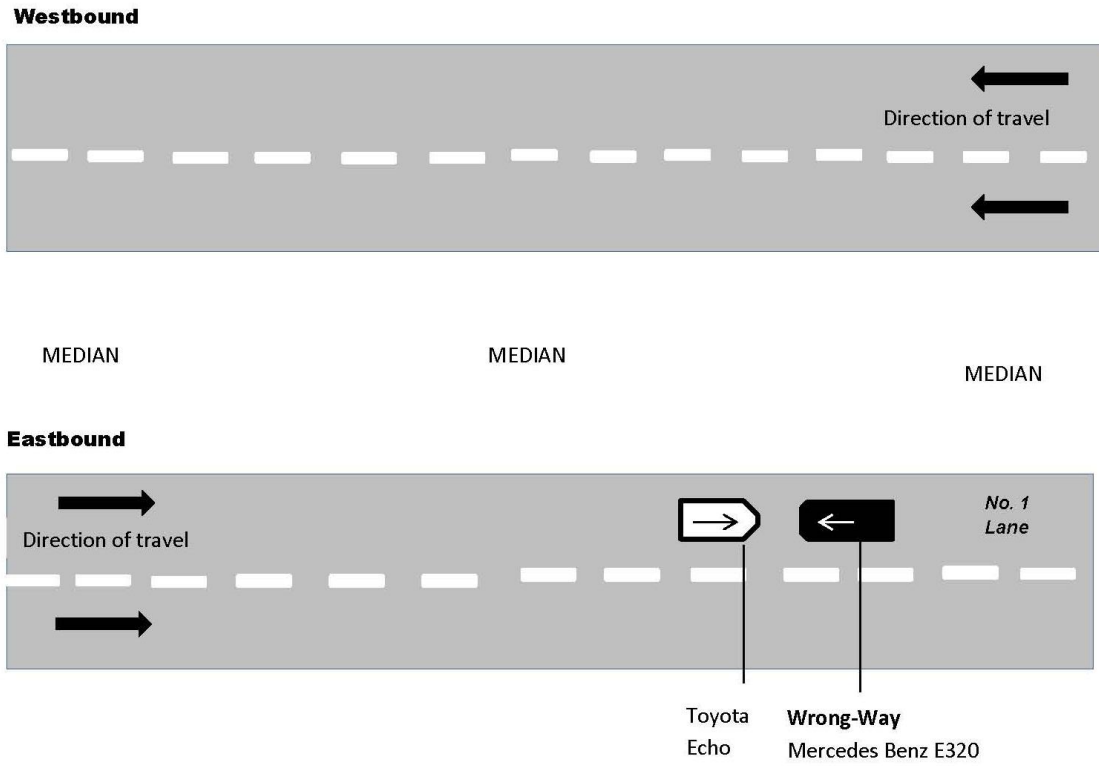
Interstate 80

Figure A-8. Highway and vehicle elements of Fernley, Nevada, wrong-way collision. (Note: Diagram is not based on accident mapping or drafted to scale.)
