# Herbert C. Hoover Building Renovation

## Washington, DC

# What Flooding?

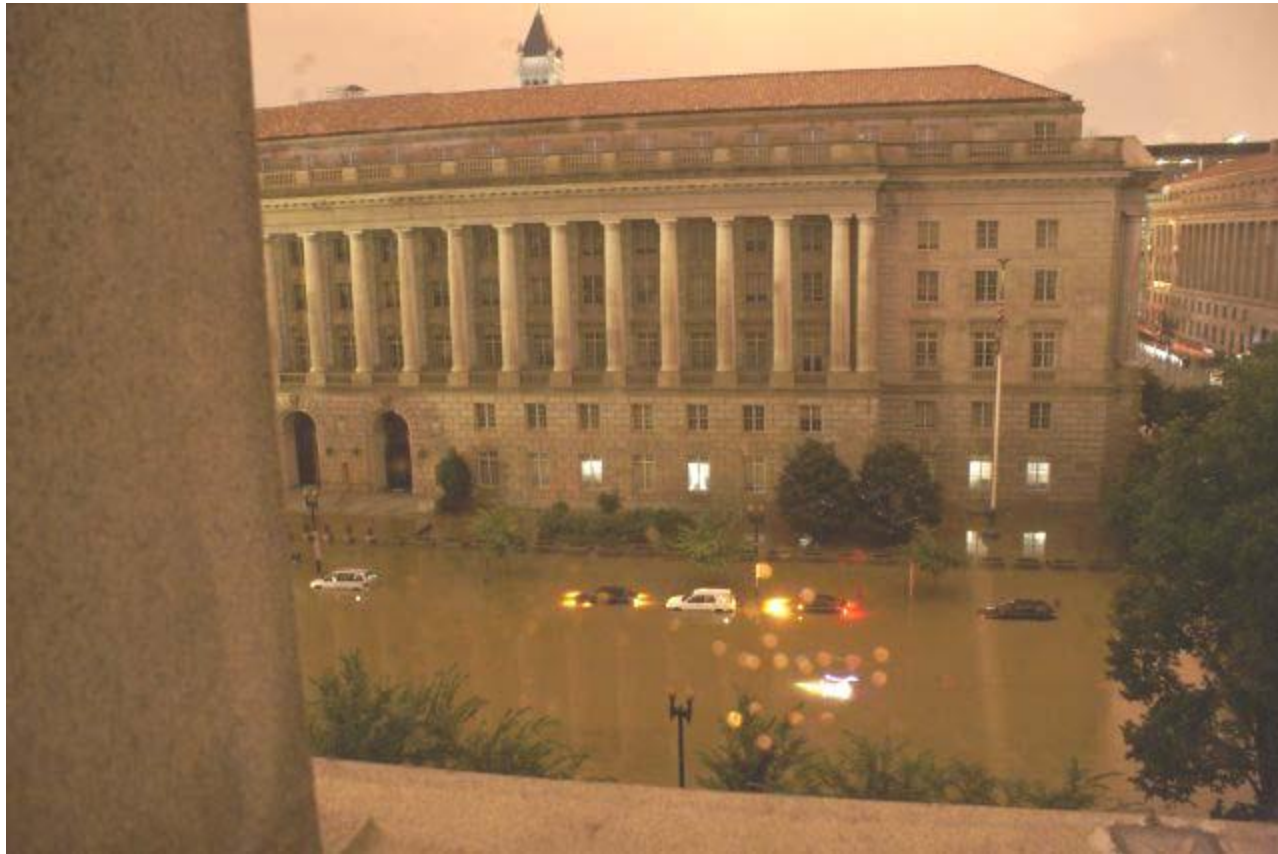
- History of flooding in subbasement areas.

- Flooding into basement areas of the building from the GSA Steam Tunnels.

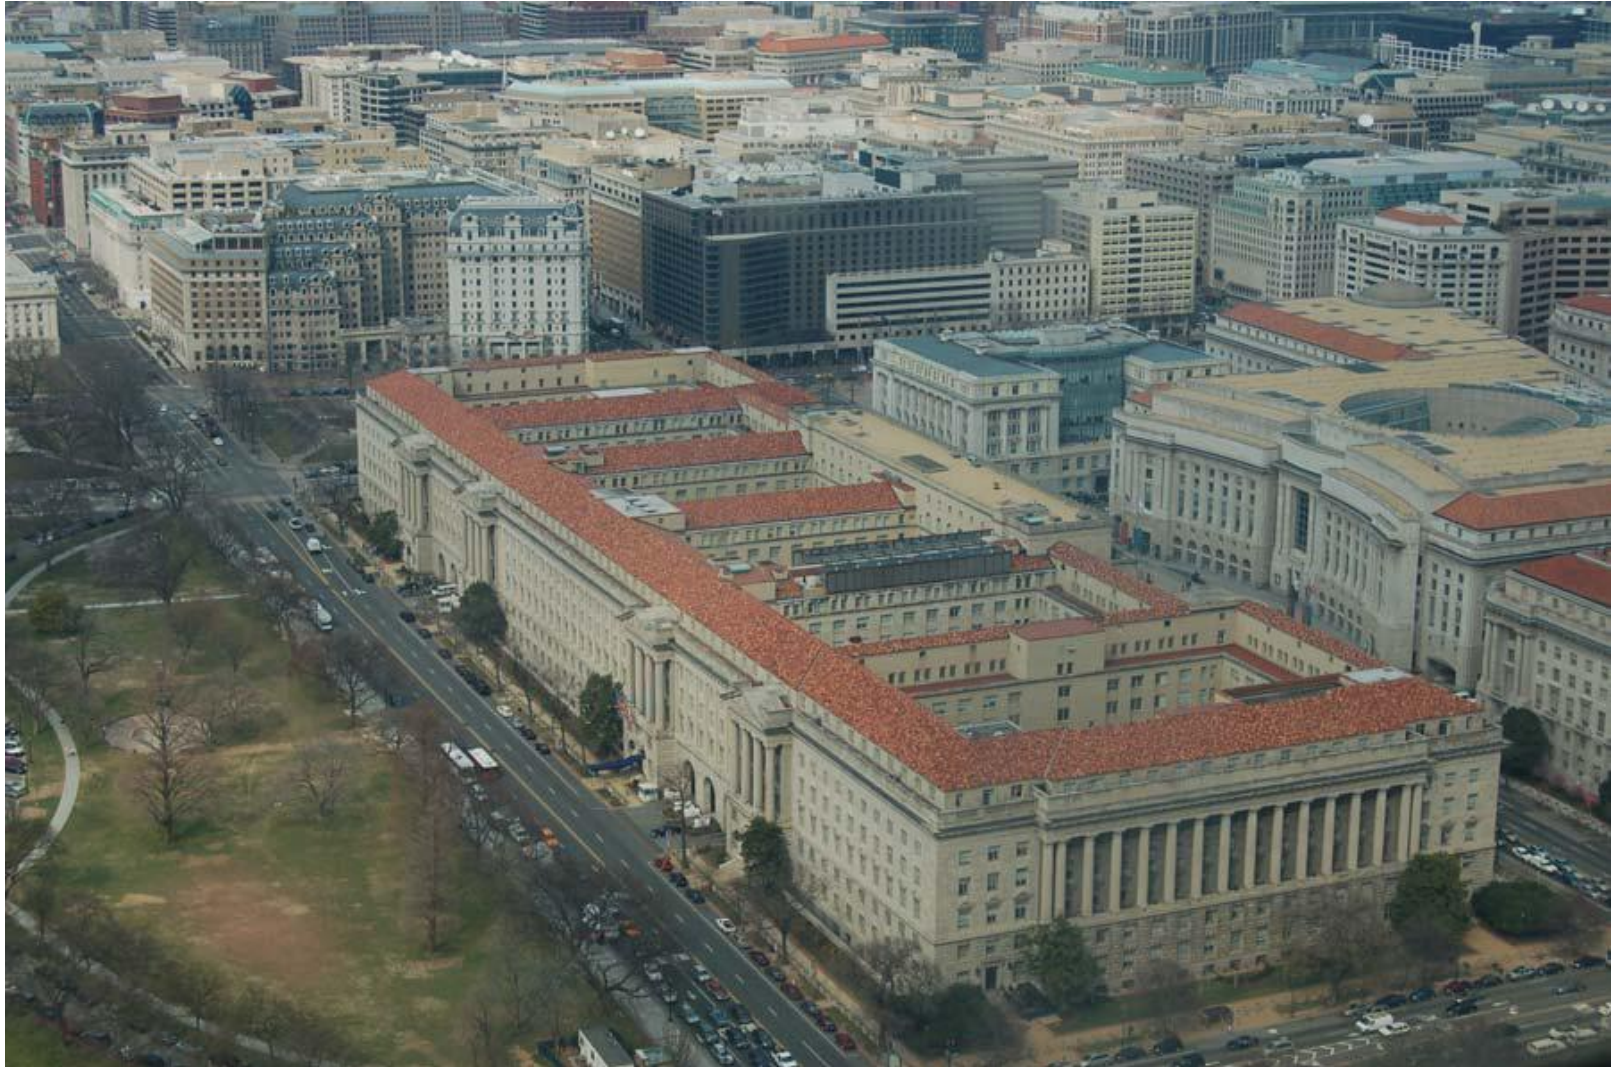
- Main electrical controls and emergency power are all located in the EEE.
- EEE location selected was new construction on top of 1<sup>st</sup> floor structure. The EEE occupies floors 2 thru 4, & will therefore not be impacted by flood events.
