CHAPTER 5 – EXAMINATION OF FIELD DATA

5.1 STANDARDIZED PRESENTATION OF THE DEFECT CHARACTERIZATION AND IMAGING RESULTS

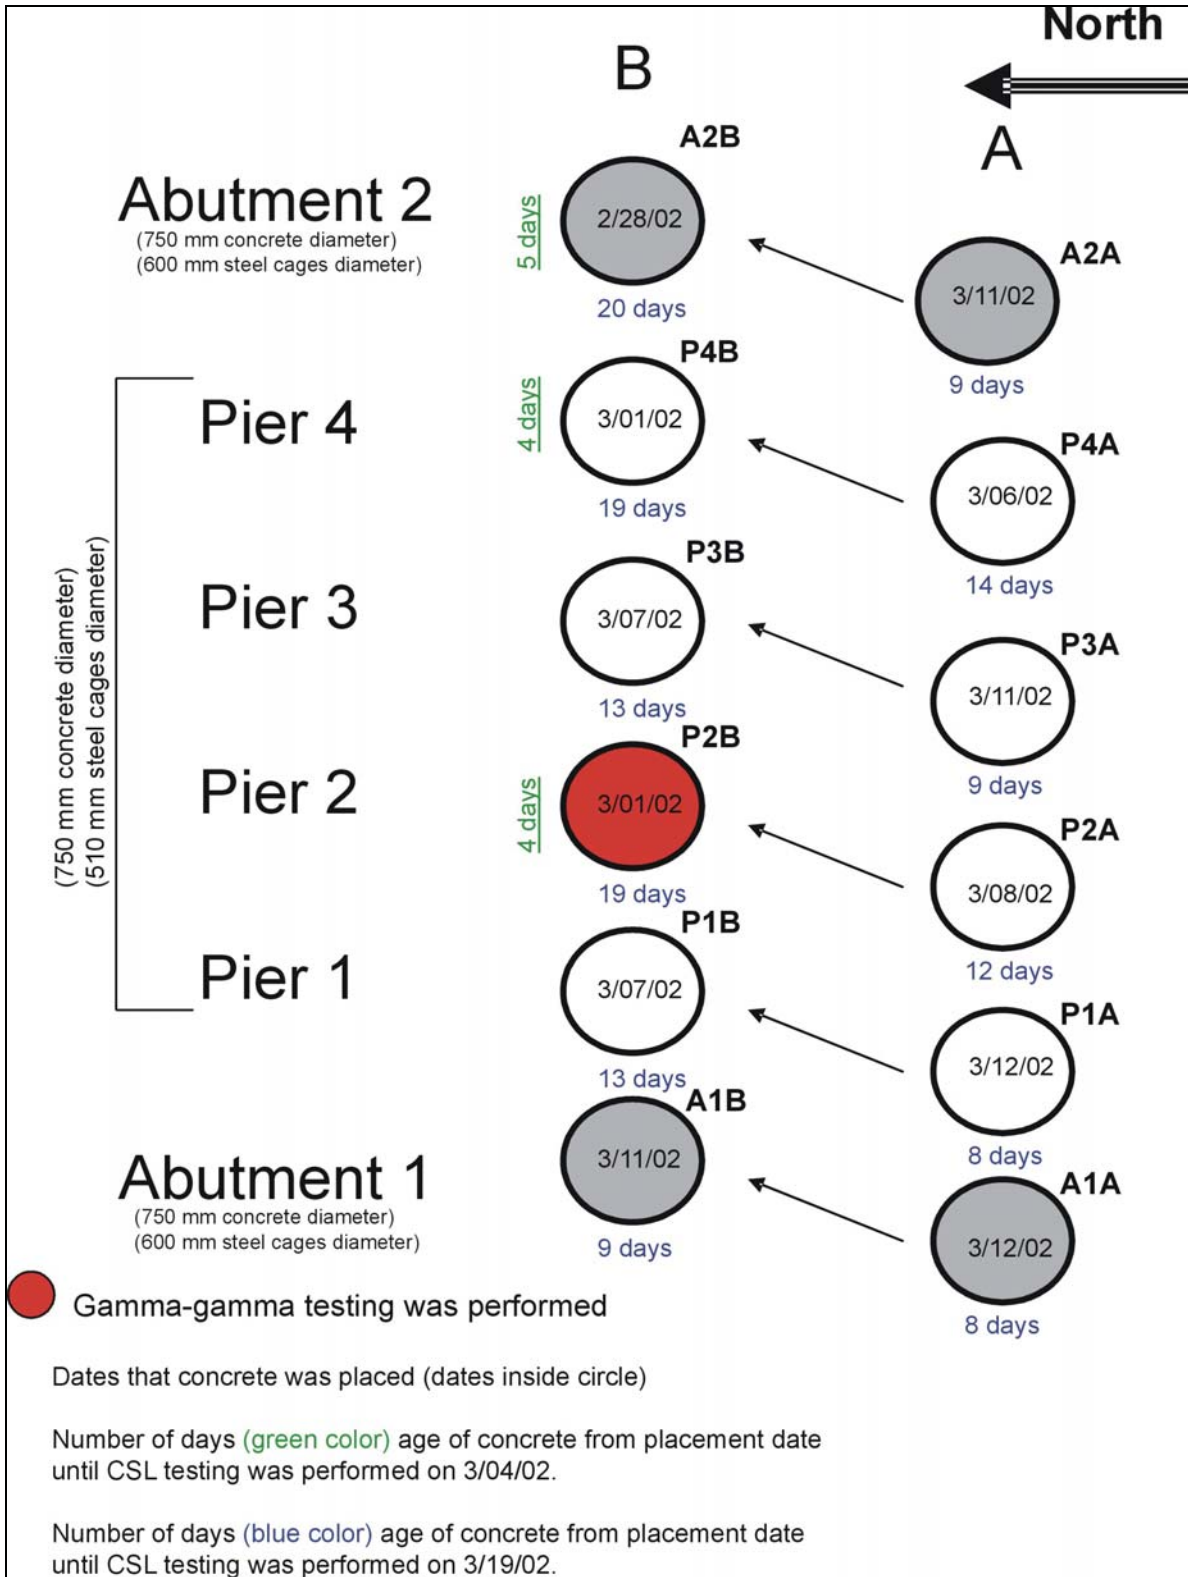
Figure 48. Schematic. Plan View of the Drilled Shafts at the Jim Camp Bridge, AZ.

As indicated in Figure 48, all shafts were tested during February – March, 2002 using only zero offset CSL. CSL data was collected by EarthSpectives, Inc. In addition to standard CSL, subsequently gamma-gamma density logging (GDL) data was collected by AMEC, Inc for Pier 2, Shaft B. The GDL logs were acquired to evaluate if the concrete integrity was jeopardized by problems that occurred during shaft construction.

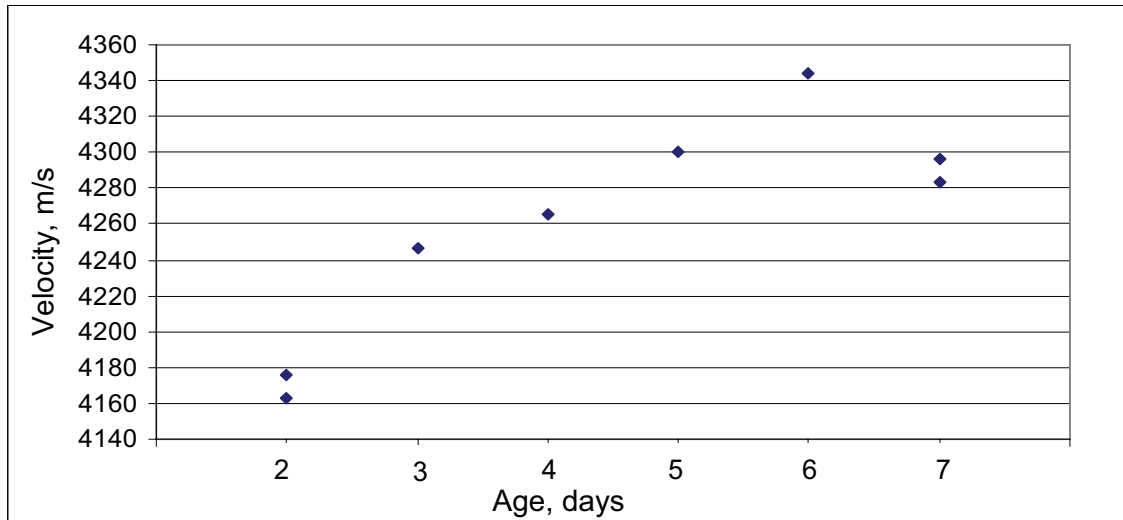
Figure 49. Graph. UPV Velocities Versus Age.

days of age. The velocities were measured on the concrete cylinders of 0.1524 x 0.3048 m (6 x 12 in) in size. Three measurements were taken from each cylinder: at the center, and from the left and right sides with the results presented in Figure 49. An average UPV velocity of 4,280 m/s is indicated for the laboratory samples. CSL testing was performed with more than 7 days of concrete age. However, CSL velocities from the drilled shafts indicated average velocity values less than the average 7-day UPV velocity of 4,280 m/s (please refer to section 4.2).
