**Collision with Trees and Crash Short of the  
Runway, Corporate Airlines Flight 5966  
BAE Systems BAE-J3201, N875JX  
Kirksville, Missouri  
October 19, 2004**

**Aircraft Accident Report**

**NTSB/AAR-06/01**

**NTSB/AAR-06/01  
PB2006-910401  
Notation 7694A  
Adopted January 24, 2006**

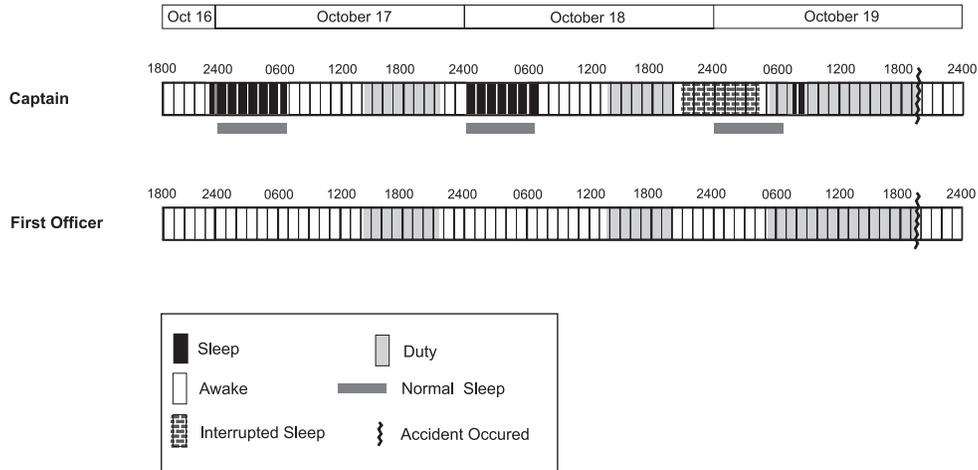
On the third day of the trip sequence (October 19), the pilots' duty period began about 0514 at BRL after about 9 hours off duty.<sup>23</sup> They departed on the first flight of the day about 0544 and flew to STL, where they arrived about 0644. The pilots were originally scheduled to depart STL again about 0930, fly to UIN and then return to STL; however, those two flights were cancelled because of poor weather conditions.<sup>24</sup> They then resumed their normal flight schedule, departing STL again about 1236. They flew to IRK and returned to STL, where they arrived about 1453. The pilots departed STL again about 1513, flew to BRL, and returned to STL, where they arrived about 1745. The accident flight departed STL about 1842. The pilots were flying their sixth flight of the day and had flown about 6 hours and 14 minutes in 14 hours and 31 minutes of duty time when the accident occurred. Figure 1 is a graph showing the estimated duty schedules for both pilots and the estimated sleep schedule

**Figure 1.** The estimated duty schedules for both pilots and the estimated sleep schedule for the captain.

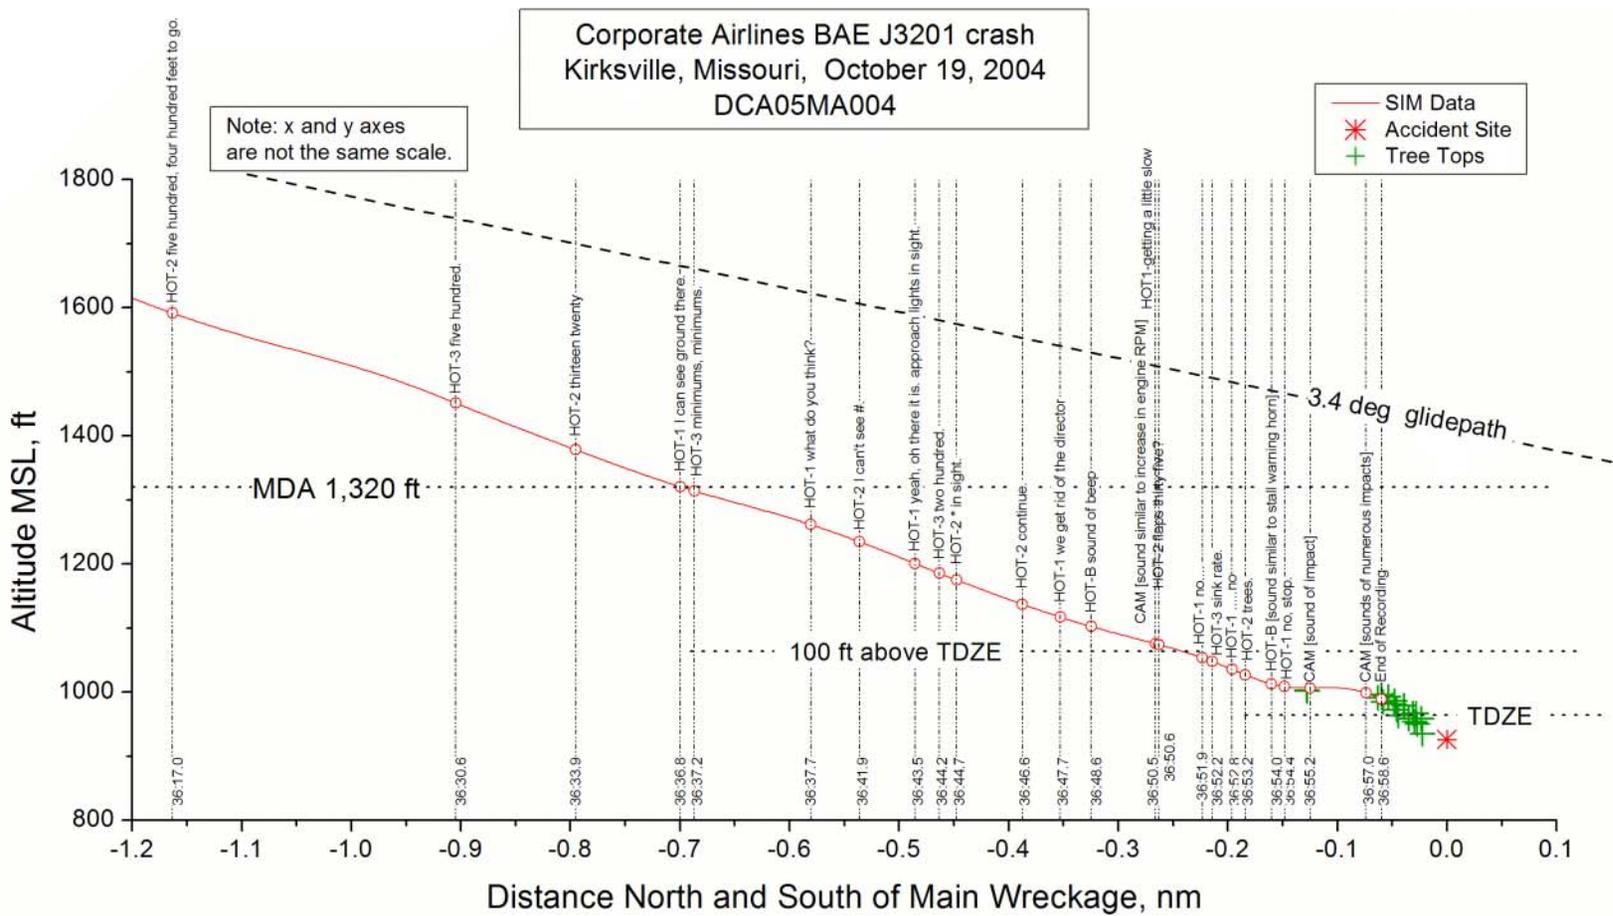
Safety Board investigators used available data from the accident airplane’s FDR and CVR, radar data from IRK Air Route Surveillance Radar, atmospheric data from the IRK ASOS, and physical evidence from the accident scene to calculate the airplane’s flightpath, angle of attack, and power settings during the airplane’s descent on the accident approach. The Board’s study indicated that the airplane did not appear to deviate in flightpath angle or heading until just before it impacted the first set of trees at an altitude of about 996 feet msl. Further, the study indicated that the airplane was in a steady descent with minimal engine power settings before the initial tree strike. Figure 6 shows the airplane’s altitude profile during the accident approach with the airport/runway location shown. Figure 7 shows the airplane’s altitude profile during the accident approach with CVR comments overlaid.

**Figure 6.** The accident airplane’s descent profile during the accident approach with the airport/runway location shown.

The following altitudes are also shown: MDA, 100 feet above the TDZE, and the TDZE. Additionally, a 3.4° visual glidepath to the airport is shown for reference purposes only.

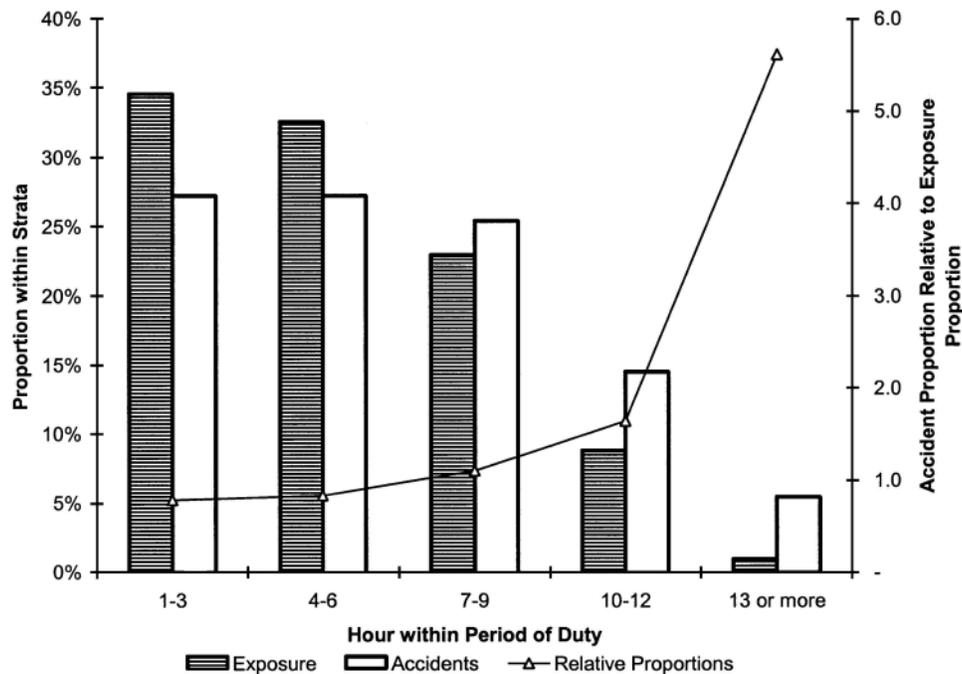
Additionally, accident data<sup>96</sup> indicate that pilots who worked schedules that involved 13 or more hours of duty time showed an accident rate that was several times higher than that of pilots working shorter schedules. The research reported that there was a "discernable pattern of increased probability of an accident the greater the hours of duty time for commercial aircraft pilots in the United States." Figure 8 shows data from 55 human factors-related accidents involving U.S. air carriers between 1978 and 1999, as well as exposure data on pilot work patterns obtained from 10 airlines. About 1 percent of the schedules reviewed involved 13 or more hours of duty time; however, pilots flying these schedules had accident rates several times higher than pilots flying schedules with shorter duty days.

**Figure 8.** Aviation accident data from 55 accidents involving U.S. air carriers between 1978 and 1999, indicating that accidents are more prevalent as the length of the pilots' duty period increases.
