Crash After Encounter with Instrument Meteorological Conditions During Takeoff from Remote Landing Site

New Mexico State Police
Agusta S.p.A. A-109E, N606SP
Near Santa Fe, New Mexico
June 9, 2009

NTSB/AAR-11/04
PB2011-910404

Aircraft Accident Report

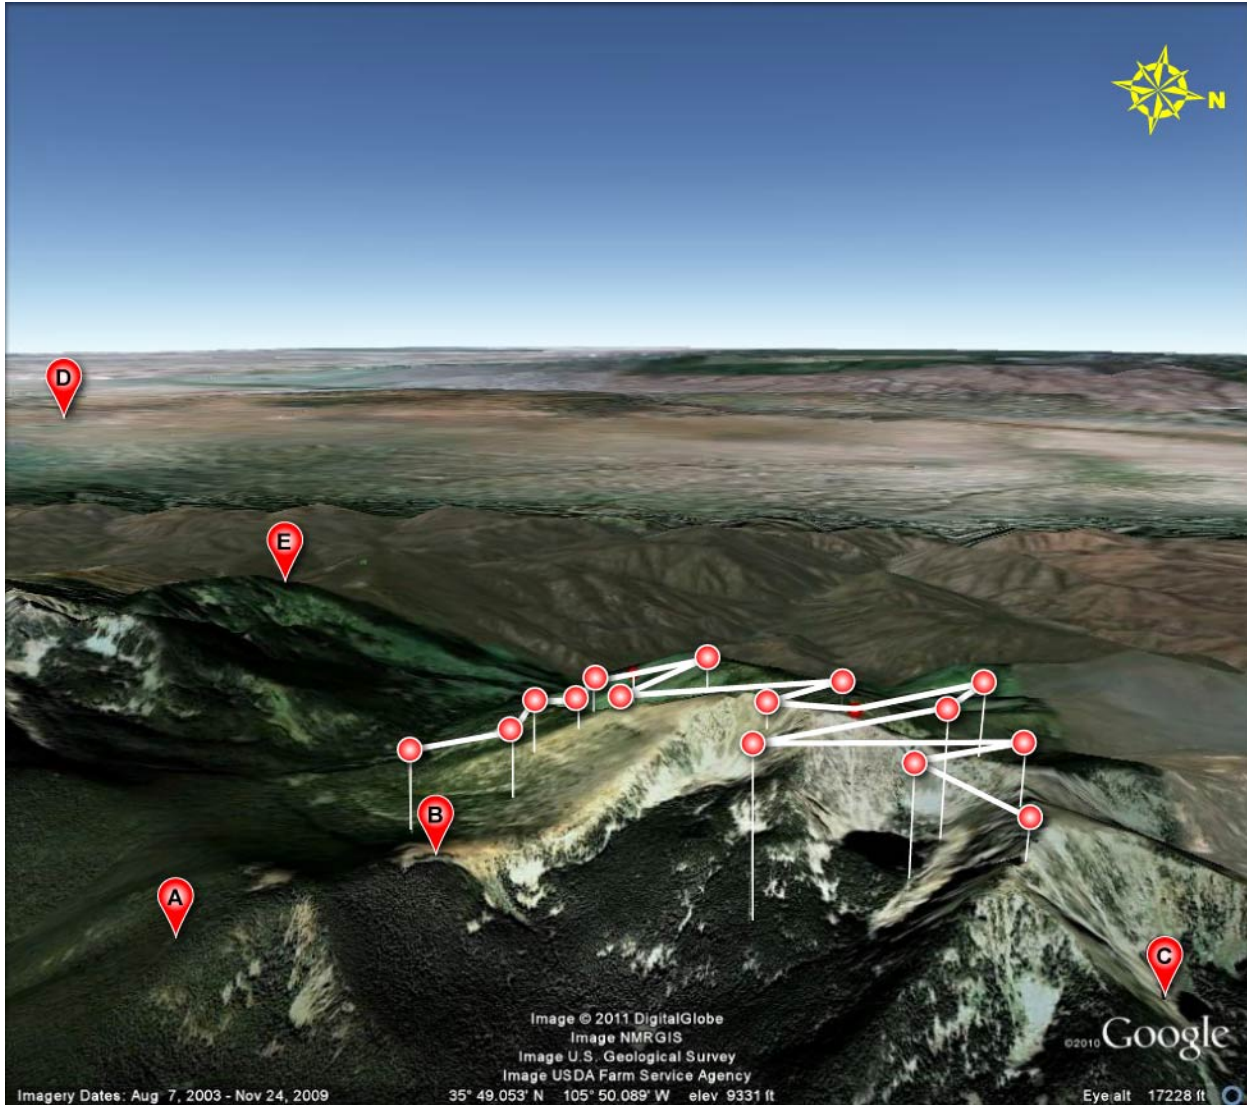
The spotter stated that the pilot took off and began to maneuver the helicopter in the direction that he had pointed; however, the spotter stated that, almost immediately after takeoff, the helicopter was in the clouds with “zero visibility” and that the flight was very turbulent. The helicopter appeared on radar¹⁵ at 2132:48, and numerous radar targets for the helicopter were recorded before the last radar target was recorded at 2135:25.¹⁶ The radar data indicated that the helicopter initially headed northwest from the remote landing site. Subsequently (beginning a little more than 1 minute after the helicopter first appeared on radar), the data indicated that the helicopter began to fly erratically in a northeasterly direction and to climb, crossing terrain as high as 12,500 feet before descending rapidly near the crash site. See figure 1 for a map with the pertinent radar data shown.¹⁷

Figure 1. Google Earth map showing pertinent helicopter radar data and other points of interest near the accident site.

Note: Helicopter radar data are indicated by red dots connected by white lines. The map also shows the hiker's approximate location (A); the helicopter's likely landing zone, confirmed by the spotter (B); the main wreckage location (C); SAF (D); and the approximate location of the SAR IB (E). A compass showing north is located in the upper left corner.

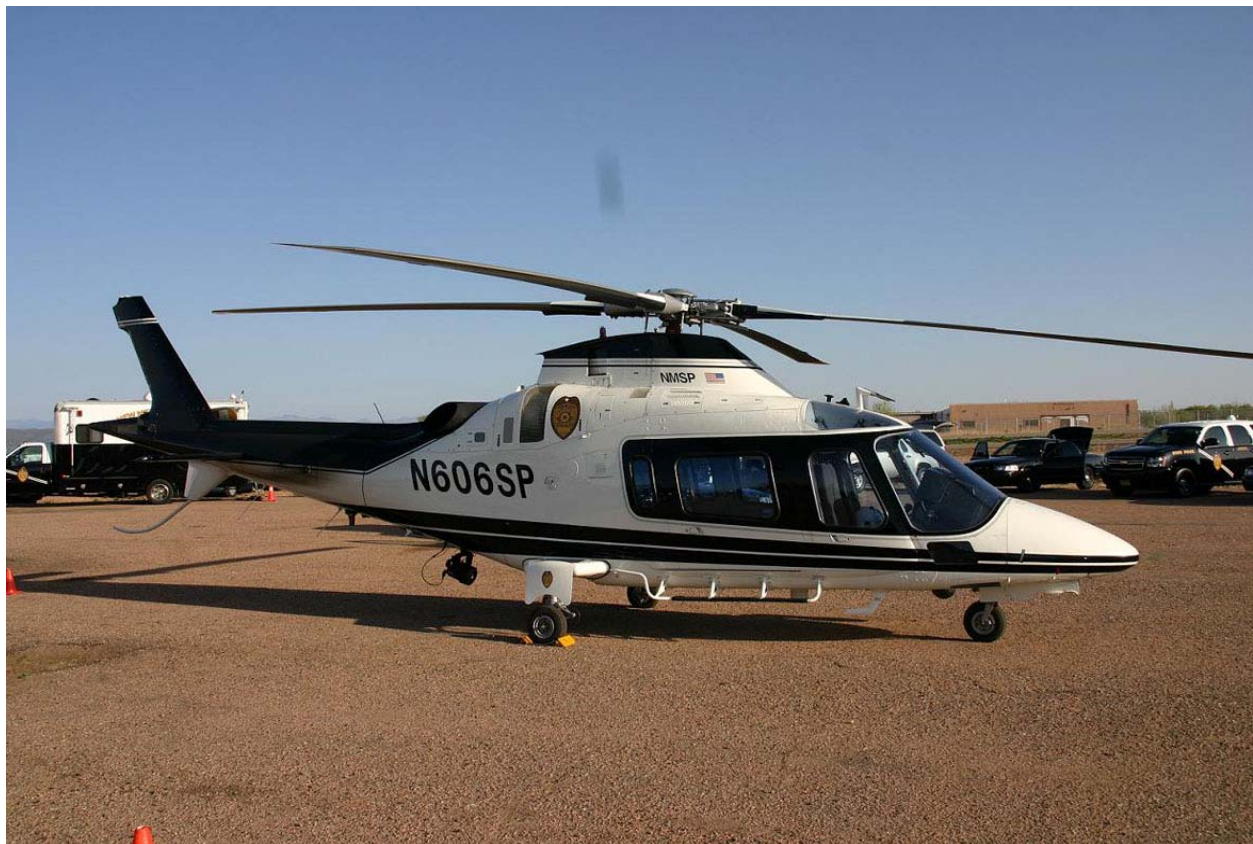
Figure 6. Preaccident photograph of the accident helicopter.

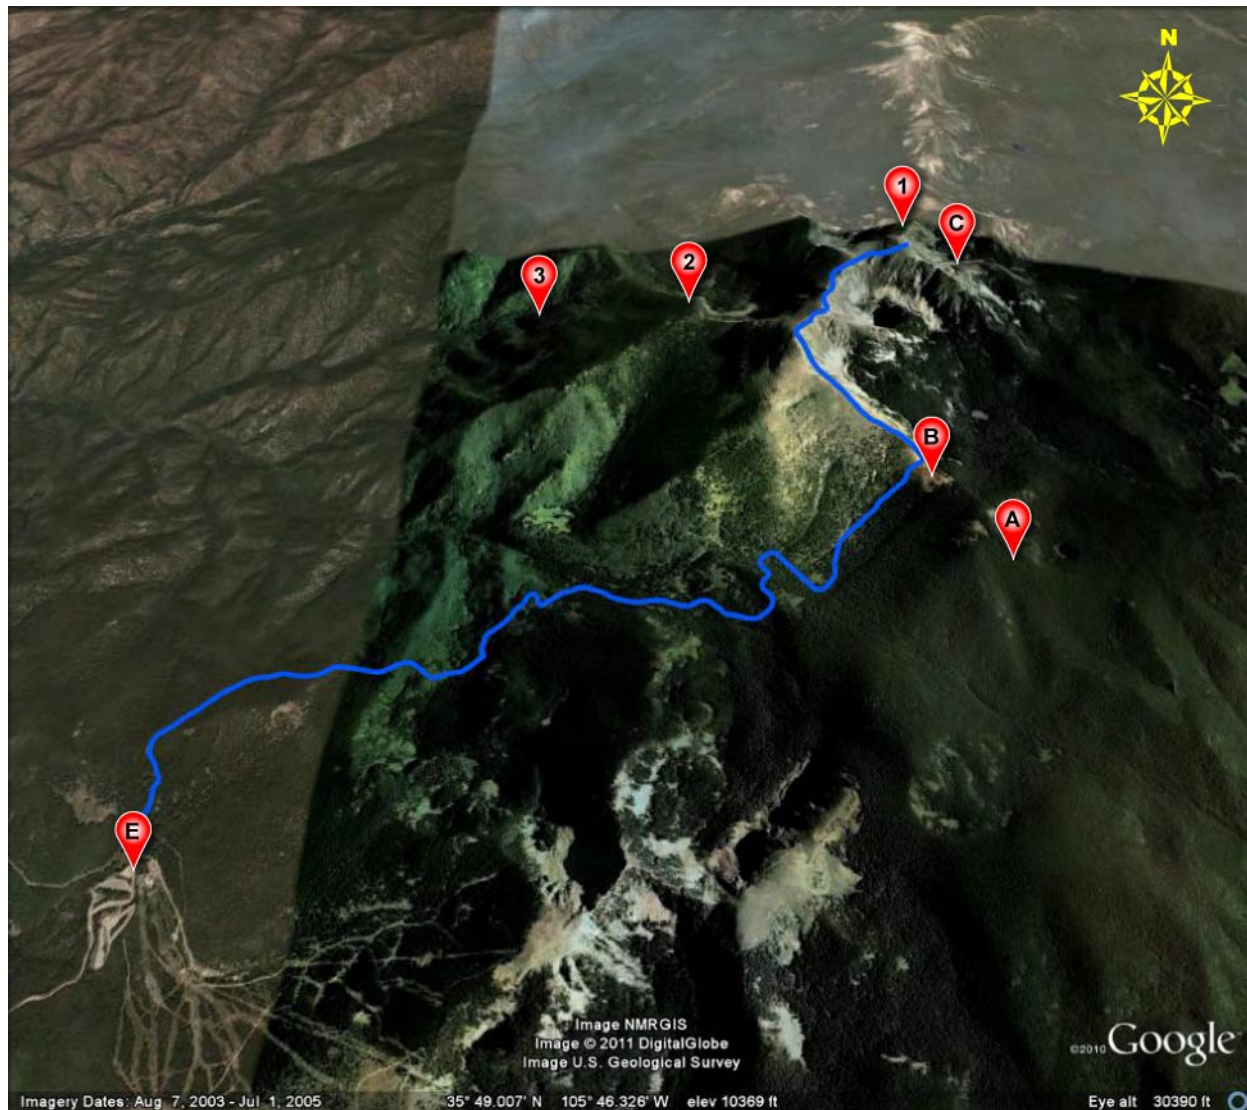
As previously mentioned, SAR ground teams did not locate the helicopter's wreckage until 1816 on June 10. The accident site was described as dangerously steep and covered with snow and ice. Figure 7 shows the approximate route that the SAR ground team took to locate the spotter.

Figure 7. Google Earth image with a blue line showing the likely route that the SAR ground team took from the SAR IB (E) to the helicopter main wreckage location (C).

Note: Also shown are the hiker's approximate location (A); the helicopter's likely landing zone, confirmed by the spotter (B); and the three AFRCC ELT-provided coordinates (1, 2, and 3, in the order in which they were provided to SAR personnel) for the accident site. A compass showing north is located in the upper right corner.
