**HIGHWAY ACCIDENT REPORT  
MULTIPLE- VEHICLE COLLISIONS  
UNDER FOG CONDITIONS, FOLLOWED BY  
FIRES, NEW JERSEY TURNPIKE,  
NORTH OF GATE 2  
NOVEMBER 29, 1969**

**REPORT NUMBER: NTSB-HAR-71-3**

ADOPTED: JANUARY 20, 1971

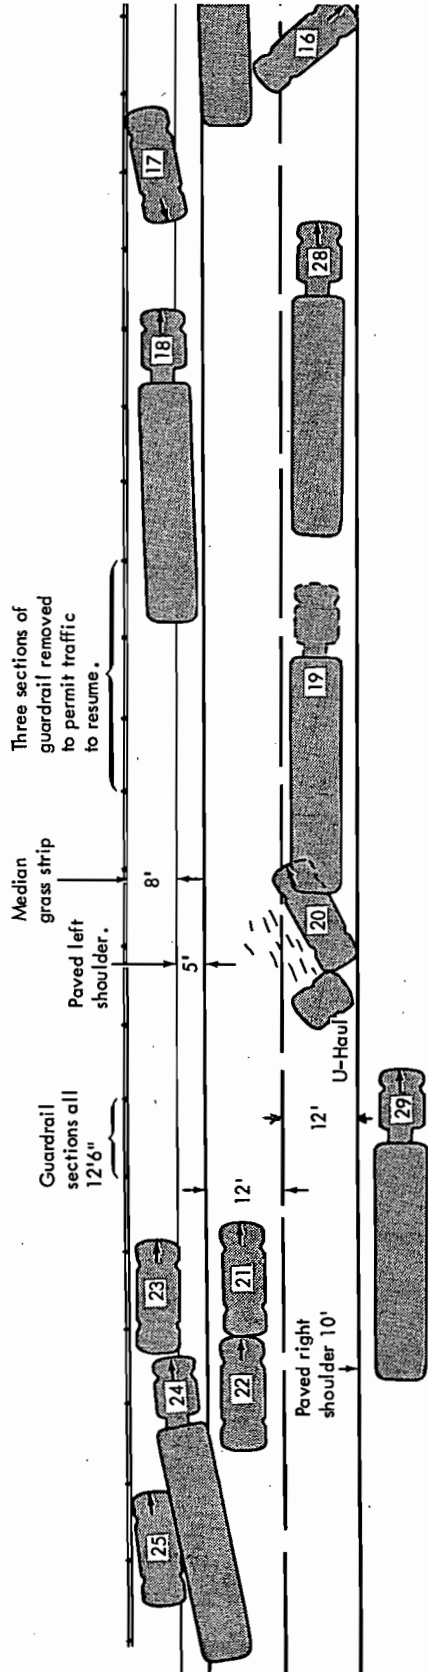
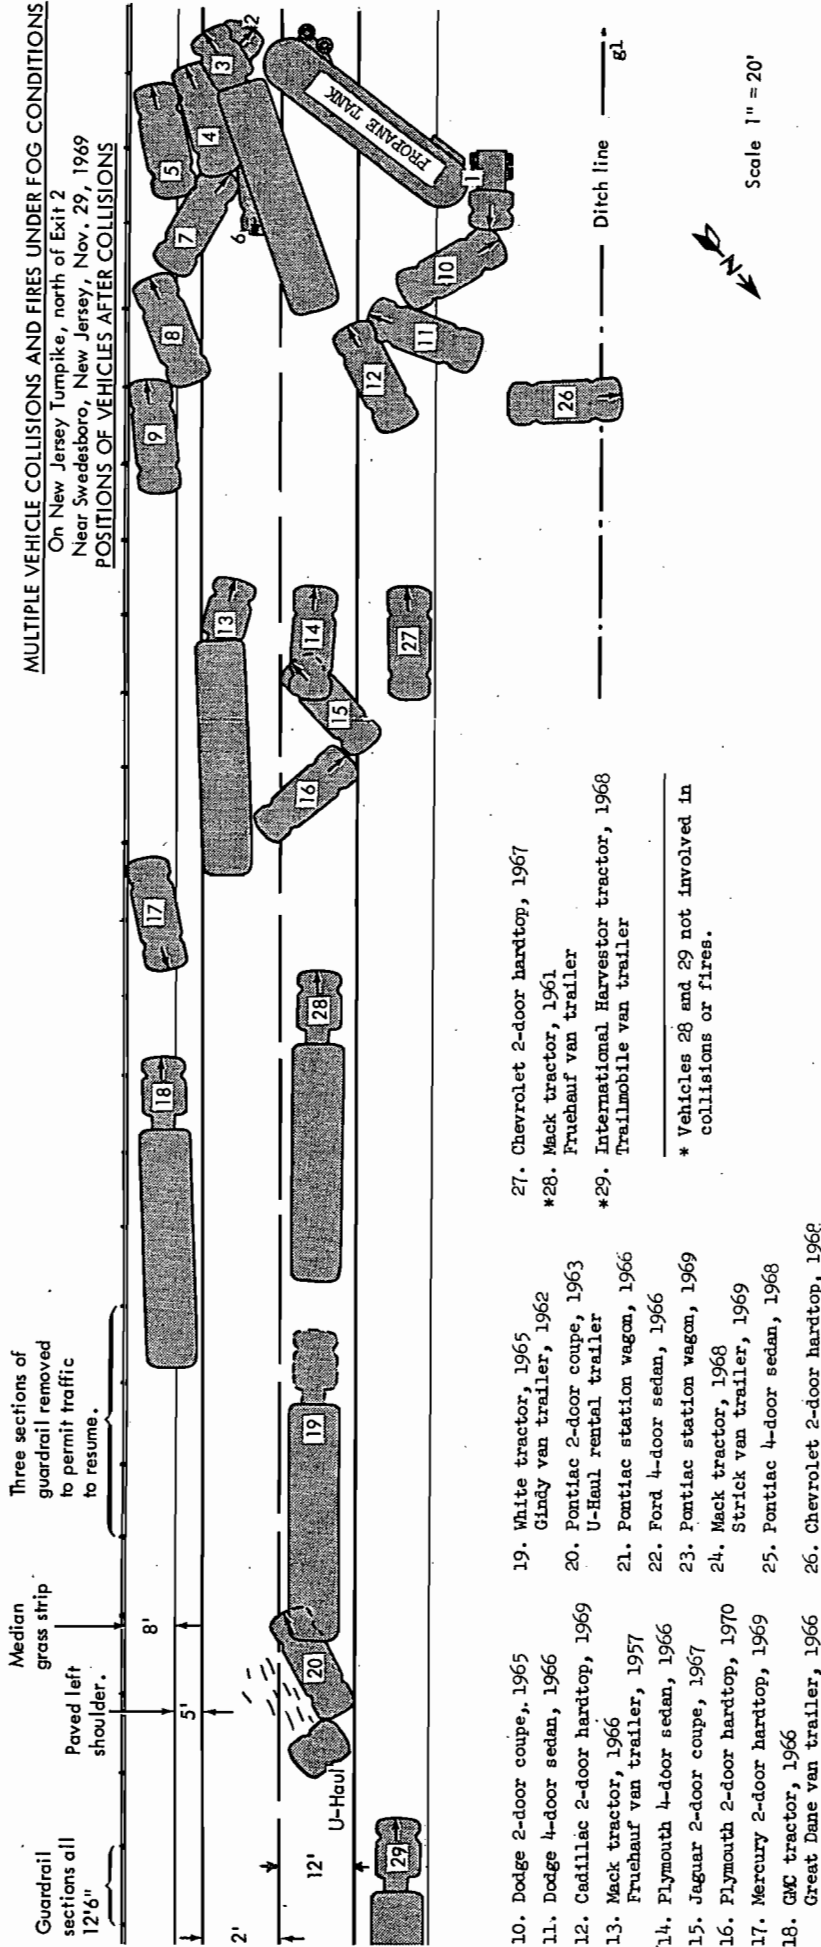
FIGURE 1

**MULTIPLE VEHICLE COLLISIONS AND FIRES UNDER FOG CONDITIONS**

On New Jersey Turnpike, north of Exit 2  
Near Swadesboro, New Jersey, Nov. 29, 1969  
**POSITIONS OF VEHICLES AFTER COLLISIONS**

In Figure 1, 29 vehicles have been identified and given identifying numbers which are used hereinafter for reference. Figure 1 shows the final positions of the vehicles, after impacts.
