Hazardous Materials Accident Report - Overturn of a
Tractor-Semitrailer (Cargo Tank) with the Release of Automotive
Gasoline and Fire, Carmichael, California, February 13, 1991

HAZARDOUS MATERIALS ACCIDENT REPORT

OVERTURN OF A TRACTOR-SEMITRAILER
(CARGO TANK) WITH THE RELEASE OF
AUTOMOTIVE GASOLINE AND FIRE
CARMICHAEL, CALIFORNIA
FEBRUARY 13, 1991

**ADOPTED: September 4, 1991
NOTATION 5471A**

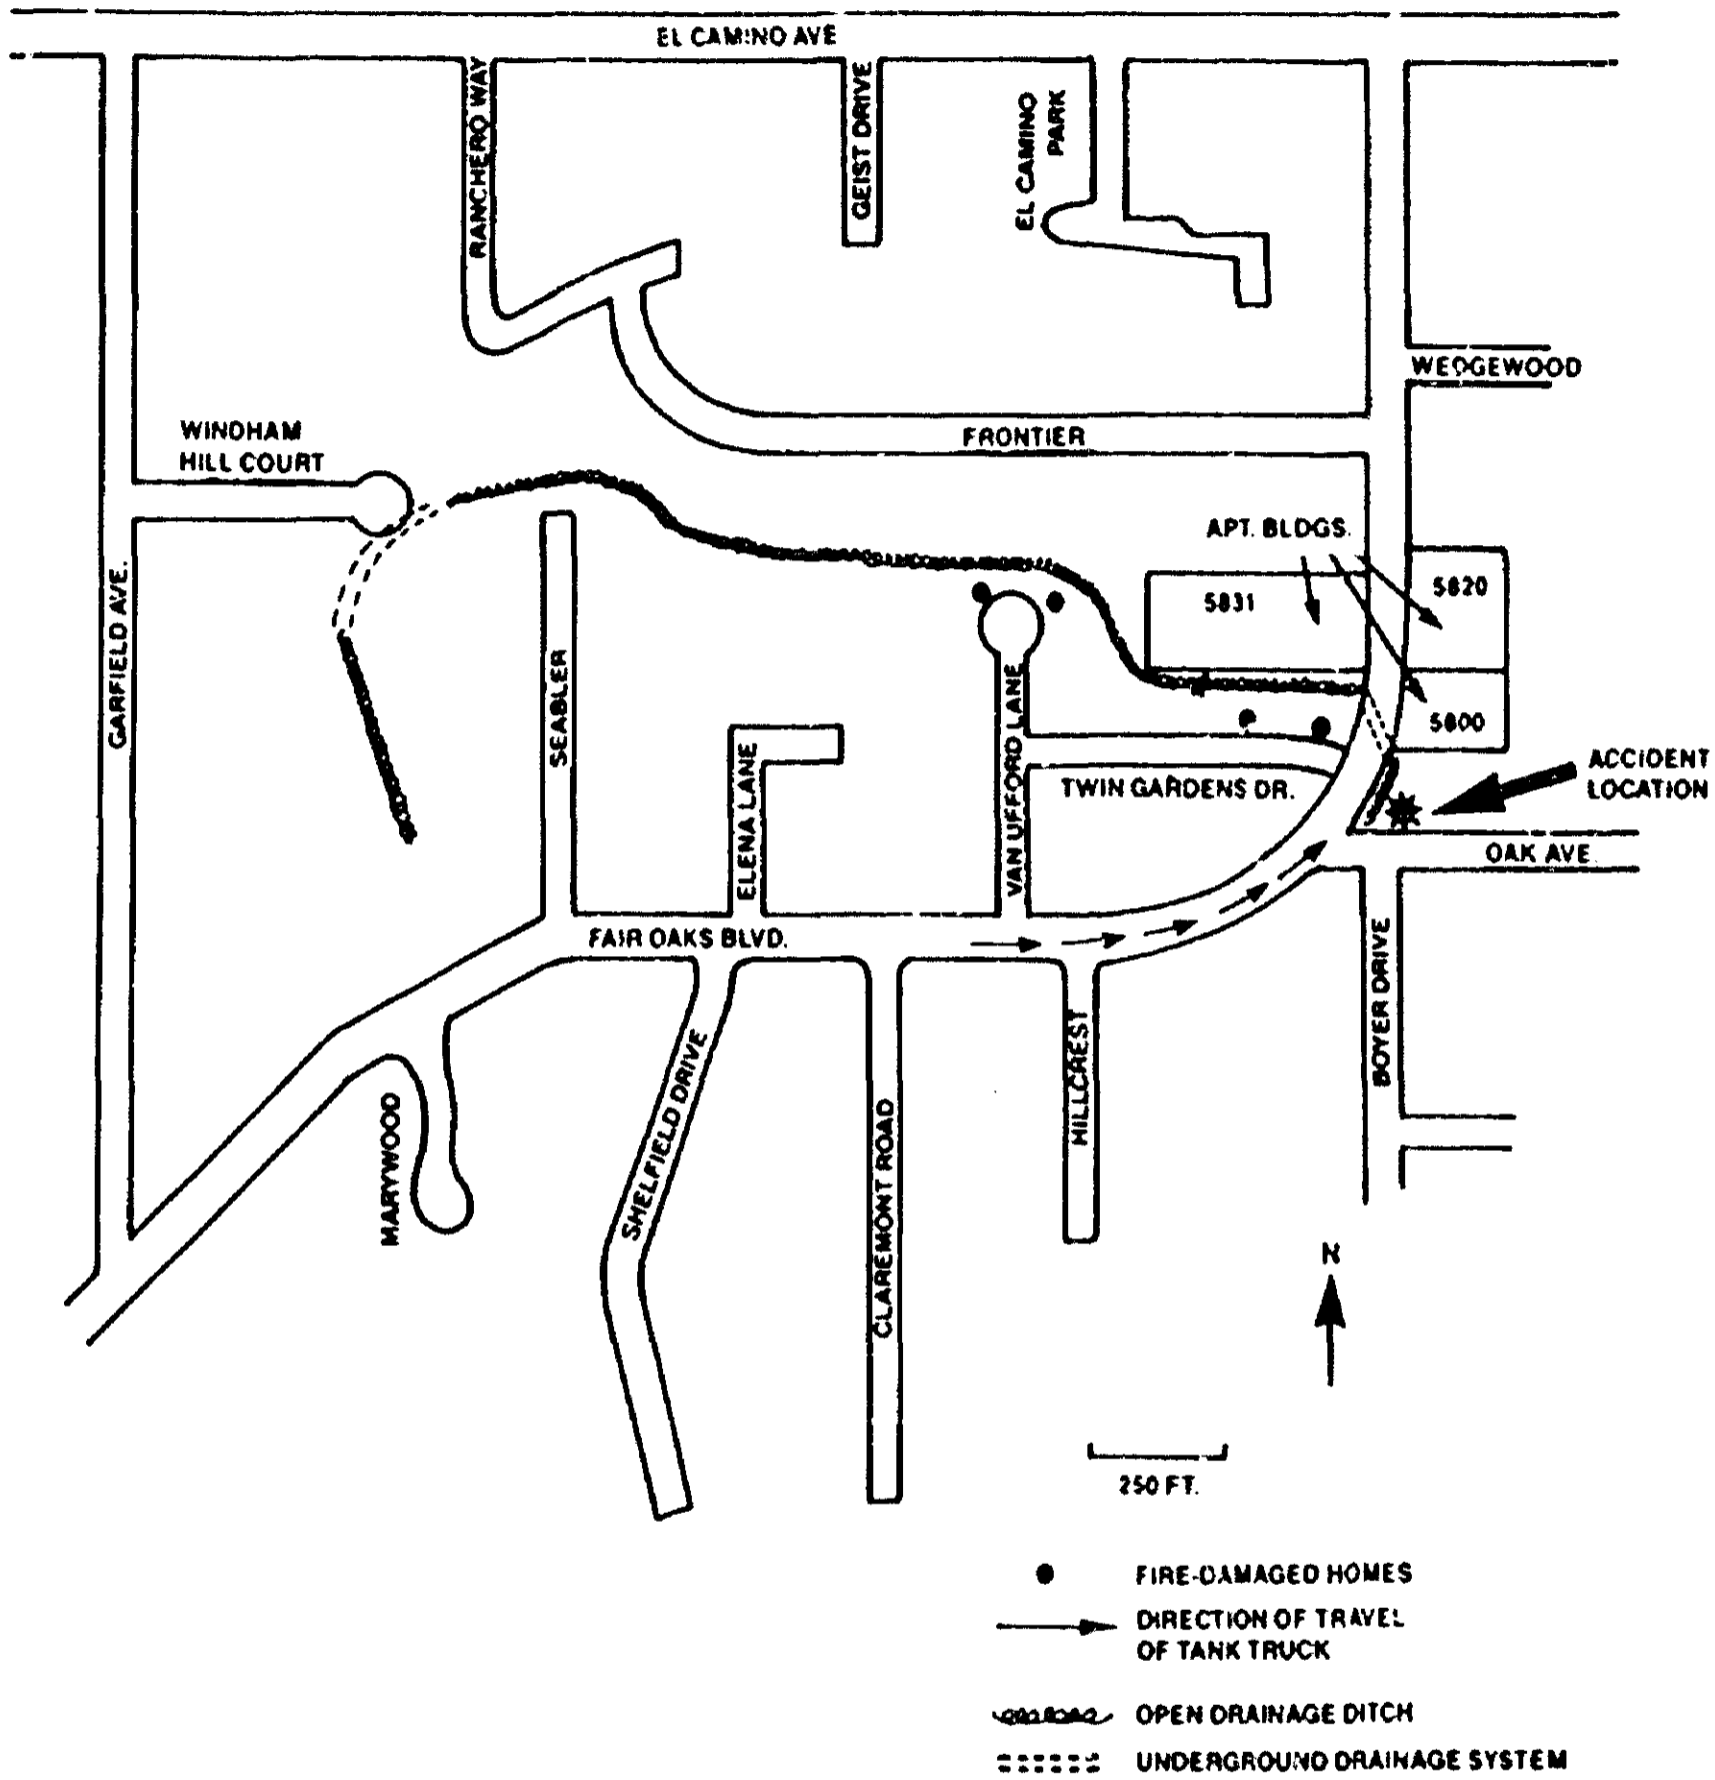
The driver indicated that after the truck had passed through the first curve on Fair Oaks Blvd. [a curve to the right preceding the accident curve to the left], the truck "leaned hard to the right and felt mushy" (fig. 2). He further indicated that he "steered into the lean" and that the truck "felt as if it was coming back," but it "suddenly leaned harder to the right" beyond the point of steering. The driver thought that a right-side tire on the tractor had a blow-out causing the vehicle to overturn.

Figure 2.--The accident site and vicinity.

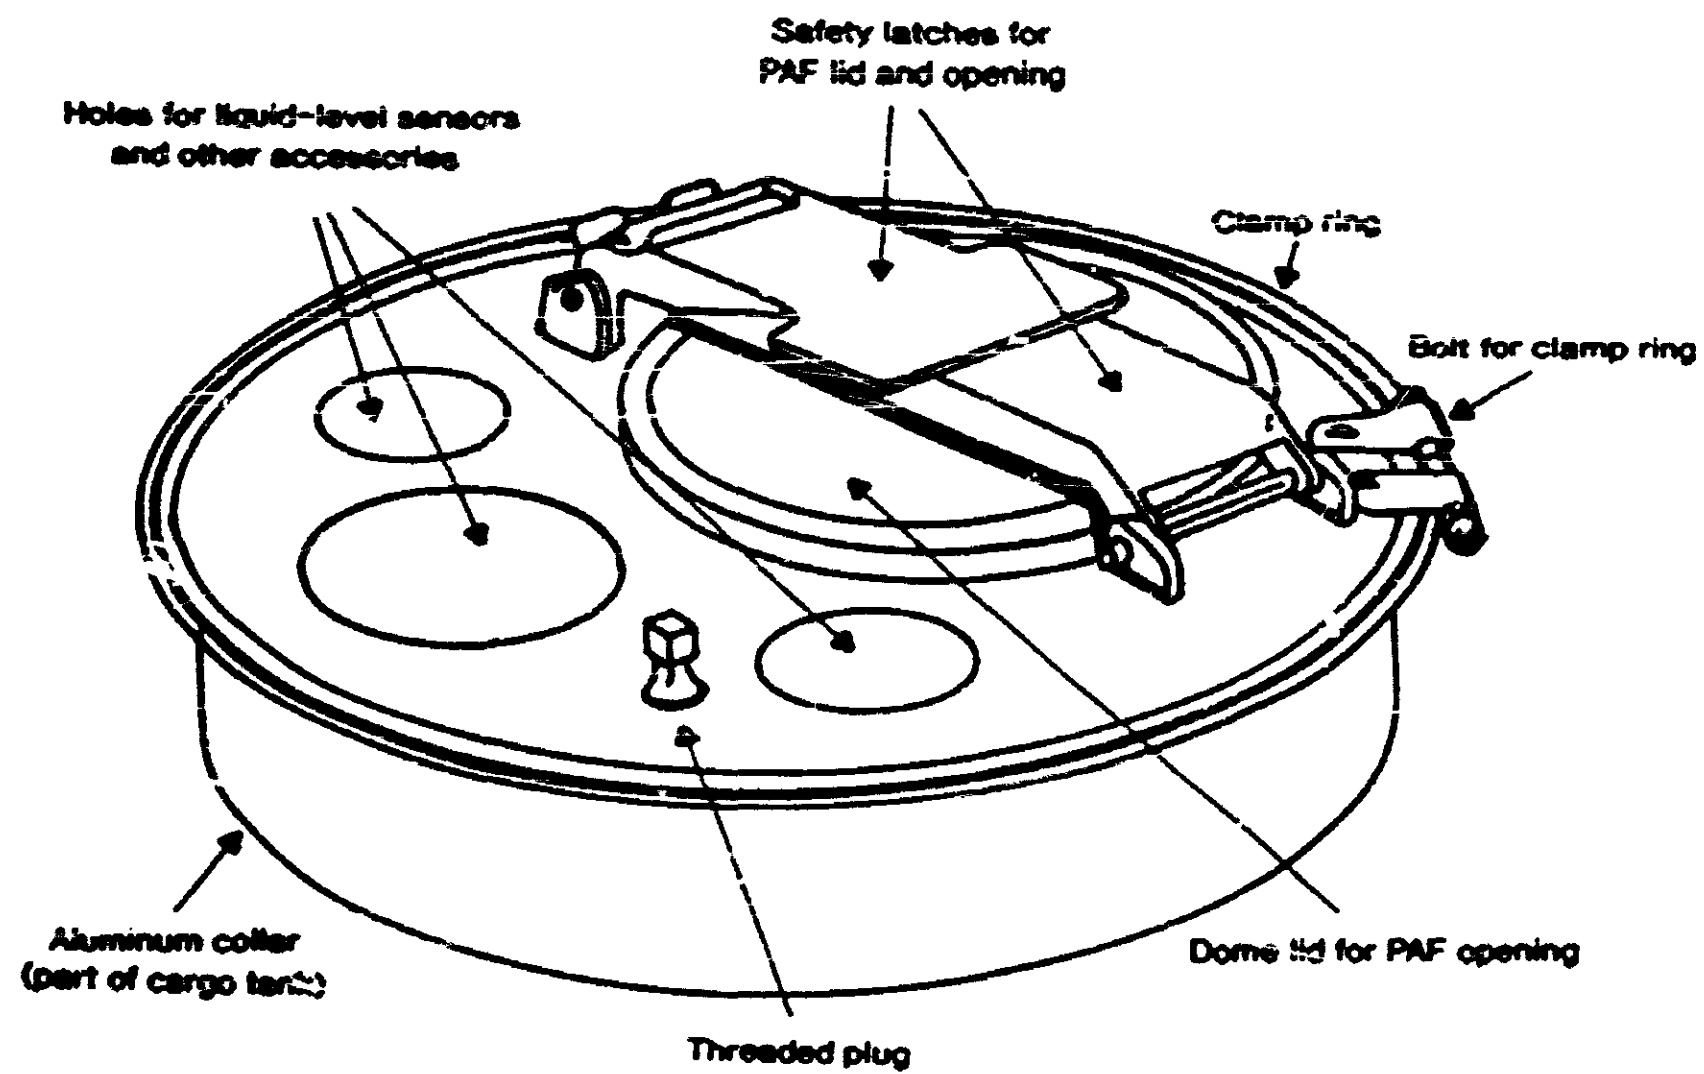
Each manhole cover was a 16-inch diameter steel cover manufactured by Betts Industries, Inc., and had an offset 10-inch diameter cast aluminum dome lid for the pressure-actuated fill (PAF) opening (fig. 6). Each cover also had three openings for mounting accessory devices on the cover. On the accident vehicle, two of the three openings were used for mounting liquid-level sensors, and the third opening was closed with a threaded plug. According to Betts, the liquid-level sensors or other accessories are typically secured to the cover by a locking nut on the underside of the manhole cover, a bolted flange, tapered pipe threads, or straight pipe threads. Each manhole cover was seated on an aluminum collar that was welded to the cargo tank, and secured by a bolt-tightened clamp ring.

The dome lid for the PAF opening was spring-loaded and held in place by two hinged steel safety latches. The dome lid assembly for the PAF opening serves as a pressure-actuated emergency vent with a venting capacity of 250,000 cubic feet of free air per hour at a pressure of 5 psig. To vent, the lid for the PAF opening lifts slightly against the force of the spring

Figure 6.--Schematic of manhole cover.
