**Rear-End Collision and Subsequent Vehicle Intrusion
Into Pedestrian Space at Certified Farmers' Market
Santa Monica, California
July 16, 2003**

NTSB/HAR-04/04

**National
Transportation
Safety Board**

Abstract: On July 16, 2003, a 1992 Buick LeSabre was westbound on Arizona Avenue, approaching the intersection of Fourth Street, in Santa Monica, California. A 2003 Mercedes Benz S430 sedan was stopped on Arizona Avenue at the intersection for pedestrians in a crosswalk on Fourth Street. The Buick struck the Mercedes, continued through the intersection, and drove through a farmers' market, striking pedestrians and vendor displays before coming to rest. As a result of the accident, 10 people were fatally injured, and 63 people received injuries ranging from minor to serious. The Buick driver and both Mercedes occupants were uninjured.

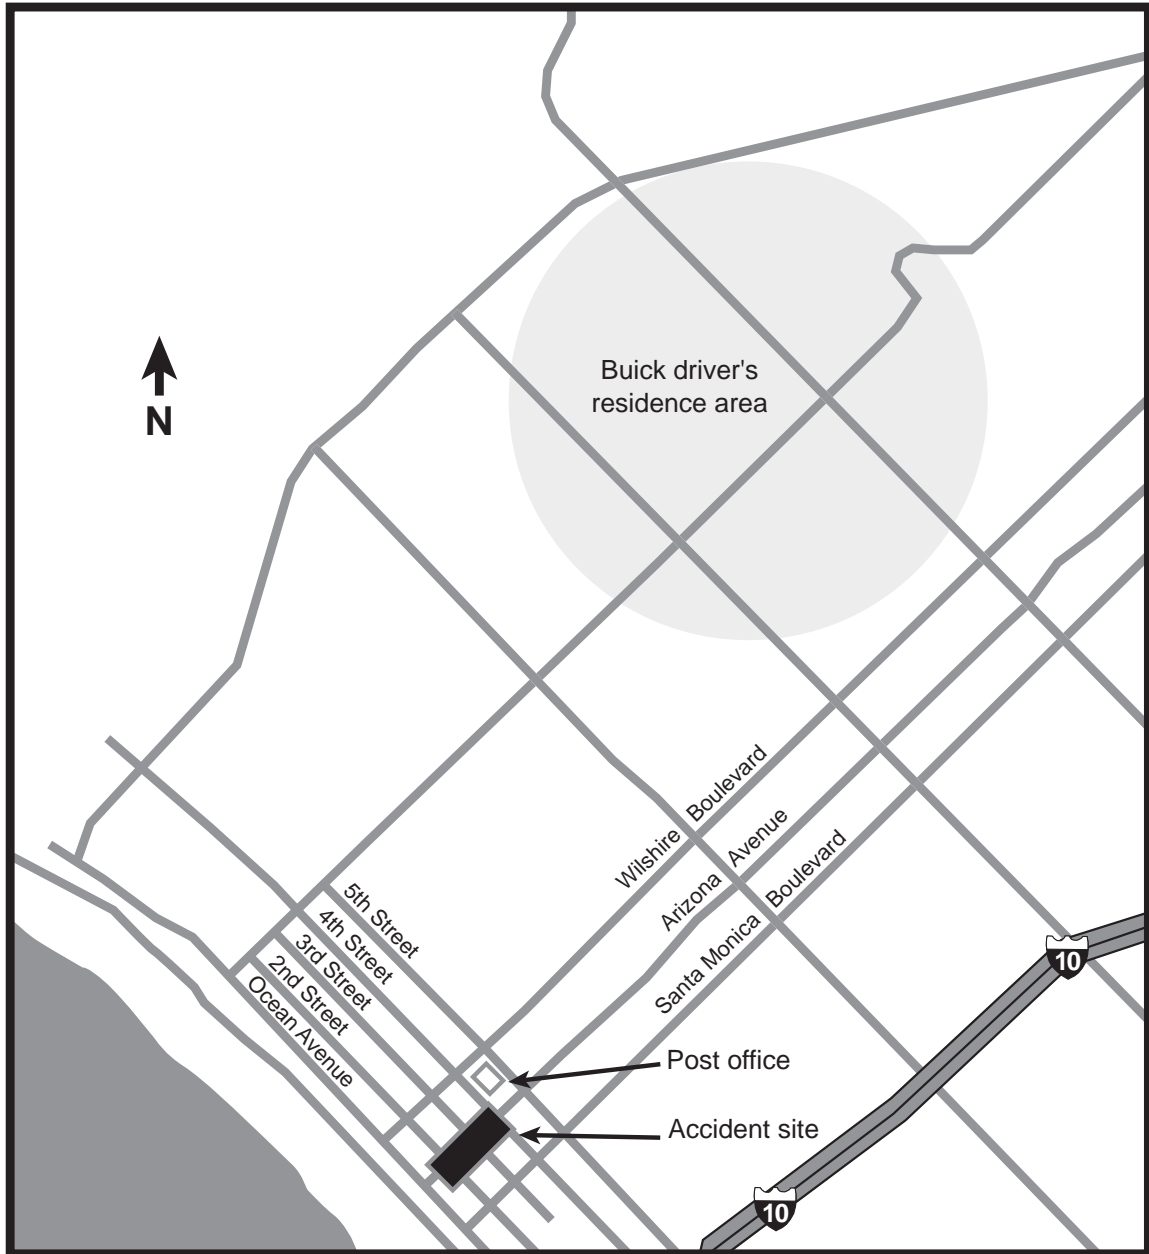
Figure 1. Accident area.

The accident occurred moments after the Buick driver had departed the Santa Monica Main Post Office on Fifth Street. The Buick driver told police investigators that he could see the farmers' market as he turned from Fifth Street onto Arizona Avenue. According to witnesses, the Buick approached the Fourth Street intersection; the Mercedes had stopped at the red light, had begun to proceed after the light turned green, and had again stopped to allow pedestrians in the crosswalk to cross Fourth Street. The Buick then struck the stopped Mercedes in the left rear, pushing it into the intersection. Witnesses stated that the Buick continued on Arizona Avenue, where it maneuvered past an orange ROAD CLOSED AHEAD sign on the yellow centerline of the roadway, through barricades, and into the area where the Santa Monica Certified Farmers' Market (SMCFM) had been set up. (See figures 1 and 2.)

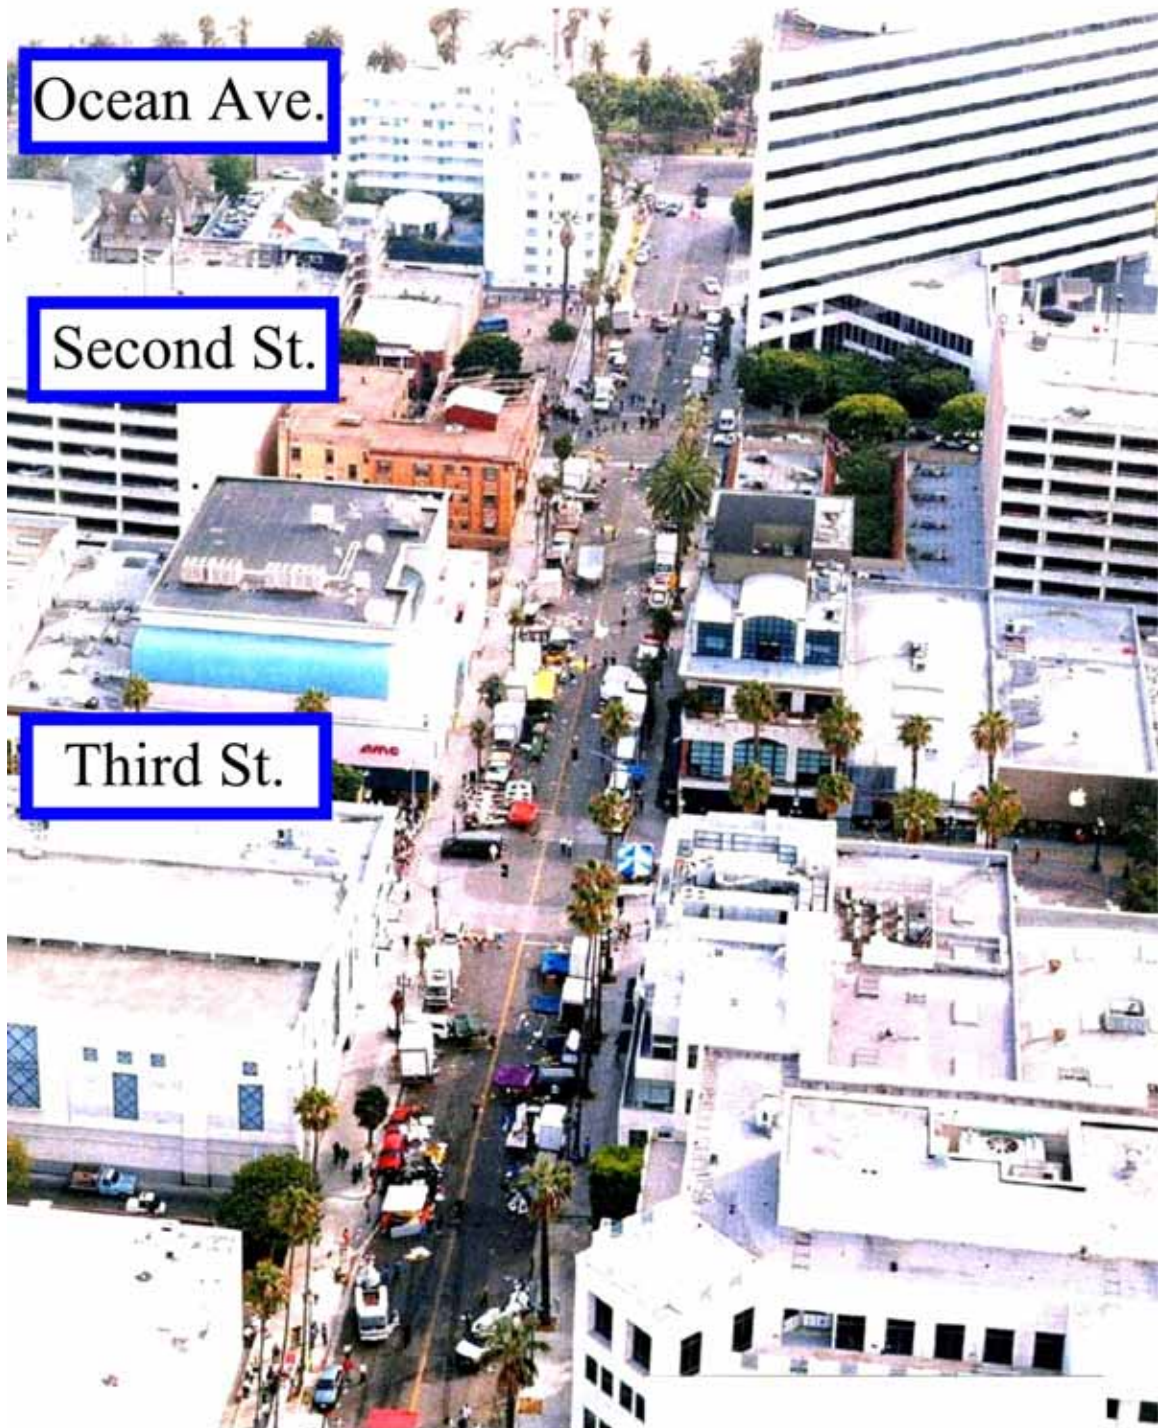
Figure 2. Aerial view of accident site.

The Buick proceeded through the farmers' market for approximately 2 1/2 blocks (750 feet) and came to rest on Arizona Avenue near the alley east of the intersection of Ocean and Arizona Avenues. As a result of the accident, 10 people were fatally injured, and 63 people sustained injuries ranging from minor to serious. The Buick driver and both Mercedes occupants were uninjured.

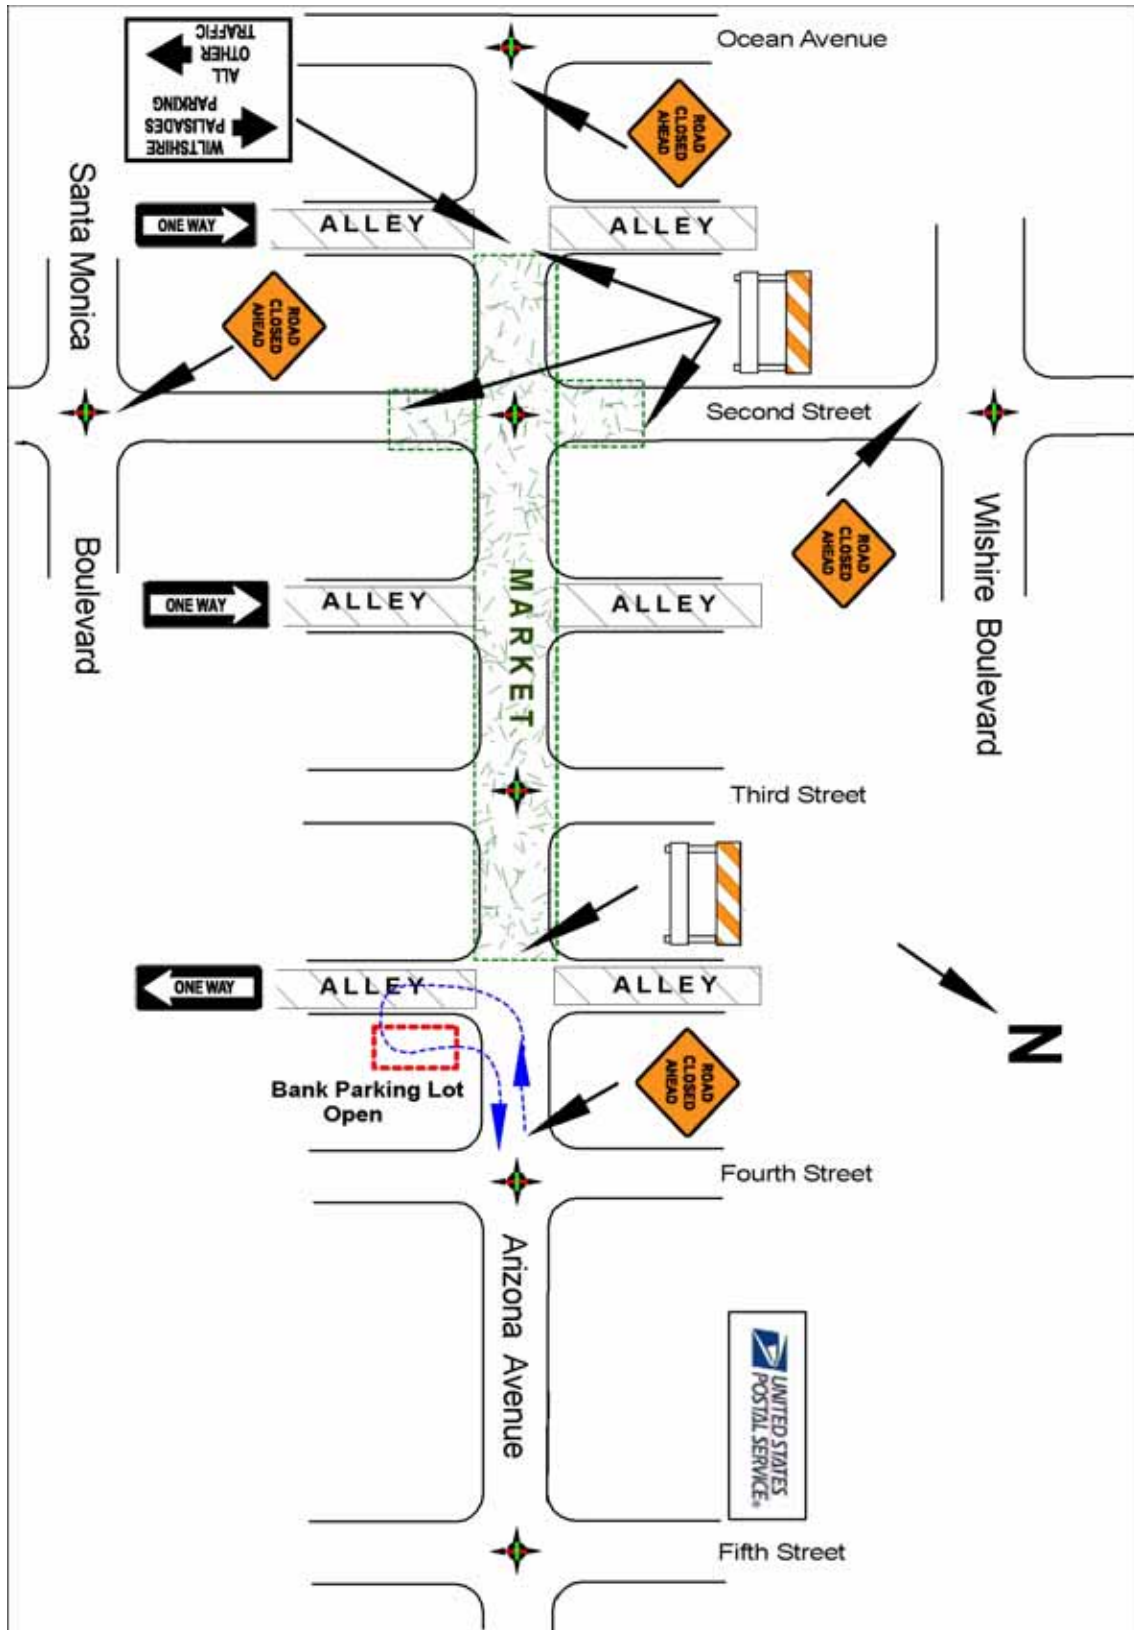
Figure 5. Road closures in place for SMCFM.

At the time of the accident, Arizona Avenue was closed to vehicular traffic between the alley east of Ocean Avenue and the alley west of Fourth Street (see figure 5), and the roadway was being used as an outdoor farmers' market from 9:00 a.m. to 2:00 p.m. Prior to the beginning of the market area, westbound traffic was allowed to use Arizona Avenue between Fourth Street and an alley, located between Third and Fourth Streets, to access a bank parking lot on the southwest corner. A full closure was located at the west side of the intersection of Arizona Avenue and the alley between Third and Fourth Streets. Past the closure points on Arizona Avenue, fruit and vegetable vendor canopy tents occupied the outer edges of the roadway from the alley midway between Third and Fourth Streets to the alley midway between Second Street and Ocean Avenue.

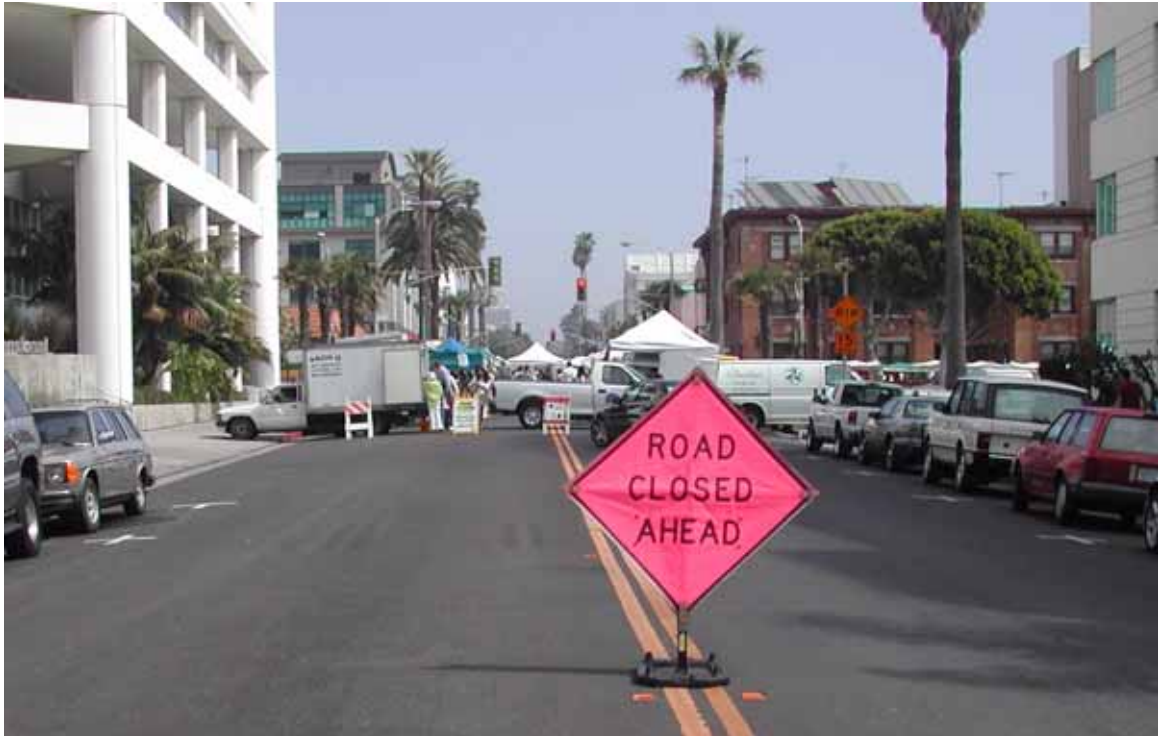
Figure 9. Traffic signal at Second Street and Arizona Avenue.

Three-phase, electrically operated traffic signals were in place at all street intersections on Arizona Avenue between Ocean Avenue and Fifth Street. Traffic signals were not in place at the alley intersections. The signal at Arizona Avenue and Third Street was a “pedestrian only” signal; Third Street is a promenade (or pedestrian mall), and vehicles do not approach Arizona Avenue from it. Even when the SMCFM was operating and vehicles were prohibited on Arizona Avenue from the alley between Second Street and Ocean Avenue and the alley between Fourth and Third Streets, all traffic signals continued to operate in their normal mode. The traffic signals at Second Street and the Third Street promenade continued to operate, even though vehicular traffic did not cross either intersection while the farmers’ market was in operation. Both signals were visible to traffic on north- and southbound Arizona Avenue, and the signal at the Second Street intersection was visible to east- and westbound Second Street traffic. (See figure 9.)

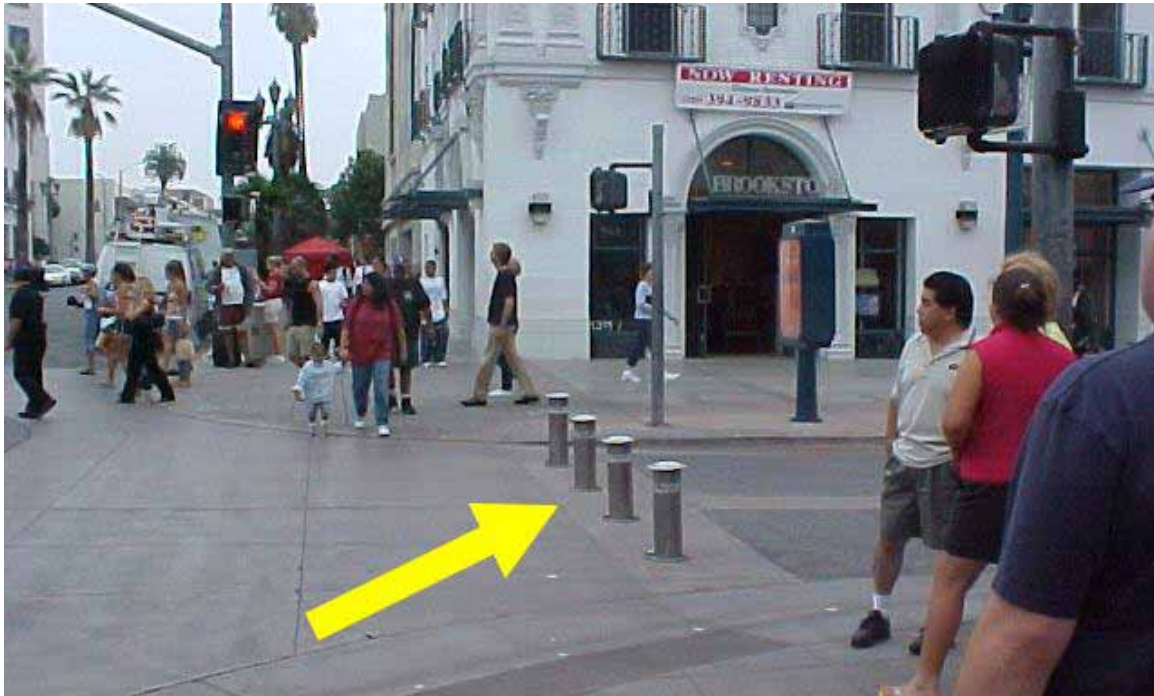
Figure 10. Bollards in place at the Third Street pedestrian promenade.

The Third Street promenade intersects Arizona Avenue midway in the SMCFM. It is a dedicated pedestrian mall that is permanently closed to vehicular traffic. Metal bollards¹¹ are positioned at the entrances to the mall at Arizona Avenue, Colorado Avenue, and Wilshire Boulevard. According to the city, “the bollards are intended to keep vehicles off the Third Street promenade on a full-time, permanent basis.” Four bollards are embedded into the Third Street roadway at each intersection, and they extend approximately 24 inches above the ground. (See figure 10.) They are locked into place with a padlock and can be lowered into the ground to allow access by emergency vehicles. Emergency response personnel have keys to the padlocks.

According to city officials, the metal bollards were installed at the mall entrances because the promenade was designated a permanent pedestrian mall. Officials indicated that bollards were not considered for the SMCFM entrances because the market does not operate on a full-time basis, necessitating permanent closure of Arizona Avenue.

Santa Monica recognized the need for and value of positive, rigid barriers to protect pedestrians when the city installed removable bollards on the Third Street pedestrian promenade (see figure 10). Metal bollards at the entrances along Arizona Avenue protect the Third Street promenade, a dedicated pedestrian mall that was once a through street. The bollards, while designed to be permanently placed in the roadway, can also be lowered to allow passage of traffic, if necessary. By providing a rigid, positive separation between vehicles and pedestrians, bollards reduce the likelihood of vehicular incursion into pedestrian traffic areas.

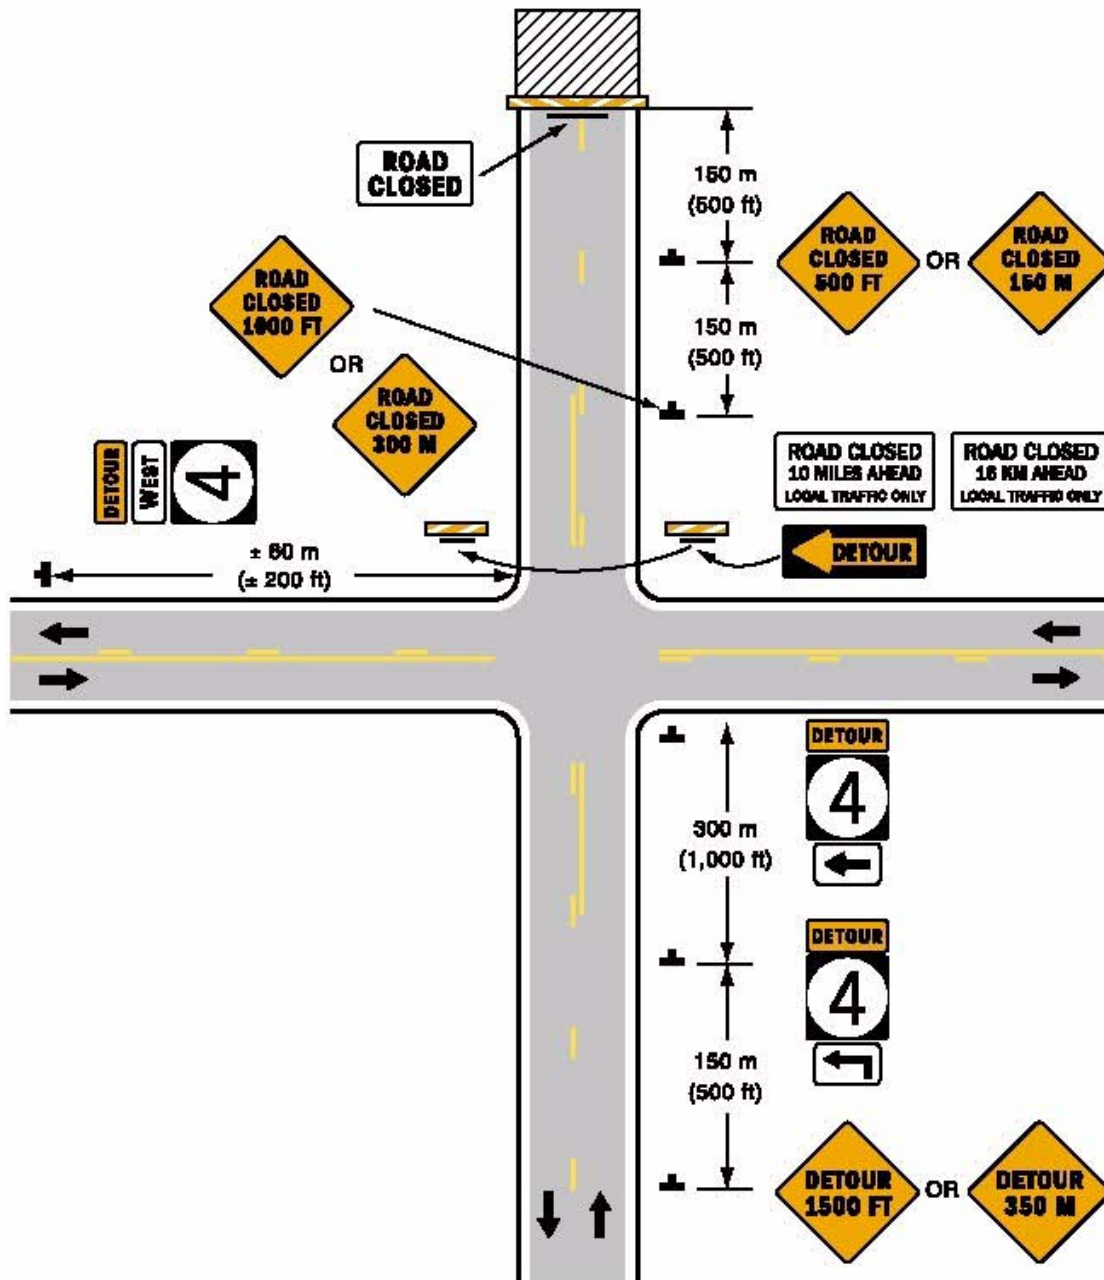
Figure 11. TA-8, the model application for road closures with off-site detour.

The model application for road closures with off-site detour is model TA-8 (see figure 11). It states that a ROAD CLOSED¹⁹ sign mounted on type III barricades (see figure 12) may be located at the edge of a roadway that is not being closed to all traffic.²⁰ If the road is closed a short distance beyond the intersection and a few origin or destination points are also beyond the intersection (for example, a few residences), the ROAD CLOSED sign may be placed on a type III barricade²¹ placed in the center of the roadway.
