Bus Loss of Control and Rollover  
Dolan Springs, Arizona  
January 30, 2009

NTSB/HAR-10/01  
PB2010-916201

**Abstract:** On Friday, January 30, 2009, about 4:06 p.m. mountain standard time, a 2007 Chevrolet/Starcraft 29-passenger medium-size bus, operated by DW Tour and Charter and occupied by the driver and 16 passengers, was traveling northbound in the right lane of U.S. Highway 93, a four-lane divided highway, near Dolan Springs, Arizona. The bus was on a return trip from Grand Canyon West to Las Vegas, Nevada, after a day-long tour. As the bus approached milepost 28 at an estimated speed of 70 mph, it moved to the left and out of its lane of travel. The driver steered sharply back to the right, crossing both northbound lanes and entering the right shoulder. The driver subsequently overcorrected to the left, causing the bus to yaw and cross both northbound lanes. The bus then entered the depressed earthen median and overturned 1.25 times before coming to rest on its right side across both southbound lanes. During the rollover sequence, 15 of the 17 occupants (including the driver) were fully or partially ejected. Seven passengers were killed, and nine passengers and the drive

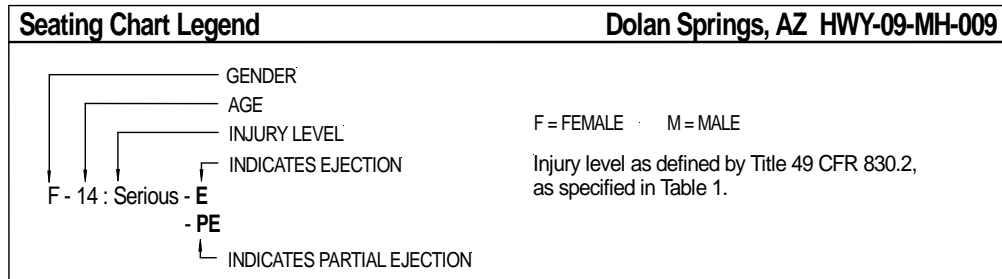
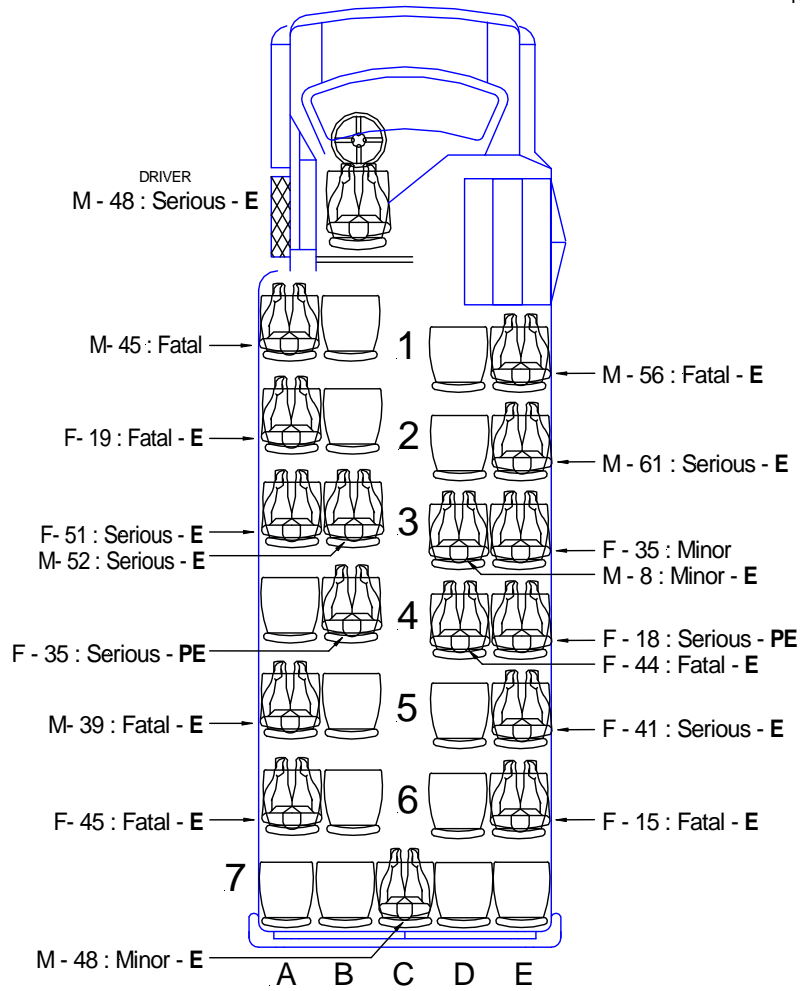
All six on-scene fatalities were transported to the Clark County medical examiner’s office in Las Vegas, where noninvasive autopsies were performed by the Mohave County, Arizona, medical examiner. Because the passenger who died at UMC in Las Vegas was under Nevada’s jurisdiction, the Clark County medical examiner conducted that autopsy. According to the autopsies, six of the seven fatalities sustained multiple head injuries, and six of the seven sustained bilateral rib fractures. Of the 10 surviving bus occupants, seven were hospitalized with serious injuries, and the three with minor injuries were treated and released. According to transport and medical records, six of the seven seriously injured occupants sustained fractures to their extremities. The passenger seated in 4B was partially ejected and sustained crushing injuries to her lower right leg. Another partially ejected passenger, seated in 4E, suffered crushing injuries to her right arm. The three passengers with minor injuries sustained contusions and abrasions to their faces and extremities. Occupant seating positions and injury information are presented in figure 4.

**Figure 4.** Seating chart reconstruction based on passenger interviews. Fifteen of the 17 bus occupants were ejected, including 6 of the 7 fatally injured passengers.

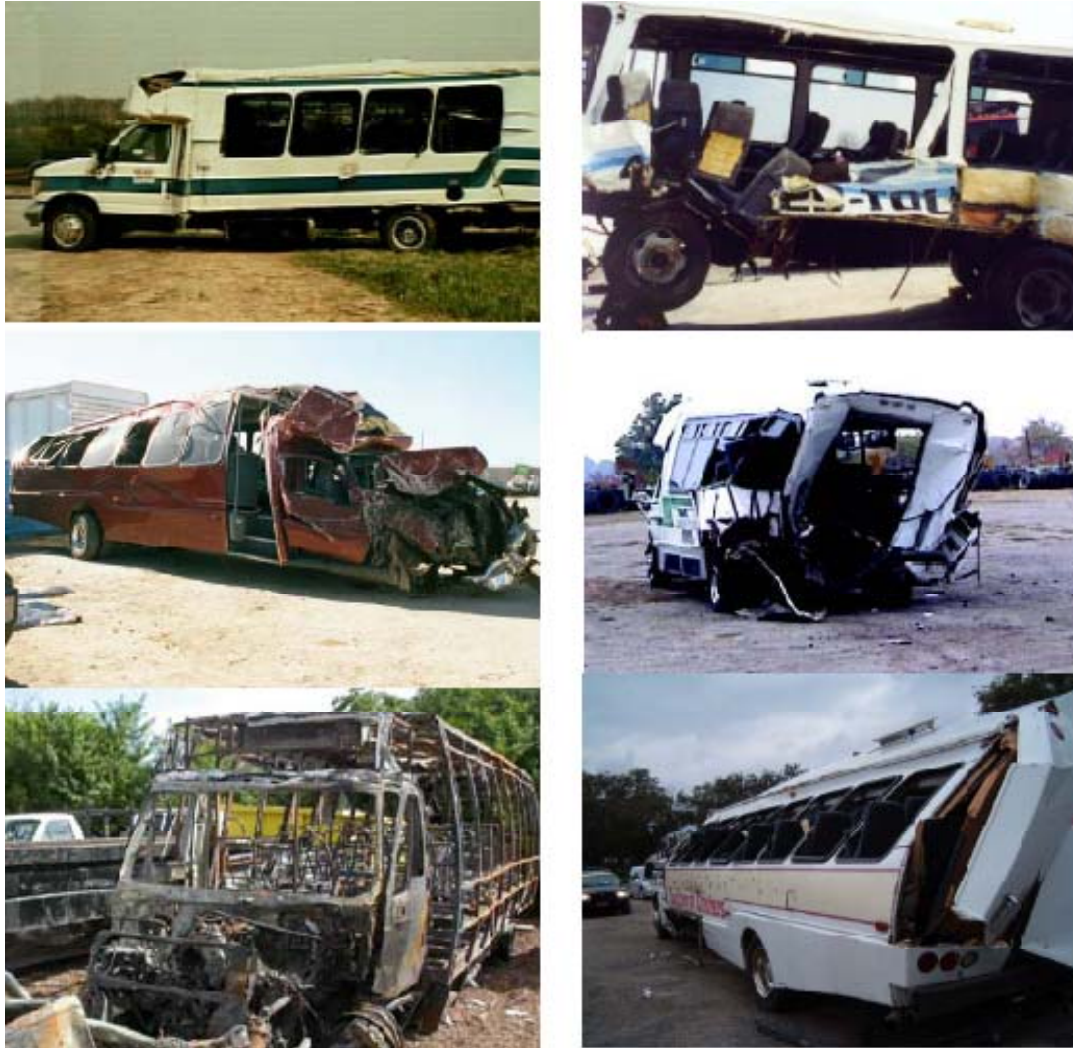
Apart from Dolan Springs, the NTSB has investigated at least six other accidents involving medium-size buses since 1990, three of which involved a rollover.<sup>40</sup> (See table 4 and figure 9.) Most recently, on February 22, 2010, the NTSB launched to Lake Placid, Florida, on an accident involving a 2001 Ford/Krystal 32-passenger medium-size bus occupied by the 68-year-old driver and 30 passengers. The bus was traveling northbound in the right lane of U.S. Highway 27, a four-lane divided roadway with an earthen center median. As the bus approached the Lake Saint Francis/Lykes Road intersection, a 2010 Mercury Sable approaching from the west, occupied by the 81-year-old driver, made a left turn into the northbound lanes of the highway and maneuvered into the right lane, striking the bus on the left side behind the driver's door. The right front wheel of the Mercury contacted the left outside rear wheel of the bus. The bus driver swerved to the right, and the bus began to rotate in a clockwise direction, crossing an acceleration lane and entering an earthen area. The bus rolled onto its roof, ejecting eight passengers, three of whom were killed. The bus came to rest on its roof facing east, and the Mercury came to rest in the acceleration lane facing north.

**Figure 9.** Photographs from NTSB-investigated medium-size bus accidents. Left to right, from top: Adirondack, New York; Lenoir City, Tennessee; San Miguel, California; Hampshire, Illinois; Broward, Florida; and Lake Placid, Florida.

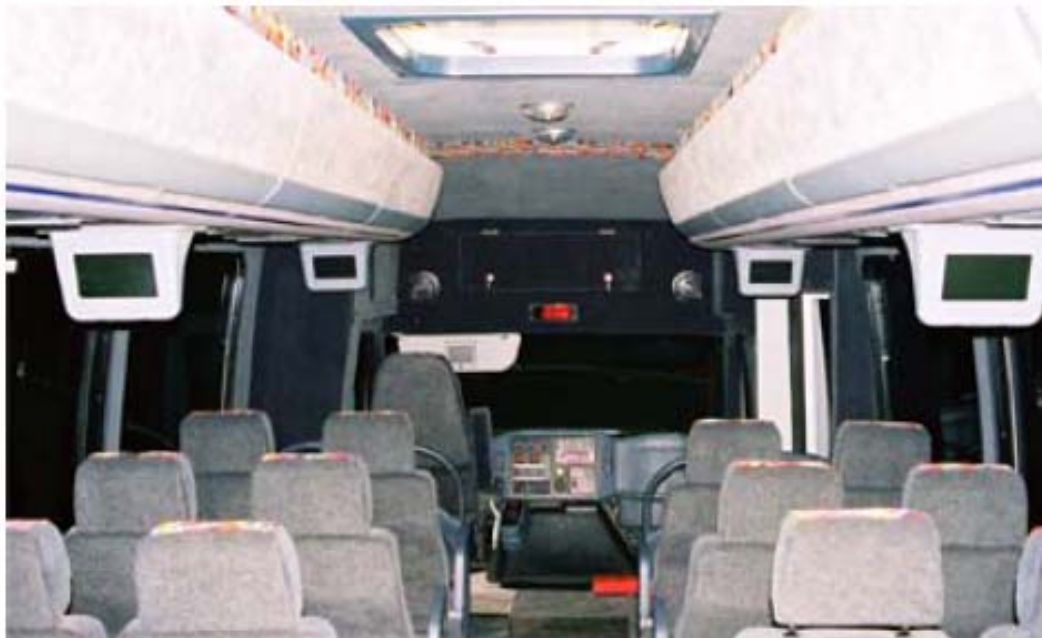
**Occupant Restraint Systems.** The interior configuration of the Starcraft XLT medium-size bus is similar to the interior of many motorcoaches. (See figures 13 and 14.) Rows of high-backed seats are located on each side of the aisle. Overhead luggage racks with some form of entertainment system are also common. Unlike school buses, however, medium-size buses and motorcoaches in the United States are not required to meet any occupant protection standards, either active or passive, except for the driver's position. Seat belts are not typically provided, though a variety of manufacturers currently have seat belt-equipped seats available for motorcoaches and other buses.<sup>48,49</sup>

**Figure 13.** Interior photograph showing seatbacks, televisions, and overhead luggage racks on exemplar Starcraft XLT bus. Note: The accident bus did not have video displays or luggage rack doors.

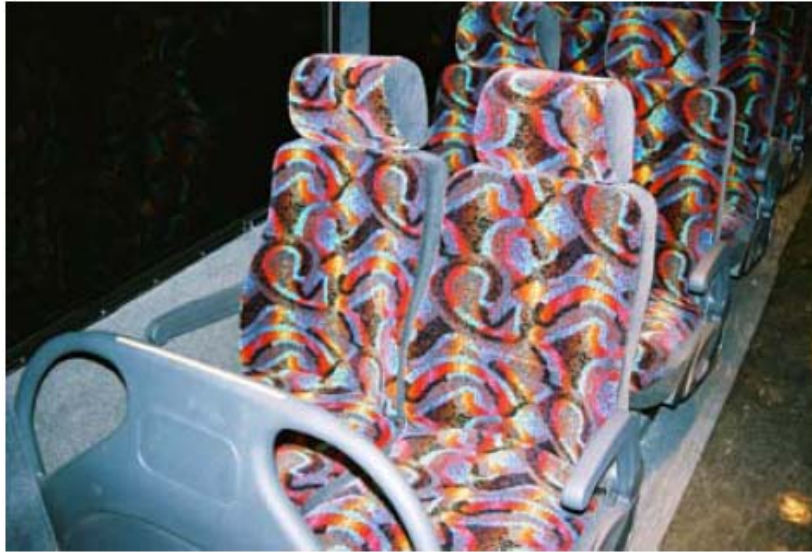
**Figure 14.** Interior photograph showing seats on exemplar Starcraft XLT bus.
