Pipeline Accident Report

**Natural Gas Pipeline Rupture and Fire
Near Carlsbad, New Mexico
August 19, 2000**

**National
Transportation
Safety Board**
Washington, D.C.

**NTSB/PAR-03/01
PB2003-916501
Notation 7310B
Adopted February 11, 2003**

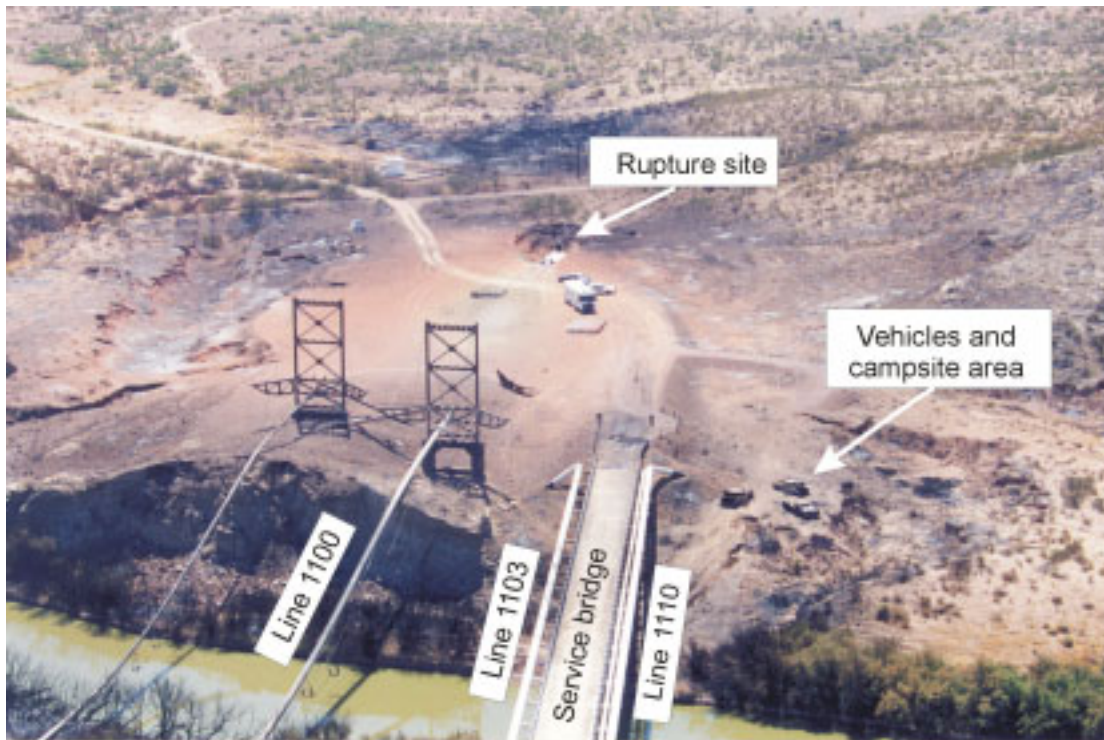
Figure 4. Aerial view of accident site looking east.

At the time of the accident, 12 members of an extended family were camping on the east bank of the Pecos River near the service bridge.¹ (See figure 4.) A locked wire rope and a “Private Right of Way—No Trespassing” sign at each entrance to the bridge restricted access to the bridge above the campsite. Two “Caution—High Pressure Gas Line” signs were posted near the east entrance to the service bridge. Also, a sign reading as follows:

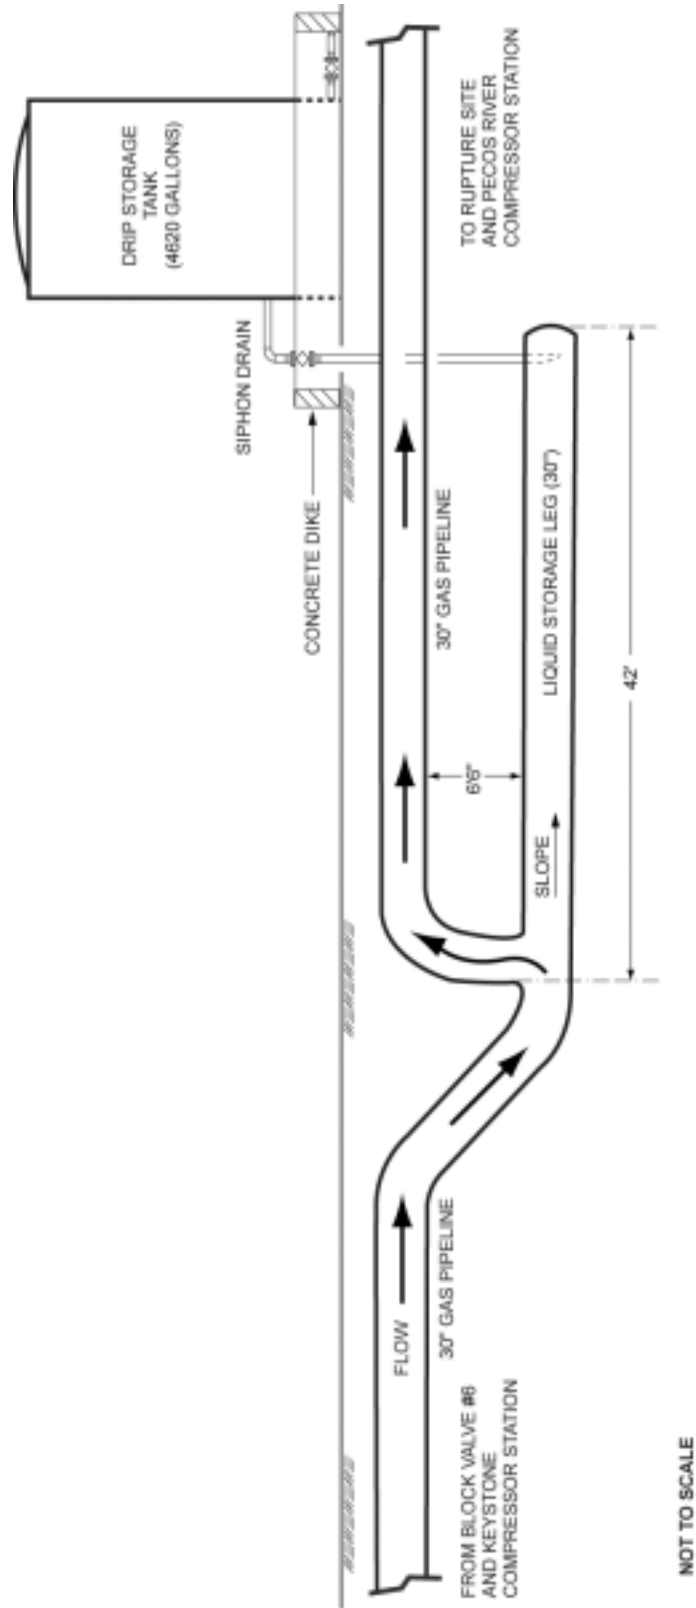
Figure 11. Diagram of line 1103 drip.

There was no pig launcher at block valve No. 6 and no pig receiver at Pecos River compressor station. For that reason, and because of a reduced port valve²² and other pipeline features, including the drip, in the section of the pipeline between block valve No. 6 and the Pecos River compressor station, that portion of the pipeline (which included the rupture location) could not be pigged.
