CHAPTER 4 – CULVERT ASSESSMENT AND DECISION-MAKING EXAMPLES

CONCRETE BOX CULVERT ASSESSMENT AND DECISION-MAKING EXAMPLE

The following example is a 6 foot wide x 9 foot rise reinforced concrete box conveying Adler Creek under Wawona Road (Route 14) in Yosemite National Park. The inspection was performed on September 2nd, 2009 by two knowledgeable hydraulic engineers from Central Division of FLH and an experienced consultant inspector, and took approximately 15 minutes. The completed Culvert Inspection Form is shown in the following Figure 33. The culvert received an overall rating of Poor.

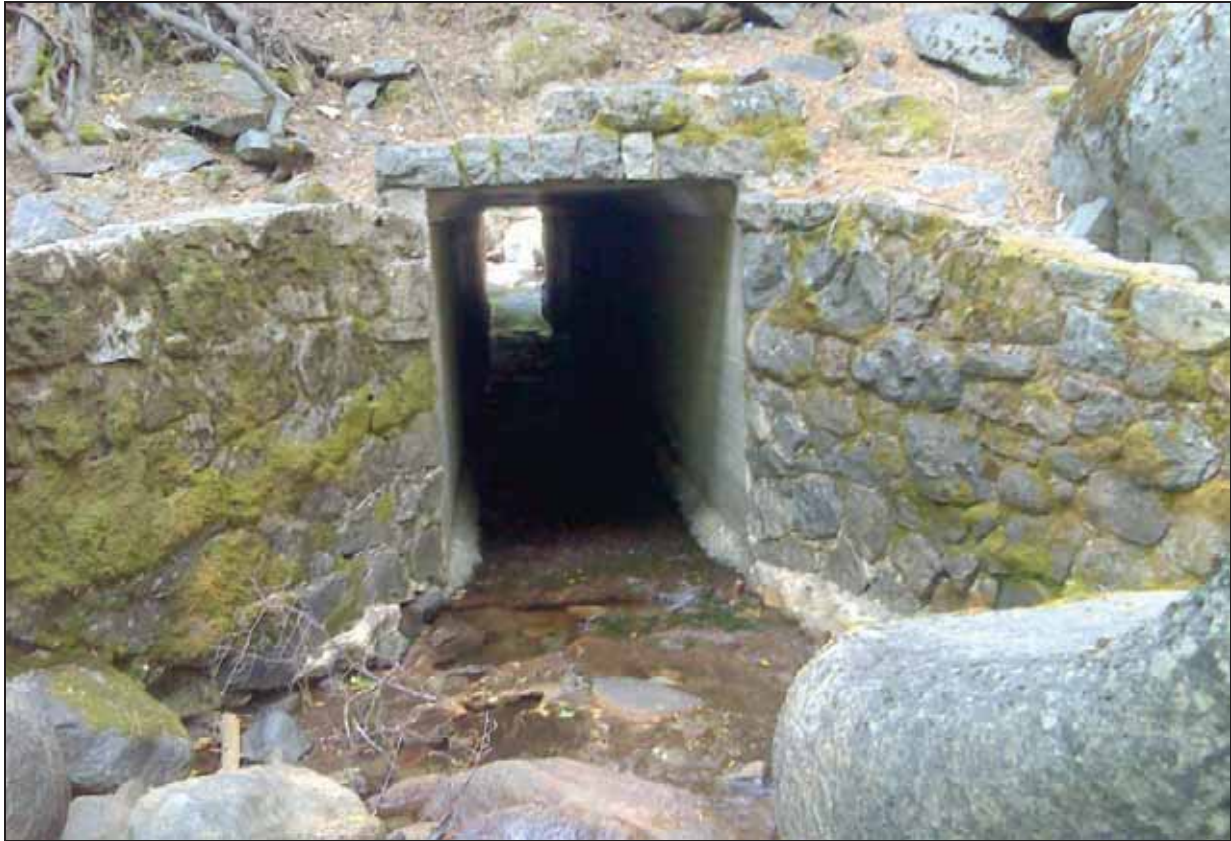
Due to the larger culvert size and condition, there were no special entry restrictions, as shown in the following Culvert Entry Diagram in annotated Figure 34. The downstream view of the culvert is shown in the following Figure 35.

Figure 35. Photo. View downstream of concrete box culvert with masonry appurtenances.

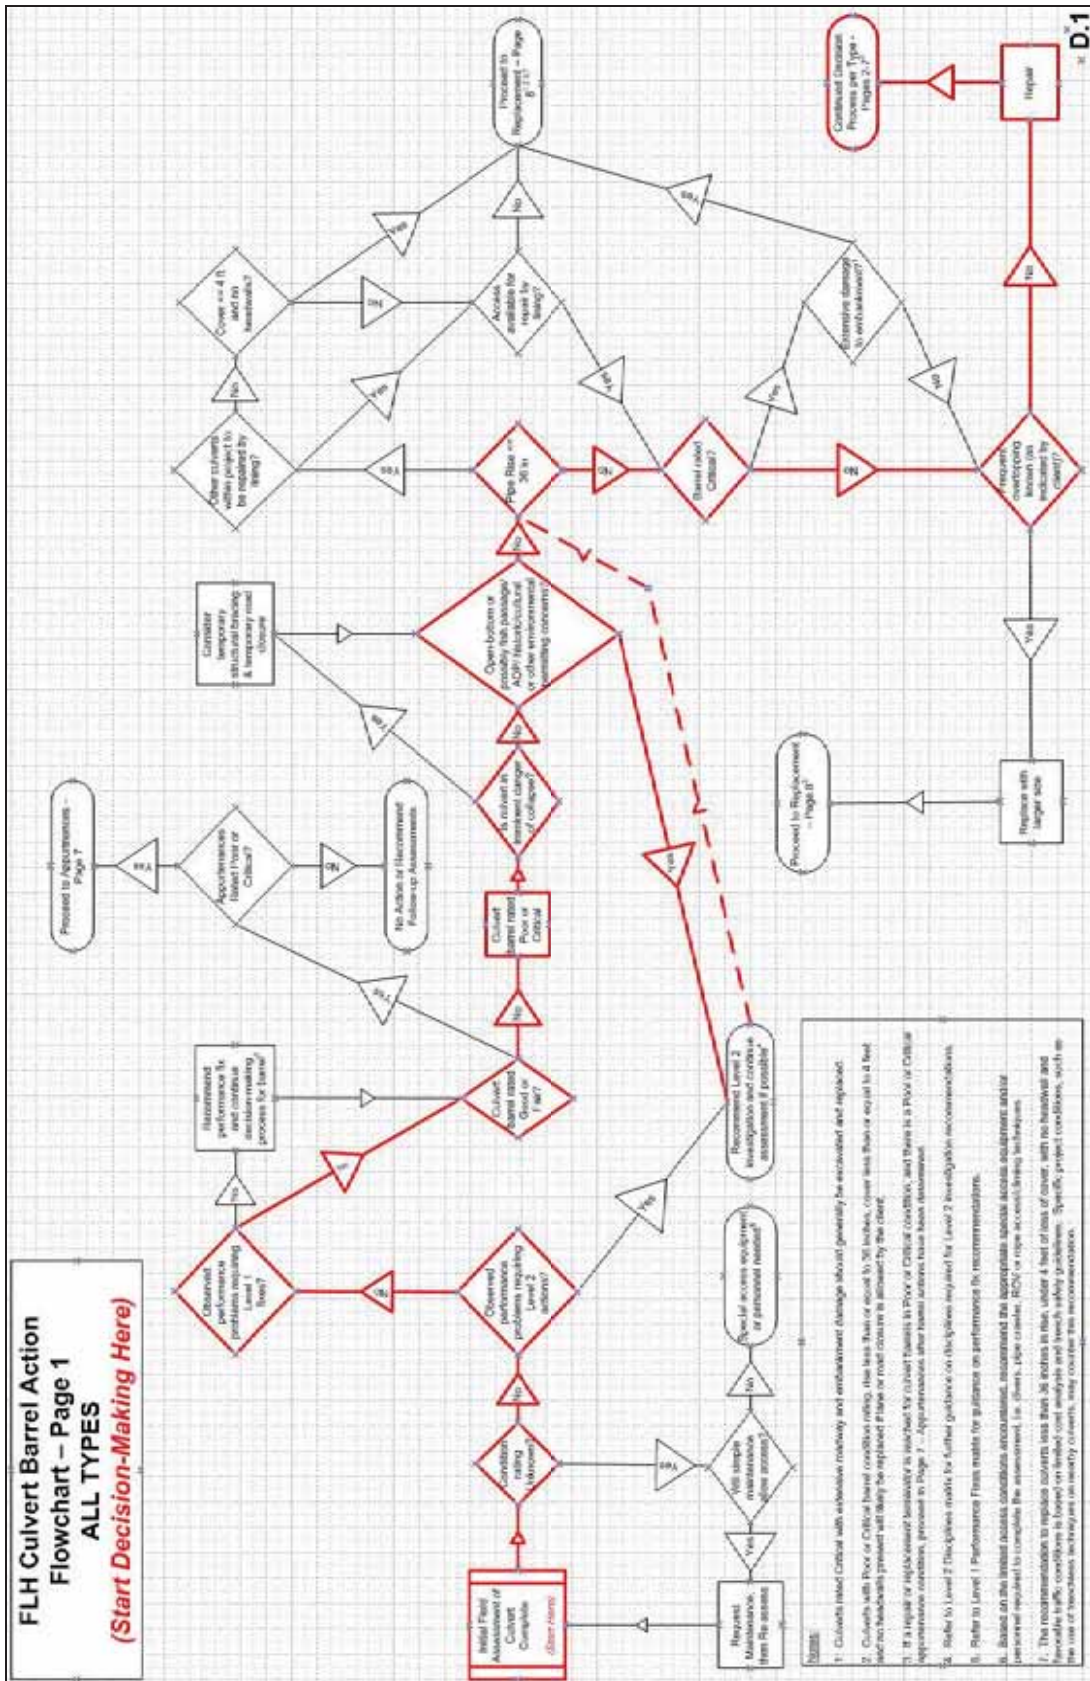
Initial Field Assessment of Culvert Complete → Condition Rating Unknown? <No> → Observed performance problems requiring Level 2 actions? <No> → Observed performance problems requiring Level 1 fixes? <No> → Culvert barrel rated Good or Fair? <No> → Culvert barrel rated Poor or Critical → Is culvert in imminent danger of collapse? <No> → Open-bottom or possible fish passage/AOP/historical/cultural? (*possibly, but continue assessment in this case*) <No> → Special environmental permitting issues anticipated? <No> → Pipe Rise ≤ 36 in? <No> → Barrel rated Critical? <No> → Frequent overtopping known (as indicated by client)? <No> → Repair → Continue Decision Process per Type – pages 2-7.

Figure 40. Flowchart. Annotated Culvert Barrel Flowchart – Page 1 ALL TYPES for concrete box example.

Based on the ratings and conditions determined in the Culvert Assessment Guide and material specific flow chart, a localized man-entry type of repair is recommended at this structure. Using the Localized Man-Entry Repair Selection Matrix, the following rehabilitation types would be recommended: Crack Epoxy Injection/Mortar, Crack/Spall Patching and Rebar Coating with Epoxy Grout, and Invert Lining. Note that although cracking was rated Fair, since repairs will be recommended for the Poor joints and invert, it is assumed other observed deterioration such as the Fair cracks will be repaired as well.

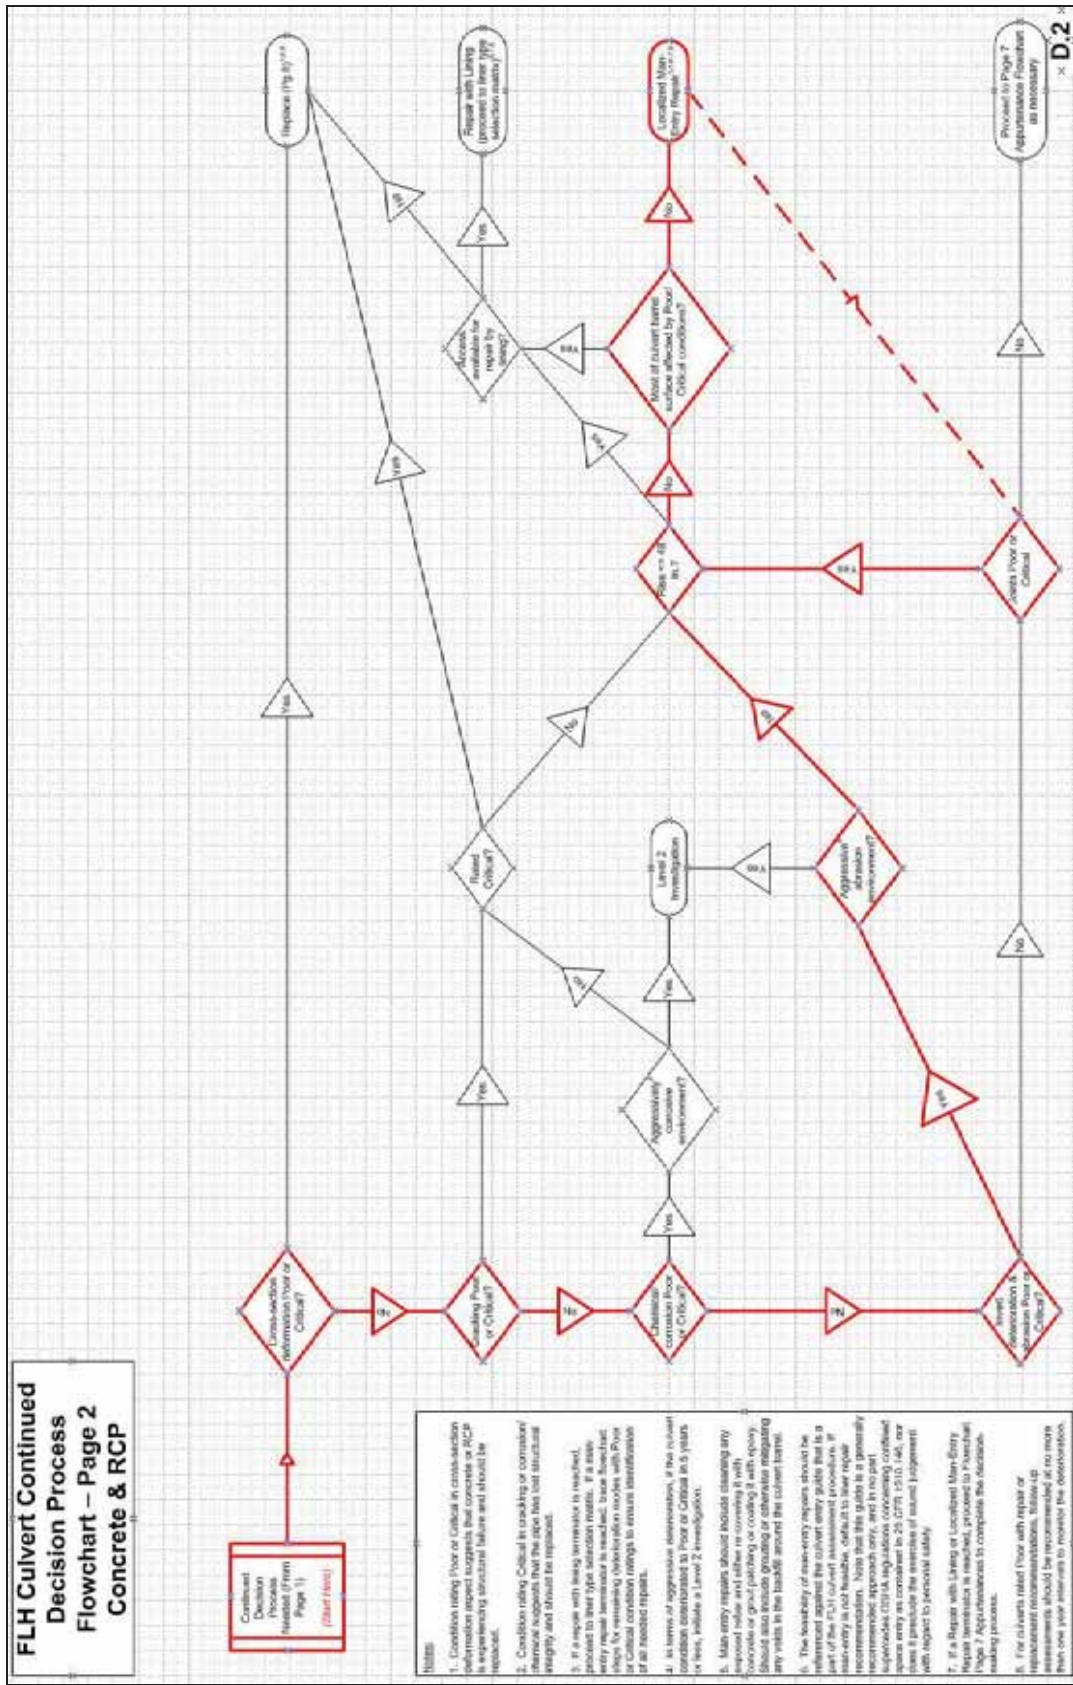
Continued Decision Process Needed (From Page 1) → Cross Section Deformation Poor or Critical? <No> → Cracking Poor or Critical? <No> → Chemical Corrosion Poor or Critical? <No> → Invert Deterioration & Abrasion Poor or Critical? <Yes> → Aggressive Abrasion Environment? <No> → Rise ≤ 48" ? <No> → Most of Culvert Barrel Surface Affected by Poor/Critical Conditions? (*all of invert affected, but not barrel surface*) <No> → Localized Man-Entry Repair → (*trace back to*) Joints Poor or Critical <Yes> → Rise ≤ 48" ? <No> → Most of Culvert Barrel Surface Affected by Poor/Critical Conditions? <No> → Localized Man-Entry Repair

Figure 41. Flowchart. Annotated FLH Culvert Continued Flowchart – Page 2 for concrete box example.

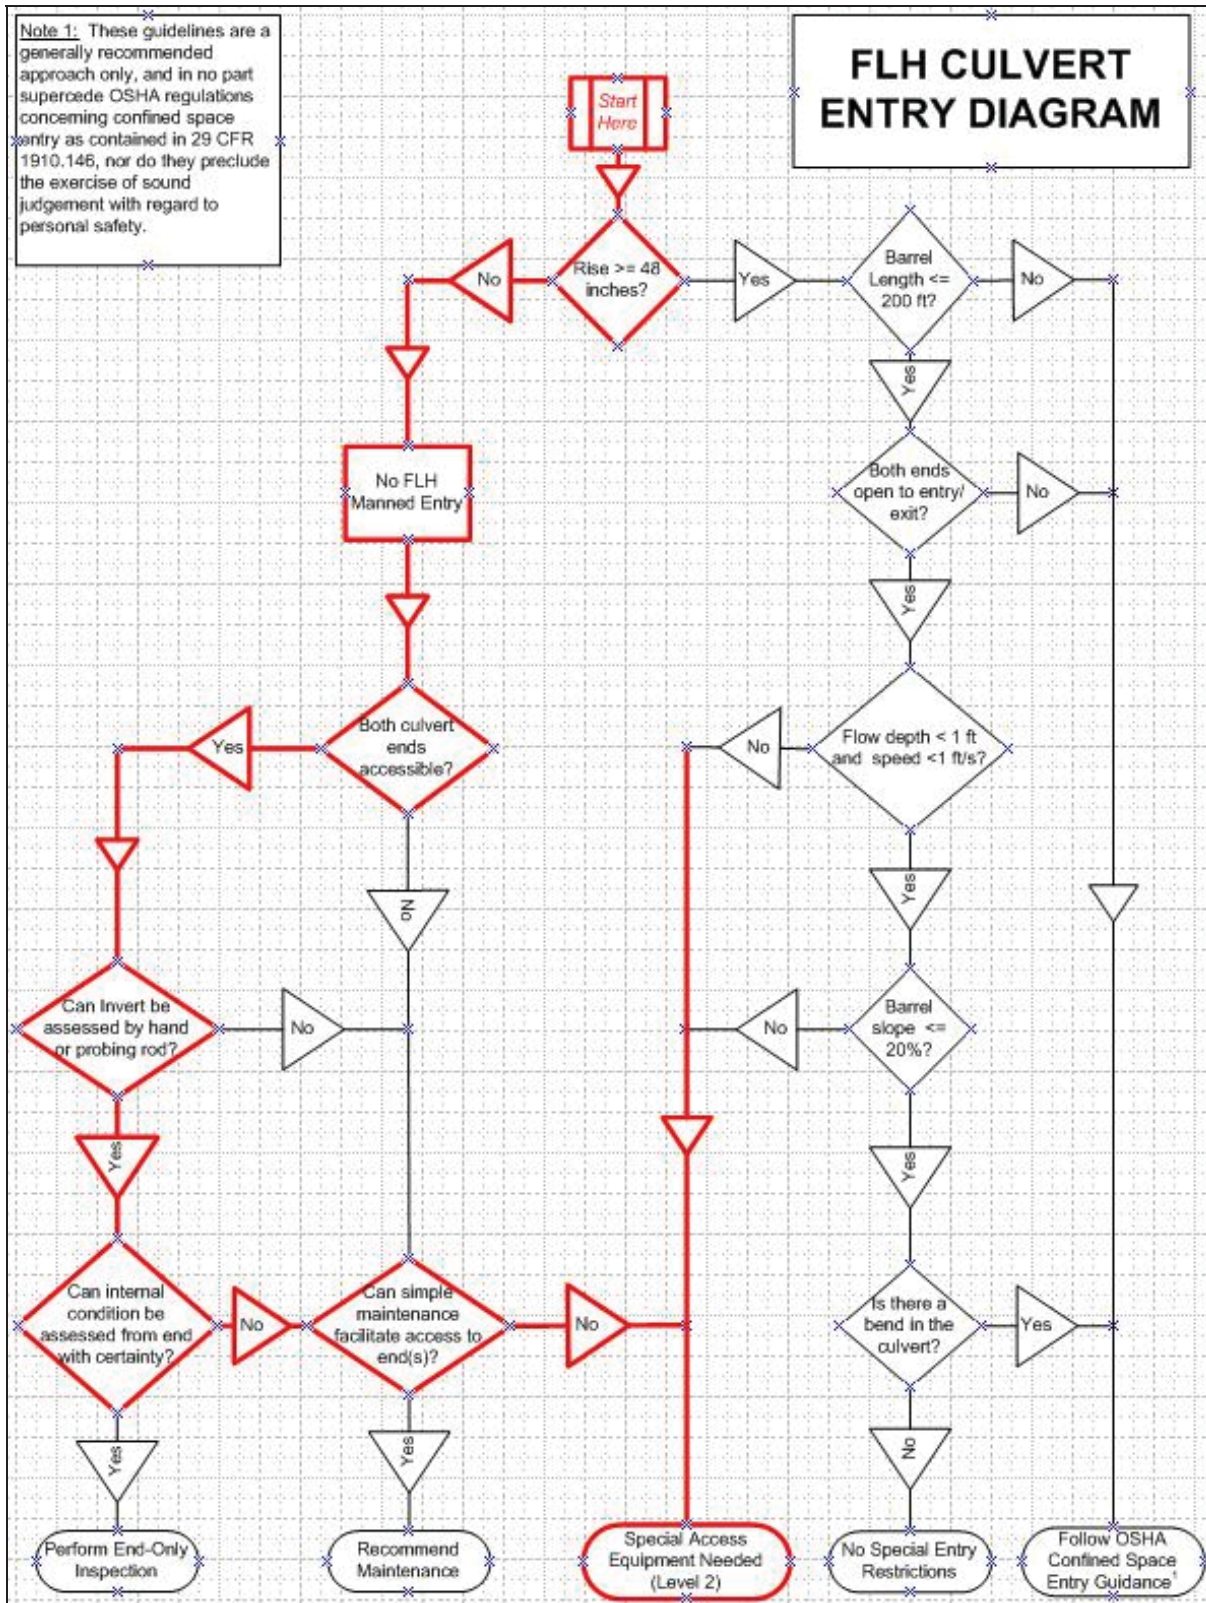
Due to the smaller barrel size and longer length, an initial “end-only” assessment was made. There was at least one bend in the culvert evident upon initial inspection; therefore, it was concluded that the internal condition could not be assessed with certainty from the end. Per the annotated Culvert Entry Diagram in Figure 43, special access equipment was called for, in this case a pipe-crawler ROV that the FLH team had readily available for the project.

Figure 43. Flowchart. Annotated FLH Culvert Entry Diagram for CMP example in Yosemite National Park.

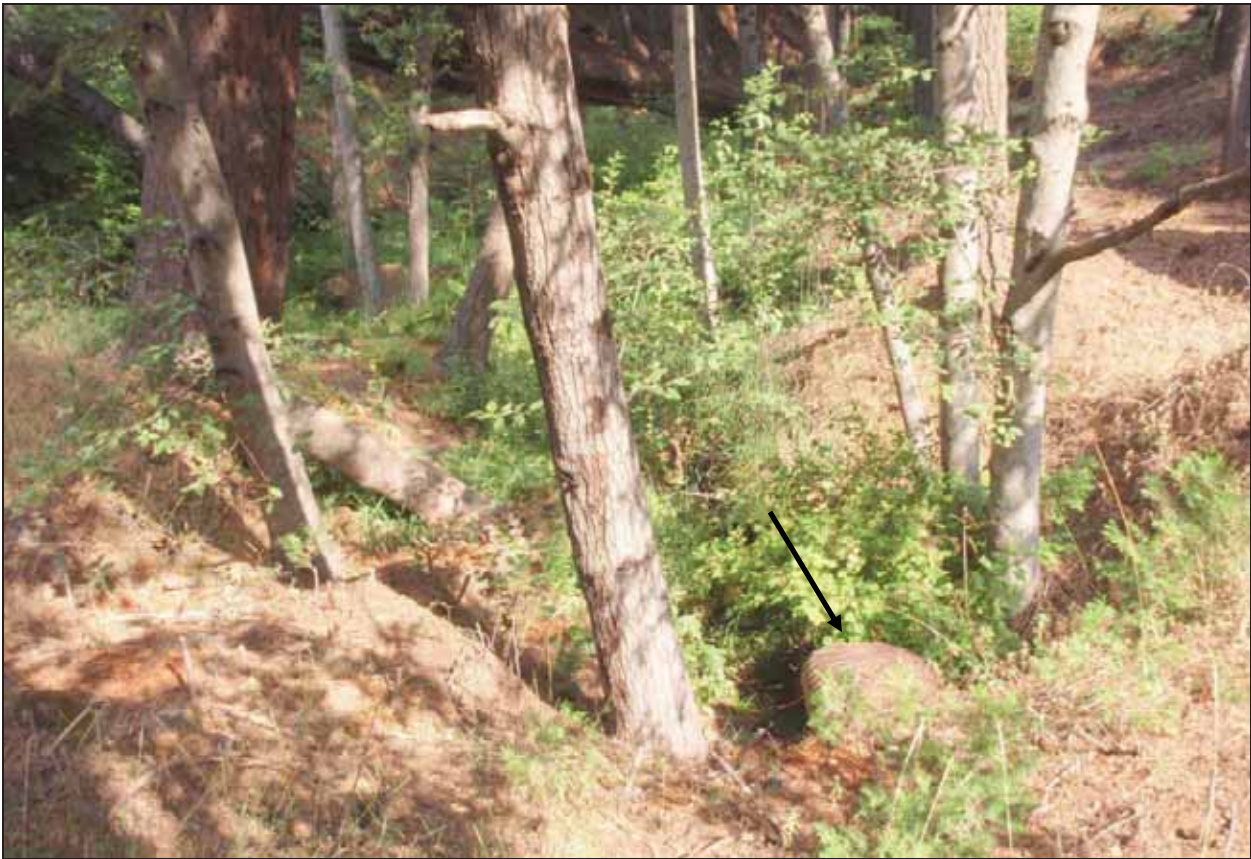
Figure 47. Photo. Stable downstream channel conditions at the outlet of CMP example in Yosemite National Park.

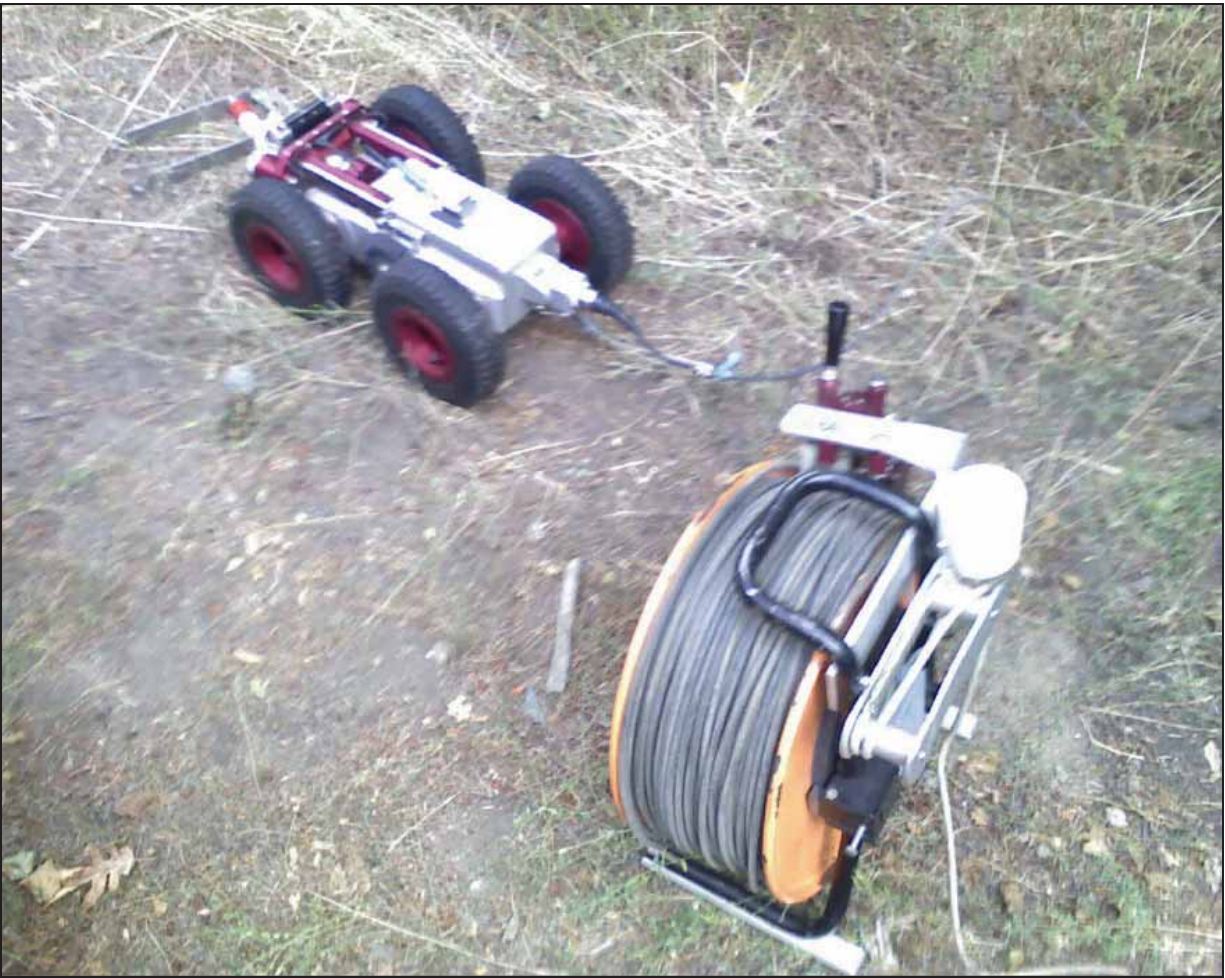
The Level 2 investigation using the pipe-crawler ROV revealed significant crown bulging and cross-section deformation under the roadway, section loss and holes at multiple joints above the flow line, suspected water exfiltration below the flow line, structural cracking in the crown of the pipe, and 50 to 100 percent section loss in the invert due to corrosion and abrasion. Heavy corrosion, pitting and section loss was observed at and above the invert throughout the pipe; however, no significant soil or water infiltration was observed. Based on these findings, the overall condition of the culvert was changed to Poor, which initiated the decision-making process for determining repair and replacement recommendations. The following Figures 48 through 52 show the ROV unit and video screenshots of internal pipe deterioration that it observed.

Figure 48. Photo. Pipe crawler ROV system ready for Level 2 inspection of CMP example in Yosemite National Park.

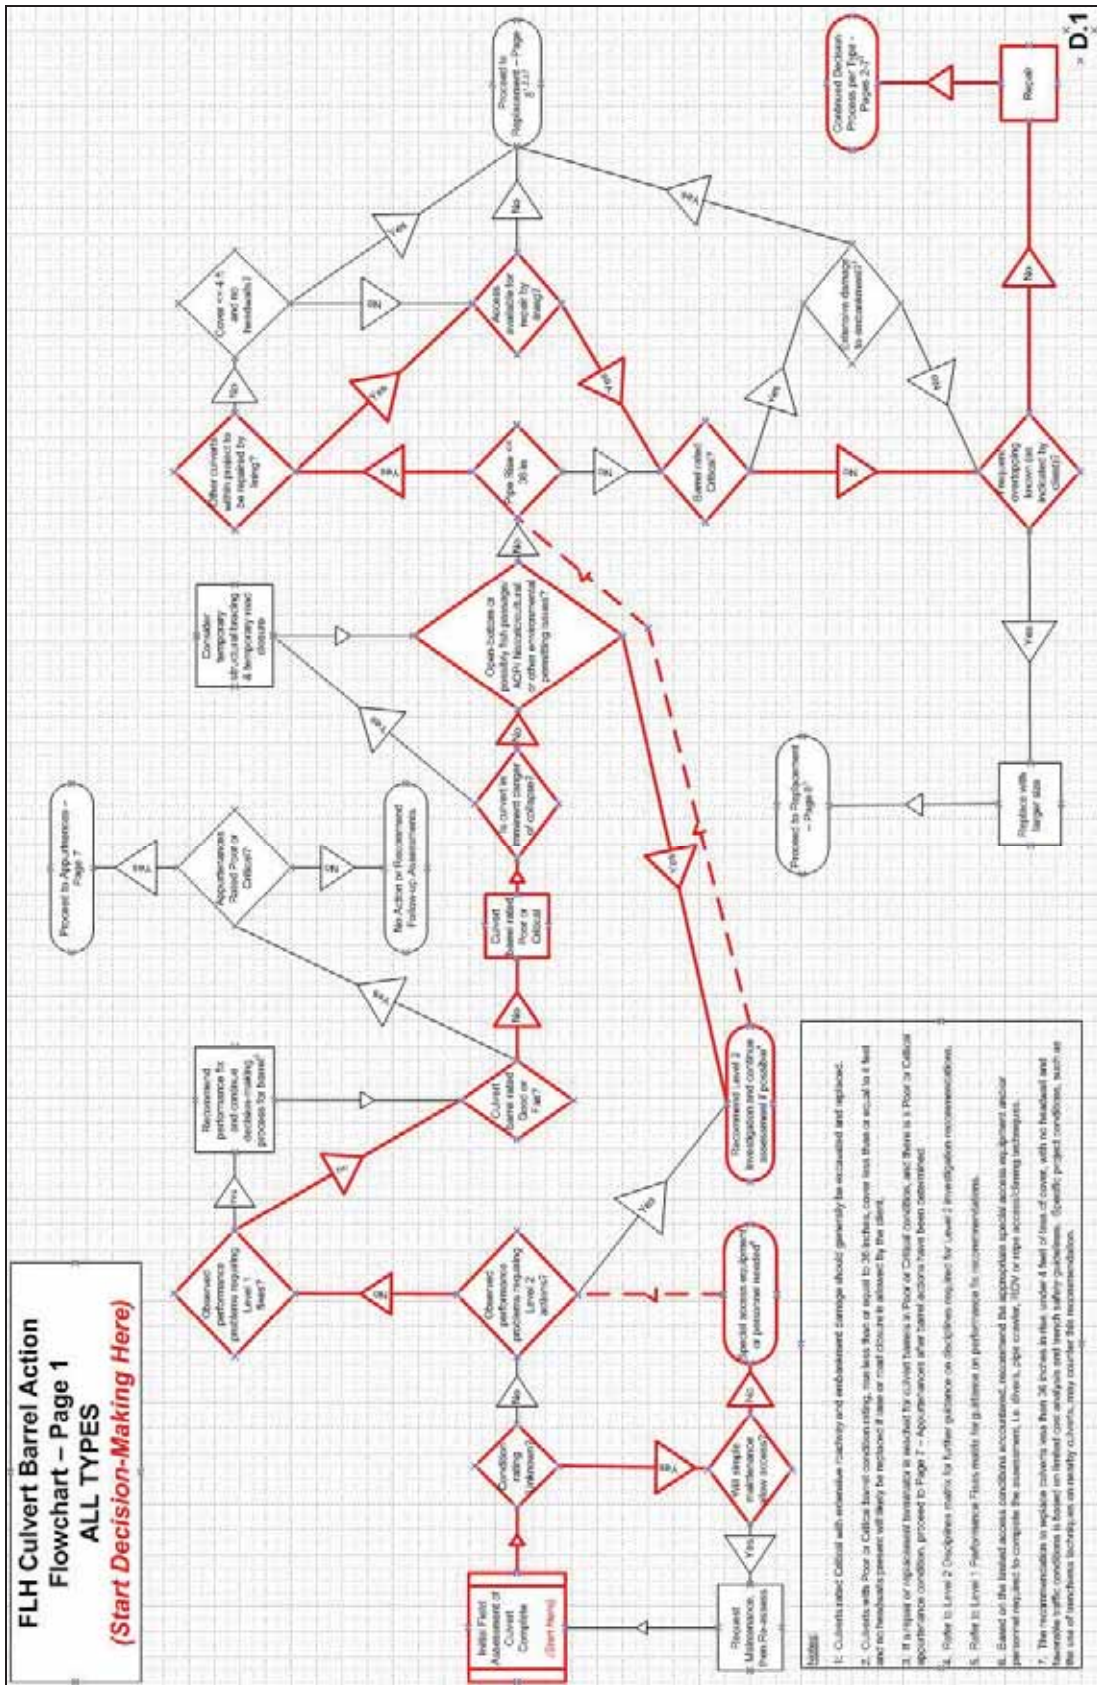
Initial Field Assessment of Culvert Complete → Condition Rating Unknown? <No> → Observed performance problems requiring Level 2 actions? <No> → Observed performance problems requiring Level 1 fixes? <No> → Culvert barrel rated Good or Fair? <No> → Culvert barrel rated Poor or Critical → Is culvert in imminent danger of collapse? <No> → Open-bottom or possible fish passage/AOP/historical/cultural? (*possibly, but continue assessment in this case*) <No> → Special environmental permitting issues anticipated? → <No> → Pipe Rise ≤ 36 in? <Yes> → Other culverts within project to be repaired by lining? <Yes> (*assume possibly for now, to keep options open*) → Cover ≤ 4 ft and no headwalls? <No> → Access available for repair by lining? <Yes> → Barrel Rated Critical <No> → Frequent overtopping known (as indicated by client)? <No> → Repair → Continued Decision Process per Type – Pages 2-7.

Figure 53. Flowchart. Annotated Barrel Action Flowchart – Page 1 for CMP example in Yosemite National Park.

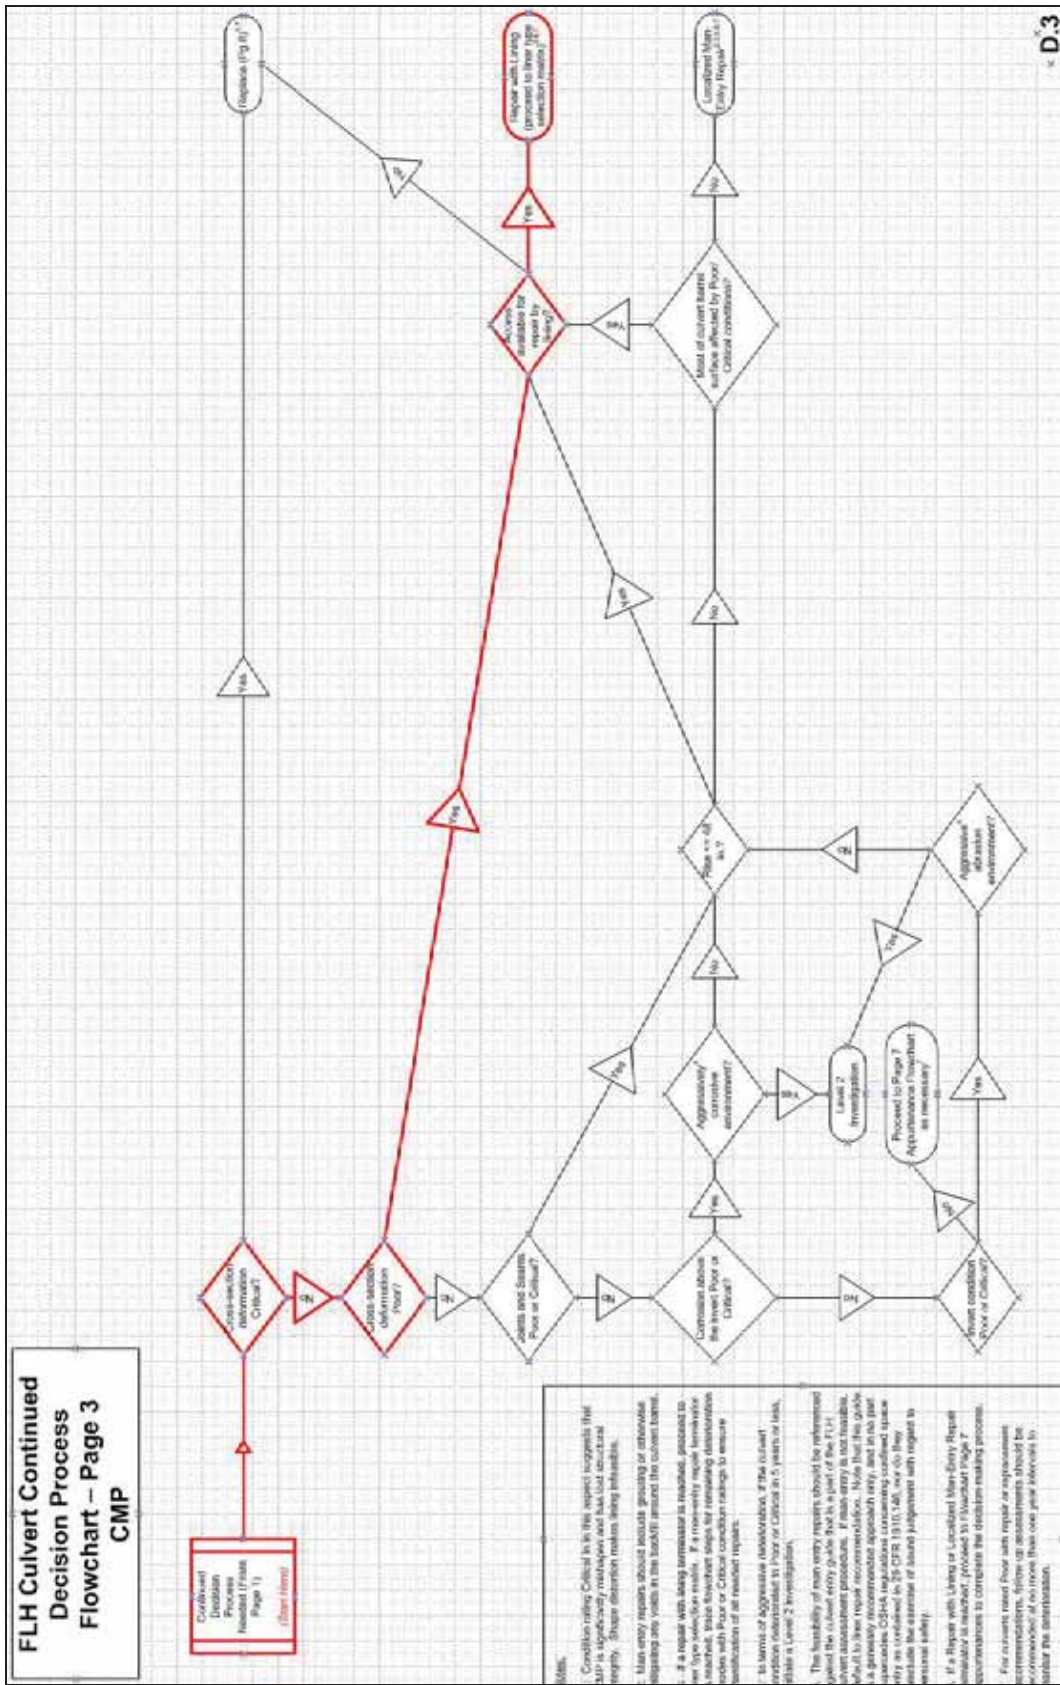
Continued Decision Process Needed (From Page 1) → Cross Section Deformation Poor or Critical? <Yes> → Cross Section Deformation Poor? <Yes> → Access available for repair by lining? <Yes> → Repair with Lining (proceed to liner type selection matrix).

Figure 54. Flowchart. Continued Decision Process Flowchart – Page 3 for CMP example in Yosemite National Park.

Based on the ratings and conditions determined in the Culvert Assessment Guide and material specific flow chart, a liner repair is recommended at this structure, as shown in the following Figure 54. Using the Liner Selection Matrix, with prime consideration given to the localized bulges and cross-section deformations, the Spray-On Cement Mortar or Epoxy Lining types might be recommended; however, additional issues and pipe conditions eventually rule out these methods.

The pipe is rather long, with a bend and low-point in the middle where groundwater infiltration through the lost invert will likely pool water and prevent setup of the mortar. The longer length, bend in the middle, and bulges and deformations present possible issues with pulling the sled through the pipe at the steady rate required to control thickness of application. Lastly, the extent of invert loss may exceed the coating capabilities of this application method, requiring the use of local patches and/or reinforcement that require manned-entry. These added considerations suggest the spray-on liners may not be appropriate for this application. A note at the bottom of the Liner Selection Matrix directs the user to proceed to the Localized Man-Entry Repair or Replacement Matrix as appropriate if no liner can be selected. The combination of small size, long length and location of the worst deterioration at the middle of the run create conditions that may not be conducive to man-entry work. Although the 10 foot depth of cover exceeds the 4 foot delineator described in this procedure, there is room for road excavation equipment and traffic diversion is possible. Referencing the culvert Replacement Flowchart D.8 and the Culvert Replacement Techniques Matrix and comparing cost information, the recommended action is Open-Trench Excavation.

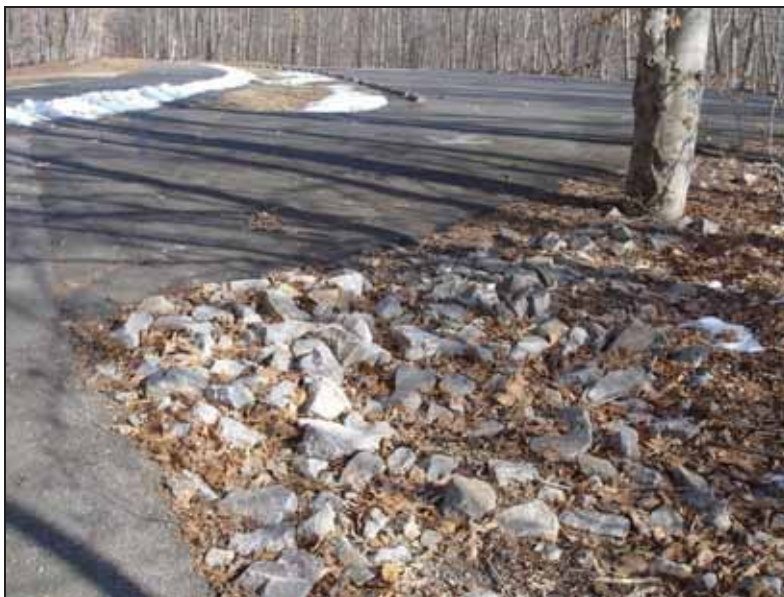
The following example is a 15 inch diameter High Density Polyethylene Pipe (HDPE) pipe is one of two pipes inspected at Fountainhead Regional Park in Fairfax, Virginia, on January 7th, 2010. The assessment was performed by a two-person consultant team in approximately twenty minutes. The culvert and roadway are shown in the following Figures 55 through 57. The completed Culvert Inspection Form is shown in Figure 58. The culvert received an overall rating of Unknown, with additional notes made regarding the clogging throughout the pipe and completely buried outlet, which will lead to constant roadway overtopping and possible damage to the roadway and embankment.

Figure 57. Photo. View of roadway crossing at plastic pipe example in Fountainhead Park.

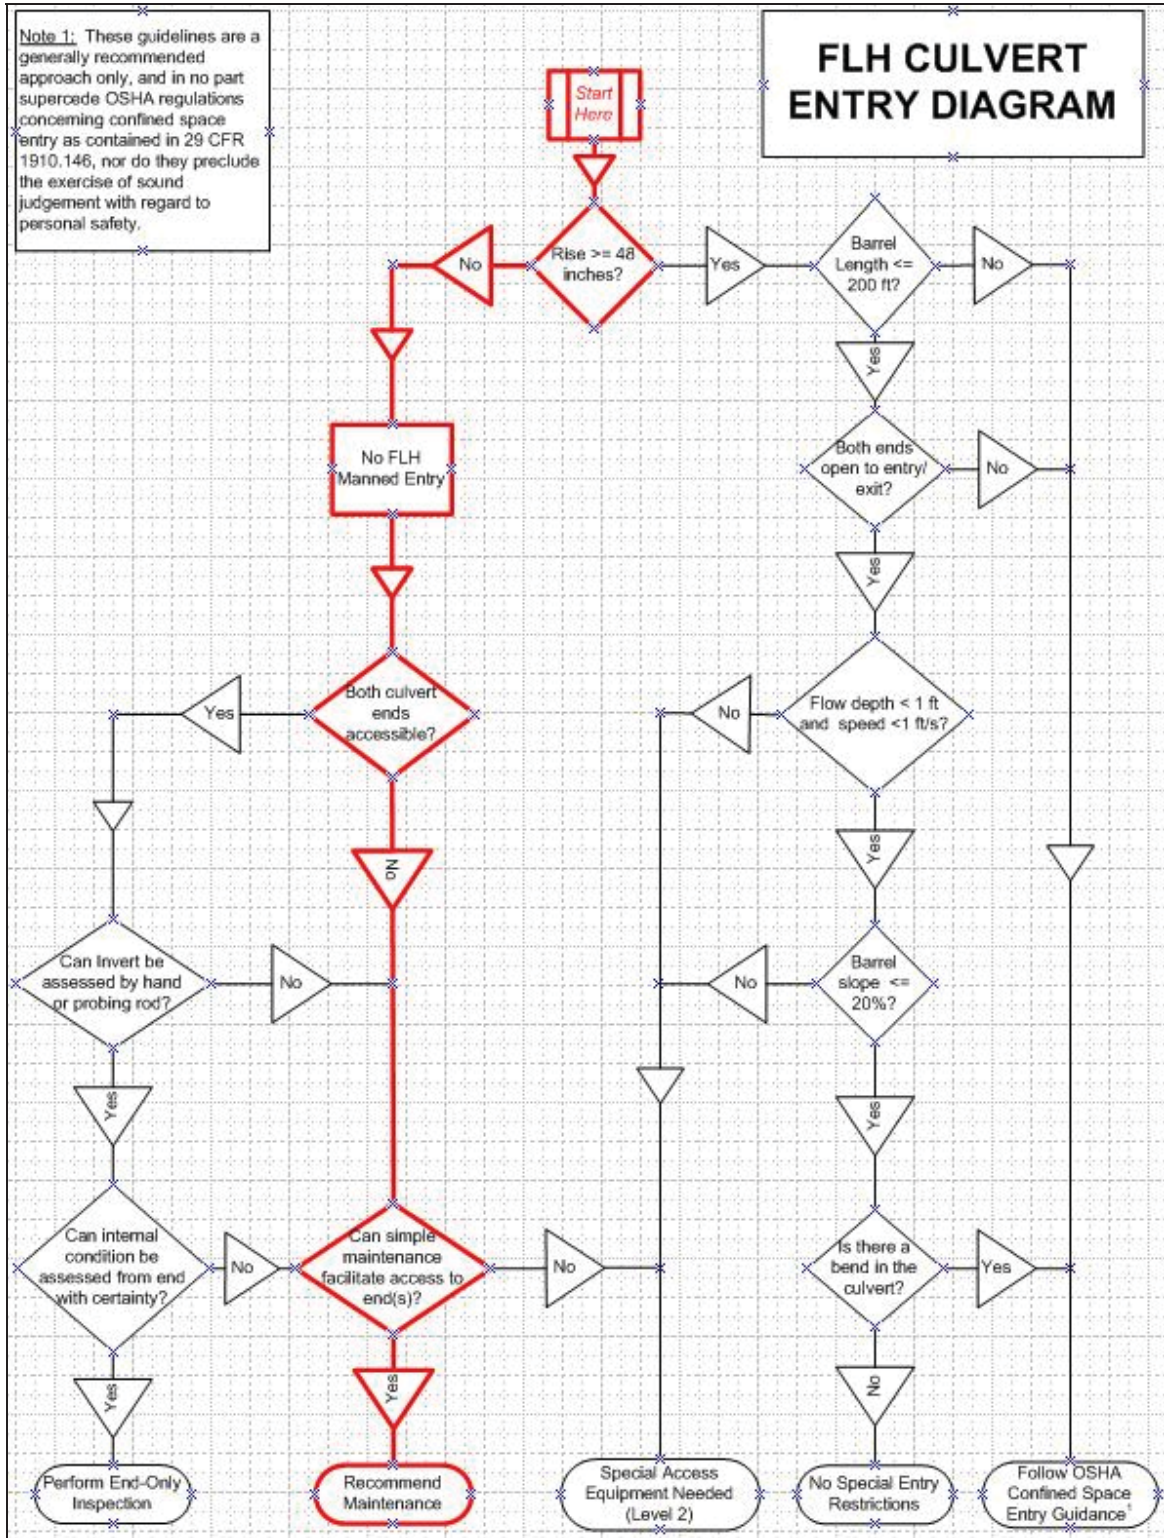
Due to the small barrel size and limited access, a maintenance recommendation was selected, as shown in the annotated entry diagram in Figure 59 below. The entrance was the only portion of the structure visible, with the invert substantially buried. The outlet could not be located and was presumed to be completely buried as well. Visibility inside the pipe was restricted due to sediment and debris. The team opted to conduct a partial Level 1 end-only assessment of the culvert to the extent possible from the inlet.

Figure 59. Flowchart. Annotated Culvert Entry Diagram for plastic HDPE example in Fountainhead Park.

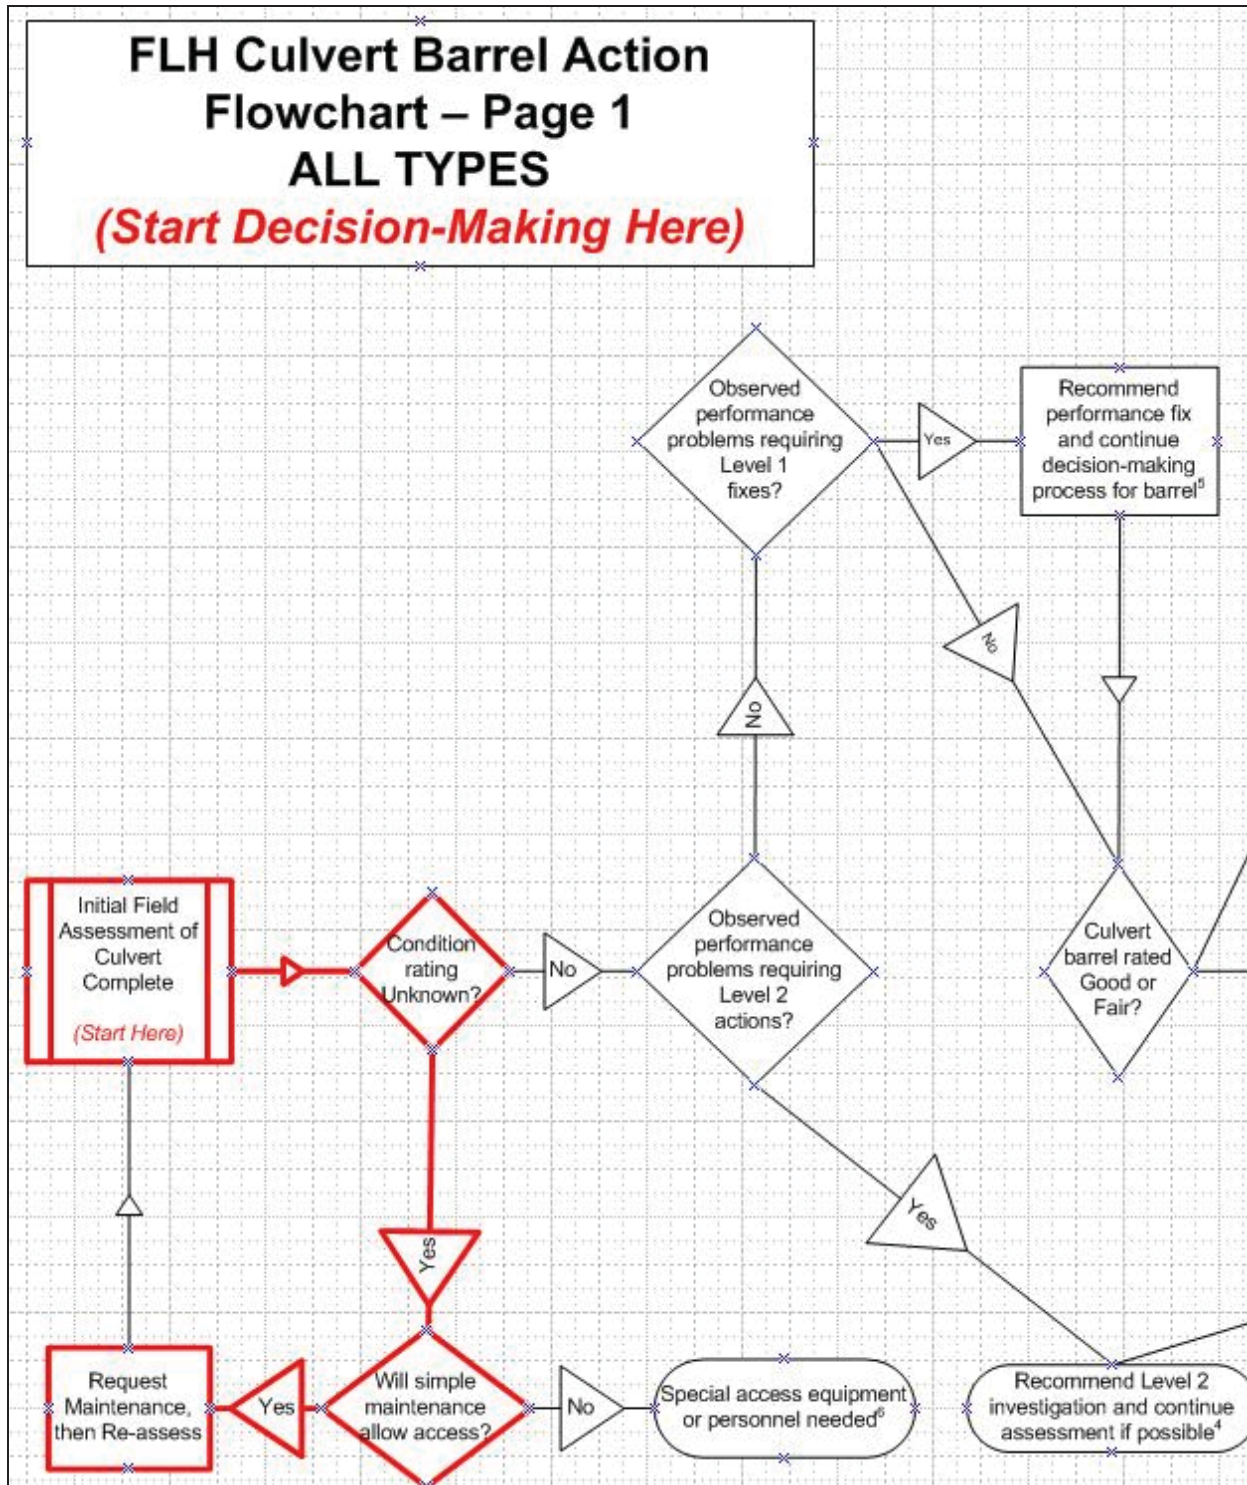
Initial Field Assessment of Culvert Complete → Condition Rating Unknown? <Yes> → Will simple maintenance allow access? <Yes> → Request Maintenance, then Re-assess.

Figure 61. Flowchart. Annotated Culvert Barrel Action Flowchart – Page 1 for plastic HDPE example.

Based on the results for the partial Level 1 assessment and decision-making process, the recommended action is to immediately uncover the outlet and clean out the pipe to enable a complete Level 1 assessment. It is recommended that the Level 1 maintenance be done immediately to prevent roadway overtopping and possible embankment and roadway damage. Due to the small culvert size and presumably low, cross-drainage nature of the flows conveyed, total failure of the culvert is not anticipated to cause public safety issues; therefore, the culvert was not rated Critical, despite the urgency of the maintenance recommended.
