CHAPTER 4 – SUBJECTIVE OBSERVATIONS

COMPARATIVE SUBJECTIVE INSPECTION SYSTEM

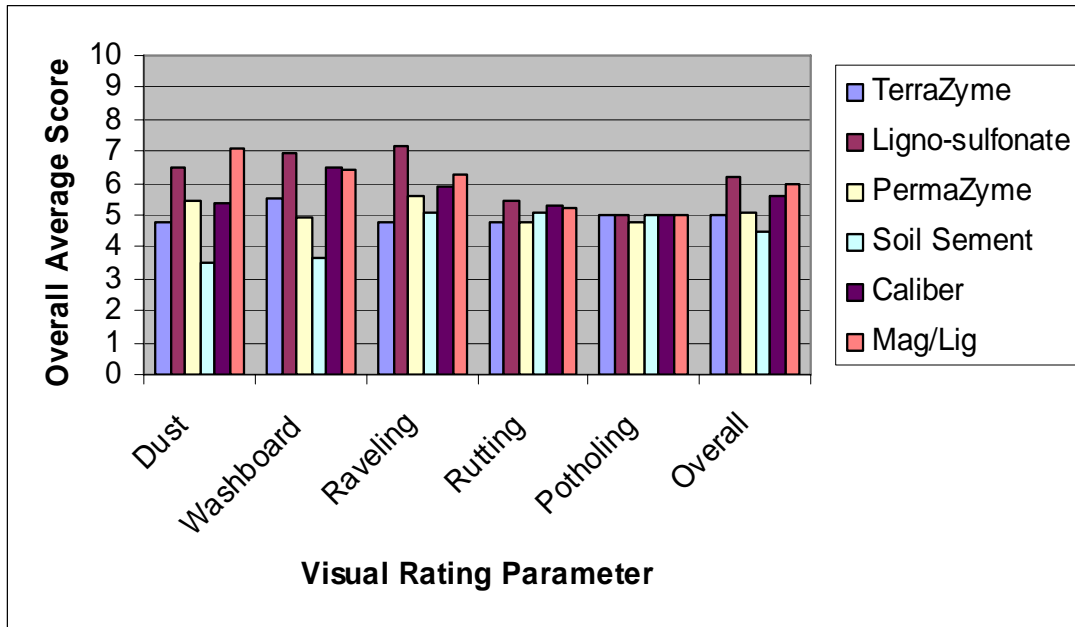
Figure 10. Plot. Relative product standings from subjective observations.

Looking at the Figure 10 plot for dust, the products can be separated into three dust abatement groups. The columns represent for each product the overall average score it received for the entire monitoring period. In the first group, Mag/Lig and Lignosulfonate showed the least amount of airborne particles. In the second group consisting of PermaZyme,

In looking at the washboarding overall average scores in Figure 10, the products can be separated into three groups. In the first group were Lignosulfonate, Caliber, and Mag/Lig. These products produced the least amount of washboarding.

In the second group, showing more washboarding were the enzyme products - TerraZyme and PermaZyme. In the third group was Soil Sement that had the highest level of washboarding as shown in Figure 12. It should be noted again that the scores given in Table 10 for each monitoring event are not absolute scores in reference to some objective criteria, but rather ratings given in comparison to a baseline section.

For raveling, Table 7 and Figure 10 show overall scores ranging from 4.8 to 7.2.

As shown in the Figure 10 plot, potholing was not an issue except for in the PermaZyme section. This section was downgraded in the 8-month monitoring event because one pothole was discovered in the section. A total of only three potholes were evident on the entire project – the second appeared in the TerraZyme section at the 13-month event and the third also in the TerraZyme section at the 20-month event. Though the team rated the PermaZyme section lower at the 8-month event, it was later decided that a total of only one or two potholes in a half-mile of roadway had to be due to something other than poor performance of a stabilizer product such as uncompacted material left in a hole by a removed rock or a gopher hole.

The overall average scores for each product covering all the parameters are shown in the extreme right column of Table 7 and plotted in Figure 10 as the right-most set of bars. These numbers, for each product, are the average of the scores it received for dust, washboarding, raveling, rutting, and potholing. Thus from subjective observations, three groups of product performance are evident. In the first group performing best, second and third, were the Lignosulfonate, Mag/Lig, and Caliber sections. The two enzyme products, TerraZyme and PermaZyme, were in the second group, and the third group consisted of the Soil Sement product that had the lowest overall average.
