CHAPTER 6 – PRESENTATION OF RESULTS

DESCRIPTION OF SITES

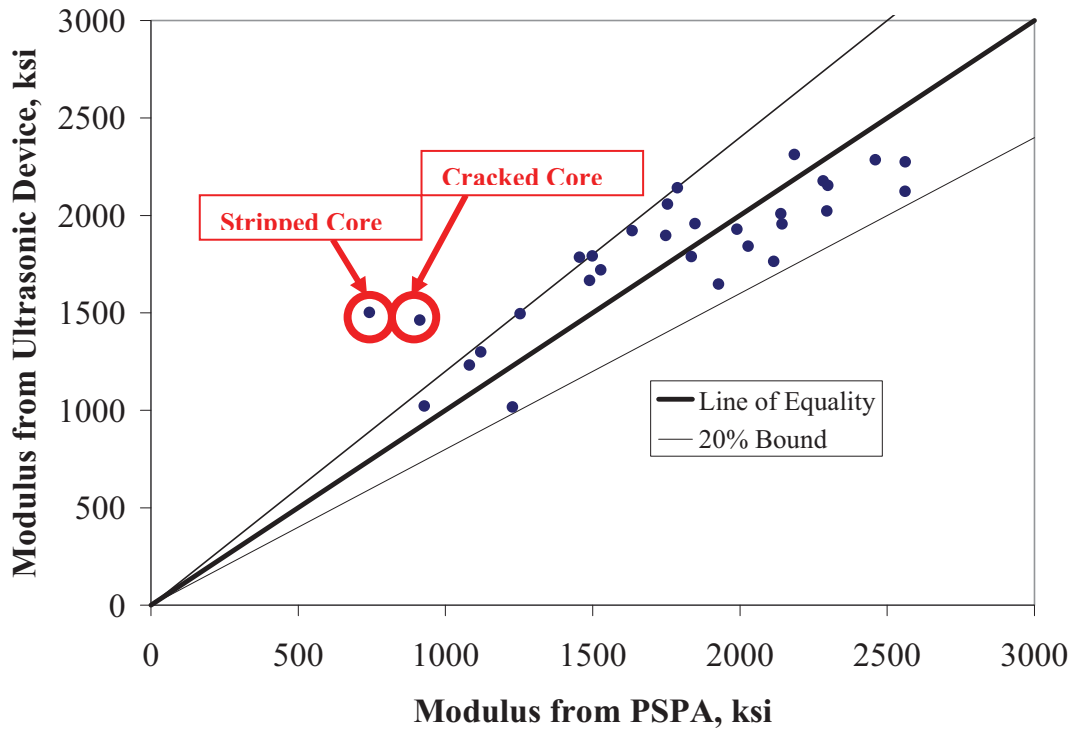
Figure 32. Graph. Variation between Moduli Obtained by Ultrasonic Device and PSPA at all Sites.

A comparison of the seismic moduli obtained with the ultrasonic device on the cores and the PSPA moduli obtained at the respective core location is presented in Figure 31. In general, close agreement between the two moduli was observed. The exception is Core 4 for Site 2 that contained micro-cracks and Core 1 of Site 4 that was badly stripped (see picture of cores in Appendix A). To further quantify the comparison between the two moduli, they are plotted against one another in Figure 32. The differences between the two moduli are generally less than 20%. The reasons for differences, aside from any experimental errors are itemized in Chapter 5.
