COLUMBIA

ACCIDENT INVESTIGATION BOARD

REPORT VOLUME I
AUGUST 2003

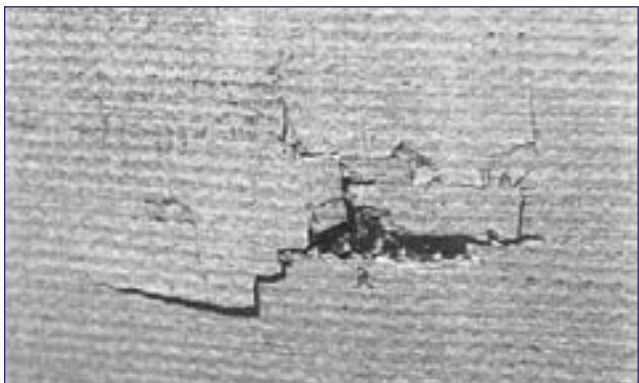
RCC components have been struck by objects throughout their operational life, but none of these components has been completely penetrated. A sampling of 21 post-flight reports noted 43 hypervelocity impacts, the largest being 0.2 inch. The most significant low-velocity impact was to *Atlantis*' panel 10-right during STS-45 in March and April 1992. The damaged area was 1.9 inches by 1.6 inches on the exterior surface and 0.5 inches by 0.1 inches in the interior surface. The substrate was exposed and oxidized, and the panel was scrapped. Analysis concluded that the damage was caused by a strike by a man-made object, possibly during ascent. Figures 3.3-2 and 3.3-3 show the damage to the outer and inner surfaces, respectively.

Figure 3.3-3. Damage on the inner surface of RCC panel 10-right from *Atlantis* after STS-45.

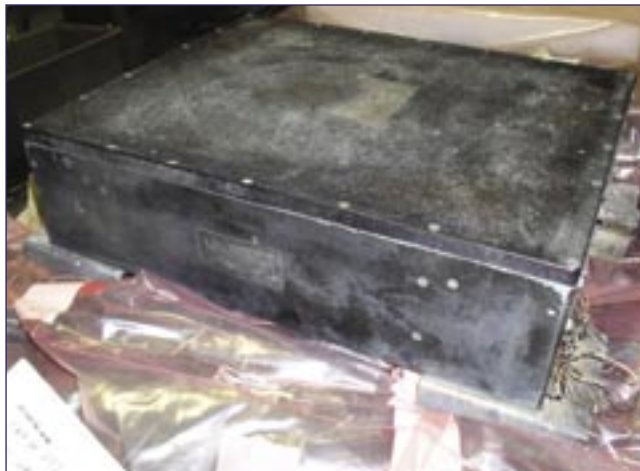
The Modular Auxiliary Data System is a supplemental instrumentation system that gathers Orbiter data for processing after the mission is completed. Inputs are almost exclusively physical sensor readings of temperatures, pressures, mechanical strains, accelerations, and vibrations. The Modular Auxiliary Data System usually records only the mission's first and last two hours (see Figure 3.6-1).

Figure 3.6-1. The Modular Auxiliary Data System recorder, found near Hemphill, Texas. While not designed to withstand impact damage, the recorder was in near-perfect condition when recovered on March 19, 2003.

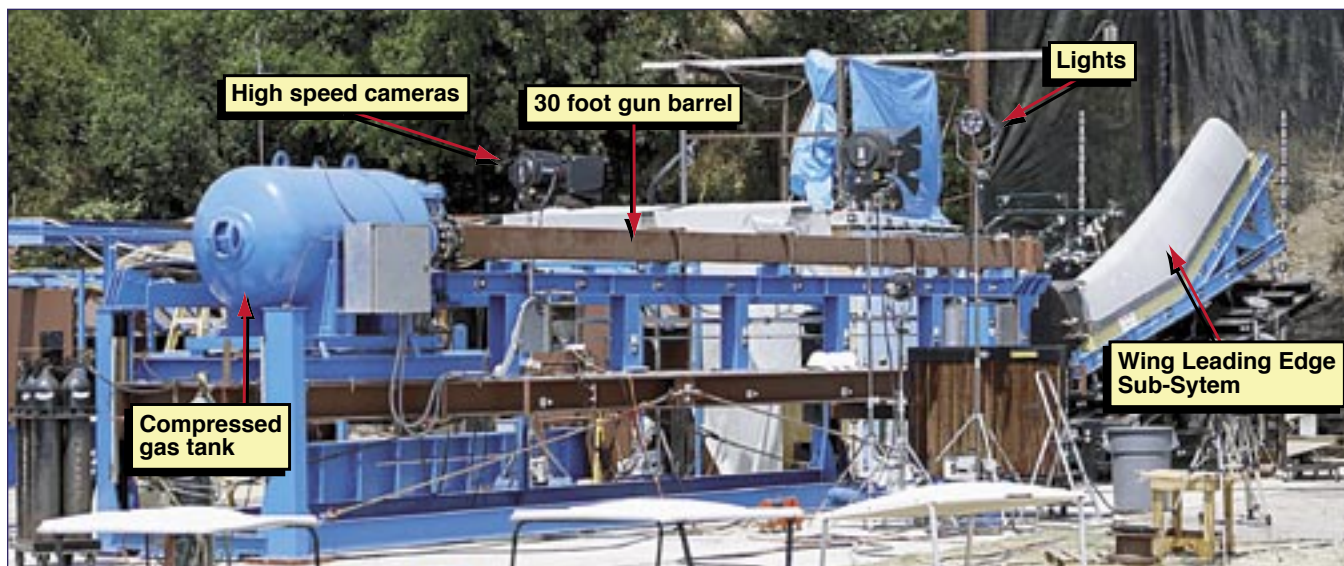
Figure 3.8-1. Nitrogen-powered gun at the Southwest Research Institute used for the test series.

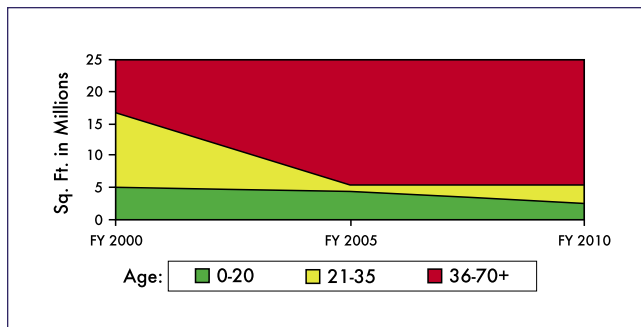
The same ambiguity about investing in Shuttle upgrades has also affected the maintenance of Shuttle Program ground infrastructure, much of which dates to Project Apollo and 1970s Shuttle Program construction. Figure 5.5-4 depicts the age of the Shuttle’s infrastructure as of 2000. Most ground infrastructure was not built for such a protracted lifespan. Maintaining infrastructure has been particularly difficult at Kennedy Space Center, where it is constantly exposed to a salt water environment.

Figure 5.5-4. Age of the Space Shuttle infrastructure. (Source: Connie Milton to Space Flight Advisory Council, 2000.)

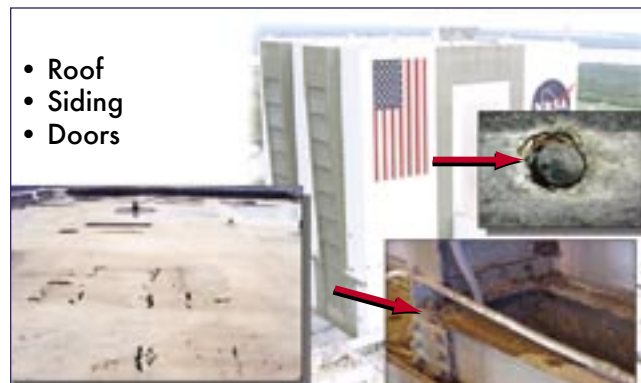
Board investigators have identified deteriorating infrastructure associated with the launch pads, Vehicle Assembly Building, and the crawler transporter. Figures 5.5-5 and 5.5-6 depict some of this deterioration. For example, NASA has installed nets, and even an entire sub-roof, inside the Vehicle Assembly Building to prevent concrete from the building’s ceiling from hitting the Orbiter and Shuttle stack. In addition, the corrosion-control challenge results in zinc primer

on certain launch pad areas being exposed to the elements. When rain falls on these areas, it carries away zinc, runs onto the leading edge of the Orbiter’s wings, and causes pinholes in the Reinforced Carbon-Carbon panels (see Chapter 3).

Figure 5.5-5 and 5.5-6. Examples of the seriously deteriorating infrastructure used to support the Space Shuttle Program. At left is Launch Complex 39A, and at right is the Vehicle Assembly building, both at the Kennedy Space Center.

In Fiscal Year 2002, Congress added \$25 million to NASA’s budget for Vehicle Assembly Building repairs. NASA has reallocated limited funds from the Shuttle budget to pressing infrastructure repairs, and intends to take an integrated look at infrastructure as part of its new Shuttle Service Life Extension Program. Nonetheless, like Space Shuttle upgrades, infrastructure revitalization has been mired by the uncertainty surrounding the Shuttle Program’s lifetime. Considering that the Shuttle will likely be flying for many years to come, NASA, the White House, and Congress alike now face the specter of having to deal with years of infrastructure neglect.

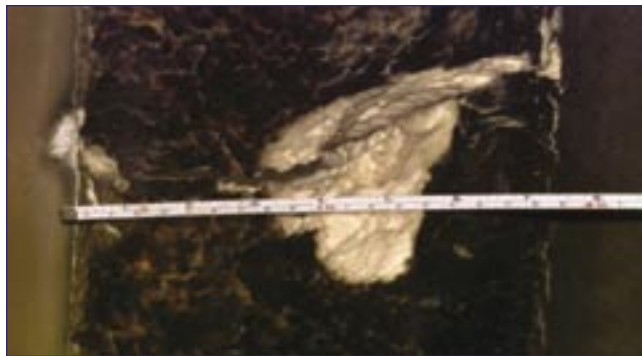
The sixth and final bipod ramp event before STS-107 occurred during STS-112 on October 7, 2002 (see Figure 6.1-3). At 33 seconds after launch, when *Atlantis* was at 12,500 feet and traveling at Mach 0.75, ground cameras observed an object traveling from the External Tank that subsequently impacted the Solid Rocket Booster/External Tank Attachment ring (see Figure 6.1-4). After impact, the debris broke into multiple pieces that fell along the Solid Rocket Booster exhaust plume.¹⁵ Post-mission inspection of the Solid Rocket Booster confirmed damage to foam on the forward face of the External Tank Attachment ring. The impact was approximately 4 inches wide and 3 inches deep. Post-External Tank separation photography by the crew showed that a 4- by 5- by 12-inch (240 cubic-inch) corner section of the left bipod ramp was missing, which exposed the super lightweight ablator coating on the bipod housing. This missing chunk of foam was believed to be the debris that impacted the External Tank Attachment ring during ascent. The post-launch review of photos and video identified these debris events, but the Mission Evaluation Room logs and Mission Management Team minutes do not reflect any discussions of them.

Figure 6.1-4. On STS-112, the foam impacted the External Tank Attach ring on the Solid Rocket Booster, causing this tear in the insulation on the ring.
