SANDIA REPORT

SAND93-1380 • UC-261

The Application of Non-Destructive Techniques to the Testing of a Wind Turbine Blade

Herbert Sutherland, Alan Beattie, Bruce Hansche, Walt Musial, Jack Allread,
Jim Johnson, Mike Summers

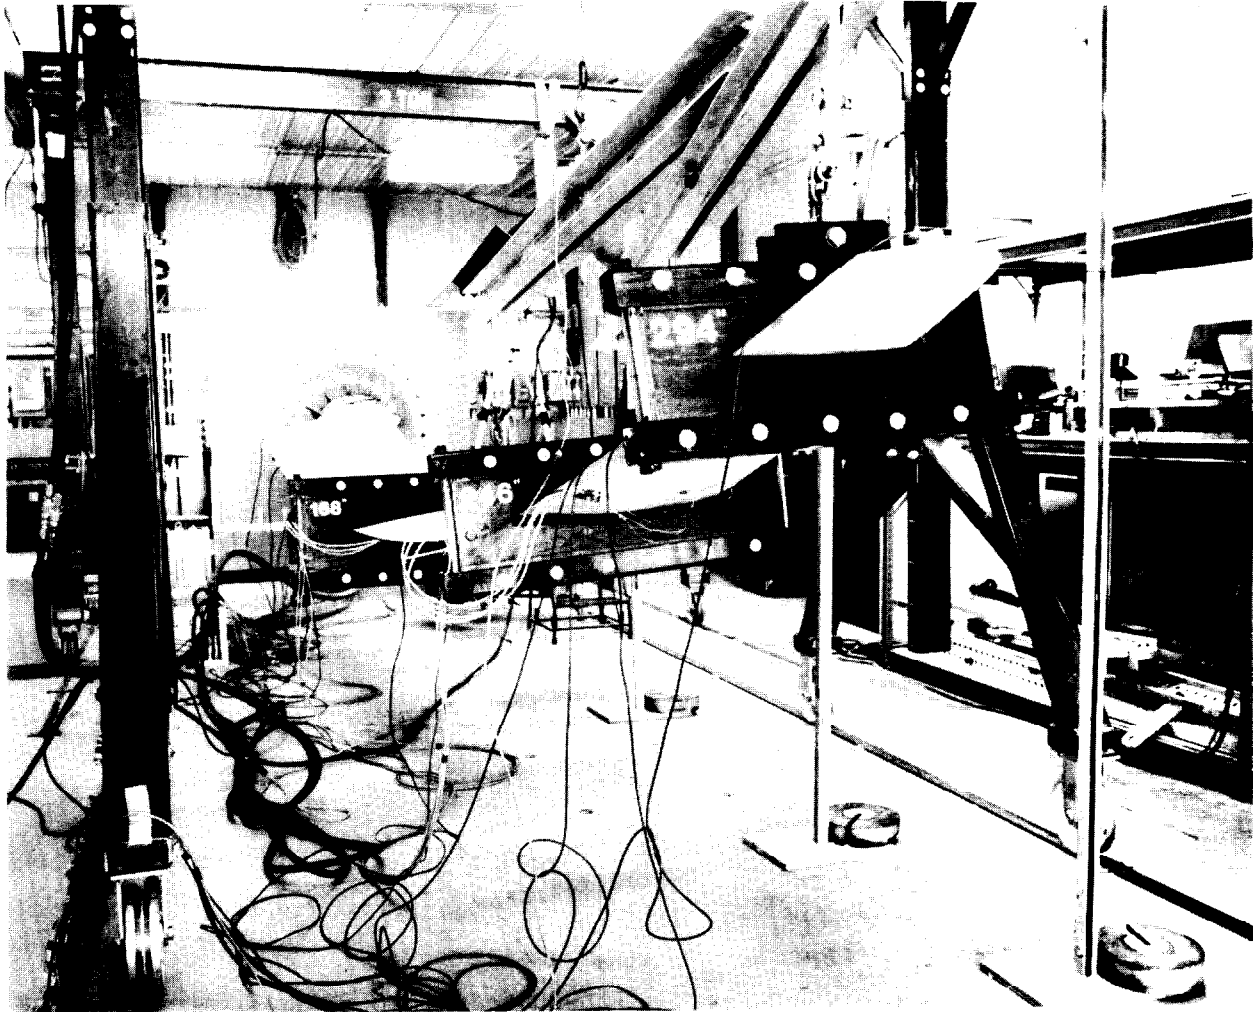
Figure 7. Phase 1 blade test.

During phase 1 testing, the initial load on the blade was 1000 lb (4.5 kN). Strain gauge data were recorded continuously at a 20 Hz sampling rate. Deflection measurements were taken manually at each 1000 lb (4.5 kN) load interval. When 2000 lb (8.9 kN) was reached, the load intervals were reduced to 500 lb (2.2 kN) increments until failure occurred. Figure 6a shows the load vs time plot for this set of loads. After failure at 3925 lb (17.5 kN), the blade was unloaded and the failure locations were documented. A photograph of the blade under three-point loading is shown in Figure 7.

The Phase 1 test resulted in a failure of the blade at approximately station 240. This station is located approximately 12 in. (30.5 cm) inboard from the split line of the pitchable tip at station and approximately 6 in. (15.2 cm) inboard from the middle saddle used to load the blade. The failure occurred near the point where the internal spar (shear web) was terminated and the pitch shaft transitions to a smaller diameter shaft. The peak load recorded at failure was 3925 lb (17.5 kN) on the load cell; see Figure 6a. This load results in a root failure load of 72,528 ft-lb (97.9 kN-m). The bending moment at the failure location due to the force on the outer two saddles was 3596 ft-lb (4.8 kN-m). The failure appeared as a cordwise crease in the skin on compression surface.

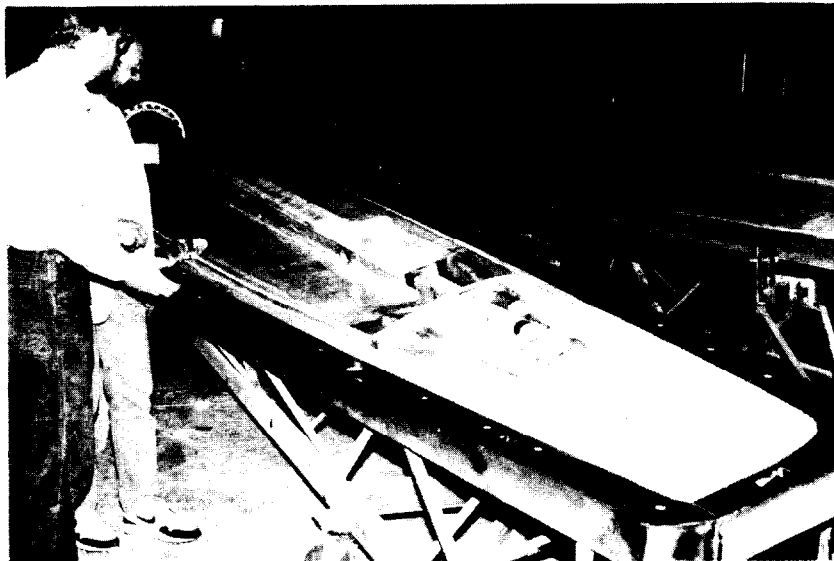
Figure 15. Internal structure of the NREL 7.9 meter blade.

Visual examination of the primary (Phase 1) failure at station 240 showed that the steel pitch shaft of the tip spoiler mechanism (see Figure 15) was bent inboard of the cam mechanism. The skin was also buckled on the low pressure side of the blade in the same radial location as the failure of the steel tip mechanism itself; see Figure 16. This failure location also coincides with the termination of the internal shear webs; see Figure 15.

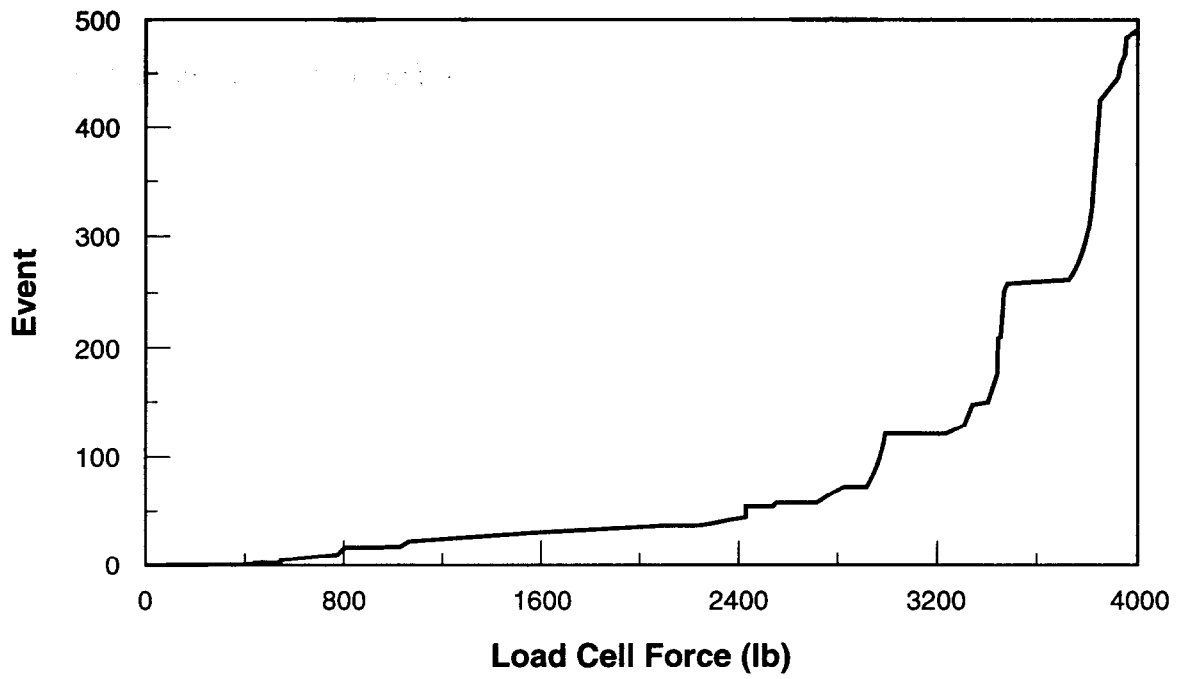
Figure 21a. Root region.

Figure 21a shows the AE events in the root of the blade plotted as a function of the load on the blade. In this plot, the number of AE events for transducers 1 through 12 is summed together to get the total number of events emanating from the root of the blade. The large number of events noted in this figure implies that significant damage may be accumulating in the root of the blade. However, the location graph, Figure 20a, illustrates that the damage is

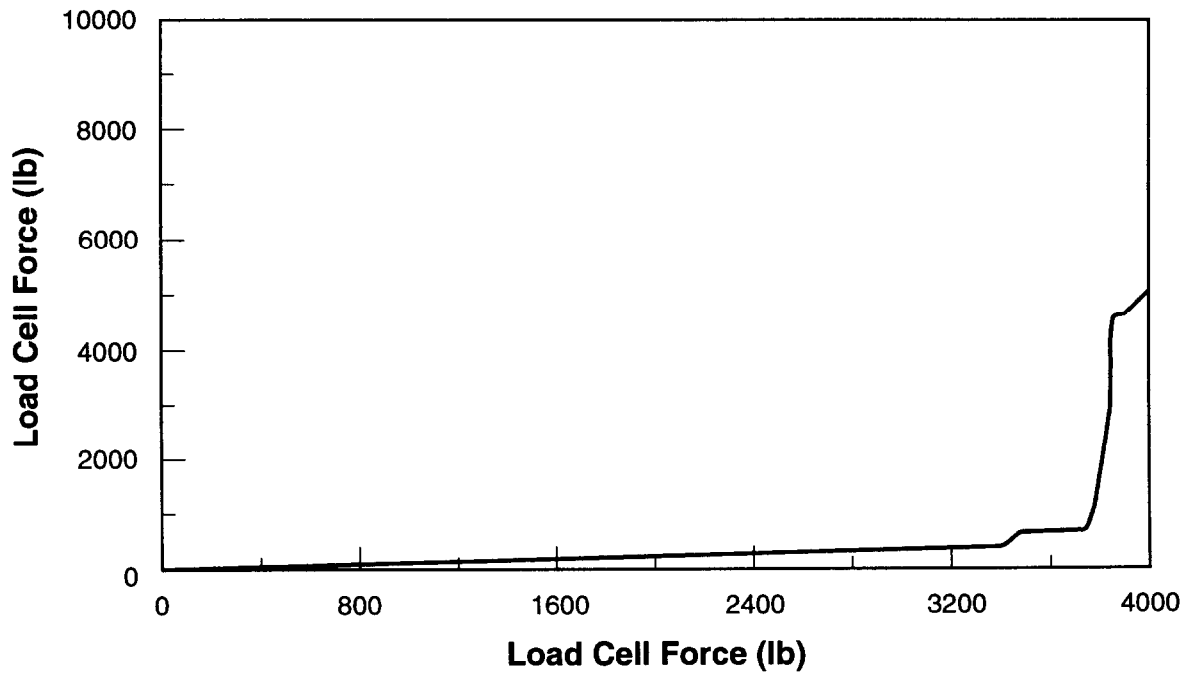
Figure 21b. Blade region.

widespread and not concentrated into a few serious flaws. Figure 21b shows the events versus load curve along the span of the blade; i.e., the AE events from transducers 13 through 23 are summed together. This plot indicates that the onset of failure started at about 2900 lb (12.9 kN) load; i.e., most of the AE events occur during the load step. As shown in Figure 20b, most of these AE events were clustered at or near the blade failure zone between stations 240 and 250.

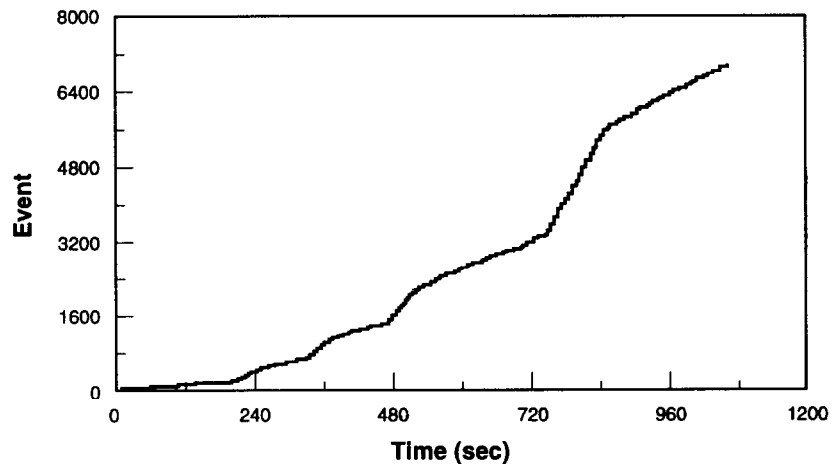
Figure 25b. Root region.

Figure 25b shows the events as a function of time for the root region of the blade. Notice that while there is some increase in the event rate during the loading, there are even more emissions for the loads above 7300 lb (32.5 kN), at approximately 480 seconds, right after a step in the load. This observation is indicative of a rapid increase of blade damage. The accumulation of damage slows as the stress is redistributed and the load drops. This figure also shows that there was steady damage growth between all load steps. Thus, blade failure probably would have occurred in this region for all loads above 6000 lb (26.7 kN), if the loads were held long enough.

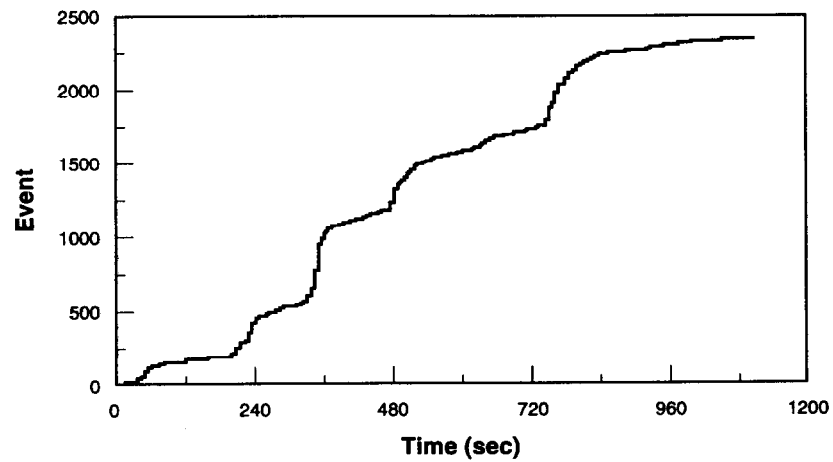
Figure 25c. Blade region.

In Figure 26b, the damage near station 50 continues for this loading sequence, and the breakup of the blade bottom under the loading fixture near station 170 is still obvious. Figure 25c shows the event versus time curve for this region. There was not as much damage occurring during the load holds here as there was in the root region.

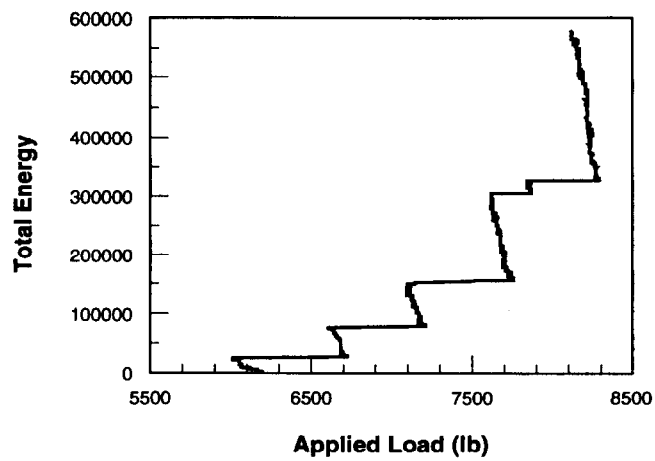
Figure 27c. Phase 2b loading.

The location map for Phase 2b loading (Figure 26a and 28) shows large scale destruction of the fiberglass. Figure 27c is the “energy” versus load curve for sensor 9 during this loading sequence. The amount of emission “energy” increases during each load hold. Most of this “energy” comes from the compression side (top) of the blade. The most probable failure mechanism is delamination of the fiberglass. In Figure 28, there is only a slight concentration of events in the triangle formed by sensors 6, 7, and 11. This area is in tension. The conclusion is that the fiberglass structure in the root region still has adequate strength under tension at the 8996 lb (40.0 kN) load [peak root bending moment of 125,944 ft-lb (170 kN-m)] but cannot support the compression stresses without damage above a load of 3925 lb (17.5 kN) [root bending load of 72,528 ft-lb (97.9 kN-m)] seen on the first loading.

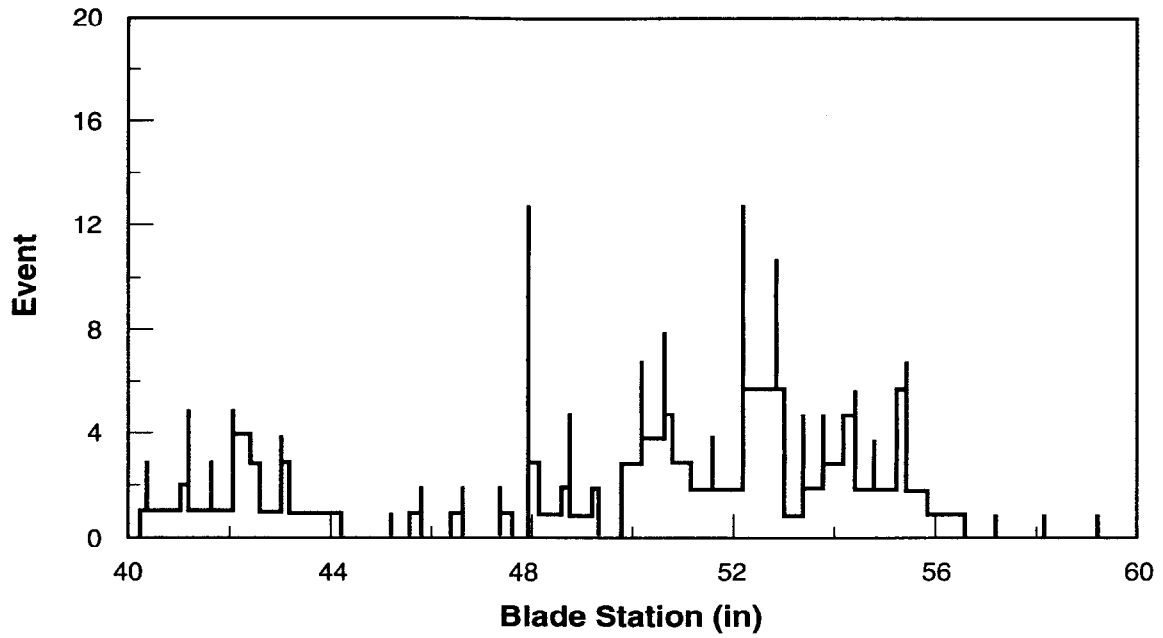
Figure 29a. Station 40 to station 60.

Phase 1 loading produced a failure in the blade near the tip. The location plot for blade during this load cycle (Figure 20b) shows two regions with a clustering of event locations. One is between stations 40 and 56 and the second is between stations 234 and 242. Expanded location plots for these two regions are shown in Figures 29a and 29b. The events shown in Figure 29a started very early in the loading and continued at a moderate level for all three loadings. Figure 30 shows the acoustic “energy” detected at sensor 14 (station 48) versus the load for the three different loadings. For Phase 1 loading, there is more “energy” emitted during the increasing load than during load holds. However on each load hold over 4800 lb (21.4 kN), there is more “energy” emitted during the hold than during the loading, although the amount of emitted “energy” decreases after the hold at 7100 lb (31.6 kN). The emitting structure between stations 40 and 56 appeared to be reaching a point where all the material which could break, had broken and the rest was still capable of bearing the load at 8996 lb (40.0 kN). Upon sectioning of the blade in this region, it was found that one side of the box spar, which started at about station 37 and then ran most of the rest of the length of the blade, was debonded from the top skin in the region from station 37 to about station 50. Also found was a section of the skin on the top of the blade, about 5 in. (127 cm) wide and running from about station 37 to station 54, which was only

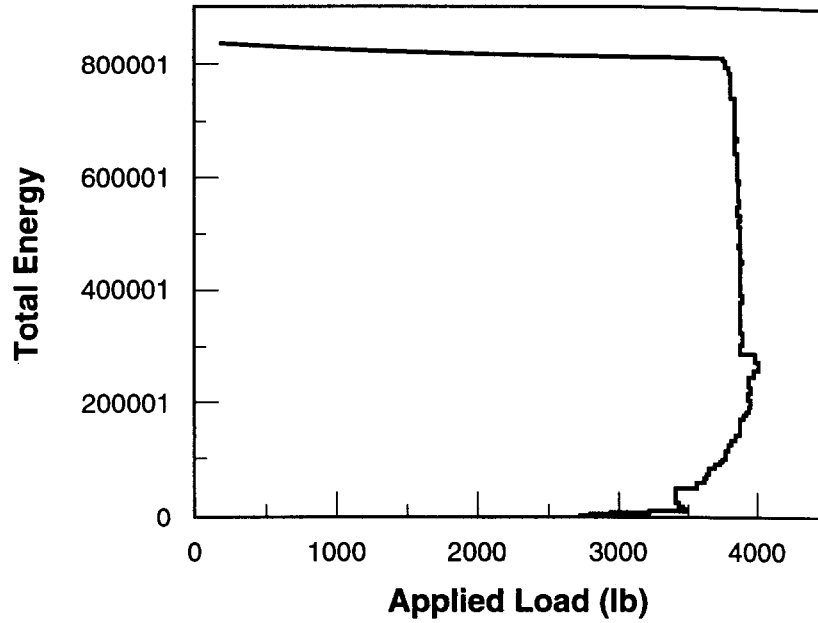
Figure 31. Total "energy" observed by sensor 21 during Phase 1 loading.

Figure 31 is the “energy” versus load curve for sensor 21 (station 250) during Phase 1 loading. This data is basically the “energy” for the events shown Figure 21b. Here the first emission is observed at 2800 lb (12.5 kN). Appreciable emissions begin during the load hold at 3500 lb (15.6 kN). Failure starts at approximately 3400 lb (15.1 kN) and continues to 3925 lb (17.5 kN). At this point there is a load drop, indicating structural failure, followed by large amounts of emissions, which was probably produced by tearing of the upper skin. Examining the sectioned blade, debonding of the strengthening web from the top skin was found from about station 230 to its end at station 239. There was also buckling and tearing of the top skin between stations 236 and 242. This is exactly the region of failure located in Figure 21b. Also shown in this figure is that almost no emissions emanated from this region for loads below 2800 lb (12.5 kN). During the Phase 2 loading, considerable emissions were detected in the region from station 155 to station 175; see Figure 32. The emissions from stations 163 to 175 are primarily caused by the bottom surface breaking up under the loading fixture. However this does not account for the events observed between stations 157 and 161.

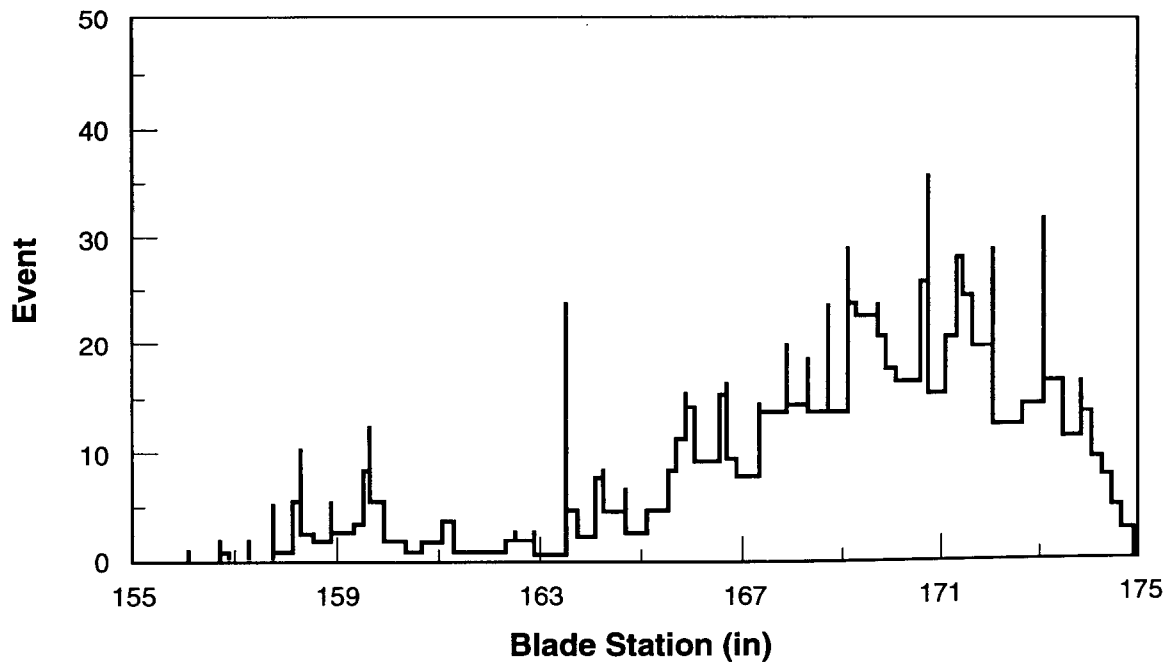
Figure 32. AE locations for Phase 1 loading between stations 155 and 175.

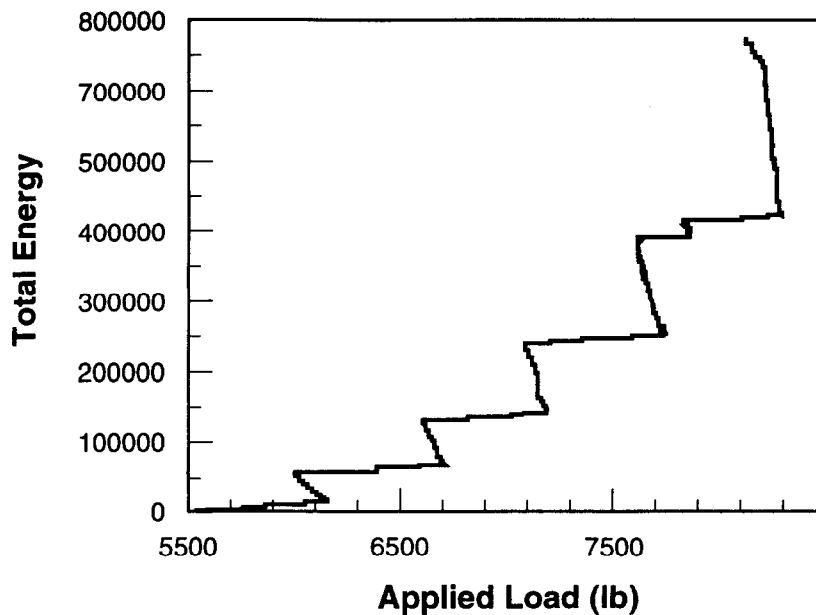
Figure 33 shows the detected acoustic “energy” from sensor 18 versus the load for phase 2 loading. Most of this energy comes from the breakup of the skin caused by the loading fixture. The blade was not sectioned in this region, but a piece from stations 132 to 138 shows debonding of the box spar from both the top and bottom skins. It is probable that such debonding was present along much of the blade during this loading. While this loading broke the blade with appreciable violence, the acoustic emission pulse associated with this failure has not been identified. The failure appeared to start near the trailing edge of the blade and the foam inserts could have damped the wave to the point where it was indistinguishable from other emissions. There was also bond failure between the top and bottom skins at the leading edge.

Figure 33. Total "energy" observed by sensor 18 during Phase 2b loading.
