ACOUSTIC EMISSION MONITORING OF A WIND TURBINE BLADE DURING A FATIGUE TEST^{*Ψ}

A.G. Beattie
Department 9742
Sandia National Laboratory
Albuquerque, NM 87185

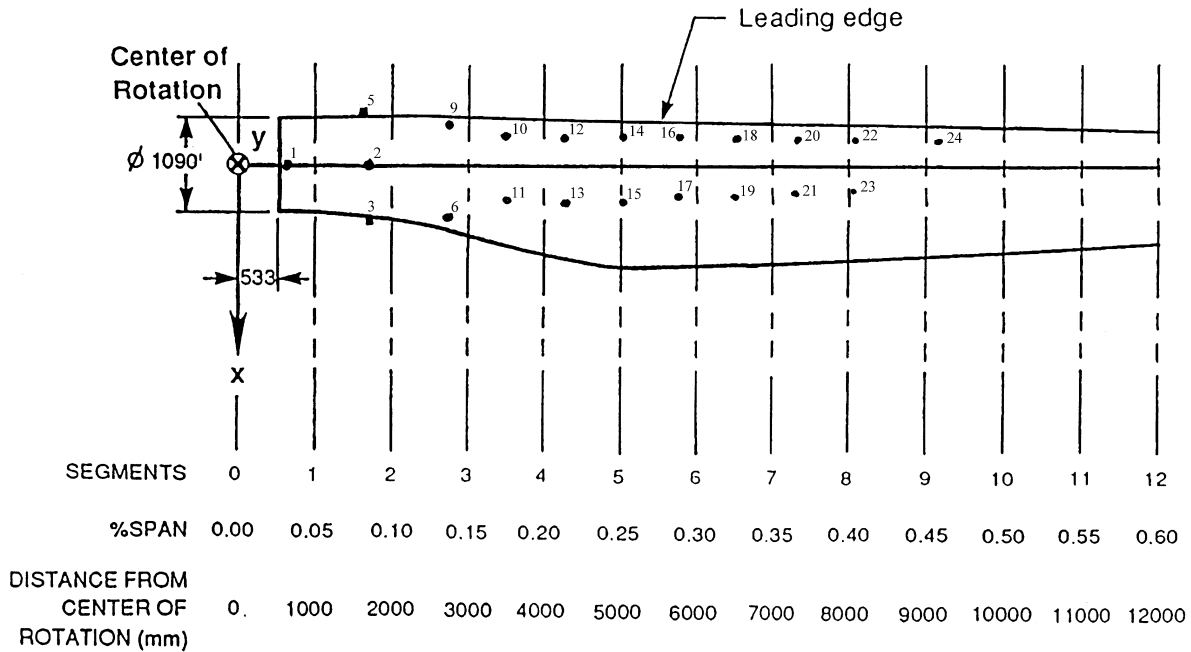
Figure 1. Blade and Sensor Layout

A brief run at the new load showed that an "oil can" deformation of the upper skin of the blade was taking place in two areas. The acoustic emission sensor array was then designed to cover these two areas as well as the root region just outside of the reinforced region. The complete sensor layout is shown in Figure 1. Sensor 24 was placed 60 inches past the top surface array to detect any acoustic signals traveling down the blade from the actuator.

The root array consisted of two rows of four sensors each, one row offset by 45 degrees from the other, covering the region with eight adjacent triangles. The sensor spacing in a row was 41 inches and the rows were 40 inches apart. Because of the high attenuation, this

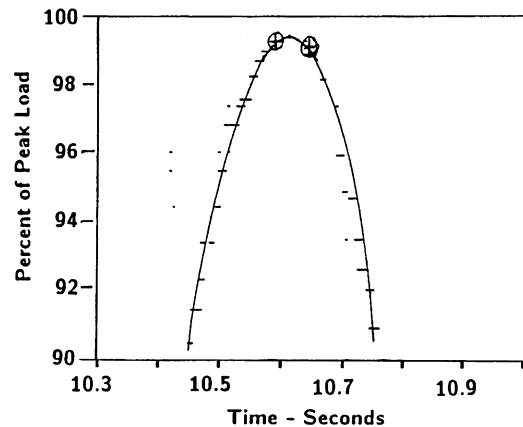
Figure 2. Load values as a function of time for the peak of a load cycle. Horizontal lines are multiple hits.

Figure 2 shows the assigned load of all hits allowed by the voltage gate on one cycle. The loads are plotted as a
