# PV Module Arc Fault Modeling and Analysis

Presented to the NREL PV Module Reliability Workshop

# Module Failure Analysis

This presentation will help to answer the question of the potential for electrical arcing in the ubiquitous module busbar solder joint failures, as well as provide insights into the time domain of these failures and material effects.

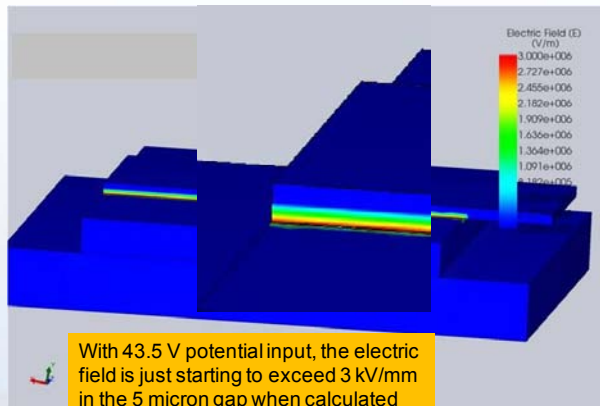
With 43.5 V potential input, the electric field is just starting to exceed 3 kV/mm in the 5 micron gap when calculated with the full integral solution, which is lower than the linear  $\frac{43.5V}{5\text{micron}} = 8.7 \frac{kV}{mm}$

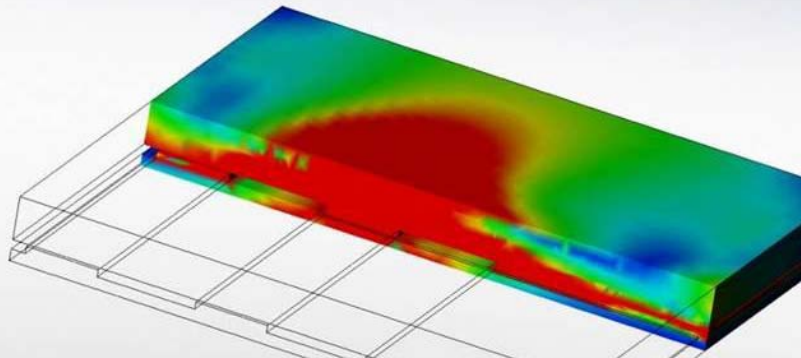
**State of thermal expansion stress after 2 seconds of arcing on the  $\sim 0.4 \text{ mm}^2$  area. Heat tempered glass has a modulus of rupture of *at most* 160 Mpa, and near 100 Mpa is more likely for glass that has a texture or pattern, as the module does. Conclusion: Glass fractured into small pieces from this temperature.**

**The thermal expansion of the area above the arc puts the surrounding areas into tension, which is the weaker direction for glass and ceramics, resulting in fracture centered at the heat source, with the small size pieces being typical for tempered glass.**

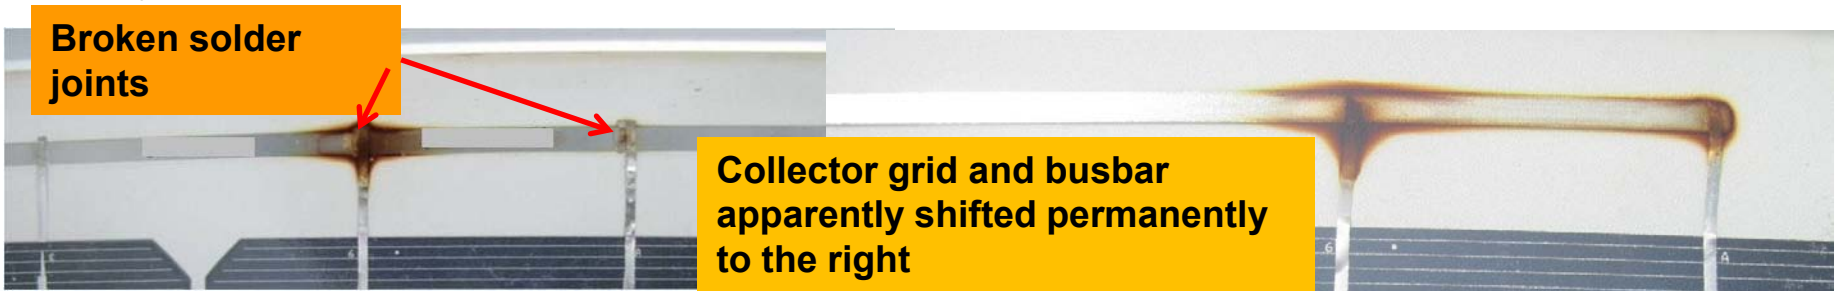
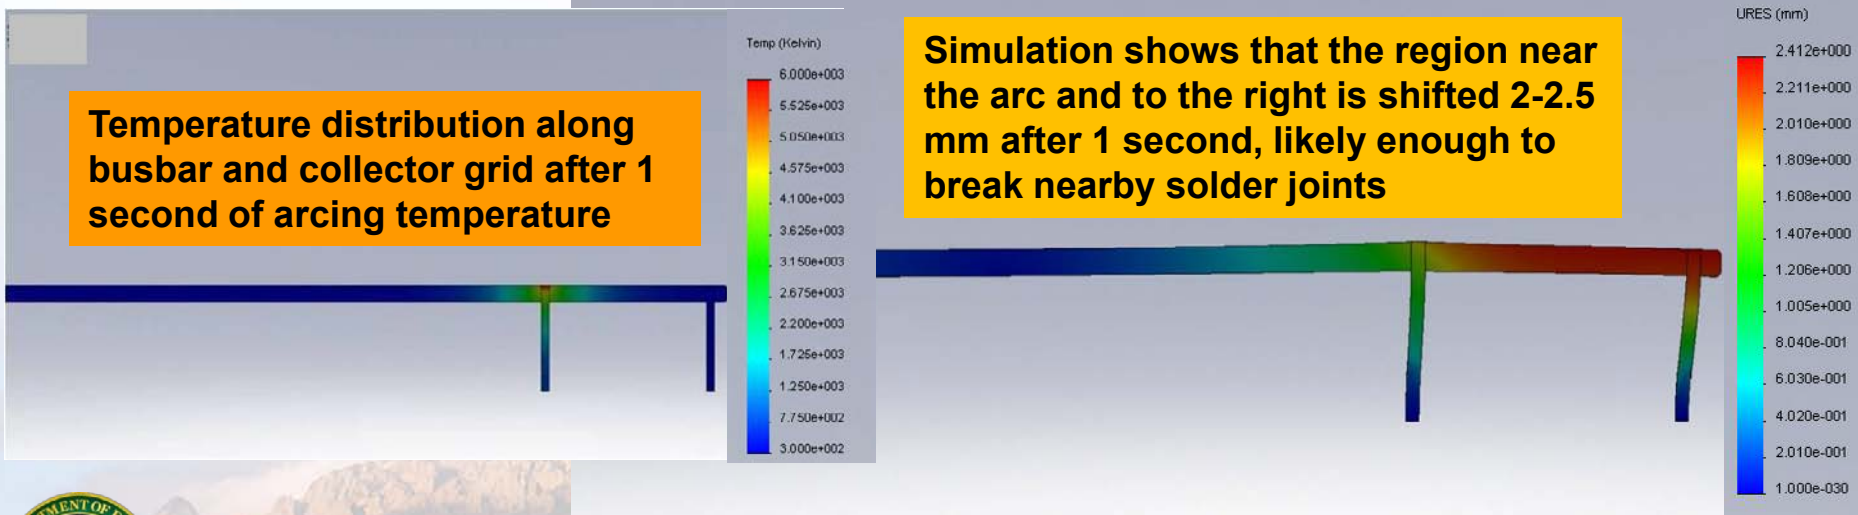
- To investigate if arc temperatures could have caused the busbar shifting and broken collector to busbar connection, the thermal study of applying 6000K to just 0.38 mm<sup>2</sup> at the end of the connector was performed.
  - Assumed busbar was restrained in the x direction at the module center, and restrained in the z direction by the module lamination.

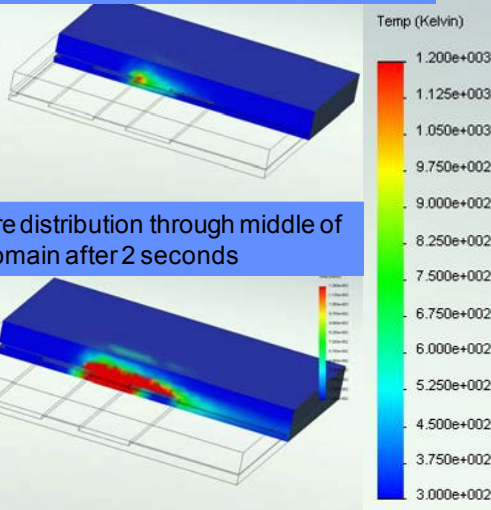
Temperature distribution through middle of domain after just 0.2 seconds

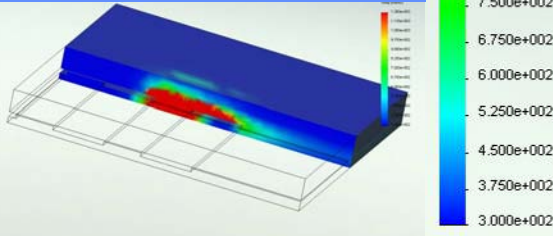
Temperature distribution through middle of domain after 2 seconds

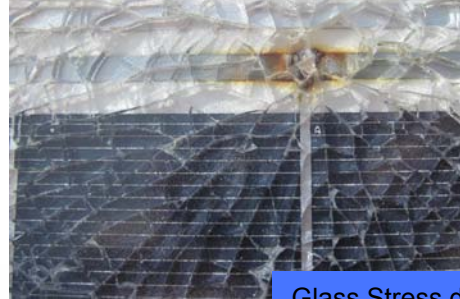
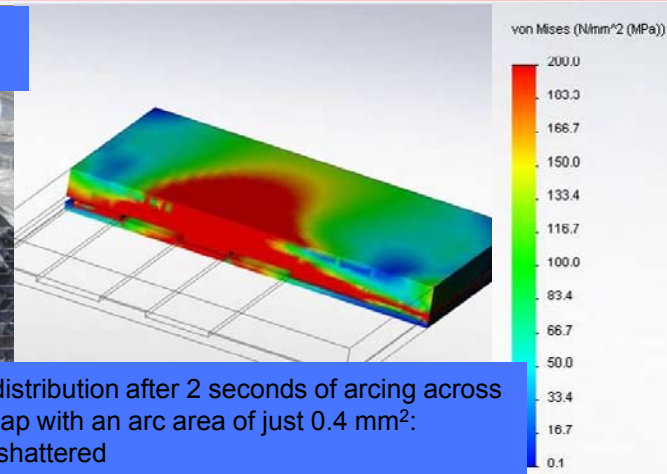
Heat transfer physics leading to this shattered glass was simulated

Glass Stress distribution after 2 seconds of arcing across the 5 micron gap with an arc area of just 0.4 mm<sup>2</sup>: the glass has shattered
