SOLAR MODULE ARC FAULT MODELING AT SANDIA NATIONAL LABORATORIES

Jason Strauch, Michael Quintana, Jennifer Granata, Ward Bower, Scott Kuszmaul
Sandia National Laboratories*
1515 Eubank Blvd SE
Albuquerque, NM 87123
jestrau@sandia.gov, 505-284-6114 ph., 505-284-67690 fax

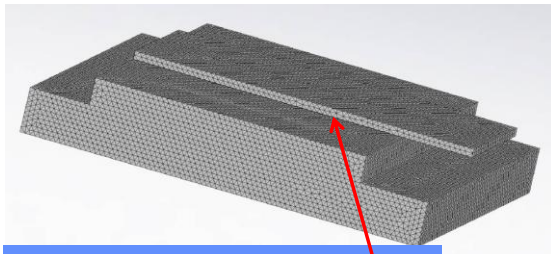
Figure 7: Busbar to ribbon electrical discharge subdomain mesh

For this study, the subdomain selected needs to be small enough to account for a single micron thickness air or metal oxide gap in between two conductors that are at the module potential. The module stack is just under 6 mm thick, and the material subdomain measures 6.5 mm wide by 7.5 mm long. The area subject to an electrical gap (or corrosion buildup) is 2.54 mm (ribbon width) by 5.08 mm (busbar width). The subdomain mesh, which accounts for single micron range gaps, is shown in Figure 7.

Further reduced domain for electrical discharge study. Mesh accounts for 5 micron air gap between parts.

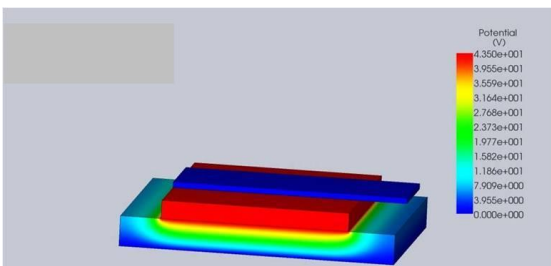
Figure 8: Module Voc applied across 5 micron gap between busbar and collector

Figure 8 shows the electric potential with the module's 43.5 V Voc applied between the busbar and ribbon with a 5 micron air gap.

43.5 V potential input. Voltage potential makes it part way through the EVA and Tedlar back sheet.

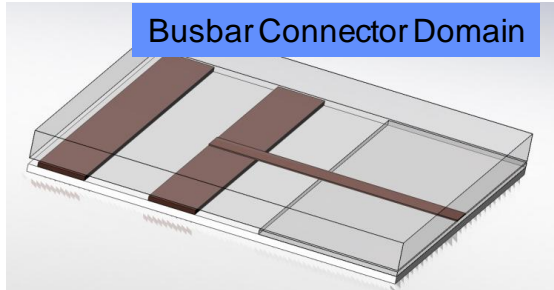
Figure 10: Glass Fracture Busbar Domain

The module with the glass fracture directly above a burned ribbon-to-busbar joint, shown in Figure 6, is analyzed next. This analysis was focused on both the temperature scale and time scale for the heating. For the glass fracture, a 40x40 mm subdomain through the thickness of the module stack, and centered over the burned busbar connection was modeled. Although the

breakdown was modeled over the entire area of the joint, it is likely that just a portion of the joint, perhaps one end, caused the burn. For this reason, the temperature input, 6000K, for the glass fracture model was applied on just the 0.4 mm² area of the end of the interconnect.

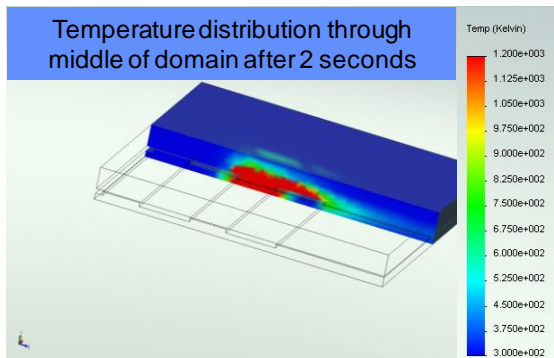
Figure 11: Arc Induced Module Temperature within seconds of Initiation

Even with such a small arc area, due to the extreme temperatures generated in the arc plasma, the time scale for heating the module stack is very short. After just 200 milliseconds the copper on the arc surfaces of the busbar and connector ribbon is 1200K, at which point the copper is about to melt and the tin coating has already failed. After 2 seconds of arcing, the glass stack has absorbed enough heat energy fast enough to exceed the modulus of rupture of the tempered, textured front side glass. The temperature distribution is shown in Figure 11.

The front glass breaks when the temperature induced state of stress, due to localized expansion near the arc, exceeds the modulus of rupture of the glass. Flabeg quotes the modulus of rupture of their tempered glass as 120 MPa and 90 MPa with a stipple pattern. Other manufacturers of solar glass, such as Saint Gobain, quote similar values for tempered and less for float glass or simply heat strengthened. The Modulus of Rupture for the Finite Element Analysis was assumed to be 100 MPa, though changes in this value will just change the time to rupture. The state of stress for the module stack and glass are shown in Figure 12.

The heat of the arcing expands the glass region directly above the arc, putting the immediate surrounding area into tension, resulting in the radial break pattern. Since the glass is tempered, the entire pane fractures into small pieces.

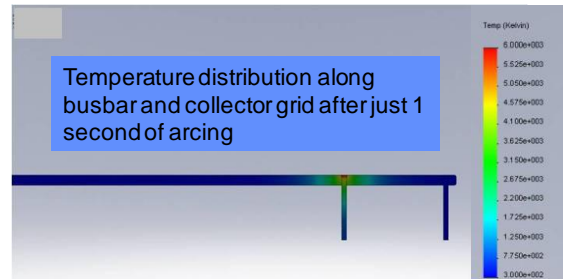
Figure 13: Busbar arc temperature distribution after 1 second

On another failed module the busbar to connector ribbon appeared burned and the busbar appears to have shifted permanently within the layup stack.

Applying the 6000K temperature heat load to the busbar structure as in the prior analysis, and calculating the displacement due to the thermal expansion shows that it is plausible that the busbars were deformed in the module stack by the arc that burned the connection. This is shown in Figure 14.
