2012 Operations, Maintenance, and Monitoring Report

Clear Marais Shoreline Protection

State Project Number CS-22
Priority Project List 2

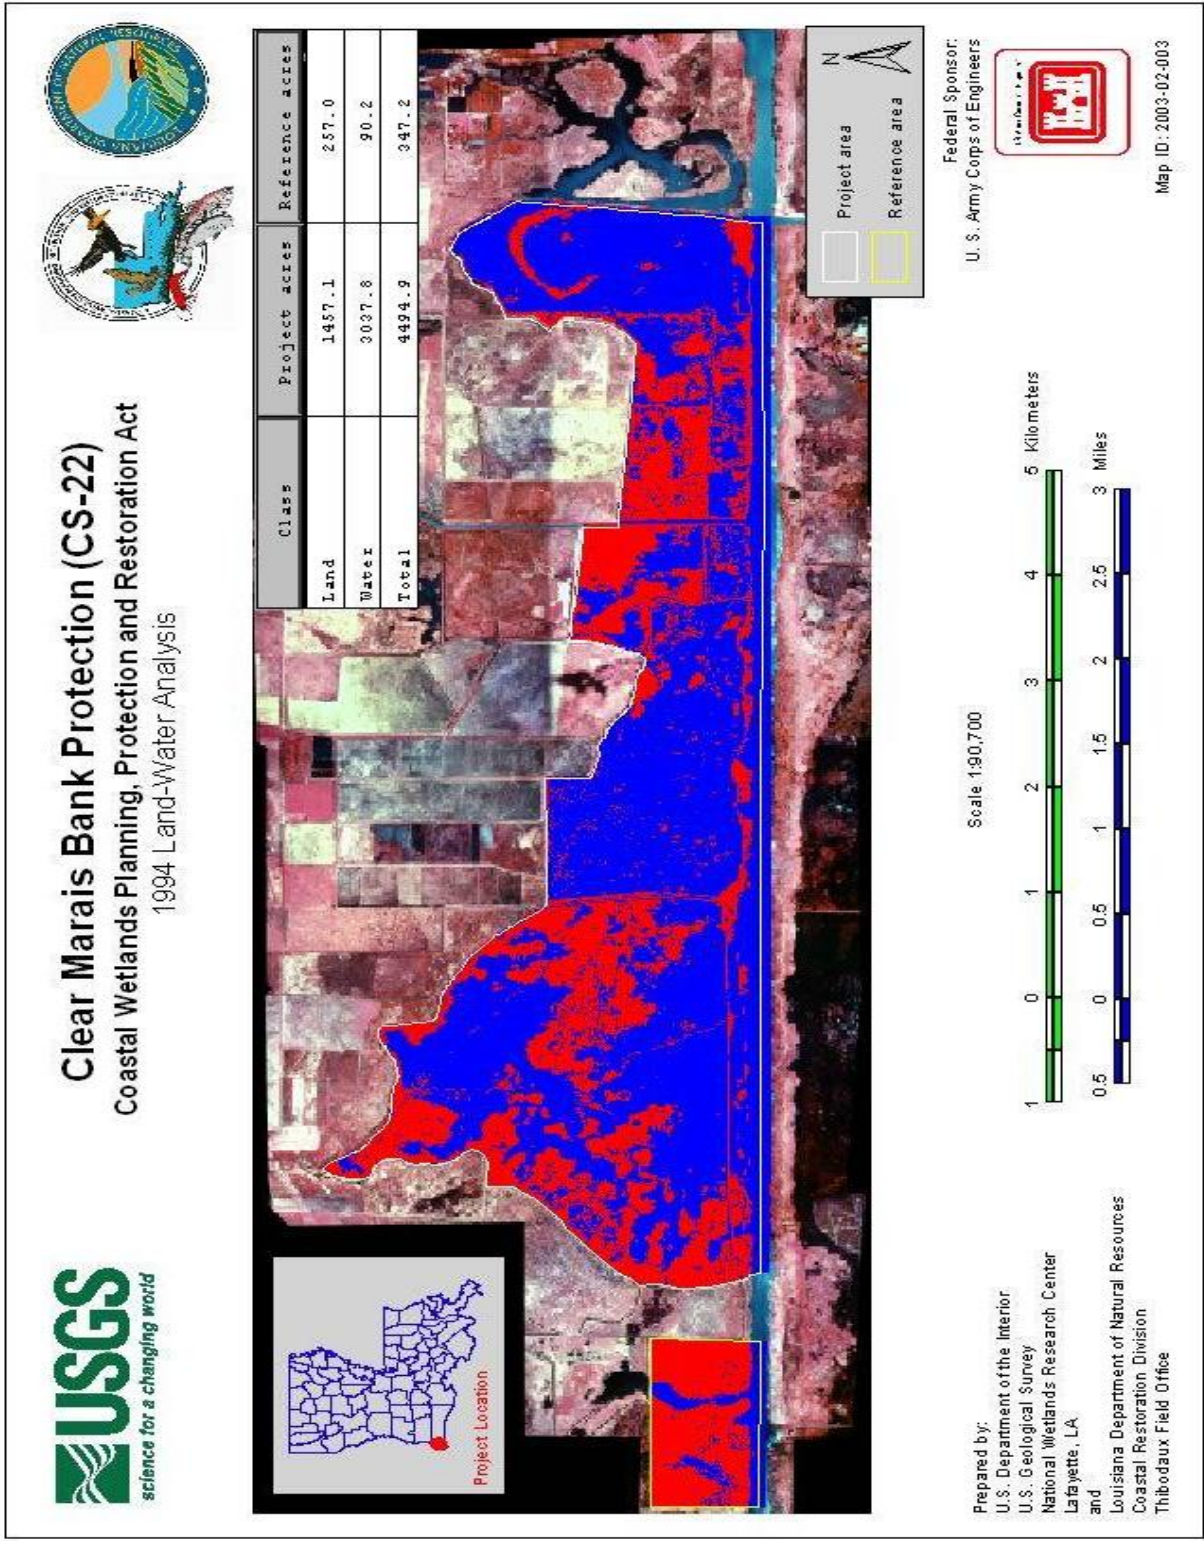
Figure 2. Land/water analysis of the Clear Marais Shoreline Protection (CS/22) project and reference areas from aerial photography taken on 11/07/94.

The 1994 land/water analysis indicated that project area had a ratio of 32.4% land to 67.6% water. The reference area had a ratio of 74.0% land to 26.0% water (figures 2 and 3). There is no additional aerial photography planned for the project.

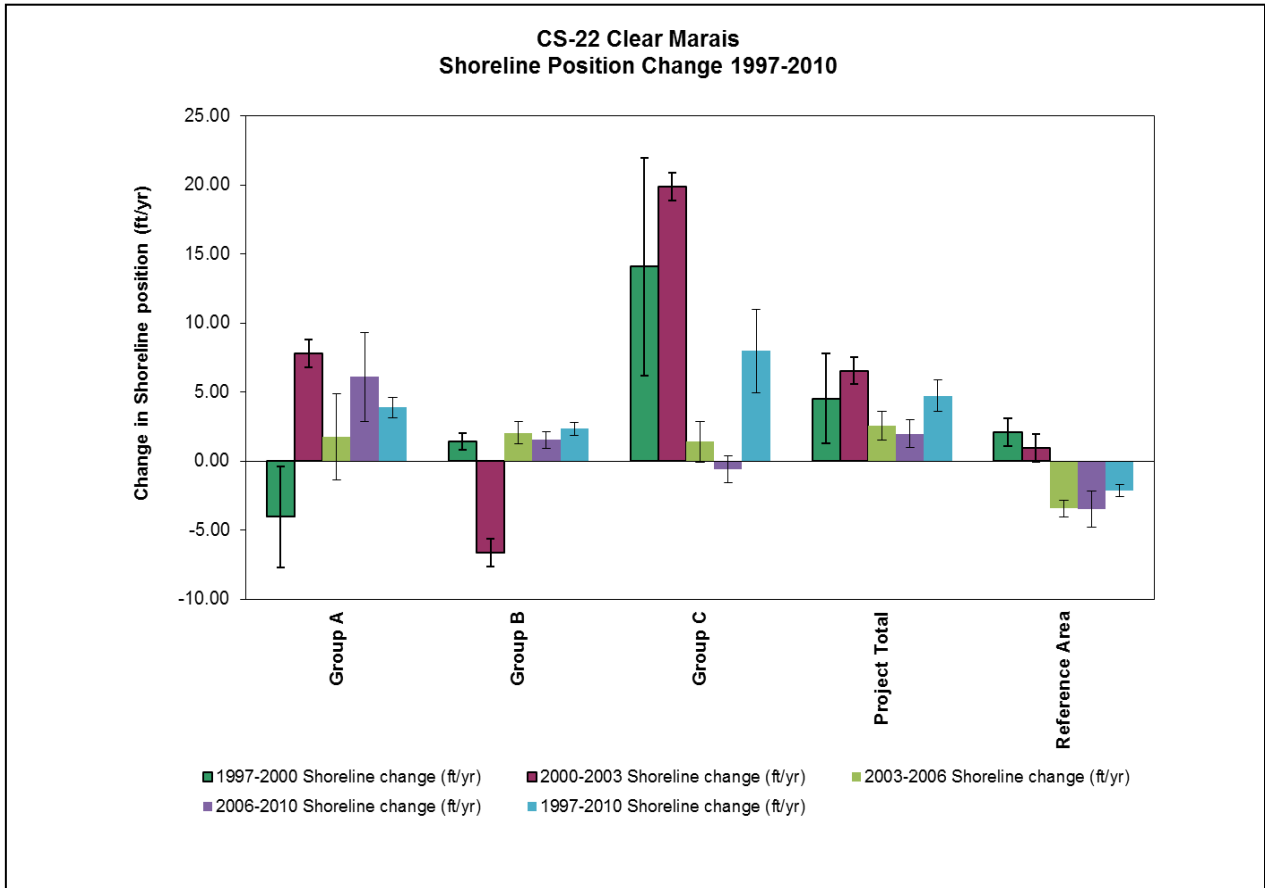
Figure 5. CS-22 Shoreline position change (ft/yr) within each group, project total and reference area from 1997-2010.

Data were collected in May 1997 (as-built), May 2000, May 2003, May 2006 and June 2010. The data indicate that overall from 1997 to 2010, the project has been effective in preventing erosion within each group (table 1, figure 5). Group A which was experiencing mild erosion prior to construction gained 3.88 ft/yr (1.18m/yr). Group B which was experiencing moderate erosion gained 2.35 ft/yr (.71 m/yr). Group C which was experiencing severe erosion gained 7.98 ft/yr (2.43 m/yr). Overall the project area gained an average of 4.74 ft/yr (1.45 m/yr) as compared to the reference area which is losing an average of -2.12 ft/yr (-0.65 m/yr).

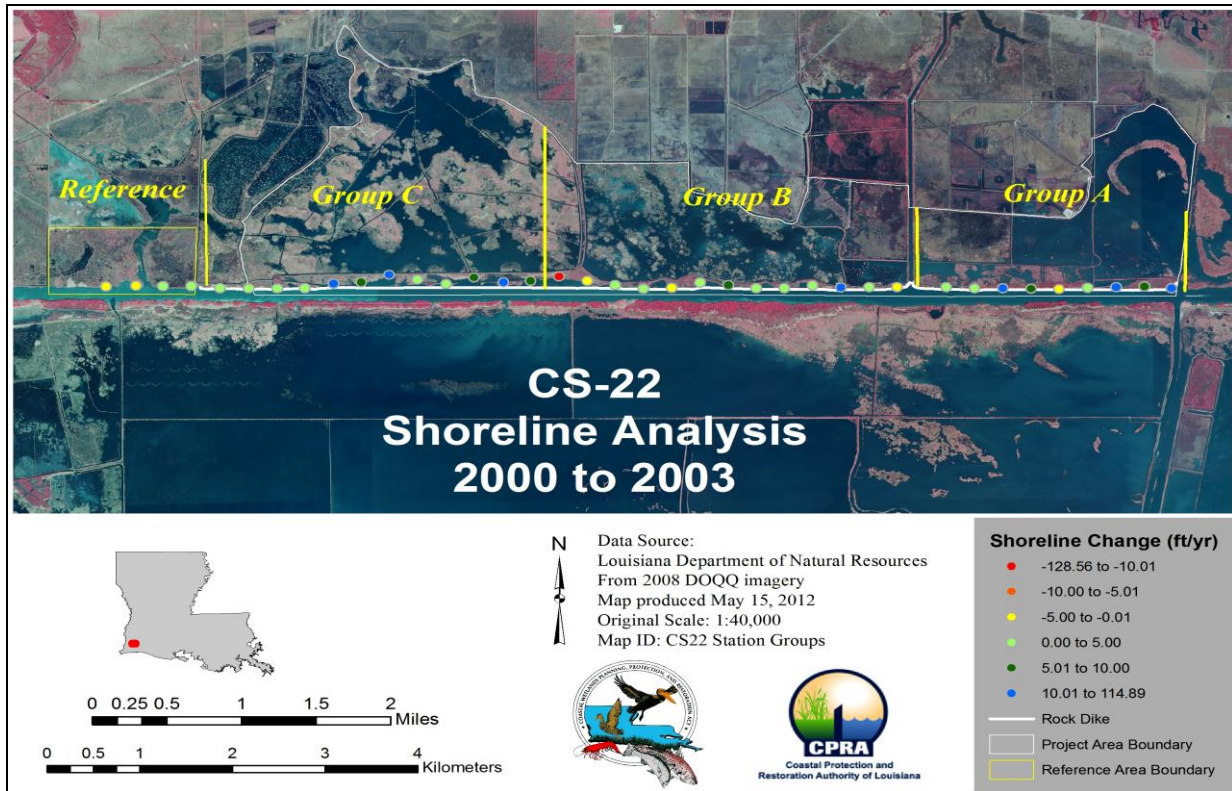
Figure 7. Shoreline change rates (ft/yr) within each group and reference area from 2000 – 2003.

Shoreline change rate maps (figures 6-10) indicate a large loss of shoreline in Group C at station CS22-26 from 1997-2000 (figure 6). This is due the shoreline being located behind a small group of broken islands and 200 to 300 feet behind the rocks. Subsequent years indicate that the shoreline has progressed southward toward the small broken islands. From 2003-2010 the area behind Group C which previously indicated shoreline loss has been curtailed and shoreline gains are now taking place (figure 9). This is due to sedimentation building behind the islands, which act as a secondary buffer, allowing the vegetation to expand southward toward the islands.

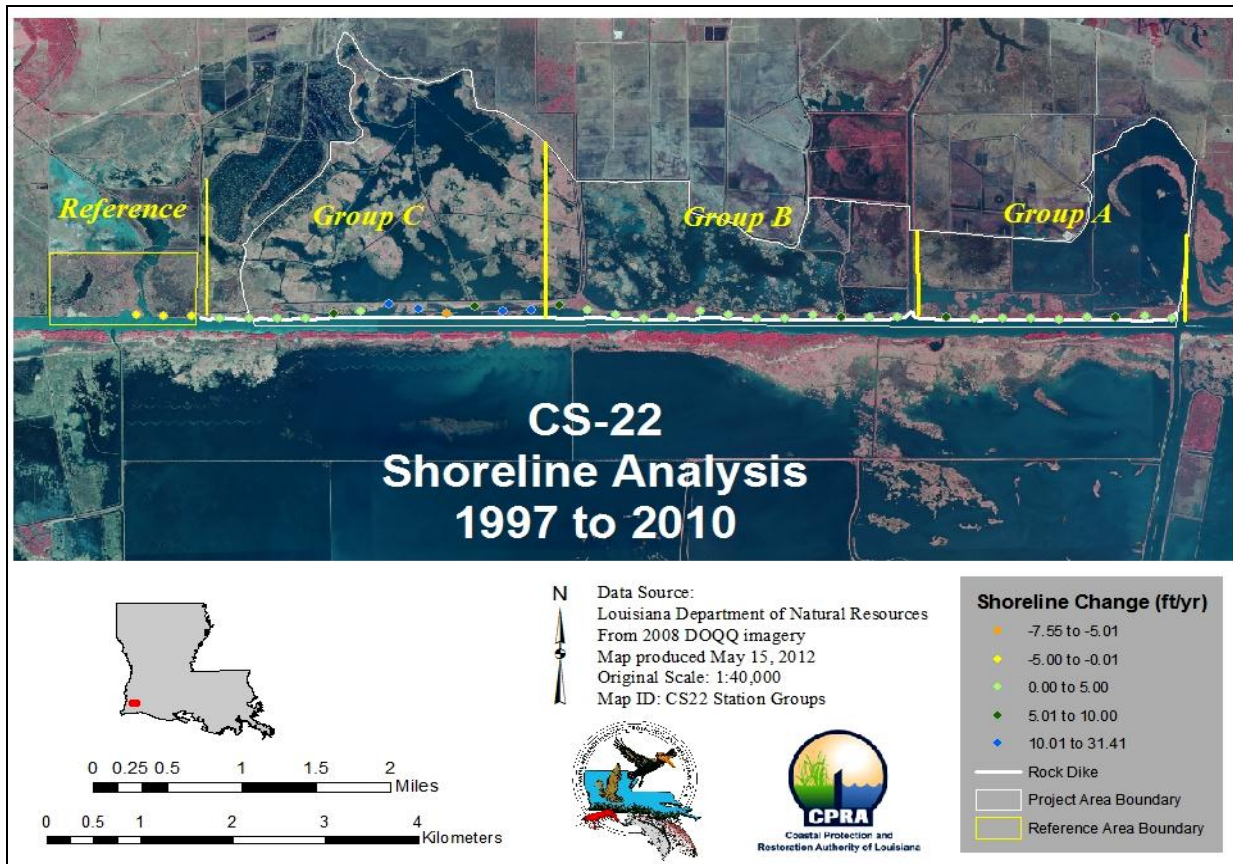
Figure 10. Shoreline change rates (ft/yr) within each group and reference area from 1997 – 2010.

The project has been effective in preventing shoreline erosion within each group and within all groups combined. Overall the project area has gained an average of 4.74 ft/yr (1.45 m/yr) as compared to the reference area which is eroding at 2.12 ft/yr (0.65 m/yr). Visual observation indicates vertical accretion of the wetland area at many locations between the foreshore rock dike and the shoreline, especially where the vegetation has infringed into the rock dike. This is supported by the shoreline change rate maps (figures 6-10) which show a decrease in erosion rates over time.
