**DOT/FAA/TC-12/43**

# **Crash Simulation of Transport Aircraft for Predicting Fuel Release**

## **First Phase—Simulation of the Lockheed Constellation Model L-1649 Full-Scale Crash Test**

Final Report

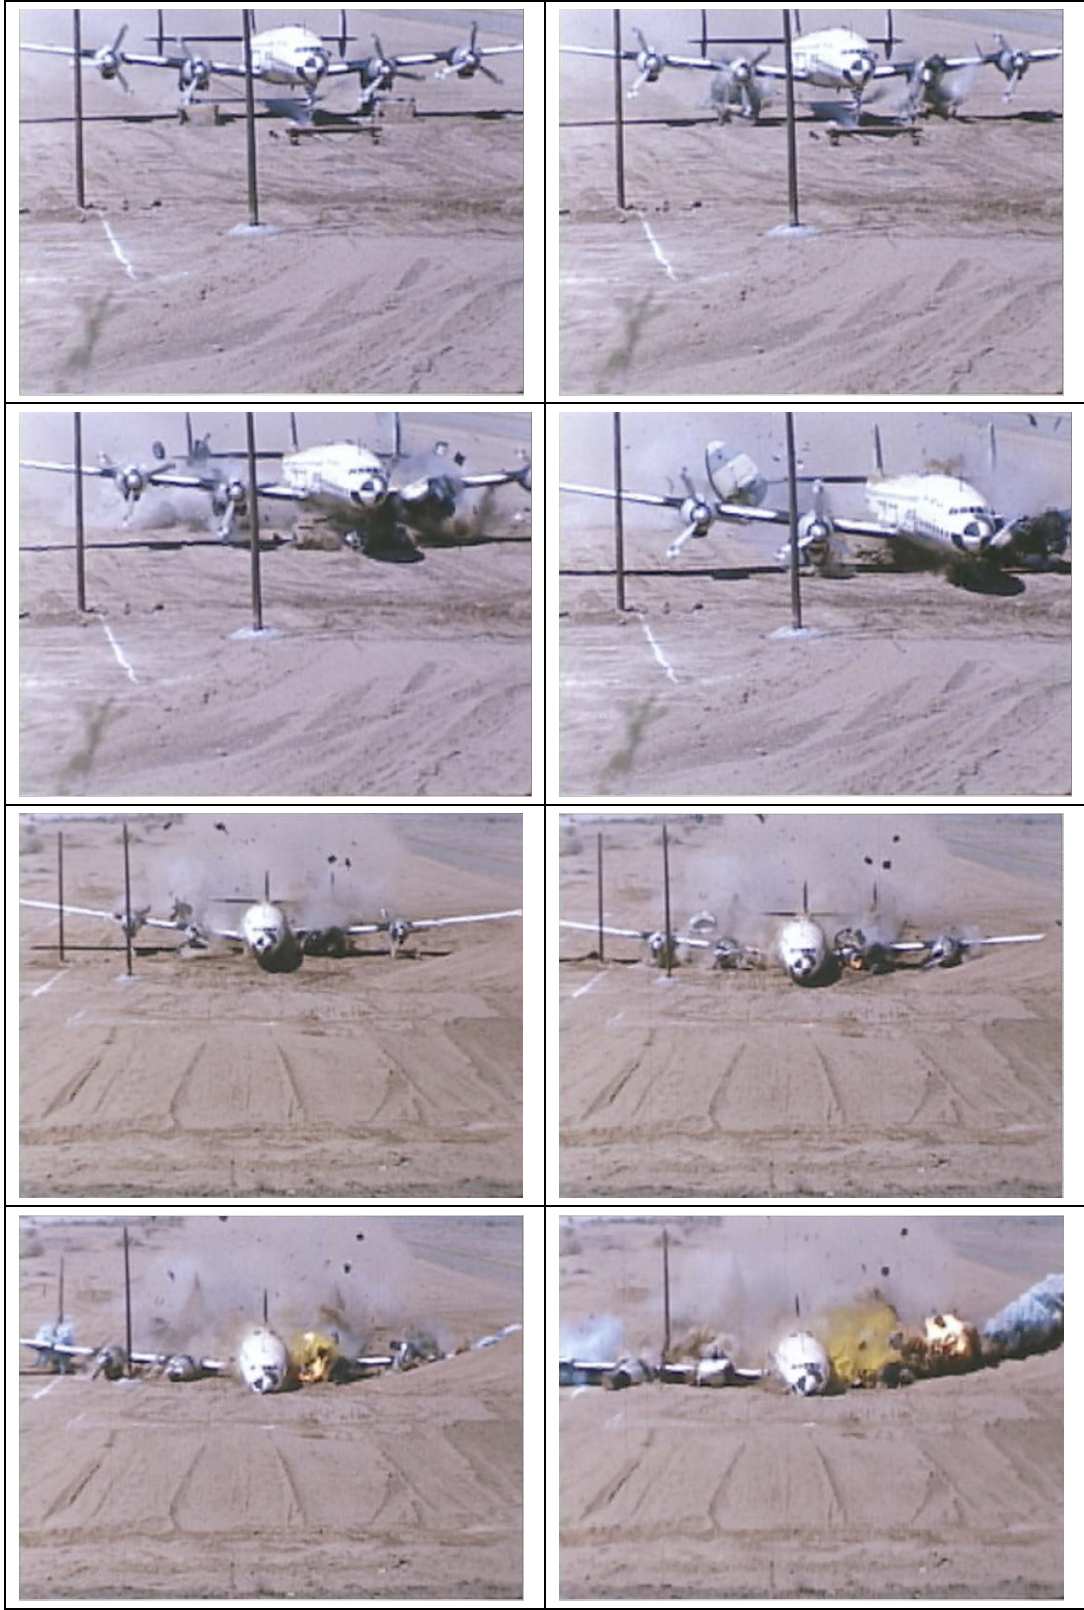
Close inspection of the high-speed films shows that the inboard left engine separates from the nacelle due to the propeller impacting the main landing gear barrier. The engine then impacts the ground and tumbles into the leading edge of the wing about half way between the wing root and the inboard nacelle. It appears that liquid is released from the No.5 tank at the time of this impact. This sequence is shown in figure 22. This is also documented in reference 5: “At impact, both main landing gears were broken off. The left gear pulled the no. 2 engine nacelle downward as it failed, causing that engine to roll under the left wing.”

Figure 22. Video Footage of Engine Impact With the Wing's Leading Edge at Tank 5

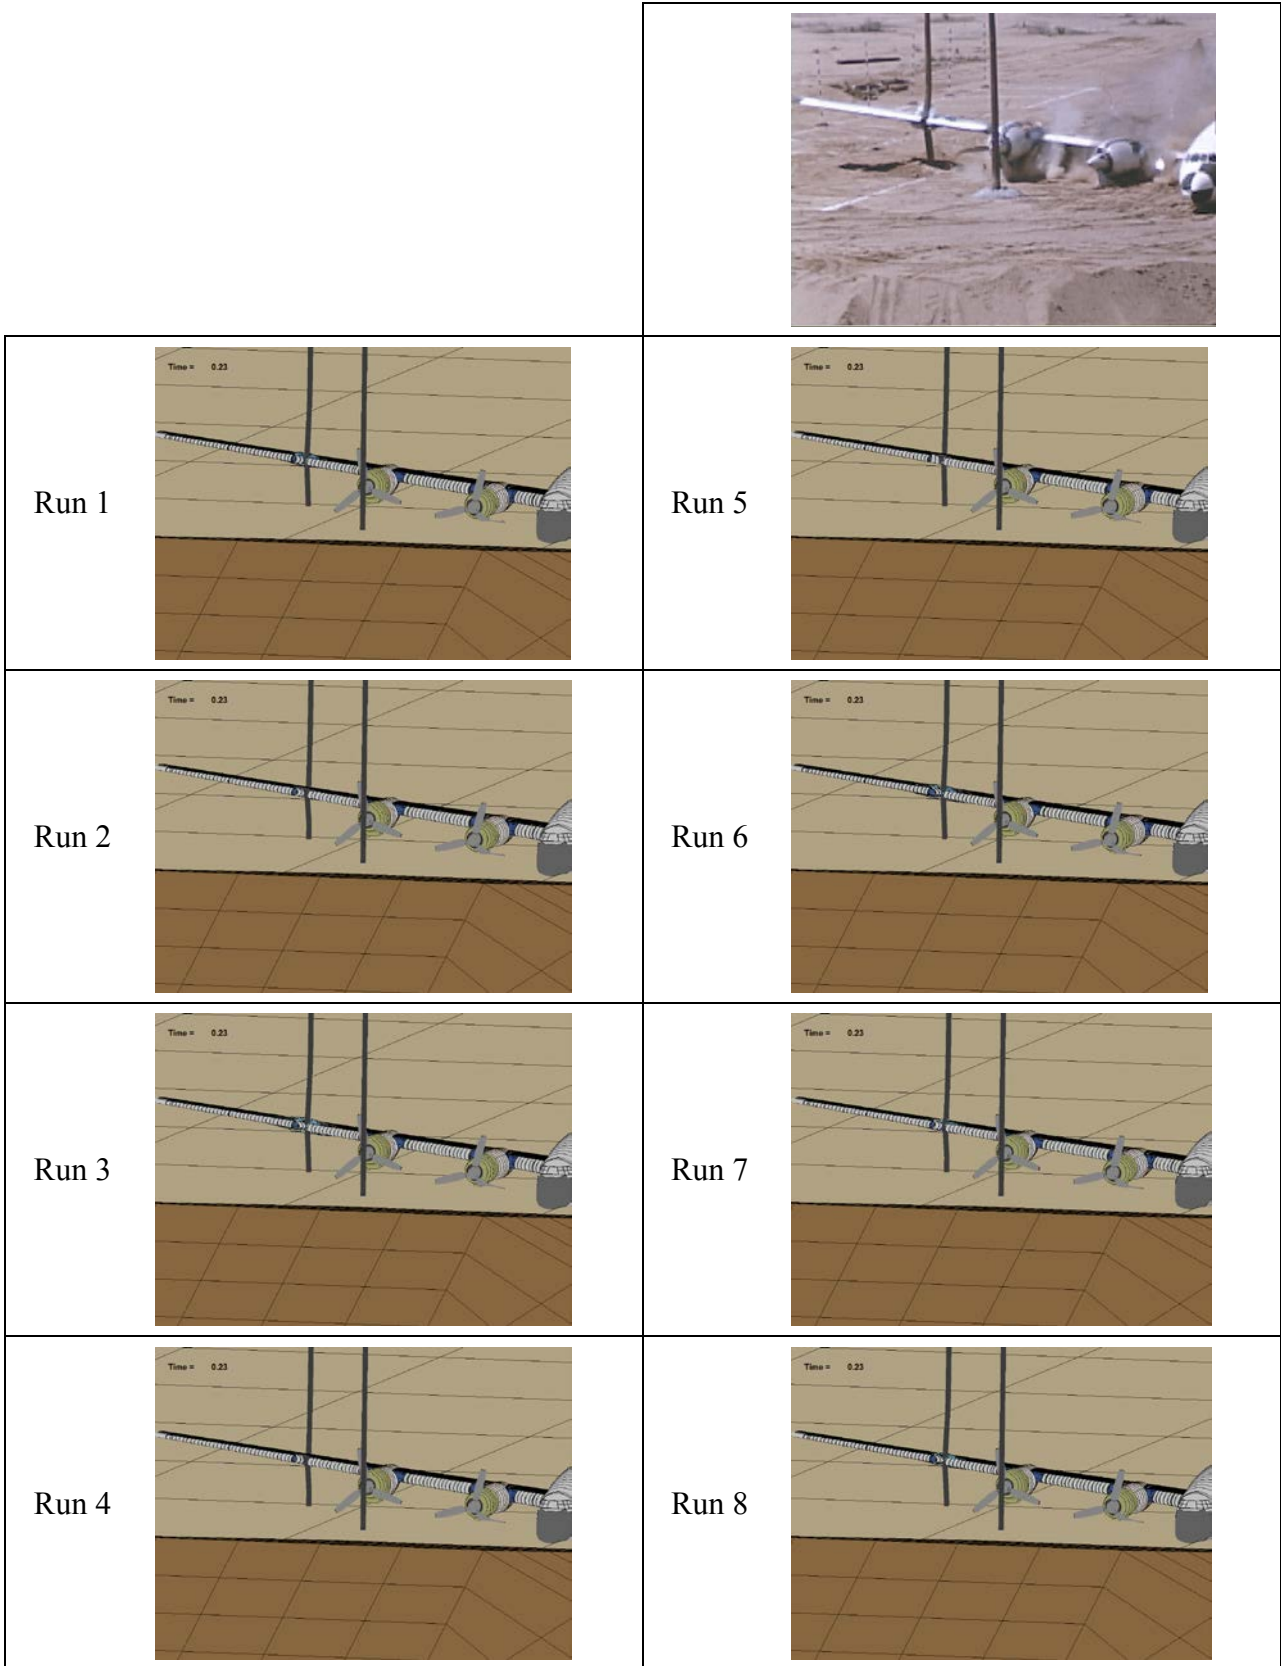
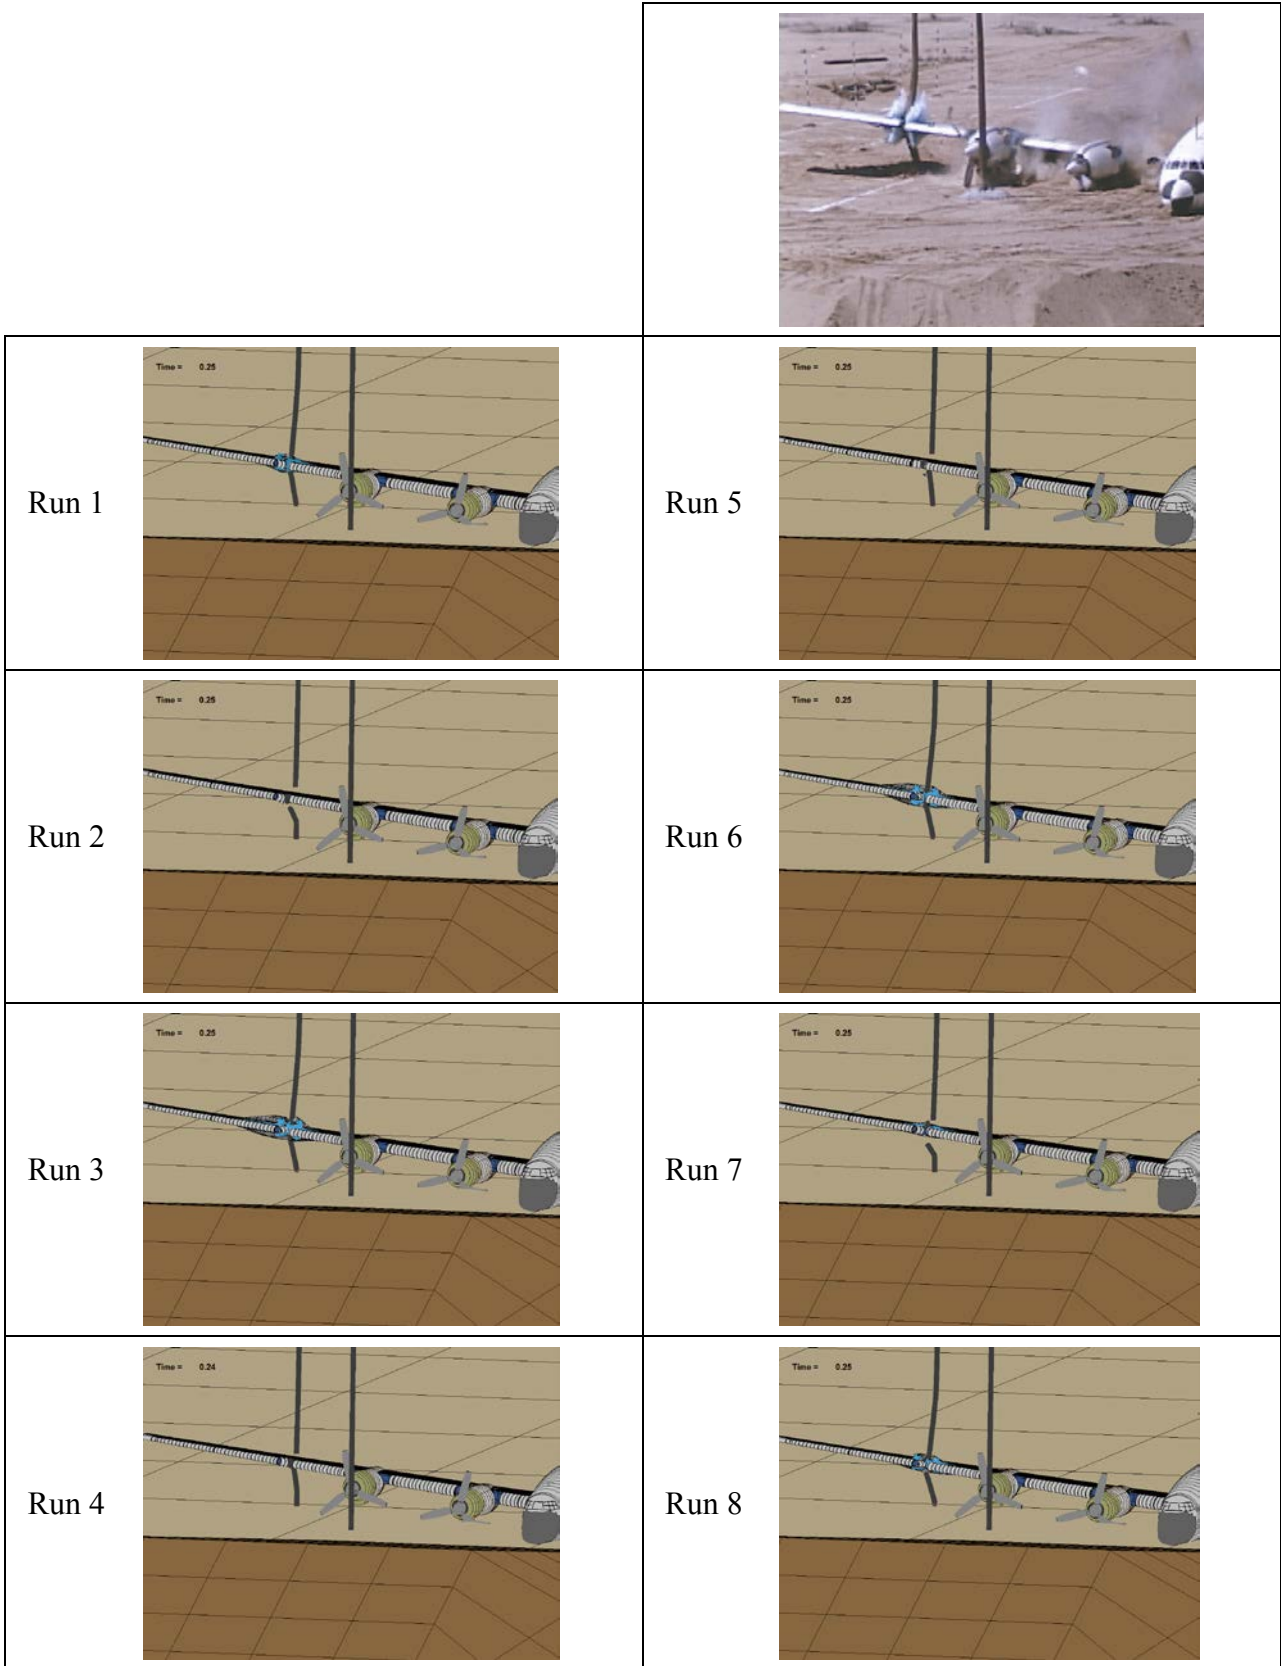
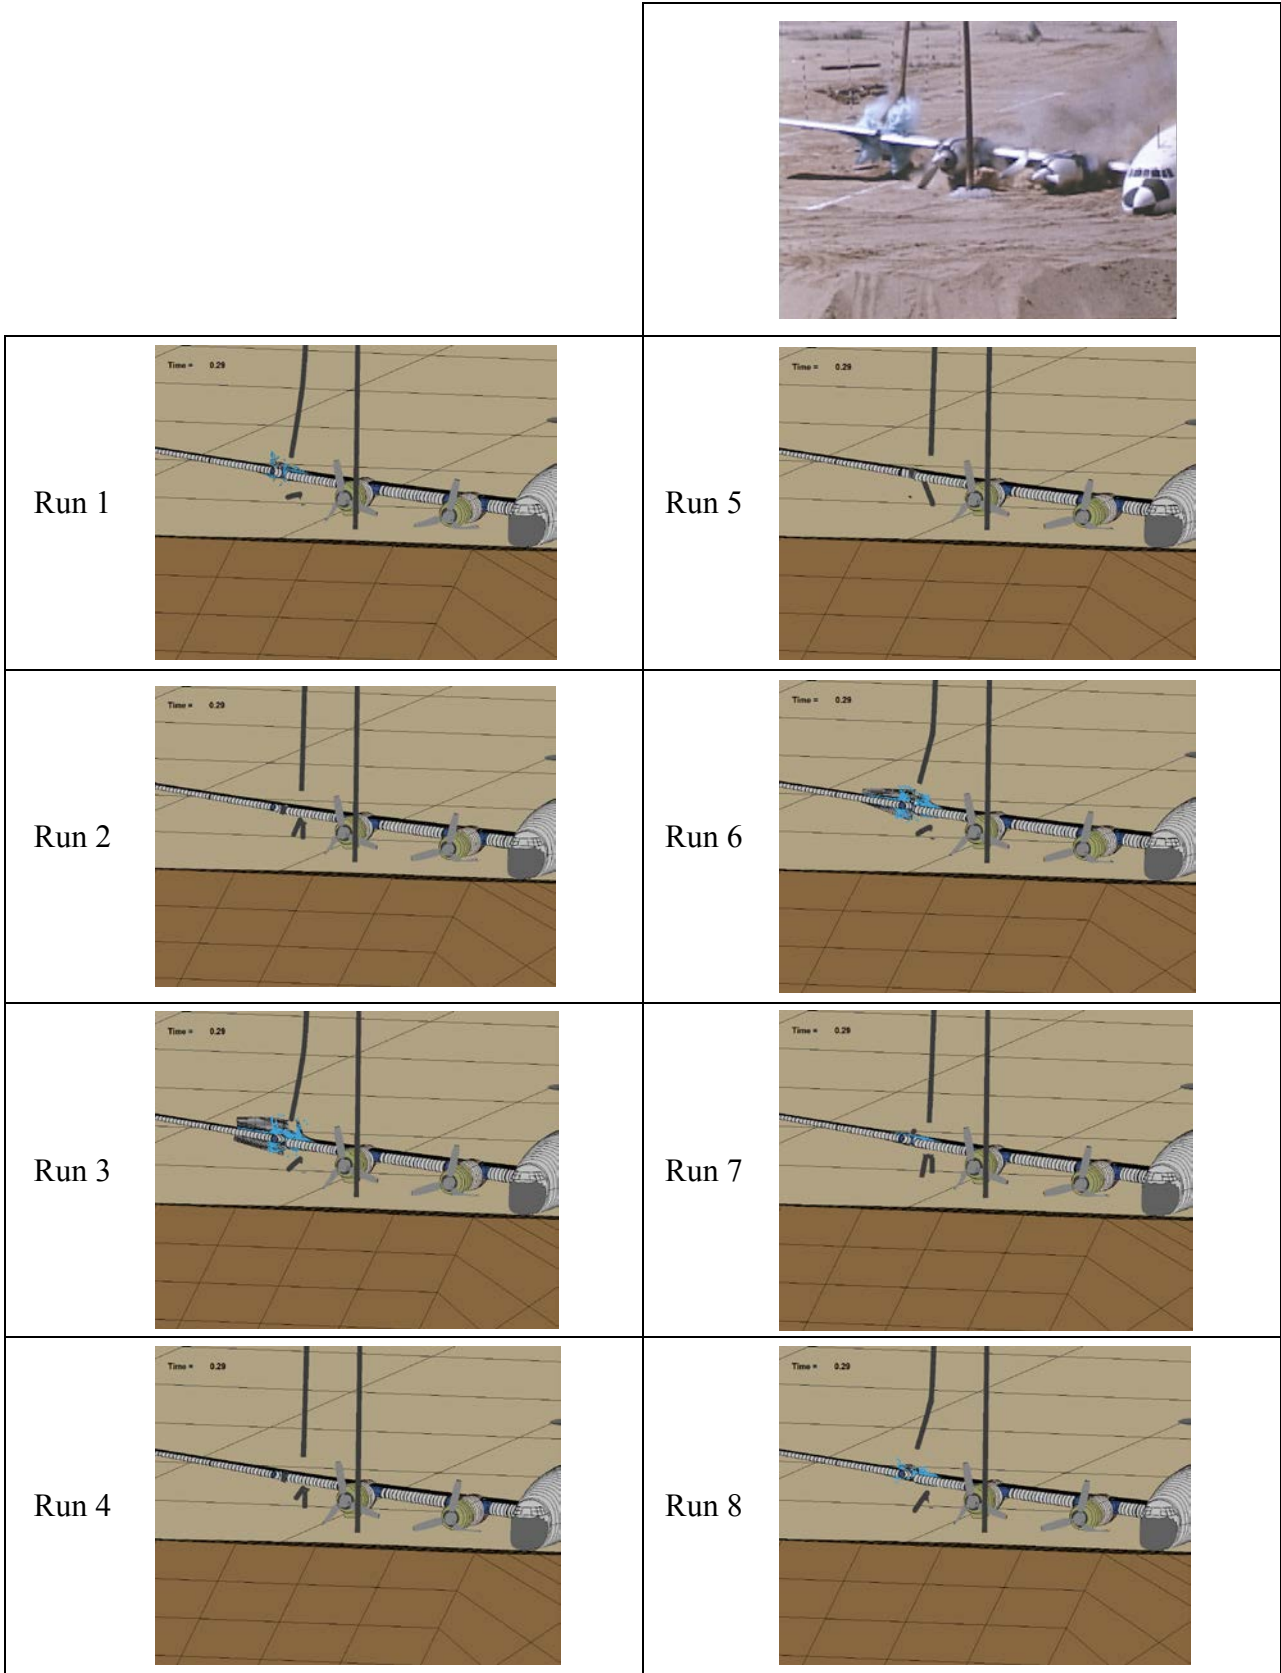
The front view of the telephone pole impacts on the right wing shows an overall good agreement between the eight runs conducted and the videographic data. In many of the simulations at early times (1.018 to 1.086 s), the initial release of dyed water was consistent with the test data. In general, the release appears to be visually smaller than in the video because the water quickly aerosolized in the test and spread over a wider area. This was evident by the fine mist observed in the photography, particularly evident at the periphery of the plume of dyed water. Effects of aerosolization were not included in the simulation. Likewise, the fidelity of the particles used in the simulations (approximately 2.5 in.) was too coarse to capture the very small release of aerosolized liquid observed at the early time of 1.018 s. However, all simulations also showed front spar cracks, which was consistent with this small liquid release.

Figure 23. Crash Test Comparison of Telephone Pole Impacts (front view)—Time = 1.018 s

Figure 24. Crash Test Comparison of Telephone Pole Impacts (front view)—Time = 1.041 s

Figure 25. Crash Test Comparison of Telephone Pole Impacts (front view)—Time = 1.086 s

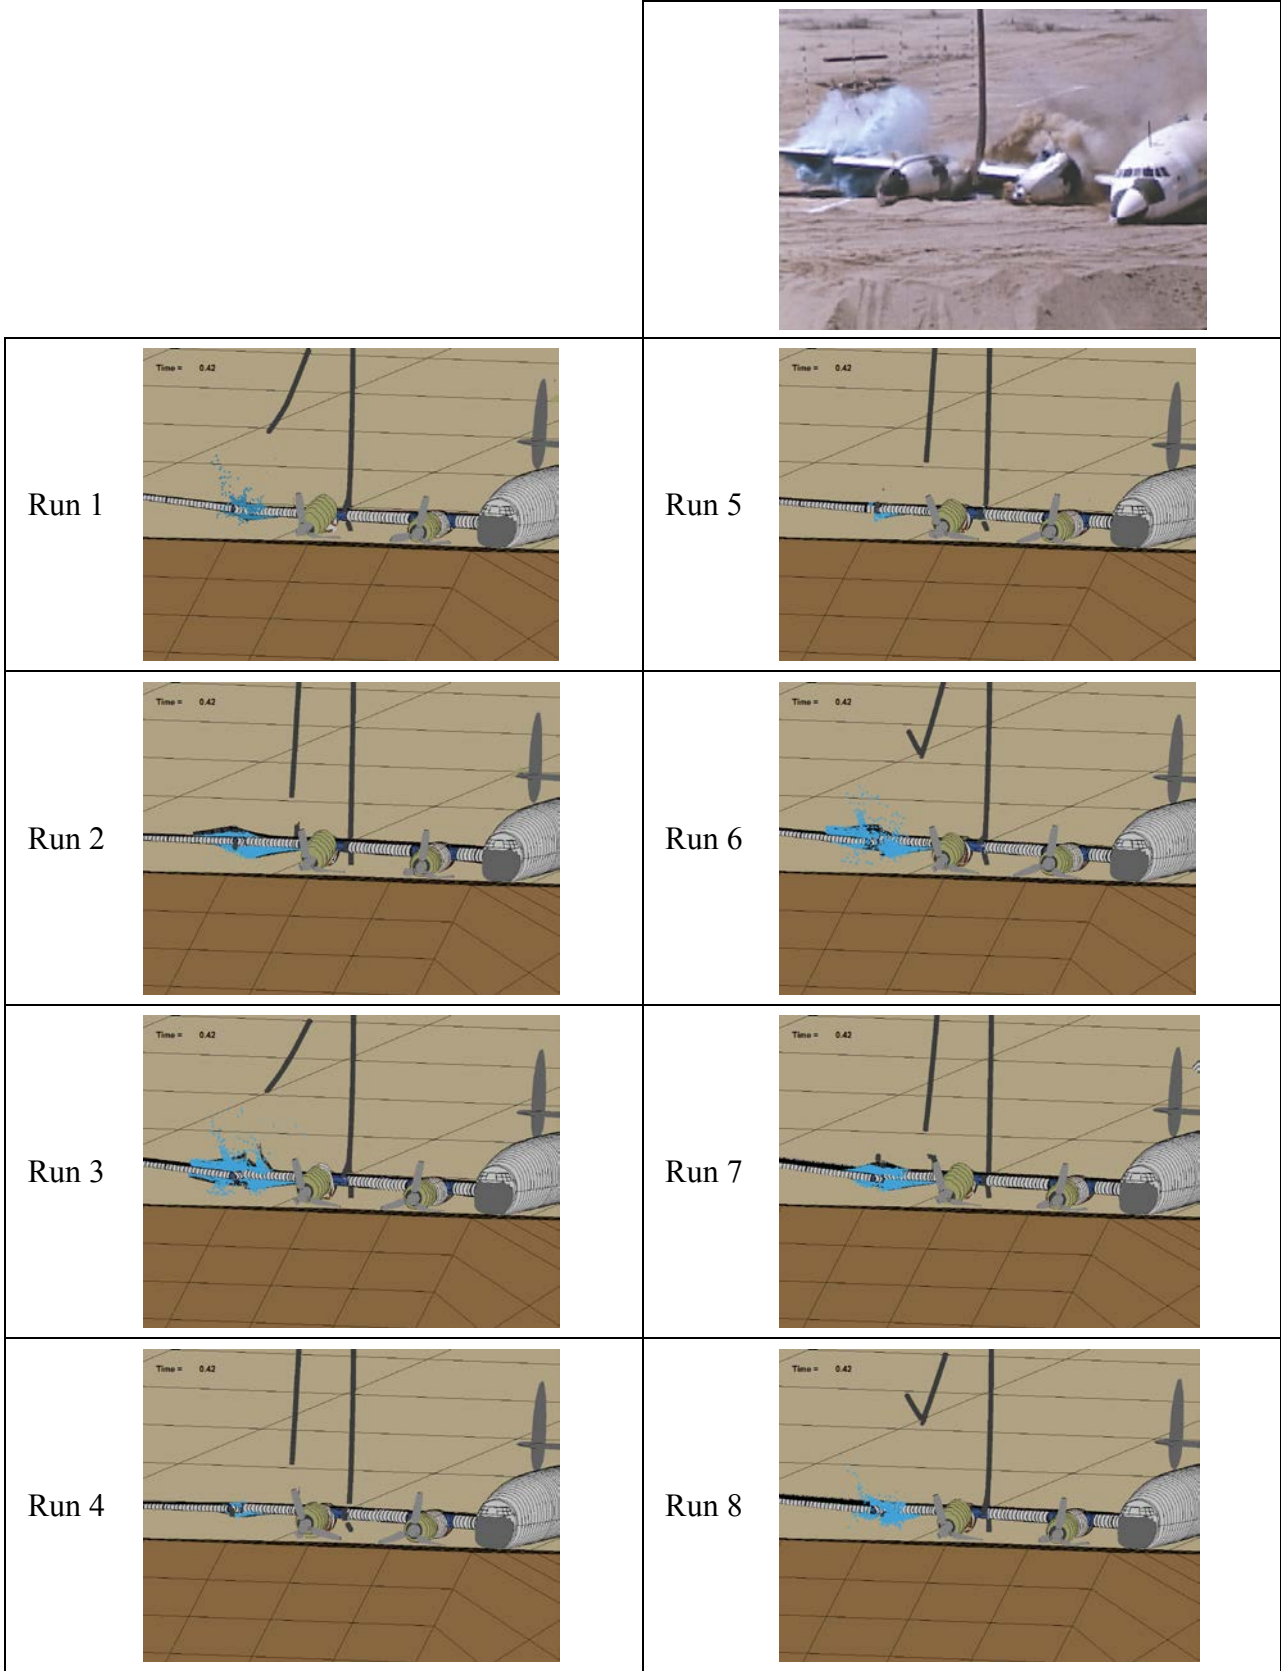
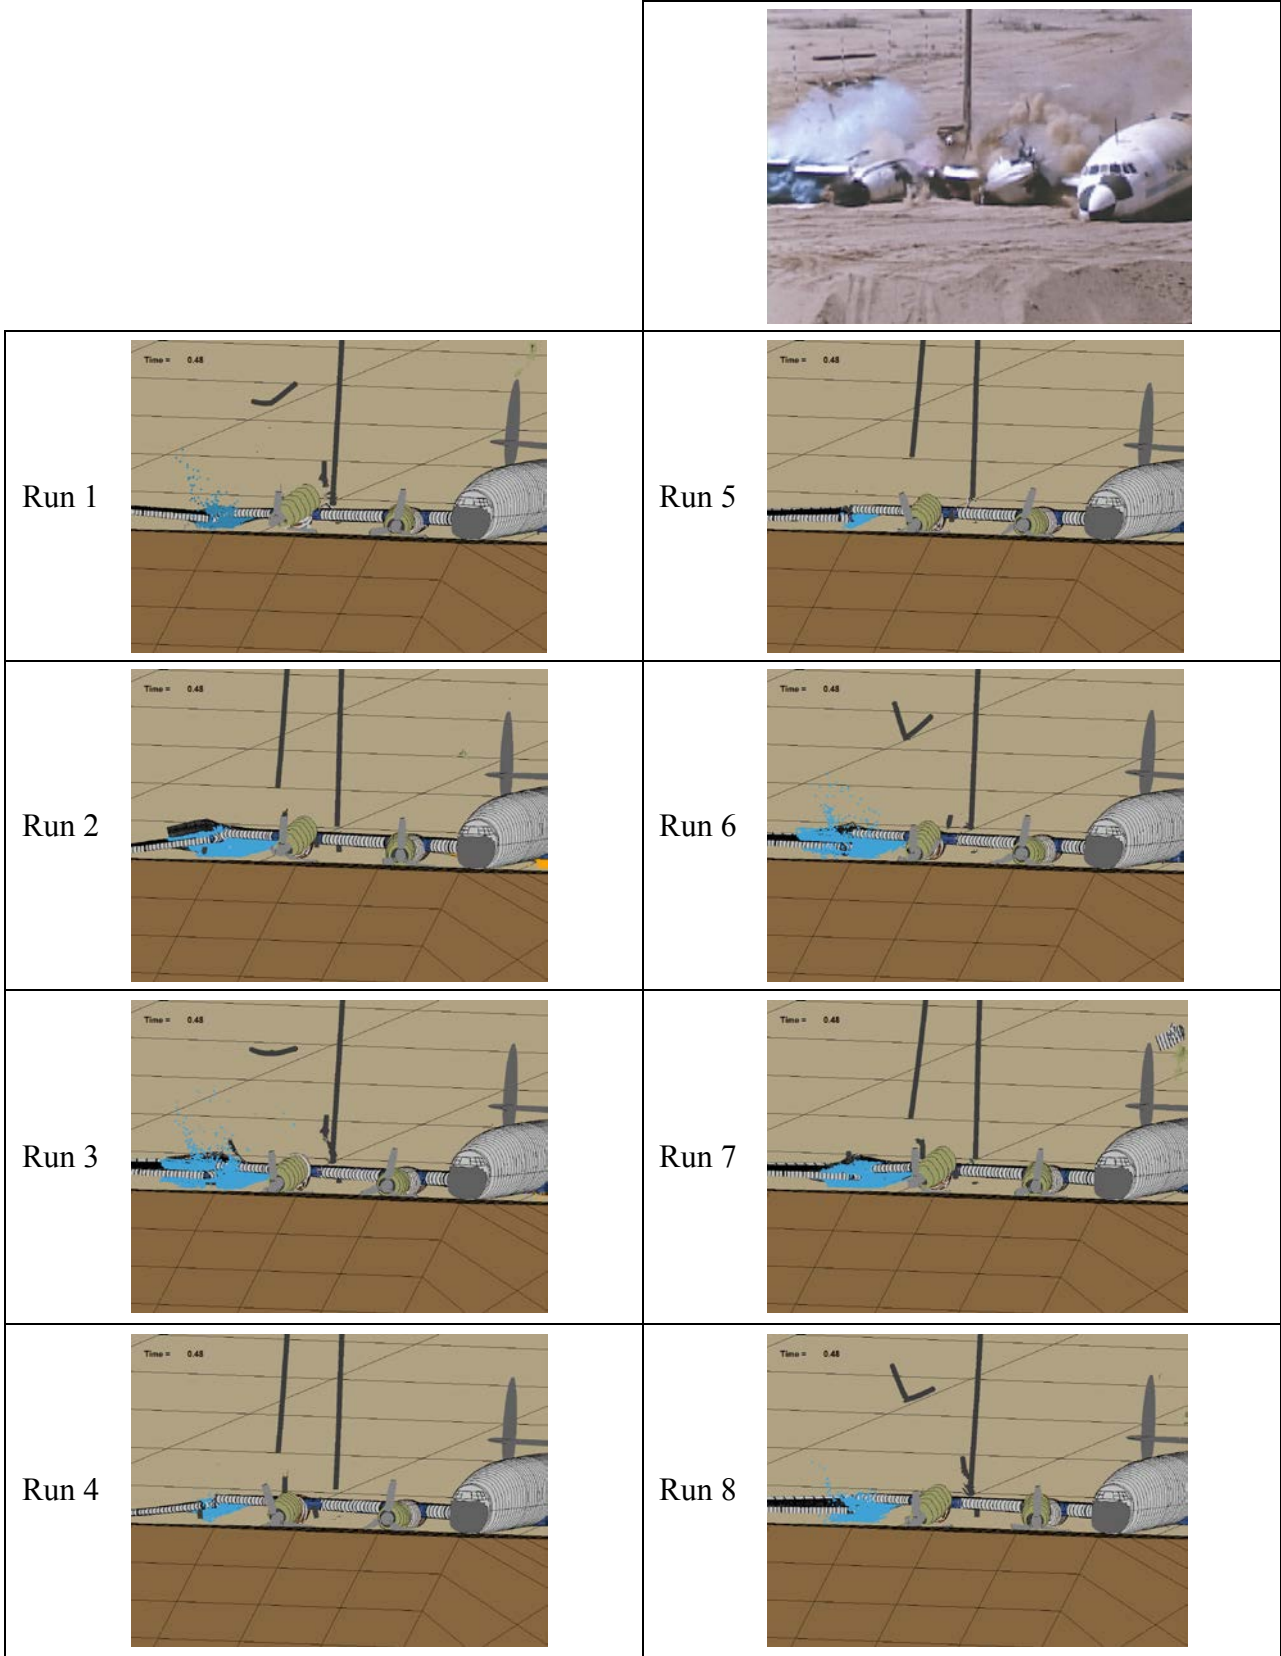
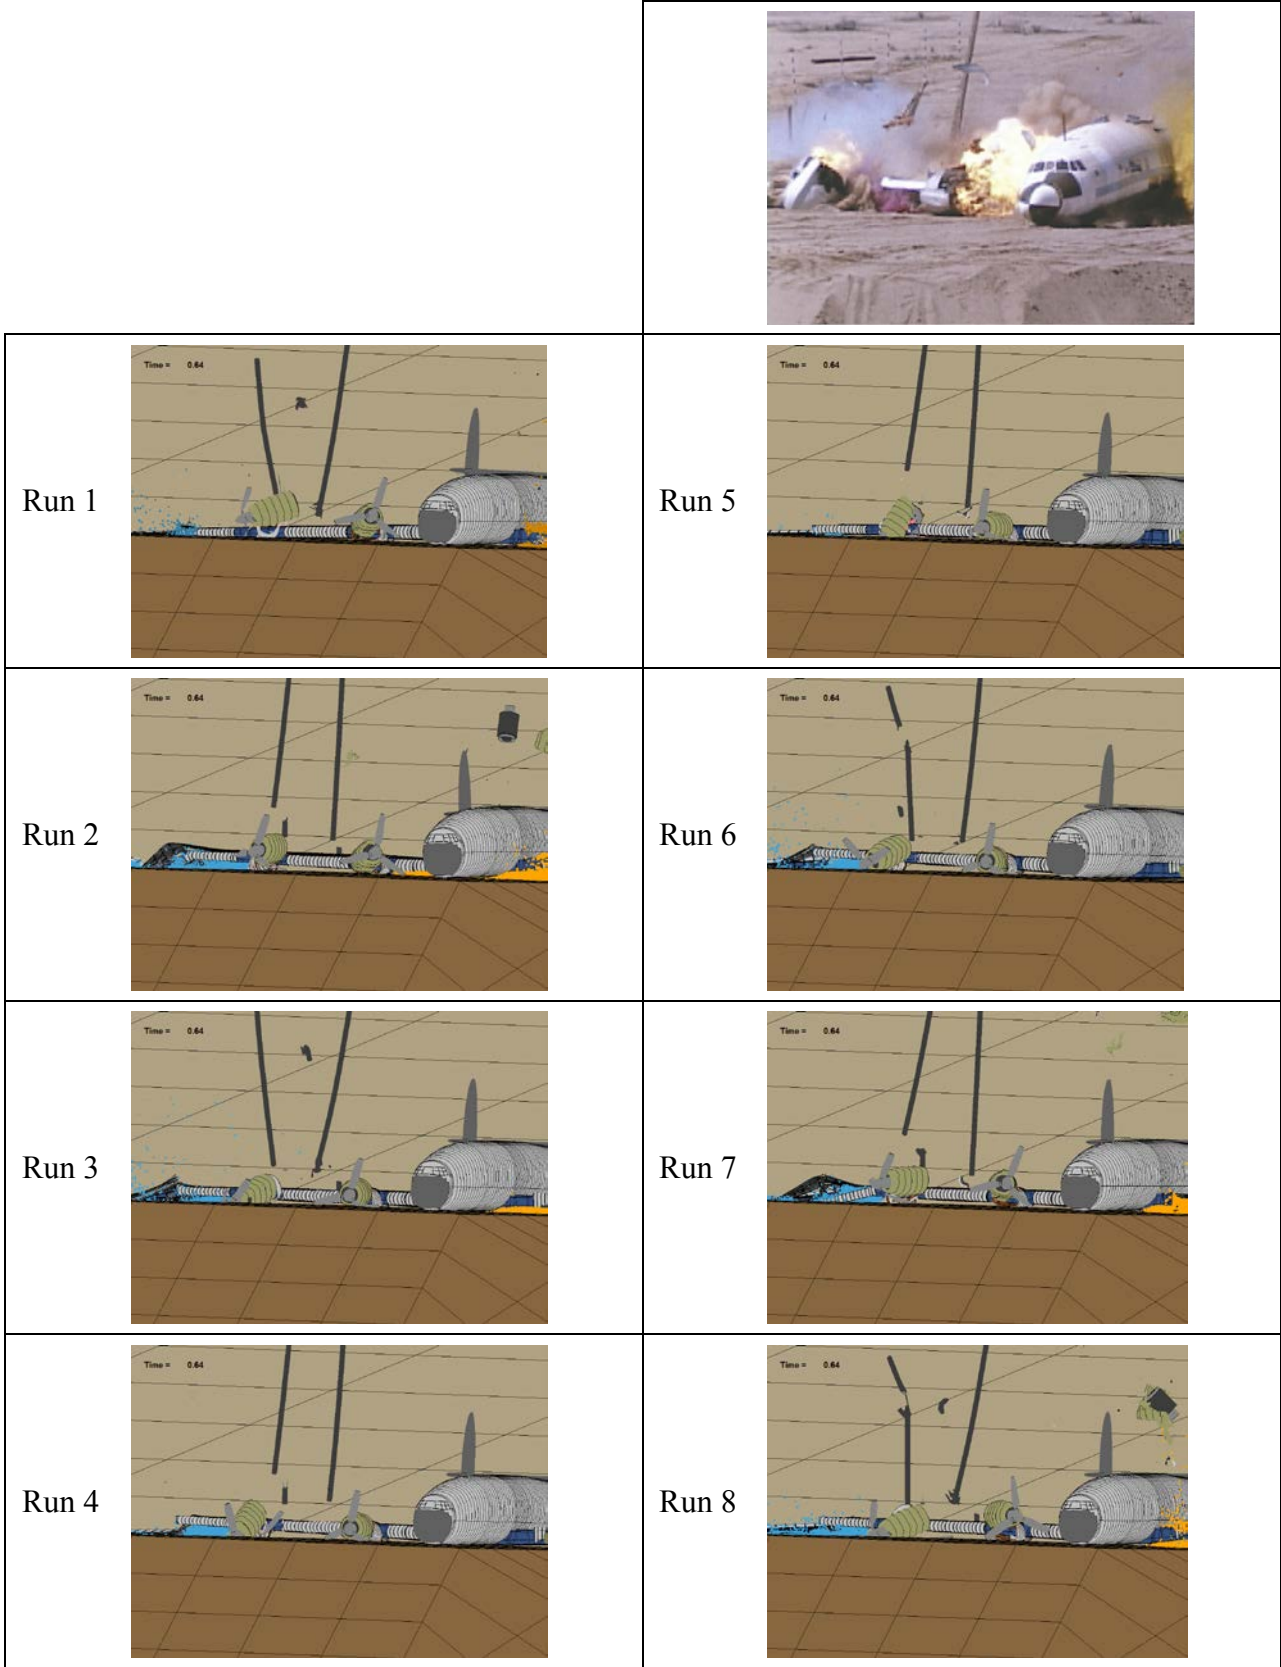
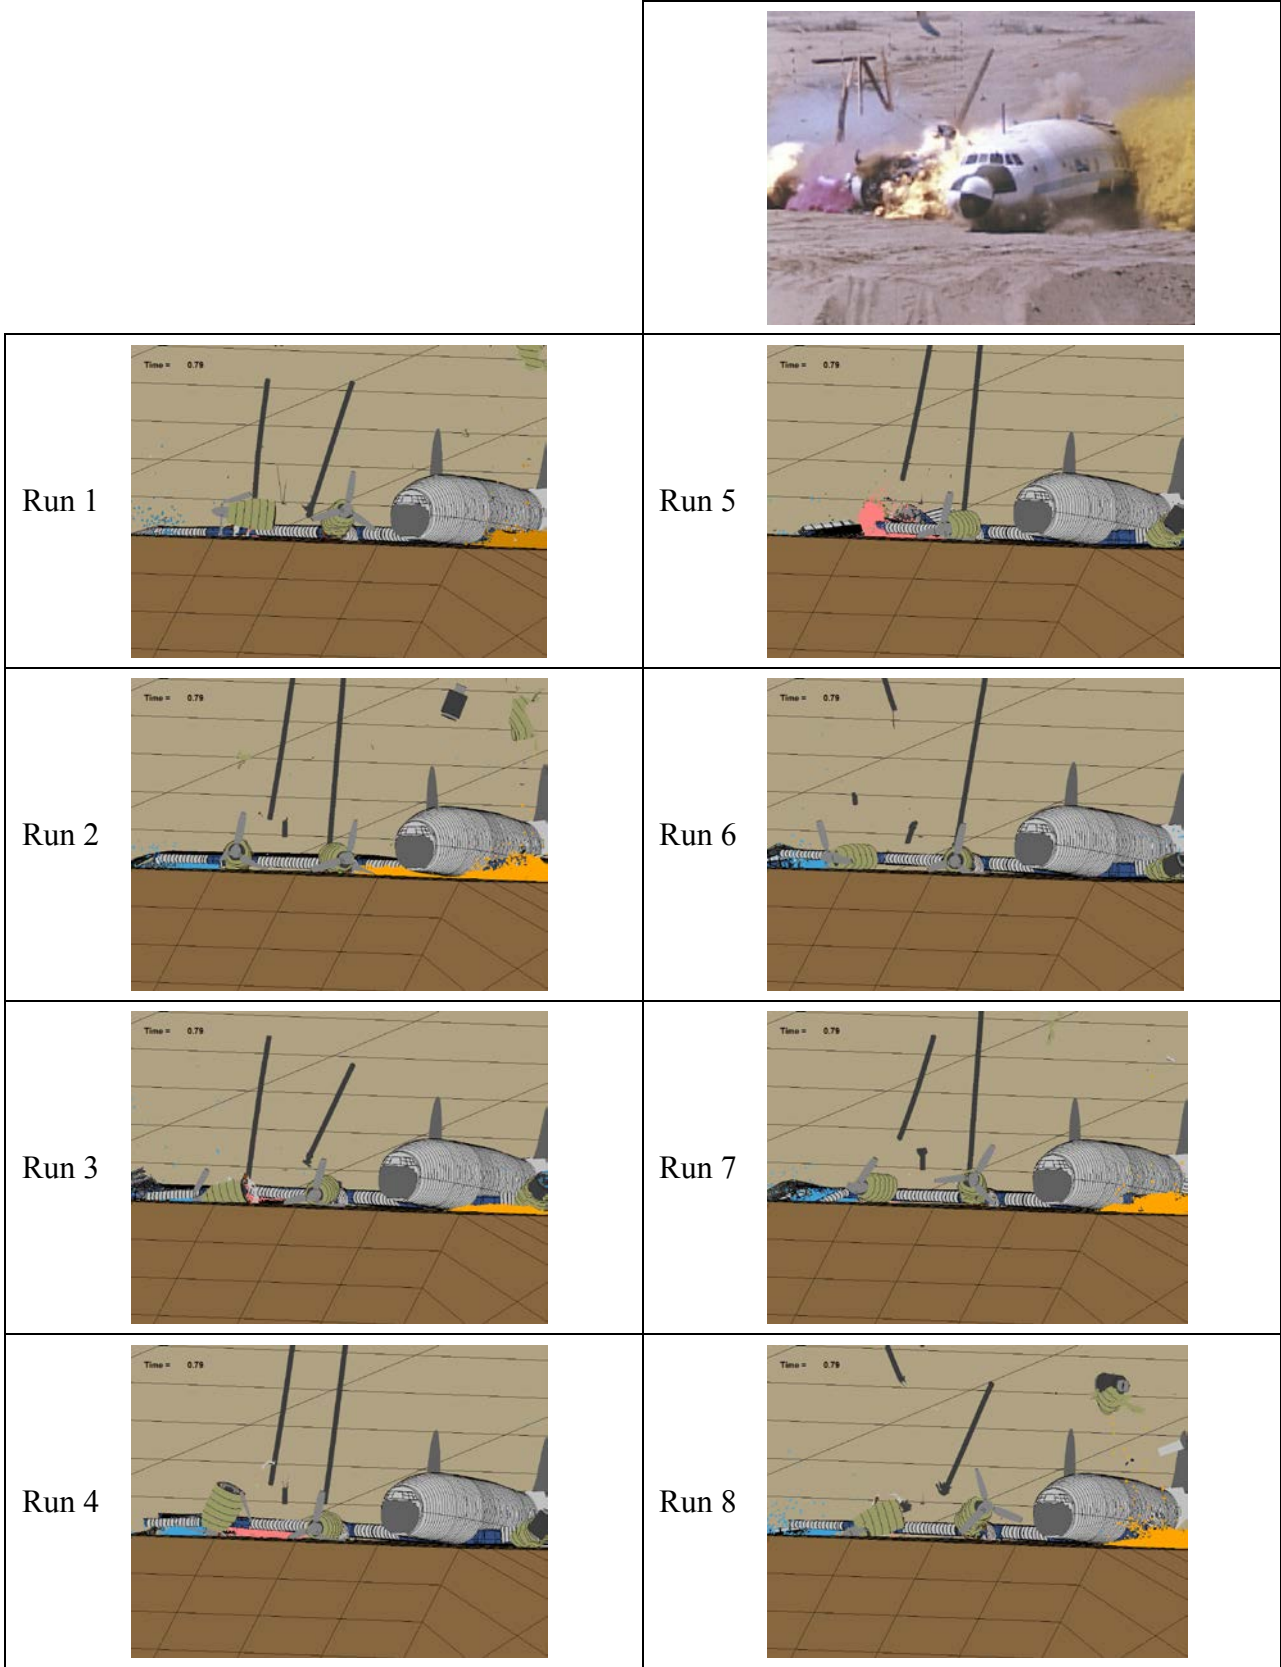
At later times (1.215 to 1.274 s), all runs also showed a large amount of liquid was released from Tank 4 (water dyed blue) beneath the wing as the bottom skin panel opened along the front spar. Much less liquid was observed above the wing. At the latest times (1.427 and 1.585 s), red gelled water was released from Tank 3 in most of the simulation runs, but not just from the telephone pole impact. The liquid was not released until later when the engine nacelle and wing hit the ground. This was also consistent with the simulations.

Figure 26. Crash Test Comparison of Telephone Pole Impacts (front view)—Time = 1.215 s

Figure 27. Crash Test Comparison of Telephone Pole Impacts (front view)—Time = 1.274 s

Figure 28. Crash Test Comparison of Telephone Pole Impacts (front view)—Time = 1.427 s

Figure 29. Crash Test Comparison of Telephone Pole Impacts (front view)—Time = 1.585 s
