**DOT/FAA/TC-12/43**

# **Crash Simulation of Transport Aircraft for Predicting Fuel Release**

## **First Phase—Simulation of the Lockheed Constellation Model L-1649 Full-Scale Crash Test**

Final Report

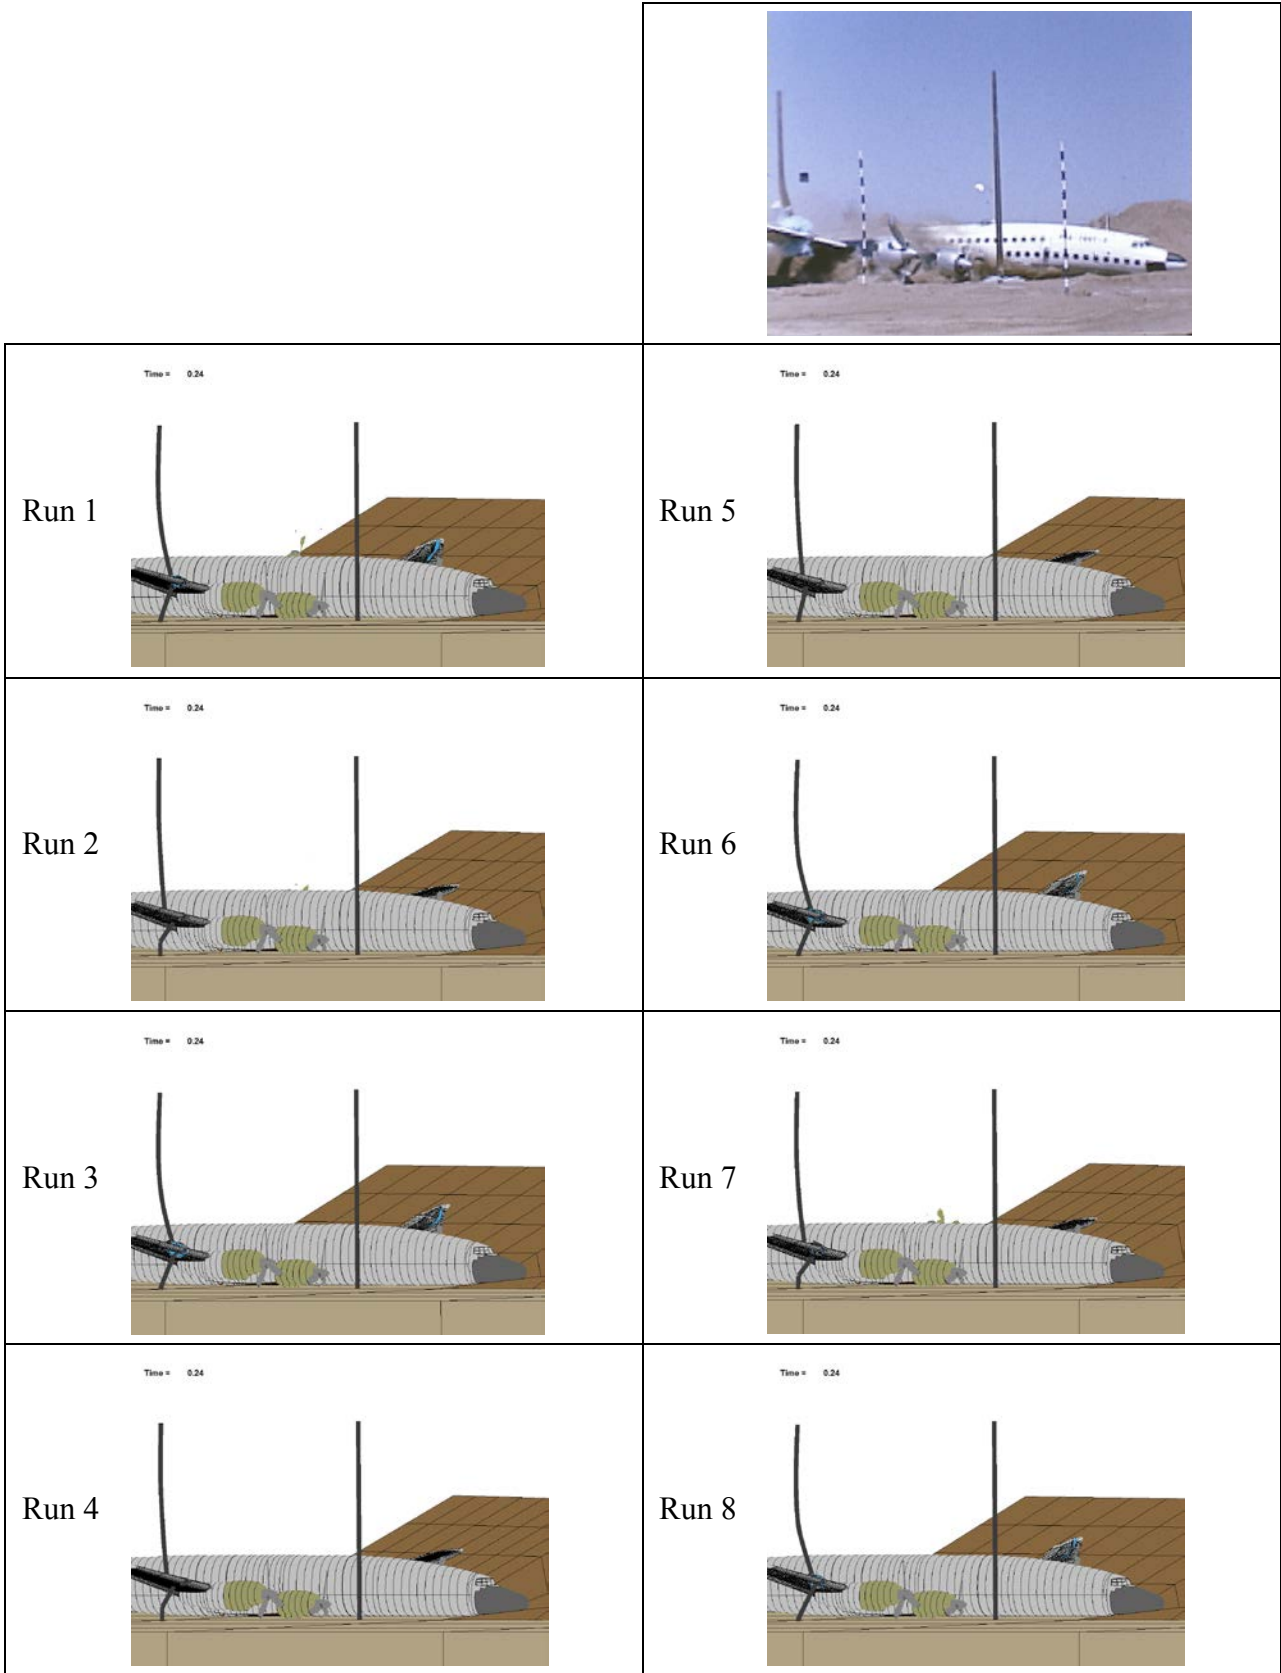
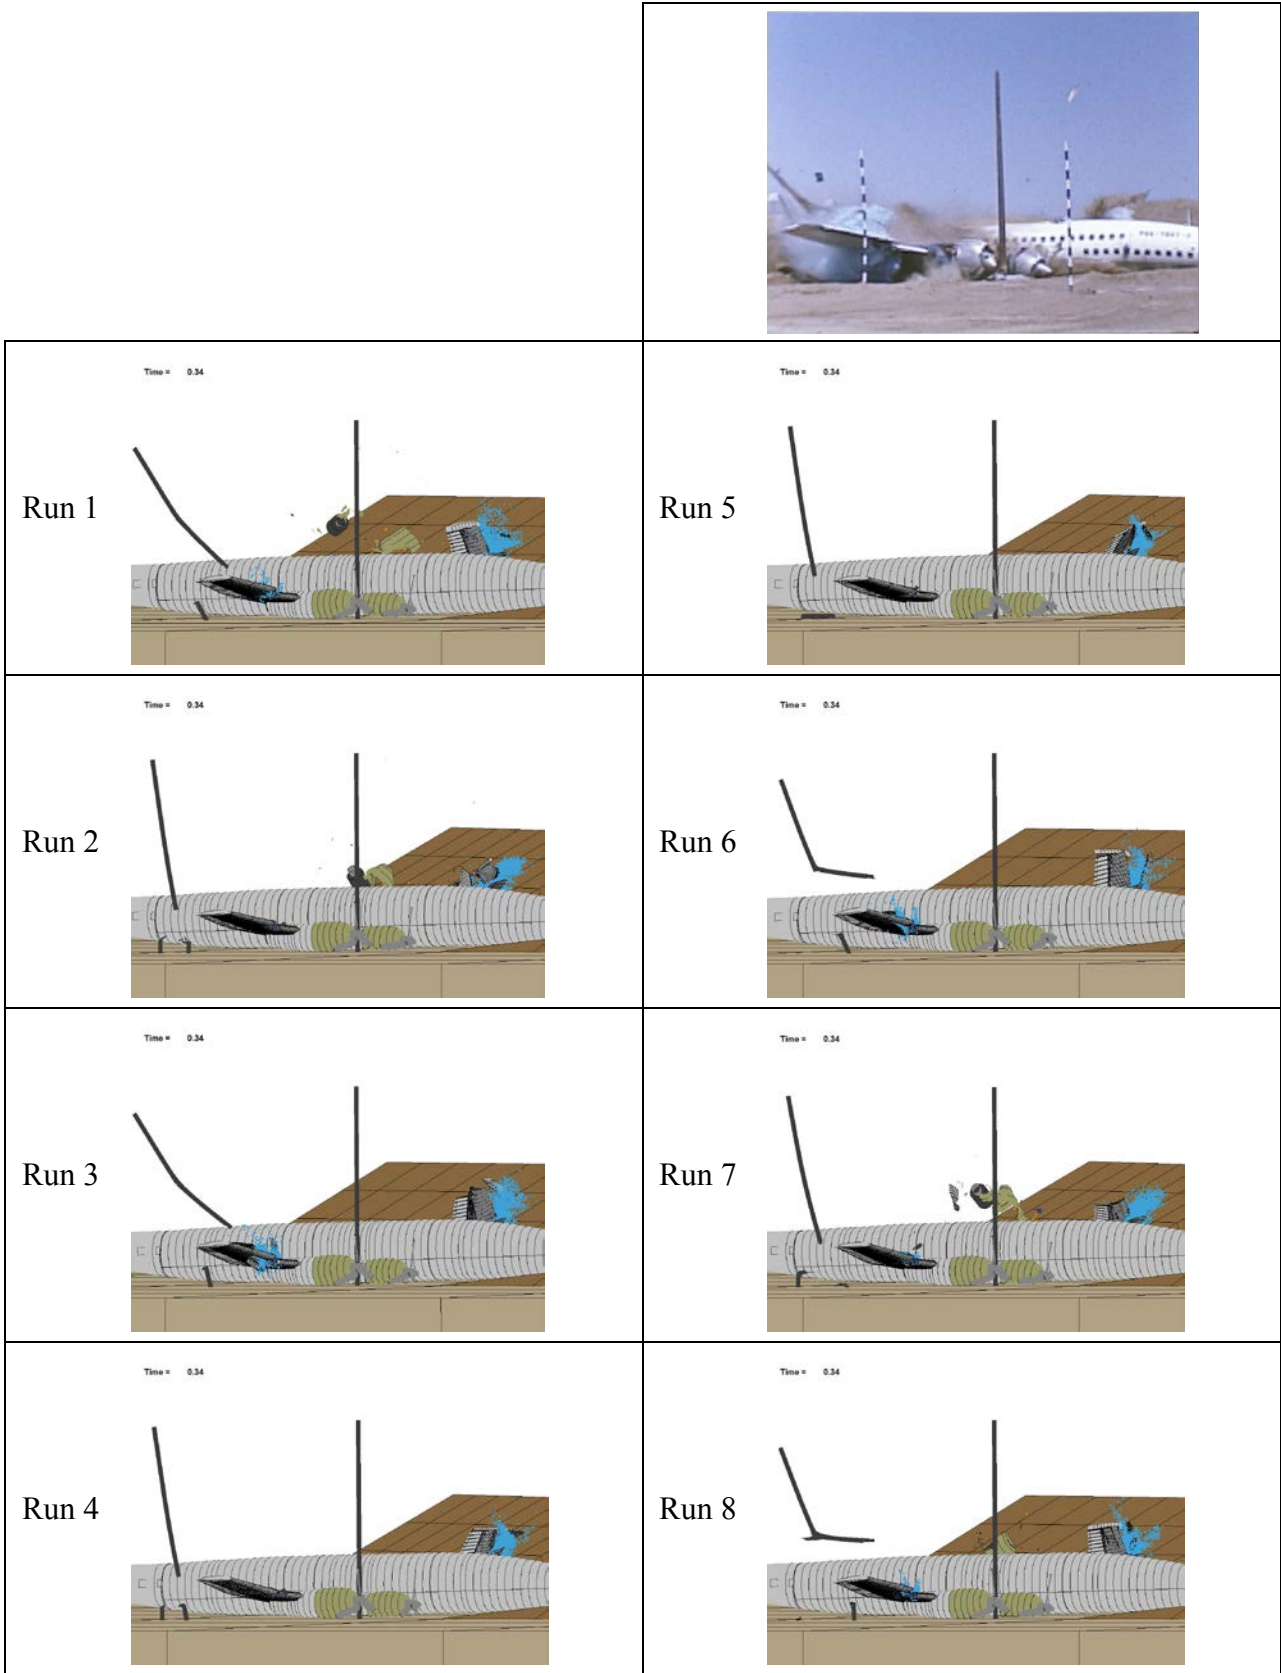
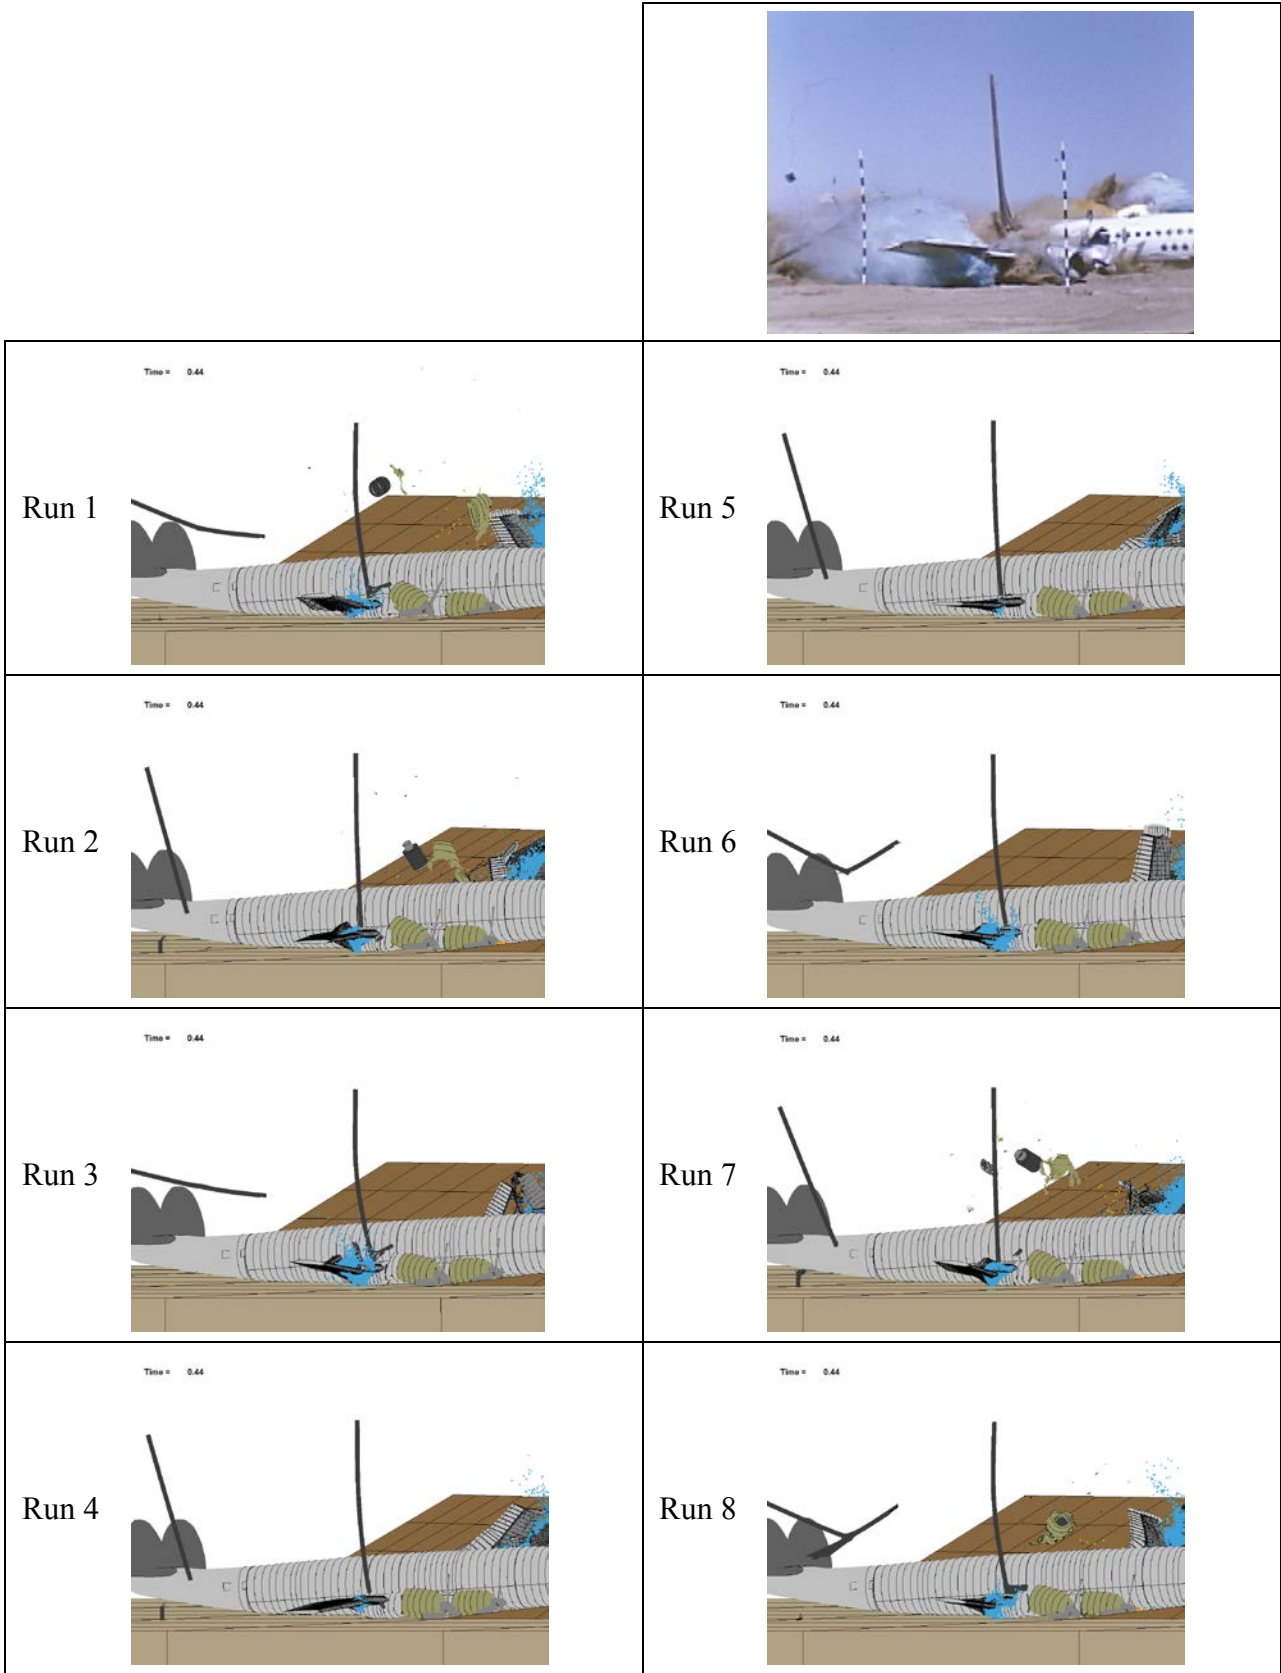
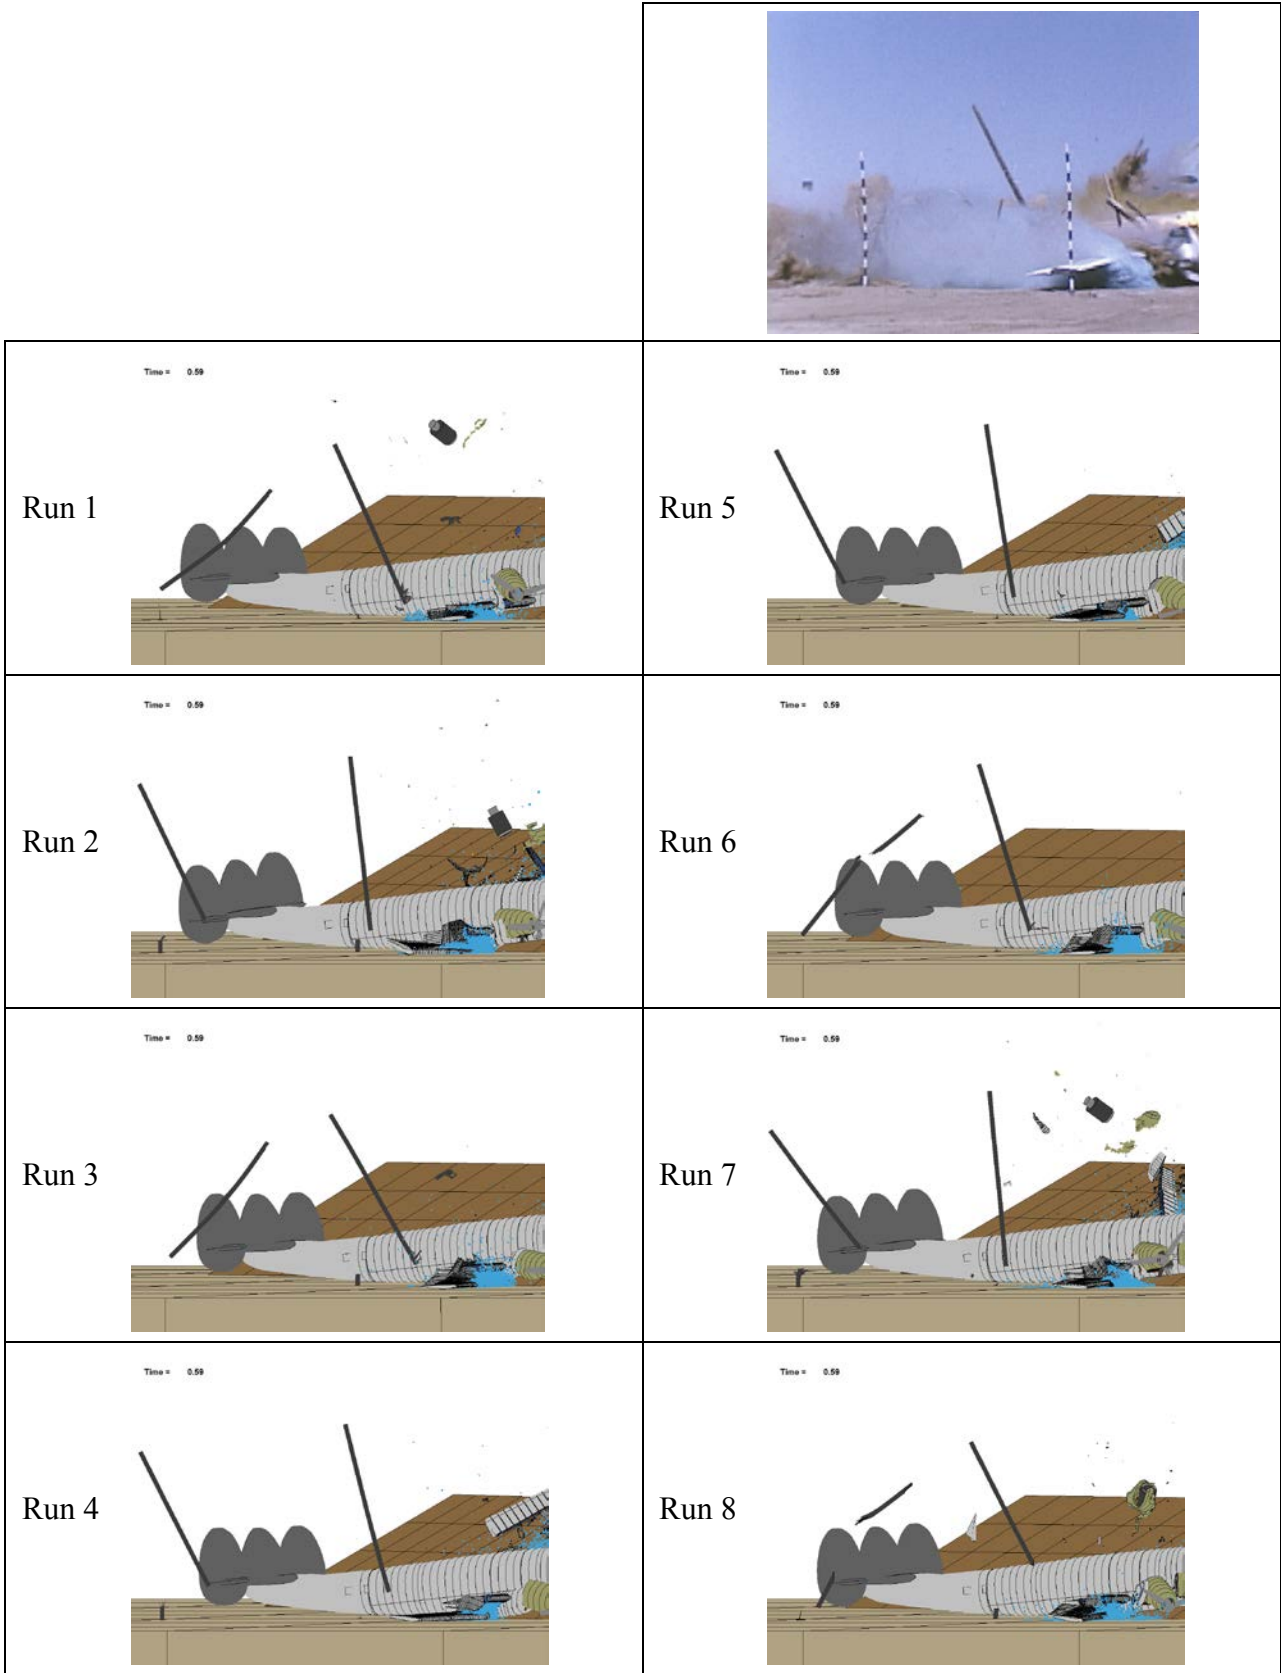
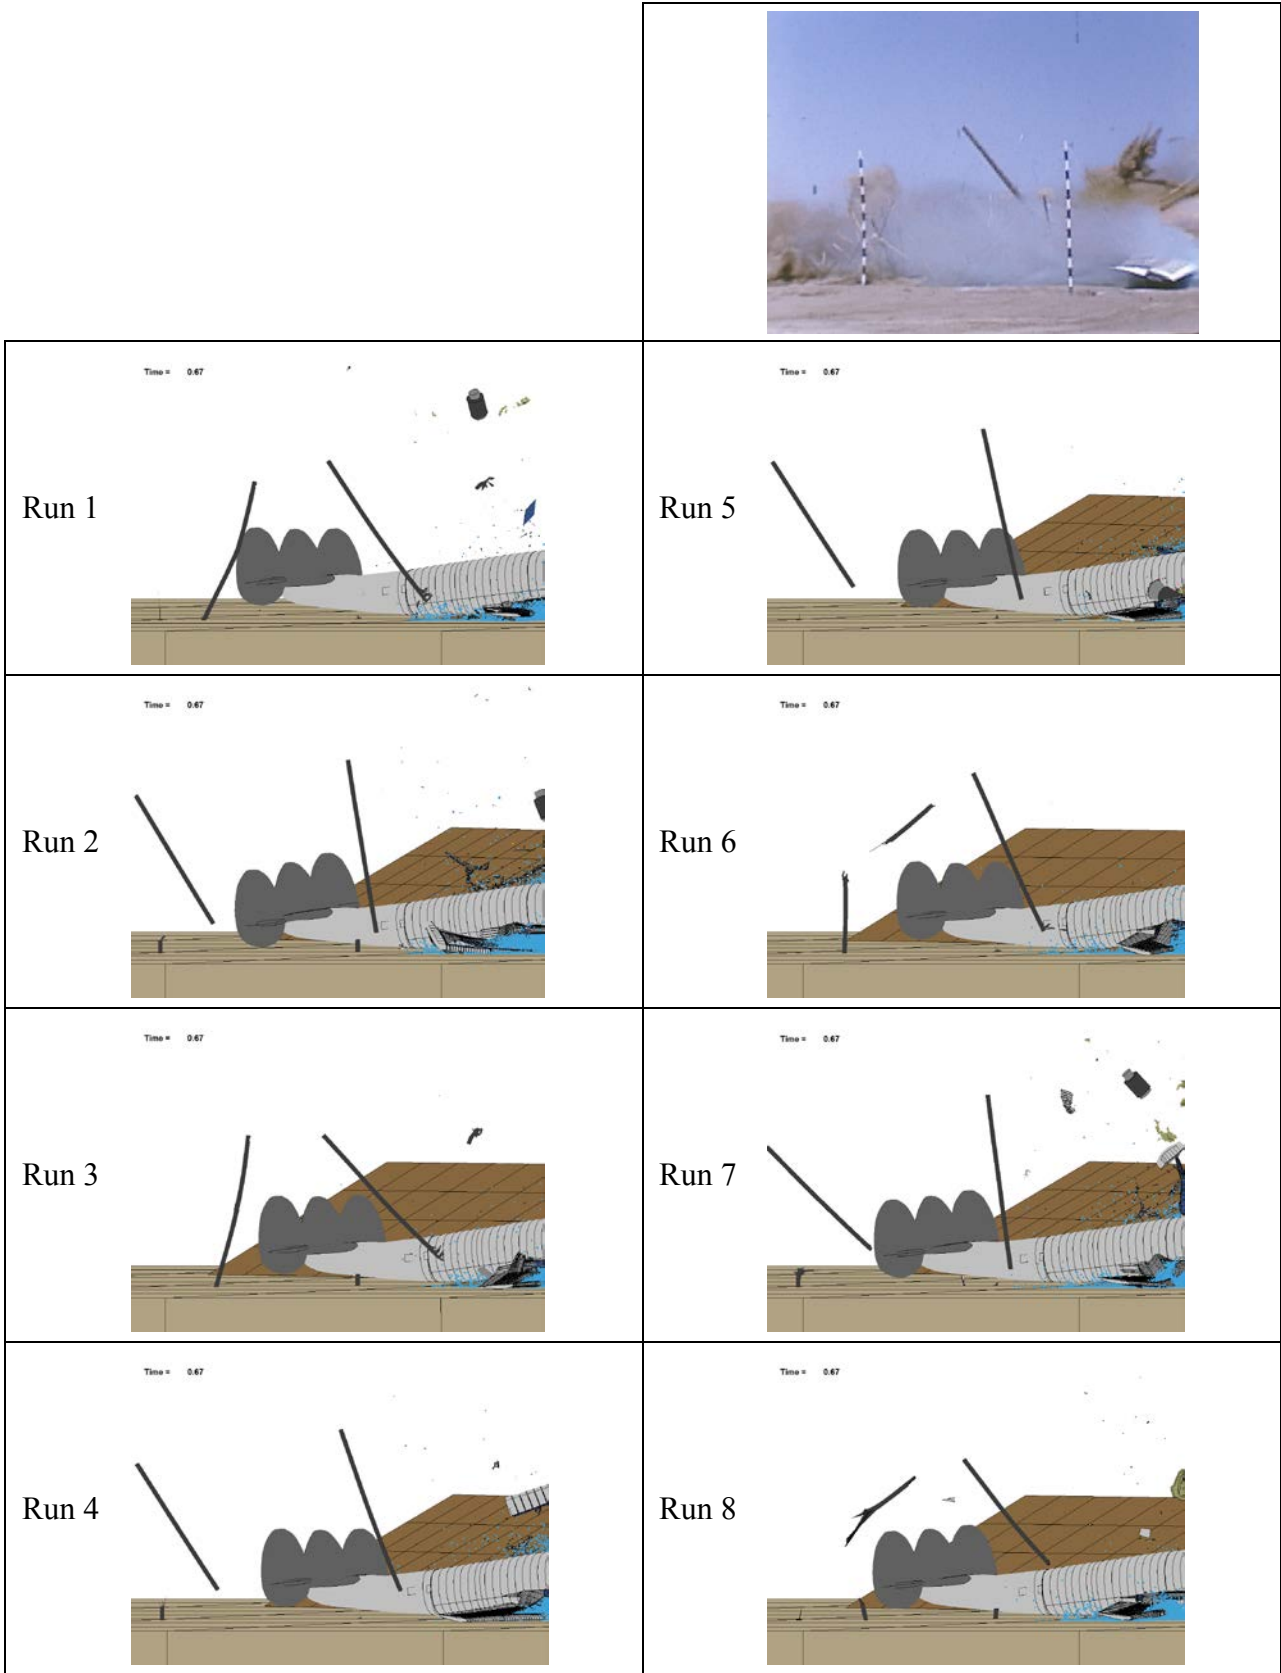
In the side view of the telephone pole impacts on the right (starboard) wing (figures 30 through 34), the bending and failure of telephone pole 1 (outboard pole) closely resembled the test footage just after impact (1.041 s). Best agreement was observed for the overall telephone pole deformation, failure, and kinematics for the runs with the higher bound for pole strength (Runs 1, 3, 6, and 8), indicating that the actual telephone pole strength was likely closer to the upper bound. The portion of the wing outboard of the telephone pole impact was observed to turn upward relative to the rest of the wing at 1.131 s, both in the crash test and in all simulations. The wing rotation and timing for when the wing tip impacted the ground varied by run after that. The same general conclusions regarding the dyed water release were observed in both the side and front views already discussed.

Figure 30. Crash Test Comparison of Telephone Pole Impacts (side view)—Time = 1.041 s

Figure 31. Crash Test Comparison of Telephone Pole Impacts (side view)—Time = 1.131 s

Figure 32. Crash Test Comparison of Telephone Pole Impacts (side view)—Time = 1.230 s

Figure 33. Crash Test Comparison of Telephone Pole Impacts (side view)—Time = 1.379 s

Figure 34. Crash Test Comparison of Telephone Pole Impacts (side view)—Time = 1.460 s
