**DOT/FAA/TC-12/43**

# **Crash Simulation of Transport Aircraft for Predicting Fuel Release**

## **First Phase—Simulation of the Lockheed Constellation Model L-1649 Full-Scale Crash Test**

Final Report

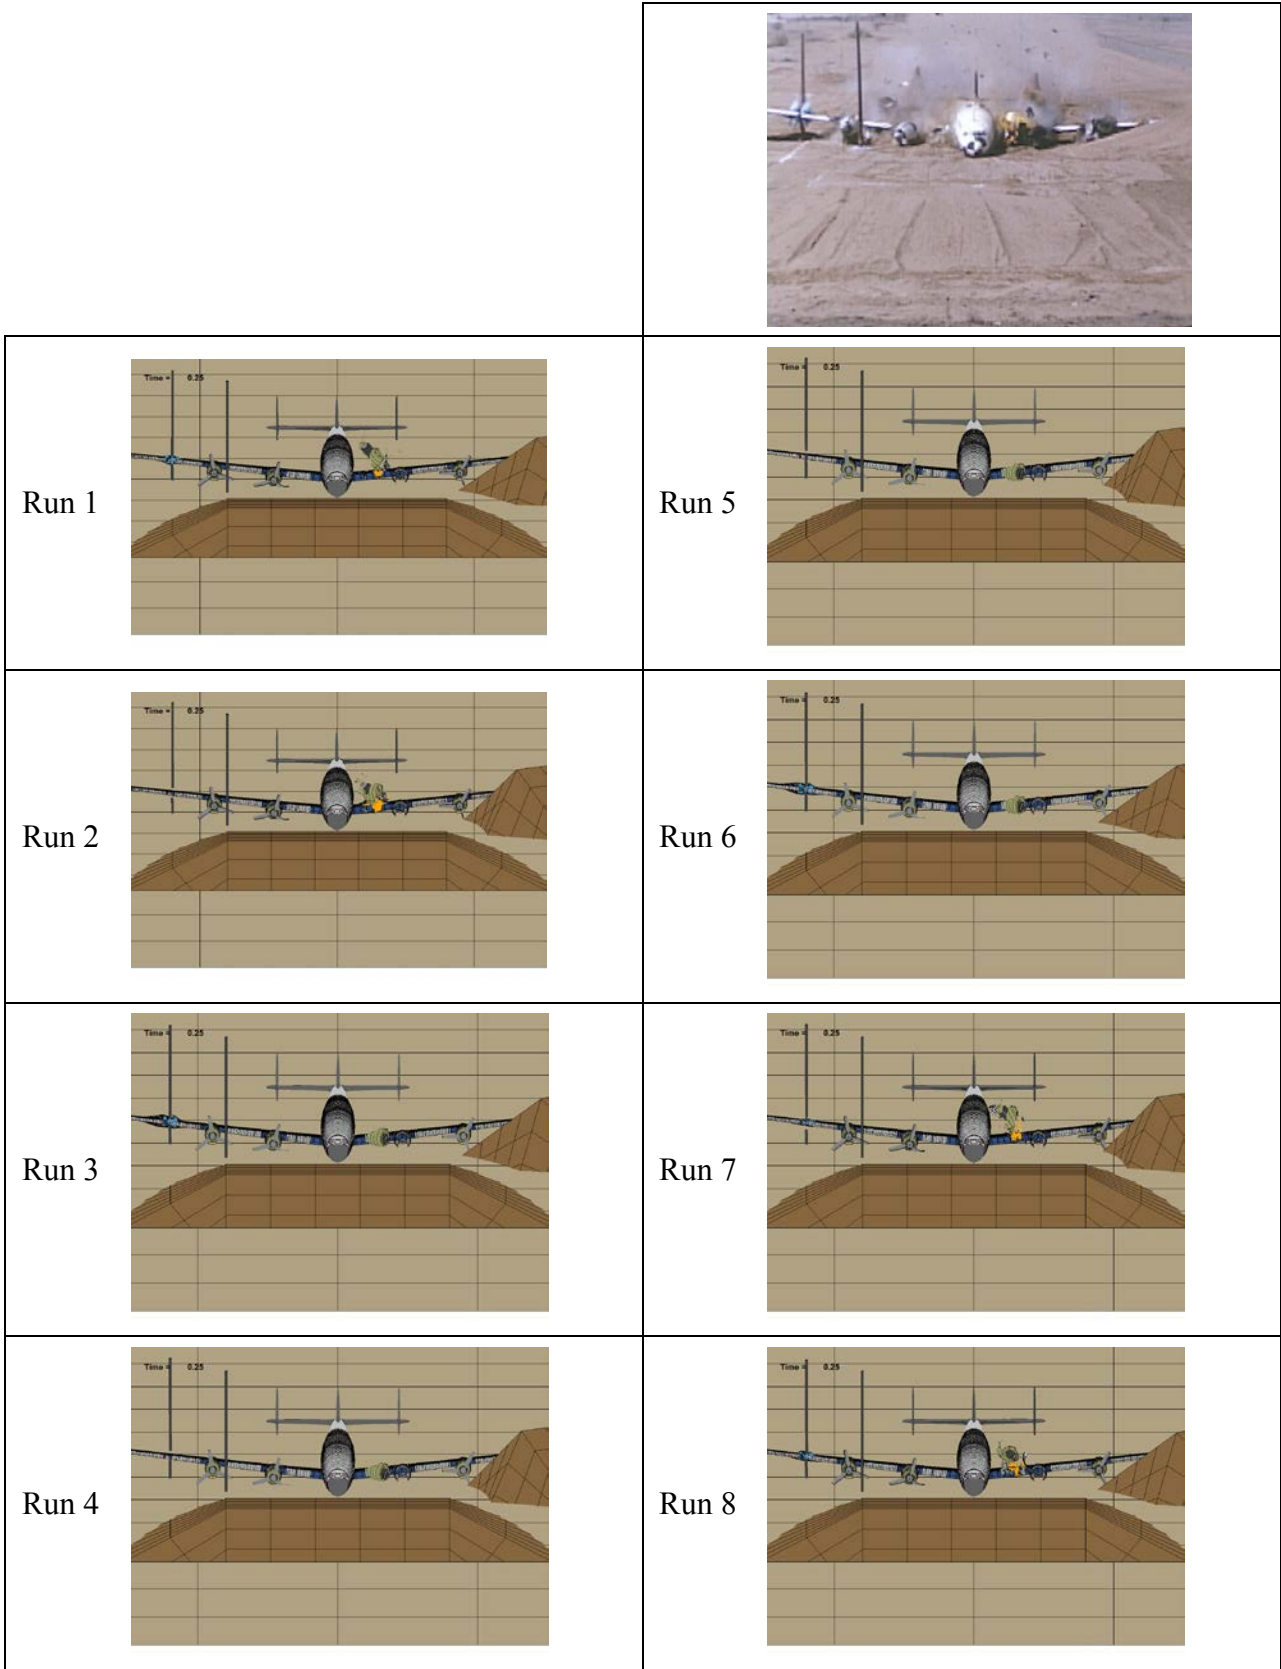
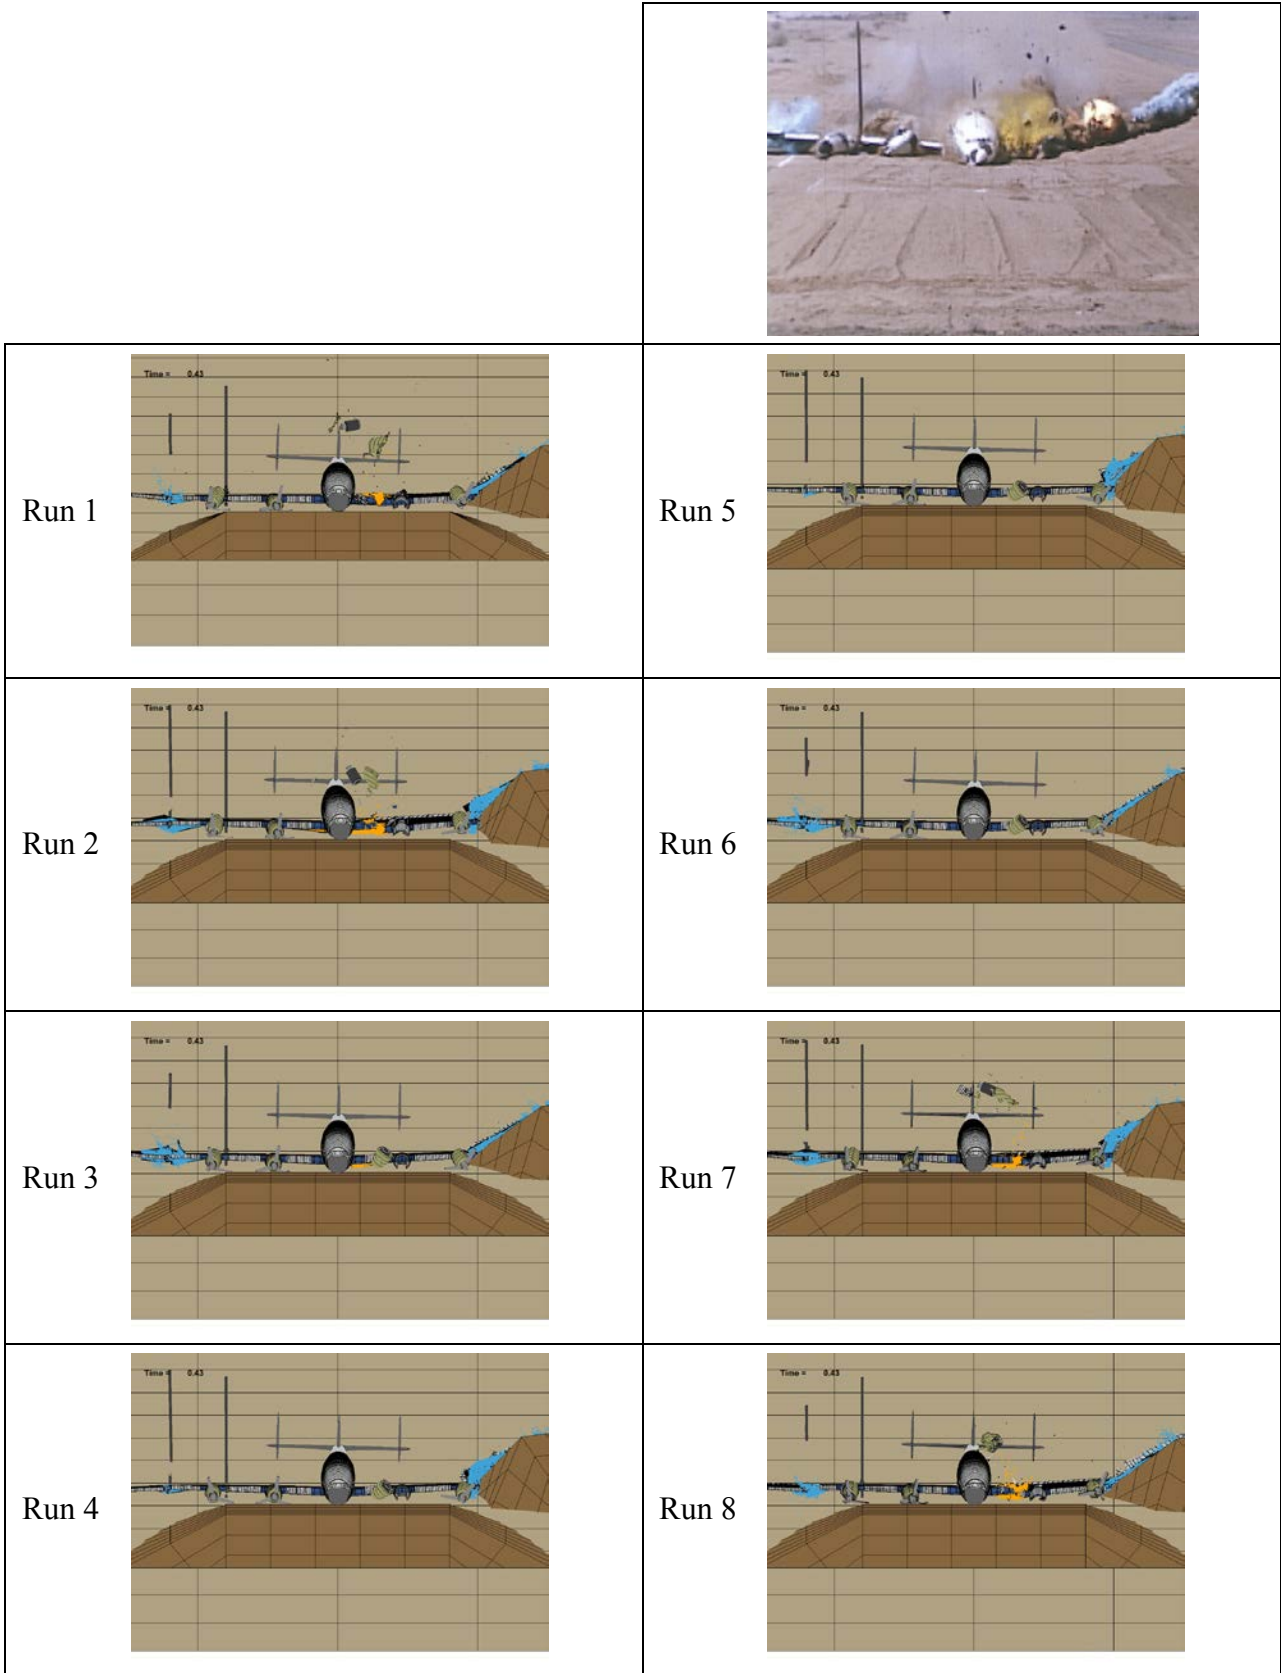
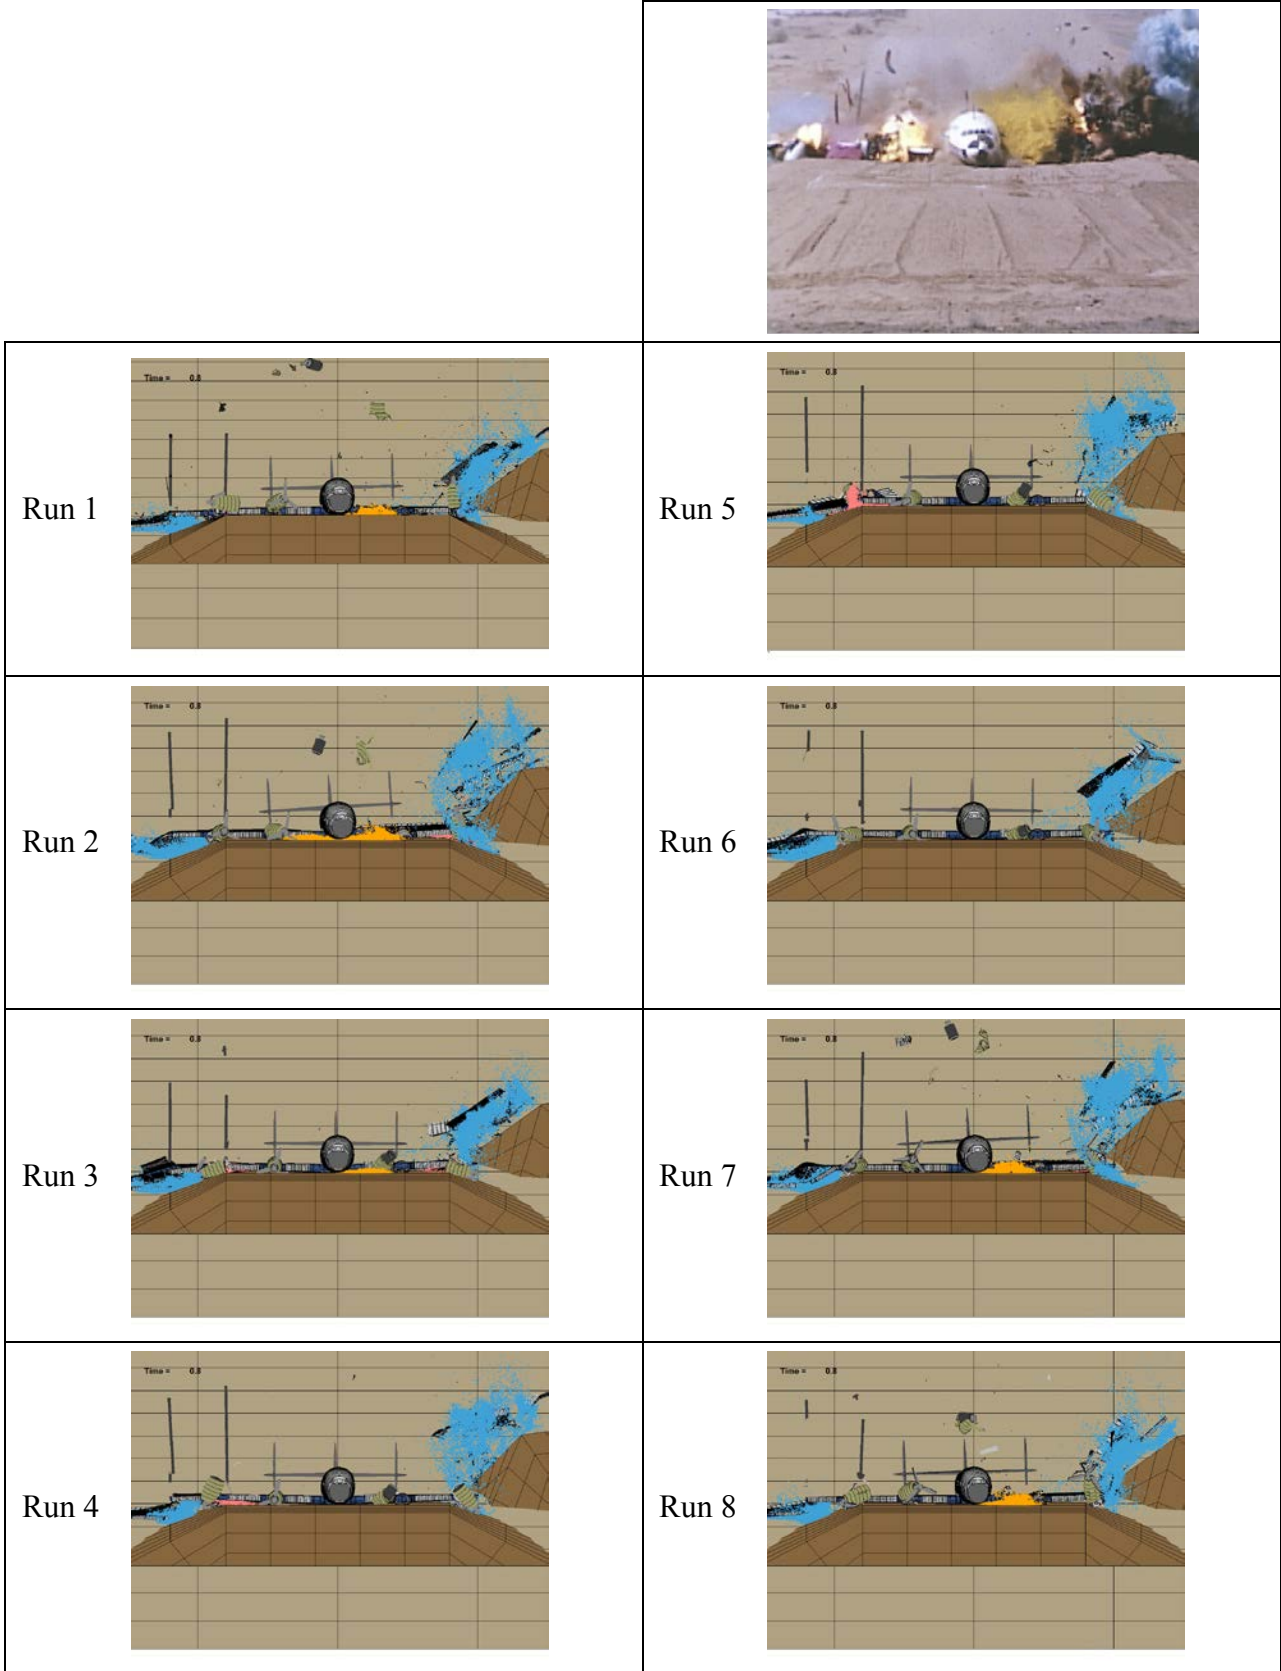
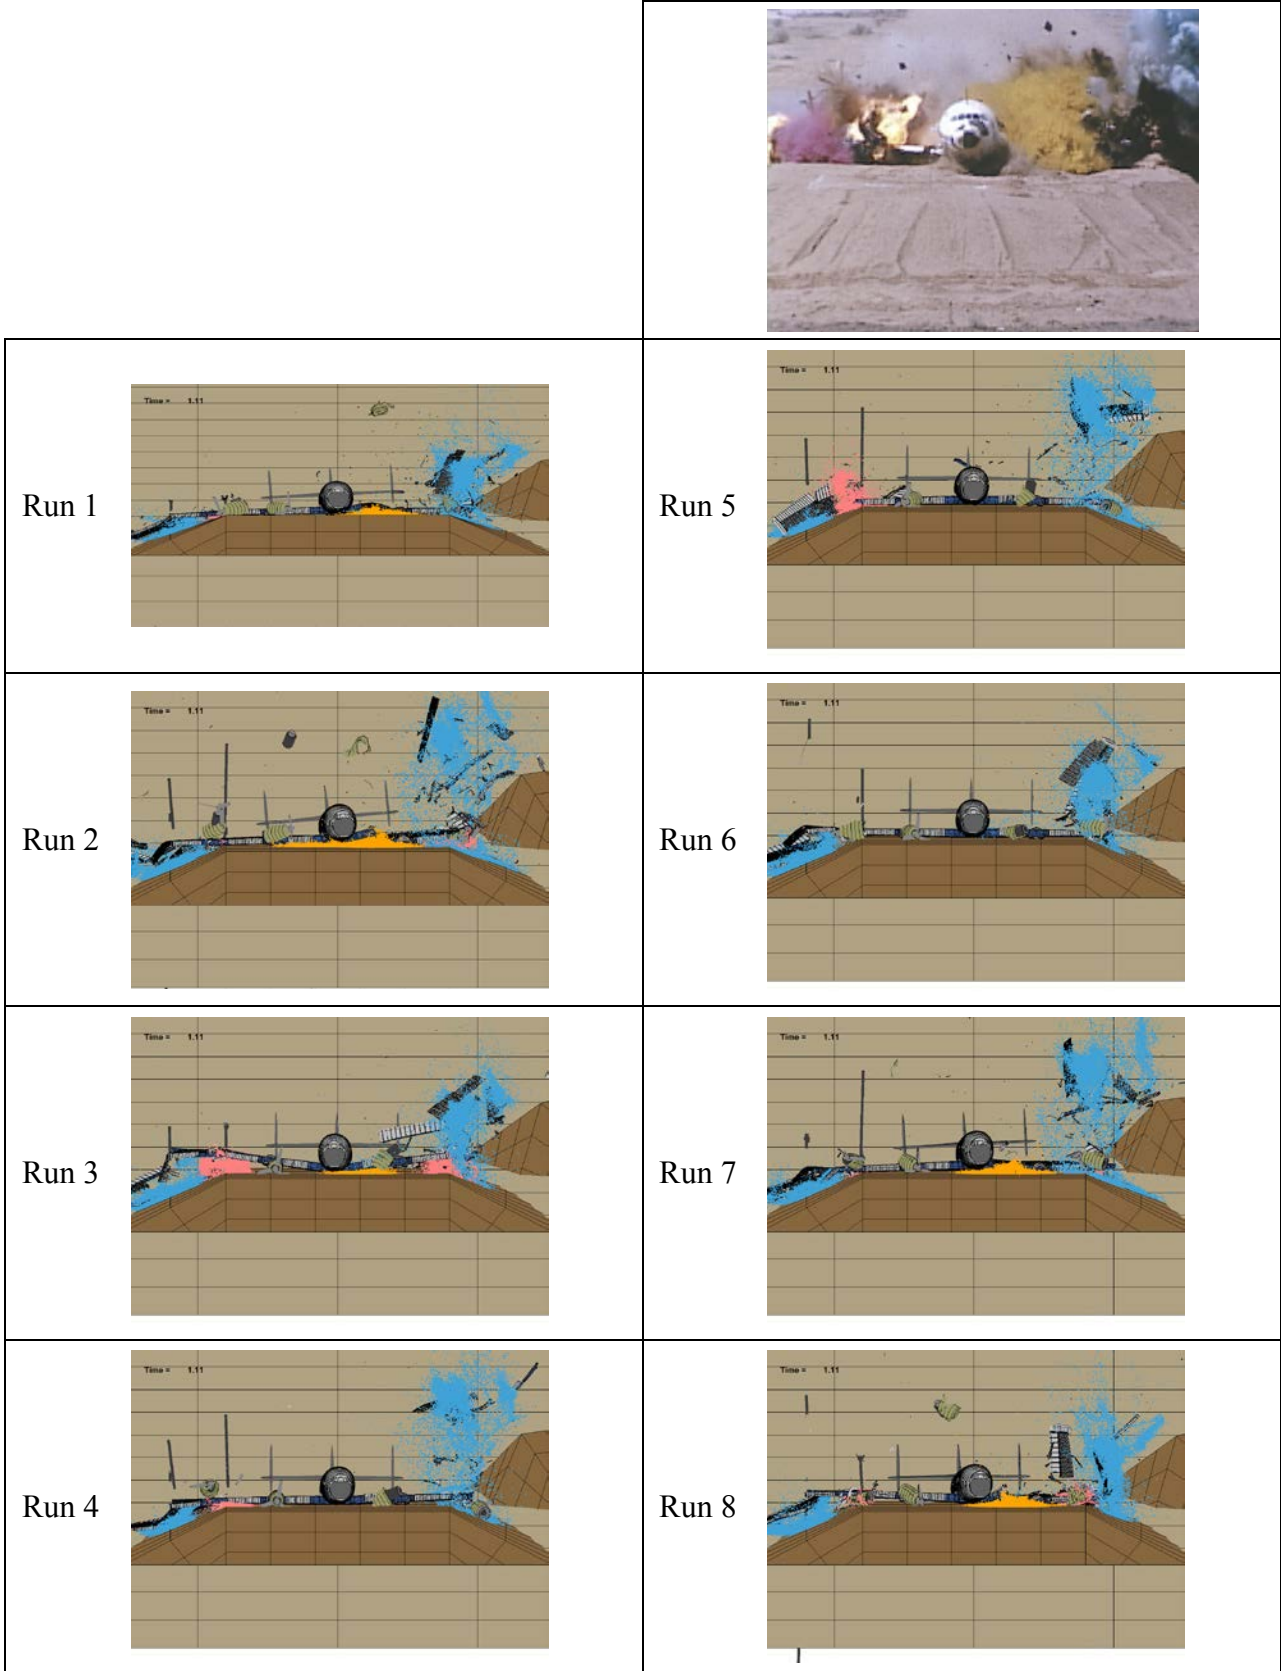
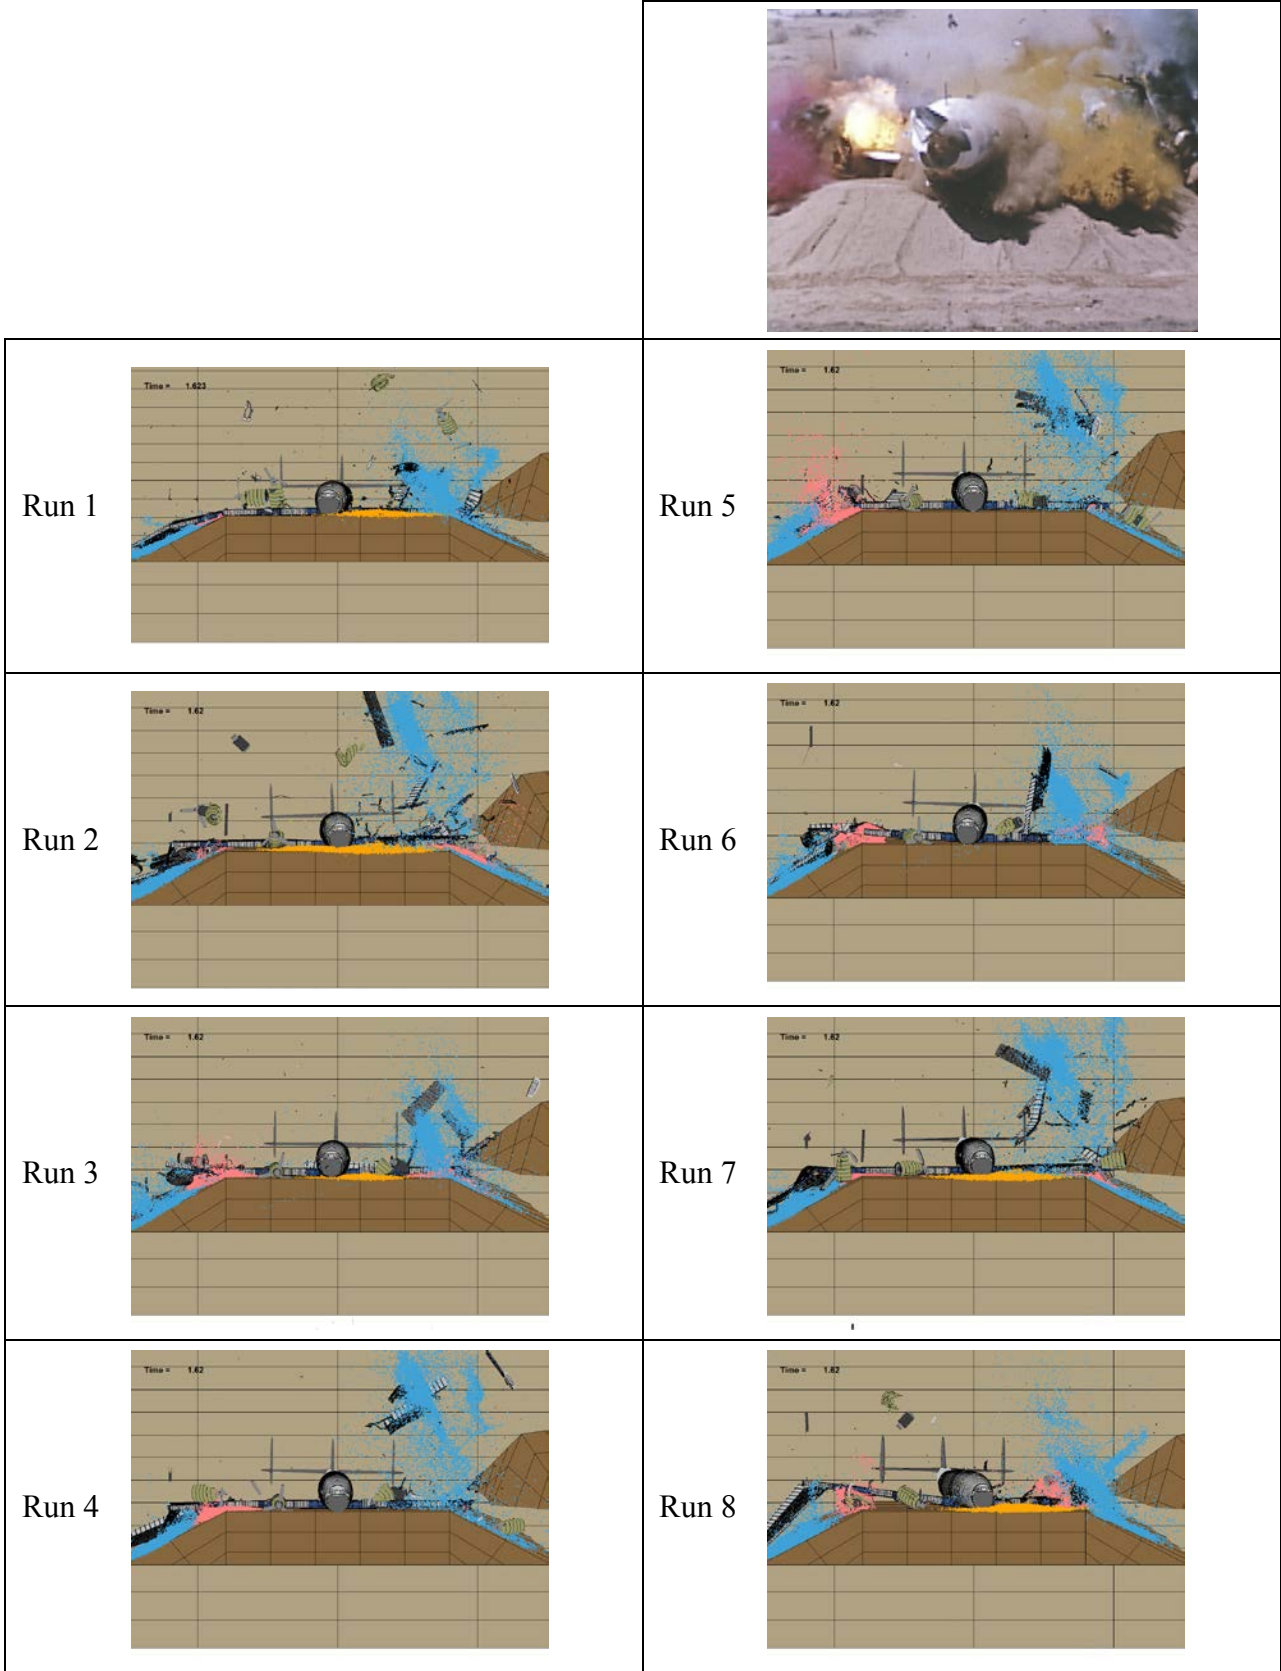
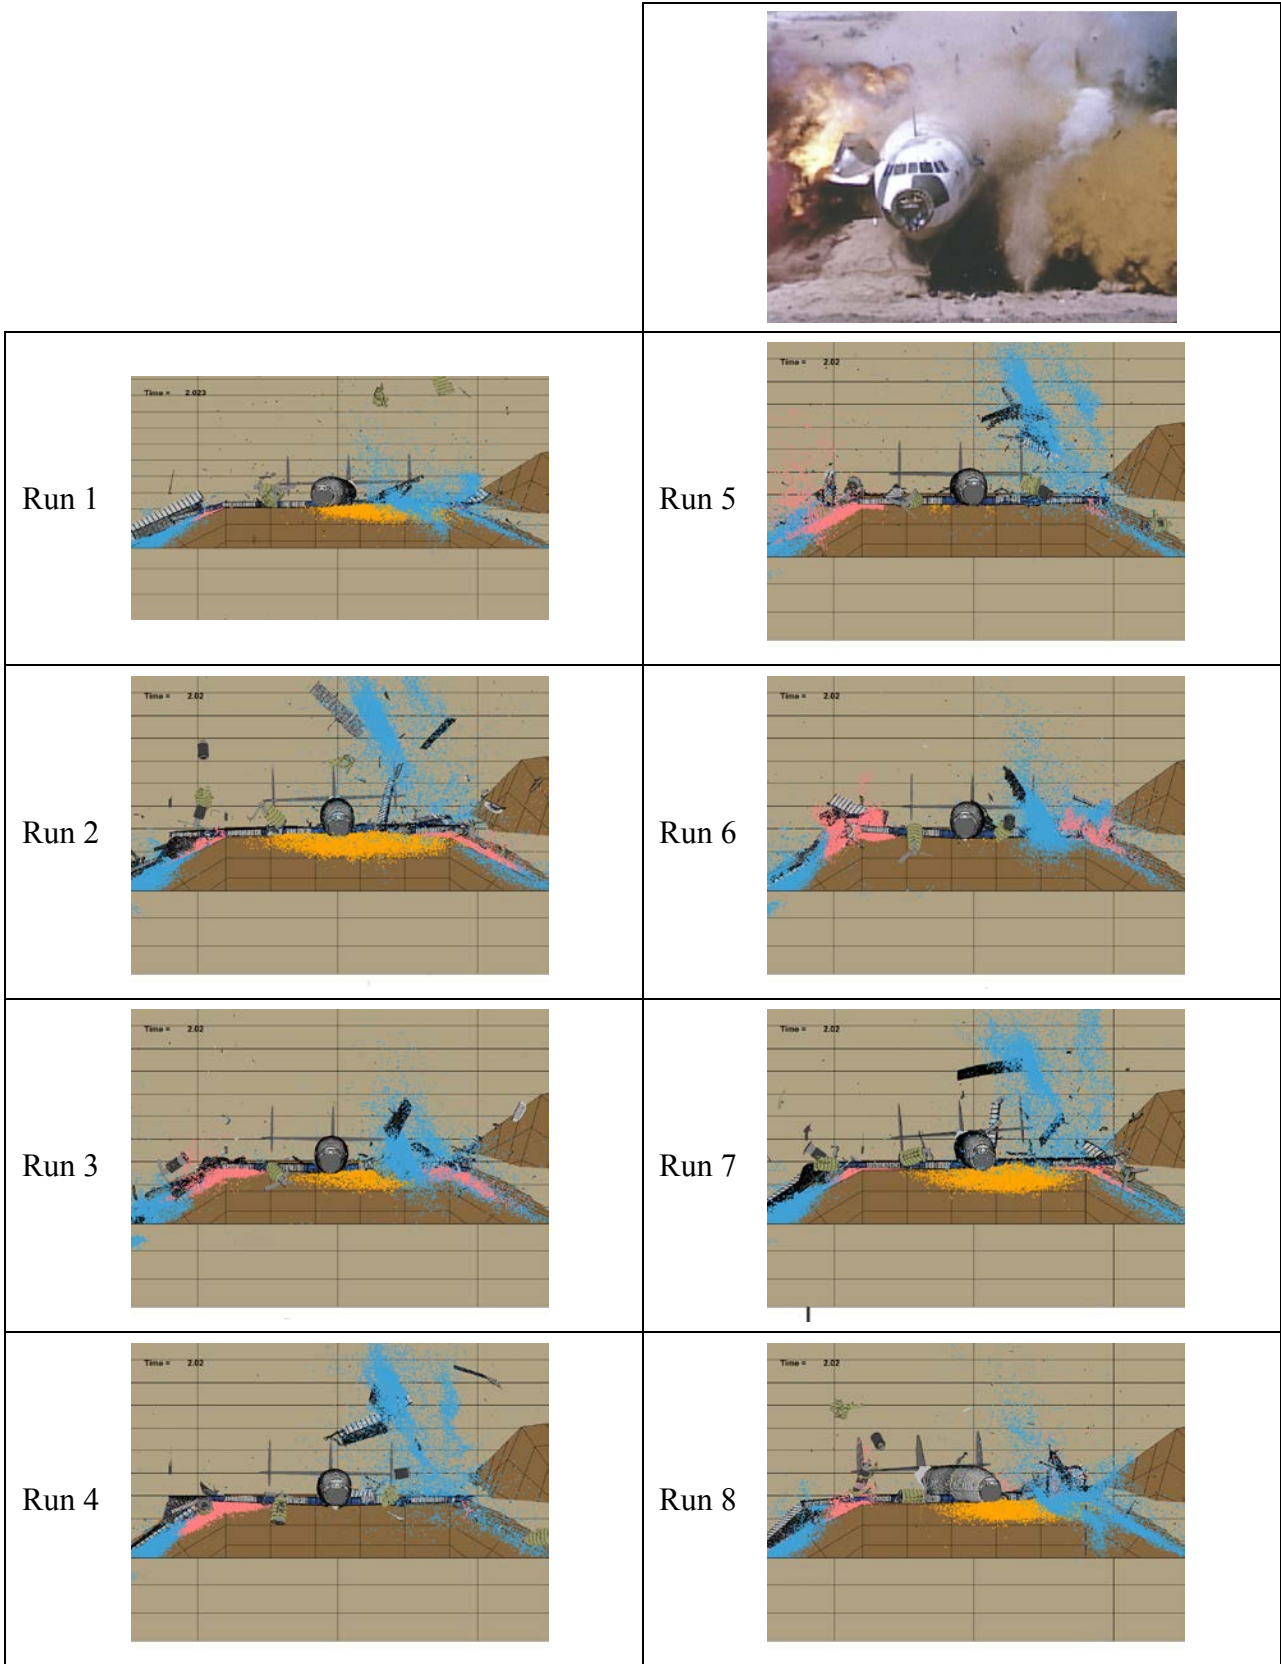
In the front view of the crash test (figures 35 through 40), the initiation of leakage from Tank 5 (water dyed yellow) is shown in the first figure and large plumes are released subsequently. The release of water at 1.045 s is only observed in the simulations when the inboard port engine impacts the wing in Runs 1, 2, 7, and 8 and is, therefore, the likely cause of the damage to the fuel tank. Note that in all cases, the blue dyed water was dramatically released from Tank 1 (outboard tank that impacts the soil barrier) as observed in the test. The fuselage yaw varied from run to run, but was, generally, in good agreement at 1.22 to 1.589 s when it first yawed to the port. Most cases then yawed to starboard in agreement with the test.

Figure 35. Crash Test Comparison (front view)—Time = 1.045 s

Figure 36. Crash Test Comparison (front view)—Time = 1.220 s

Figure 37. Crash Test Comparison (front view)—Time = 1.589 s

Figure 38. Crash Test Comparison (front view)—Time = 1.904 s

Figure 39. Crash Test Comparison (front view)—Time = 2.417 s

Figure 40. Crash Test Comparison (front view)—Time = 2.808 s

It is not clear from the high-speed photography or from the test report [5] whether there was a significant impact of the outboard engine with Tank 3. It is very possible, as the engine was tumbling in the high-speed photography ahead of the wing, see figures 36 and 37, but it quickly became shielded from view in a cloud of debris, see figure 38. The gelled water’s initial release was caused by some combination of the telephone pole impact and/or the engine nacelle and

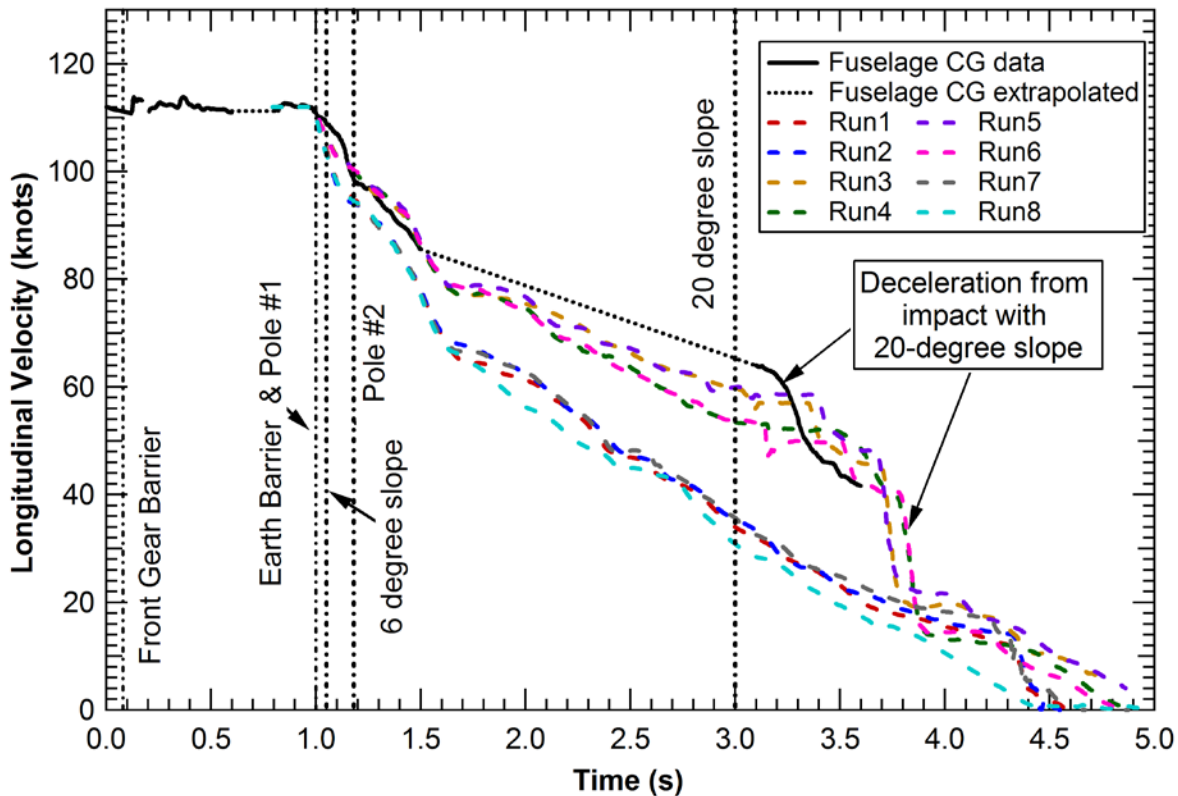
Acceleration data from the onboard instrumentation were also compared. Figure 41 shows a comparison of the velocity-time history at the aircraft's center of gravity. Experimental data from an accelerometer placed on the fuselage floor at the center of gravity were digitized and integrated. Only certain time periods were available from the test report [5] so the velocity was linearly extrapolated as shown in figure 41. Also shown are the times at which each significant event occurred in the crash sequence.

Figure 41. Comparison of the Velocity-Time History at the Aircraft's Center of Gravity

The fuselage deceleration around the time of the initial impact events, 1.0 to 1.5 s, with telephone poles and earth barriers was, generally, in good agreement. The best agreement was for Runs 3 through 6, which all have the lower bound for the ground friction coefficient. The sharp deceleration observed at approximately 3.2 s in the experiment and 3.7 s in Runs 3 through 6 was from impact with the 20° slope. The runs with the upper bound for friction with the ground do not fully reach the 20° slope, as shown in figure 42. In fact, the lower bound still appears to be too high since the aircraft engages with the 20° slope roughly 0.5 s sooner in the test, indicating that it was traveling at a greater average speed while sliding up the 6° slope. A value 10%-15% lower would likely yield the best comparison.

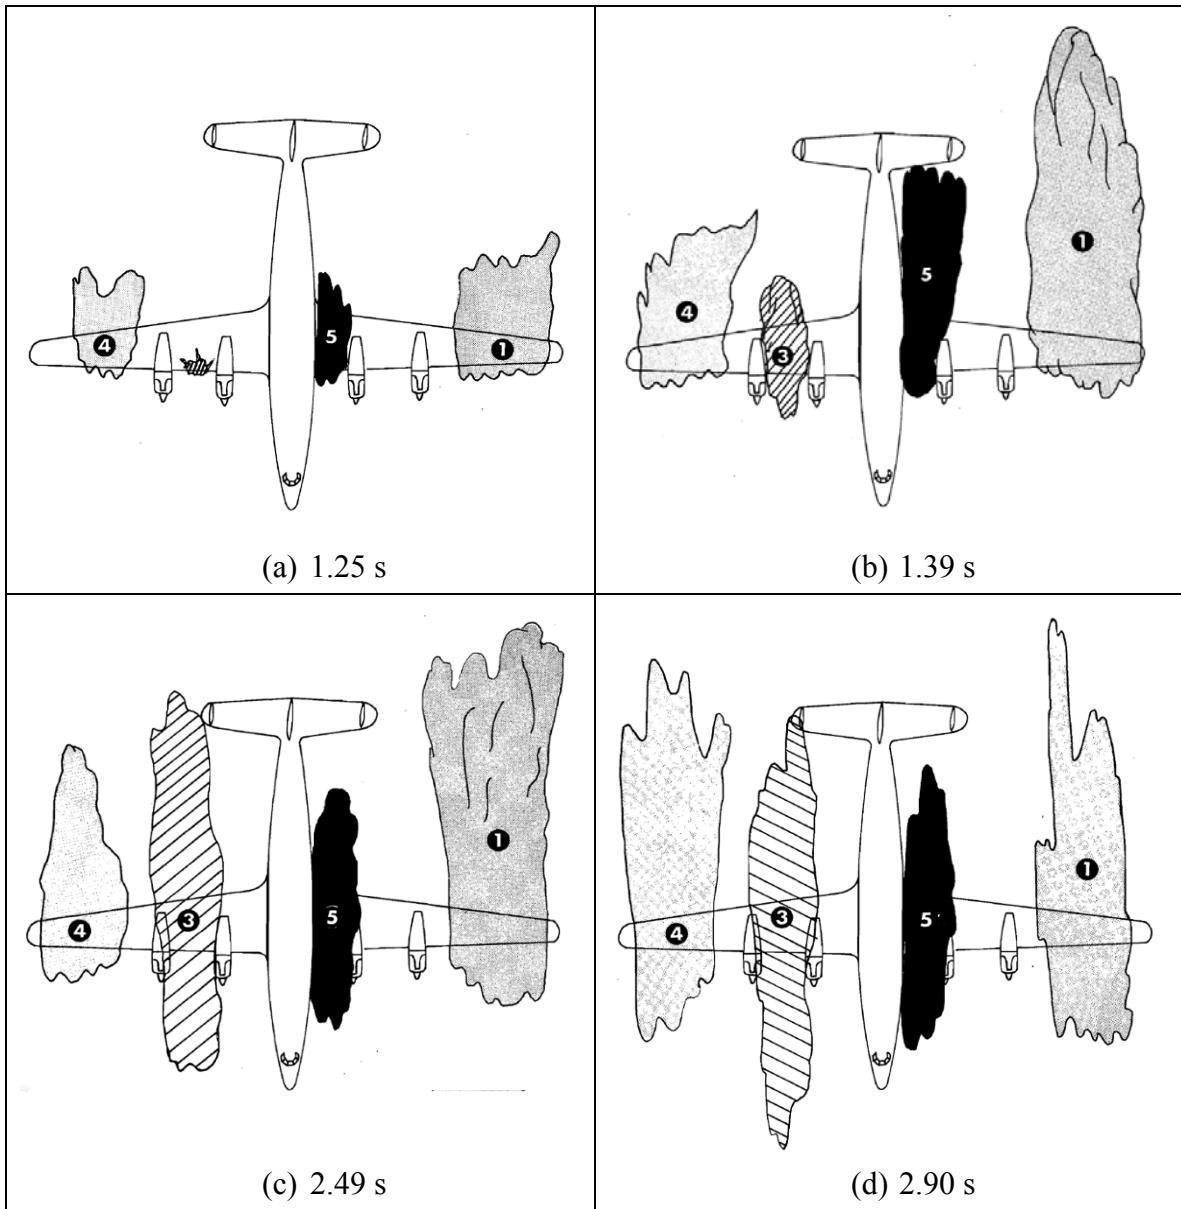
Figures 43 through 51 show a comparison of liquid dispersed during the crash. The sketches in these figures are from the test report [5]. It should be noted that the times indicated in the sketches have been modified from the test report [5]. The first image, figure 43(a), shows fuel spillage due to impacts with both telephone poles and was labeled with a test time of 1.0 s in the test report [5]. This cannot be accurate since impact with the second telephone pole does not occur until sometime after 1.09 s, as shown in figure 19 of the test report [5]. It was estimated that the first sketch occurred at 1.25 s. At this time, the first evidence of the red gelled water was observed in the high-speed photography. The times for all subsequent sketches were, therefore, increased by the same 0.25 s from that listed in the test report [5].

Figure 43. Sketches of Fuel Spillage Documented From High-Speed Photography of the L-1649 Full-Scale Crash Test [5] (Times shown are after main gear impact.)
