**DOT/FAA/TC-12/43**

# **Crash Simulation of Transport Aircraft for Predicting Fuel Release**

## **First Phase—Simulation of the Lockheed Constellation Model L-1649 Full-Scale Crash Test**

Final Report

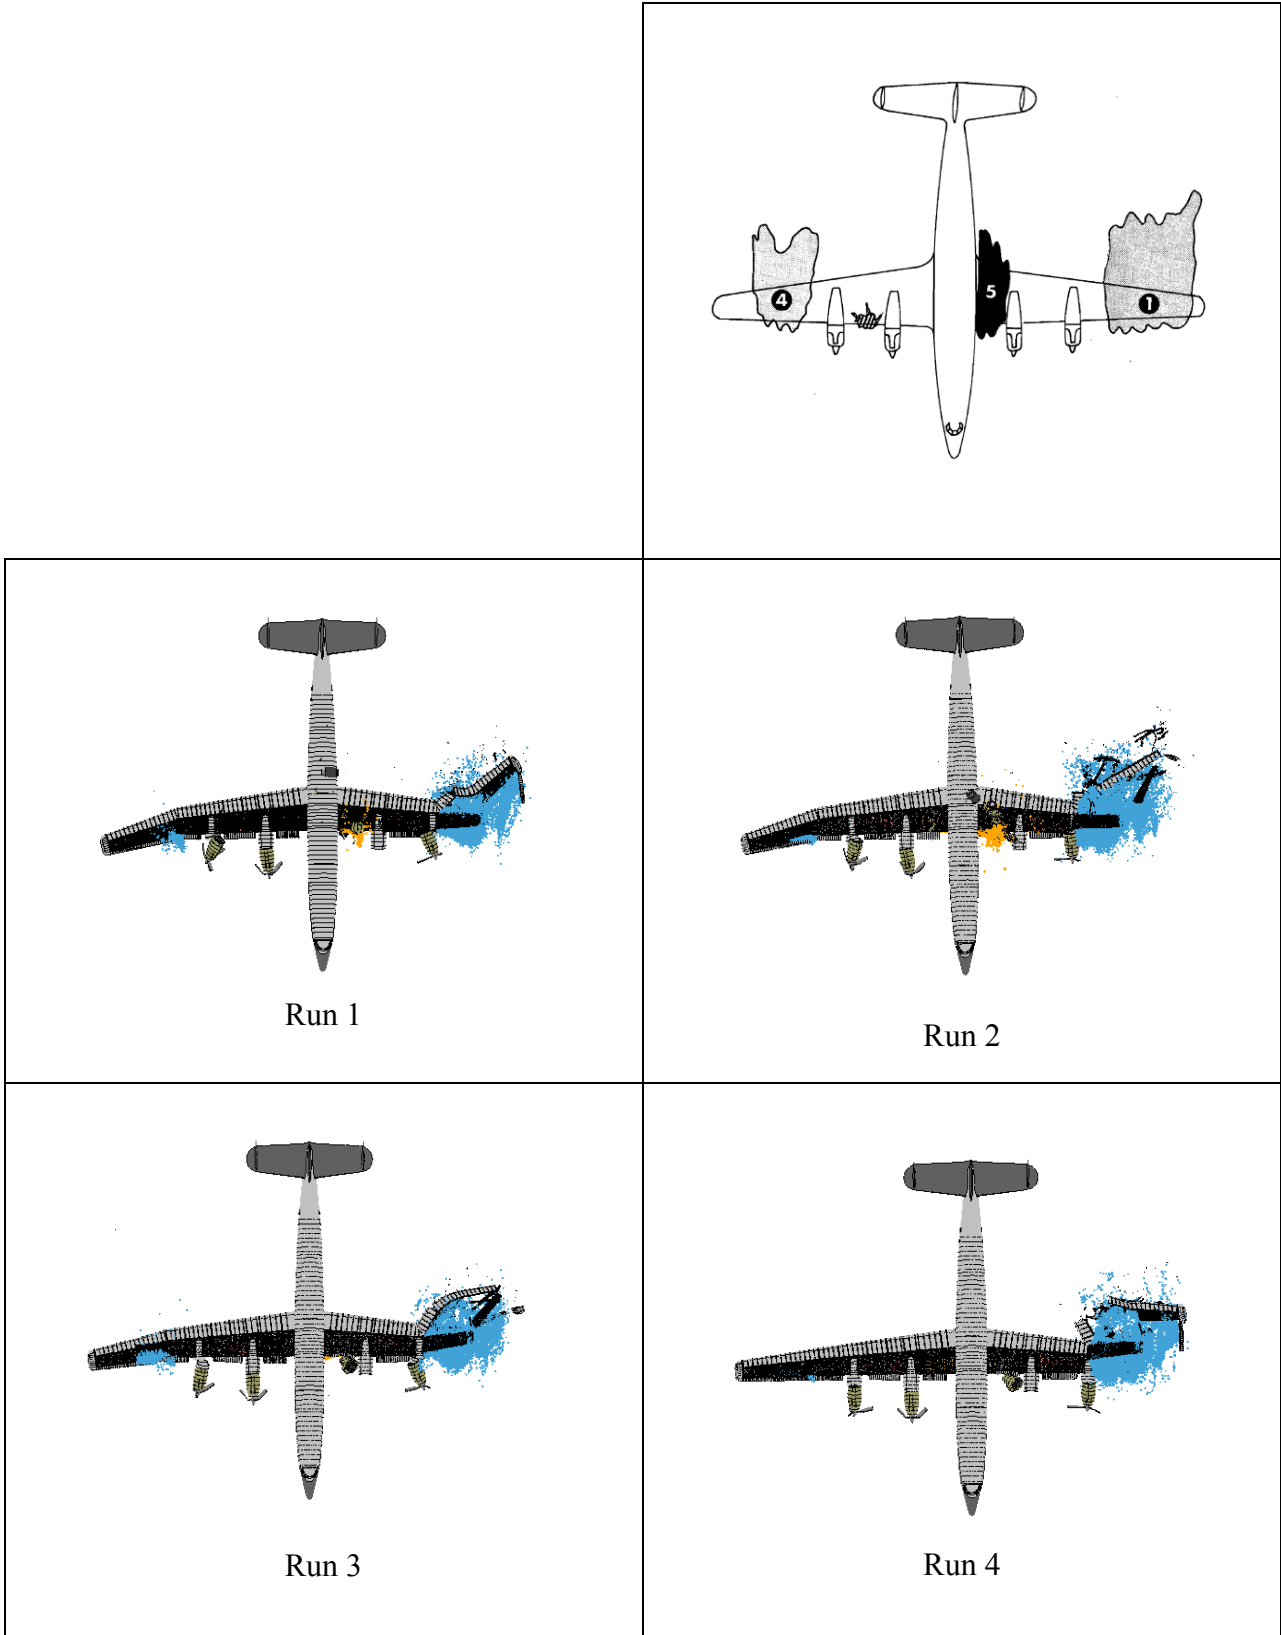
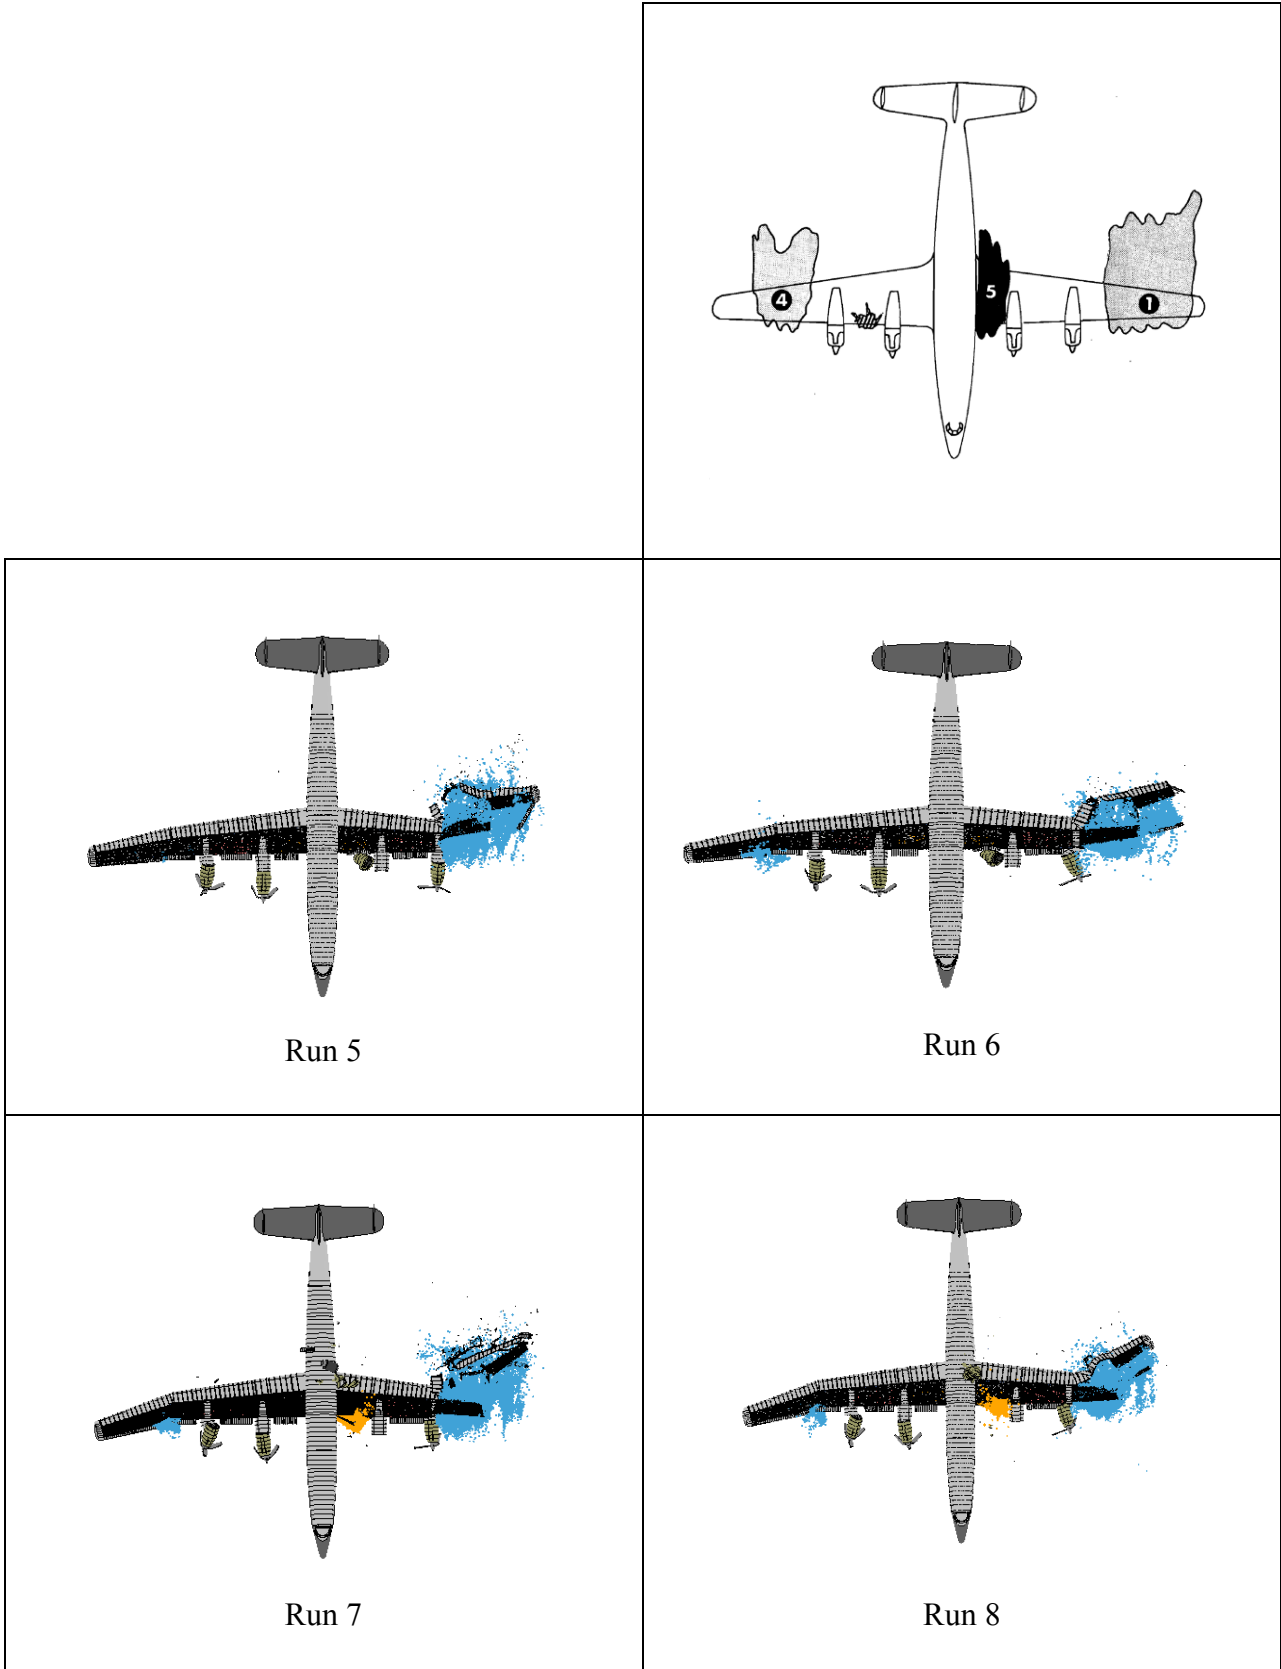
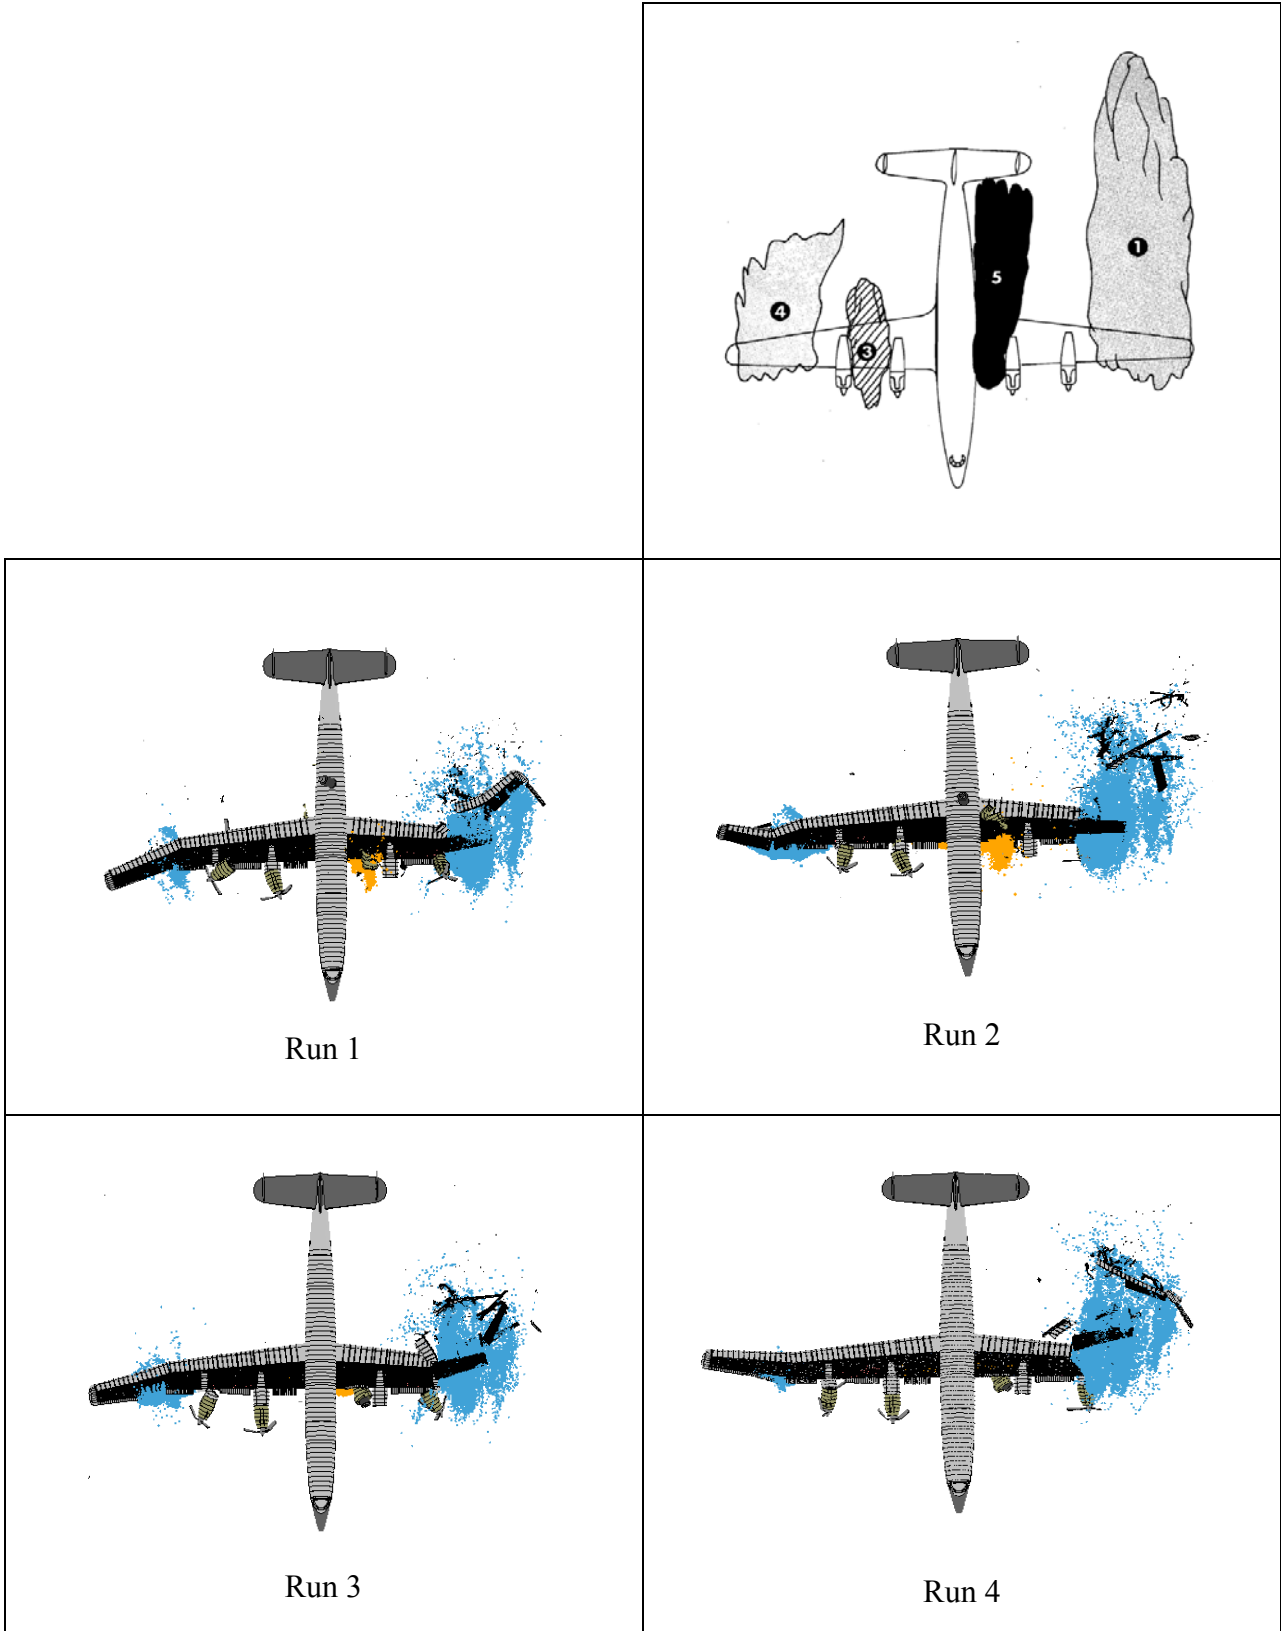
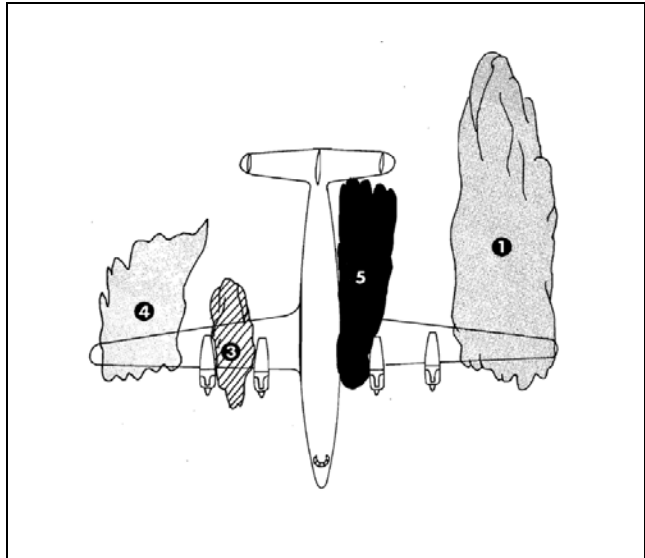
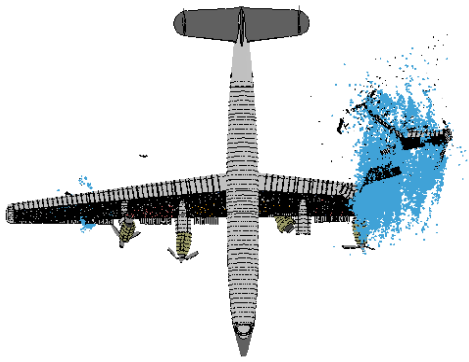
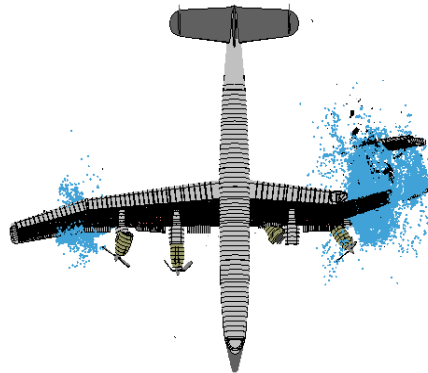
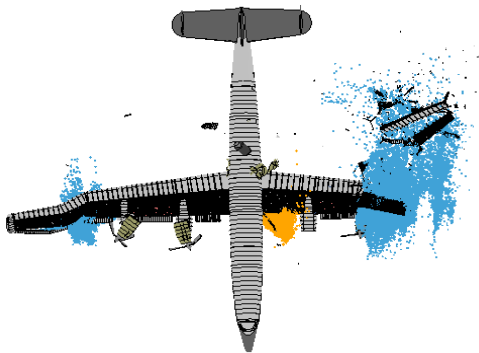
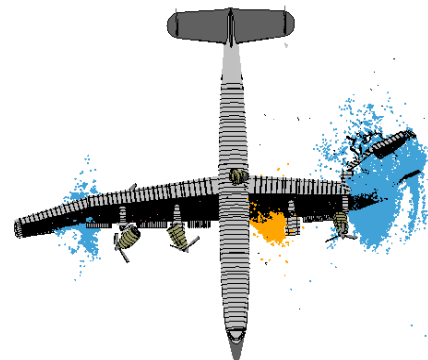
Liquid was expelled from the wing and extended backward in a plume from the impact loads (in the simulation) in addition to the aerodynamic drag in the test. The drag was not included in the simulation. Therefore, in general, the plume was observed to extend further back behind the wing in the sketches. The plume from Tank 1, which was dominated by the impact with the earthen barrier, looks very similar until the plume is significantly spread out by aerodynamic drag. Except at 2.90 s, where the liquid trailing behind the aircraft was observed to extend out further than in the sketches. This was because some of the liquid that was visible in these images had been stopped by hitting the ground. It is unlikely that this fuel was part of what was included in the sketch.

Liquid was also observed to extend out in front of the wing due to wing damage and the aircraft's deceleration. The liquid was ejected forward due to its momentum that was no longer contained by the decelerating tank. There are many similarities in the sketches, depending on the run. As the crash event progressed, the liquid progressively extended further out from the wing than in the sketches for many simulations. This was likely caused by the greater deceleration in the simulations.

Figure 44. Fuel Spillage—Time = 1.25 s (Runs 1-4)

Figure 45. Fuel Spillage—Time = 1.25 s (Runs 5-8)

Figure 46. Fuel Spillage—Time = 1.39 s (Runs 1-4)

Figure 47. Fuel Spillage—Time = 1.39 s (Runs 5-8)

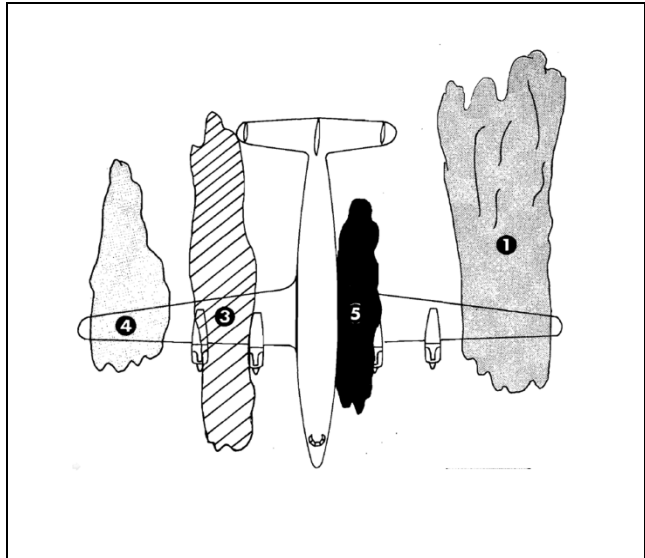
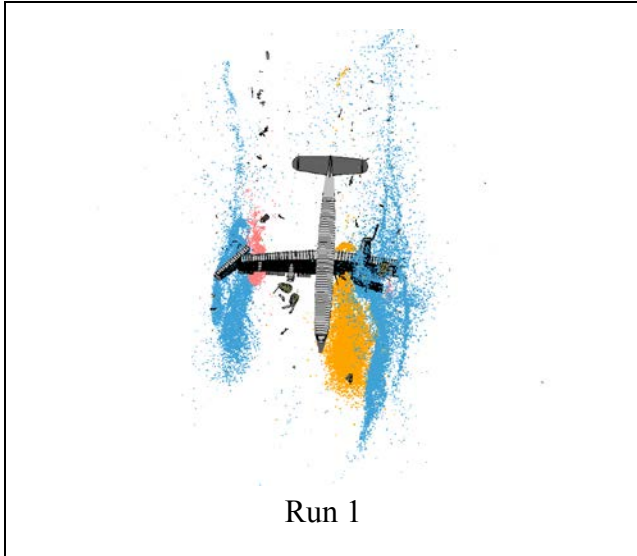
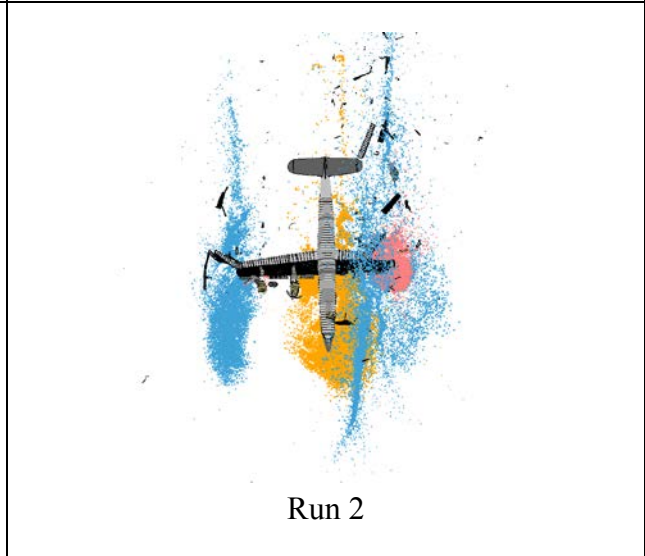
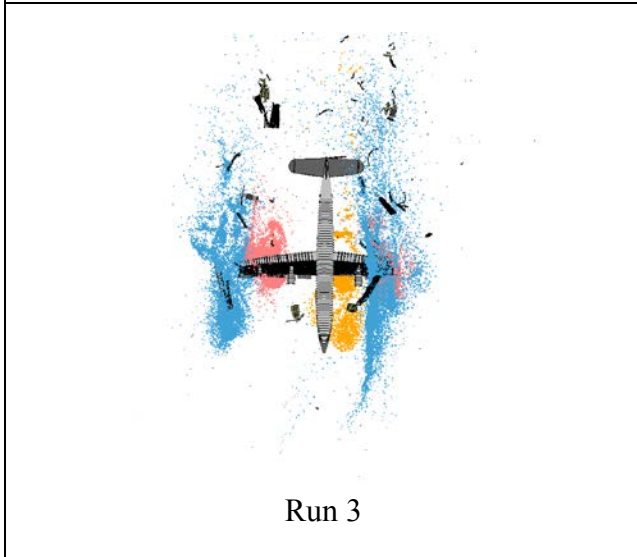
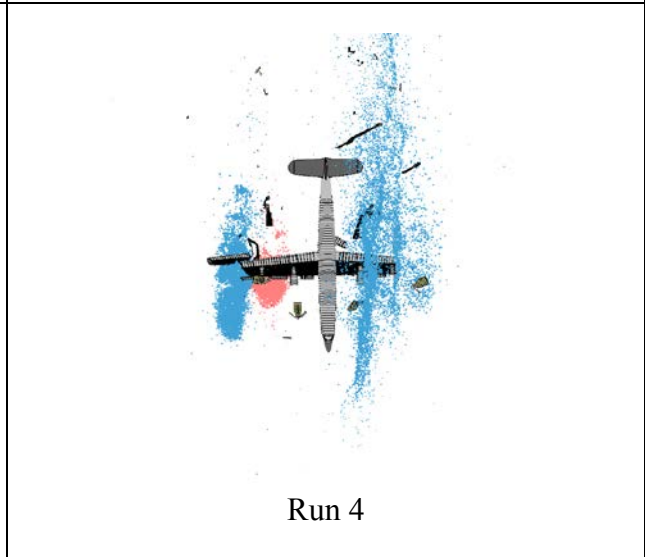
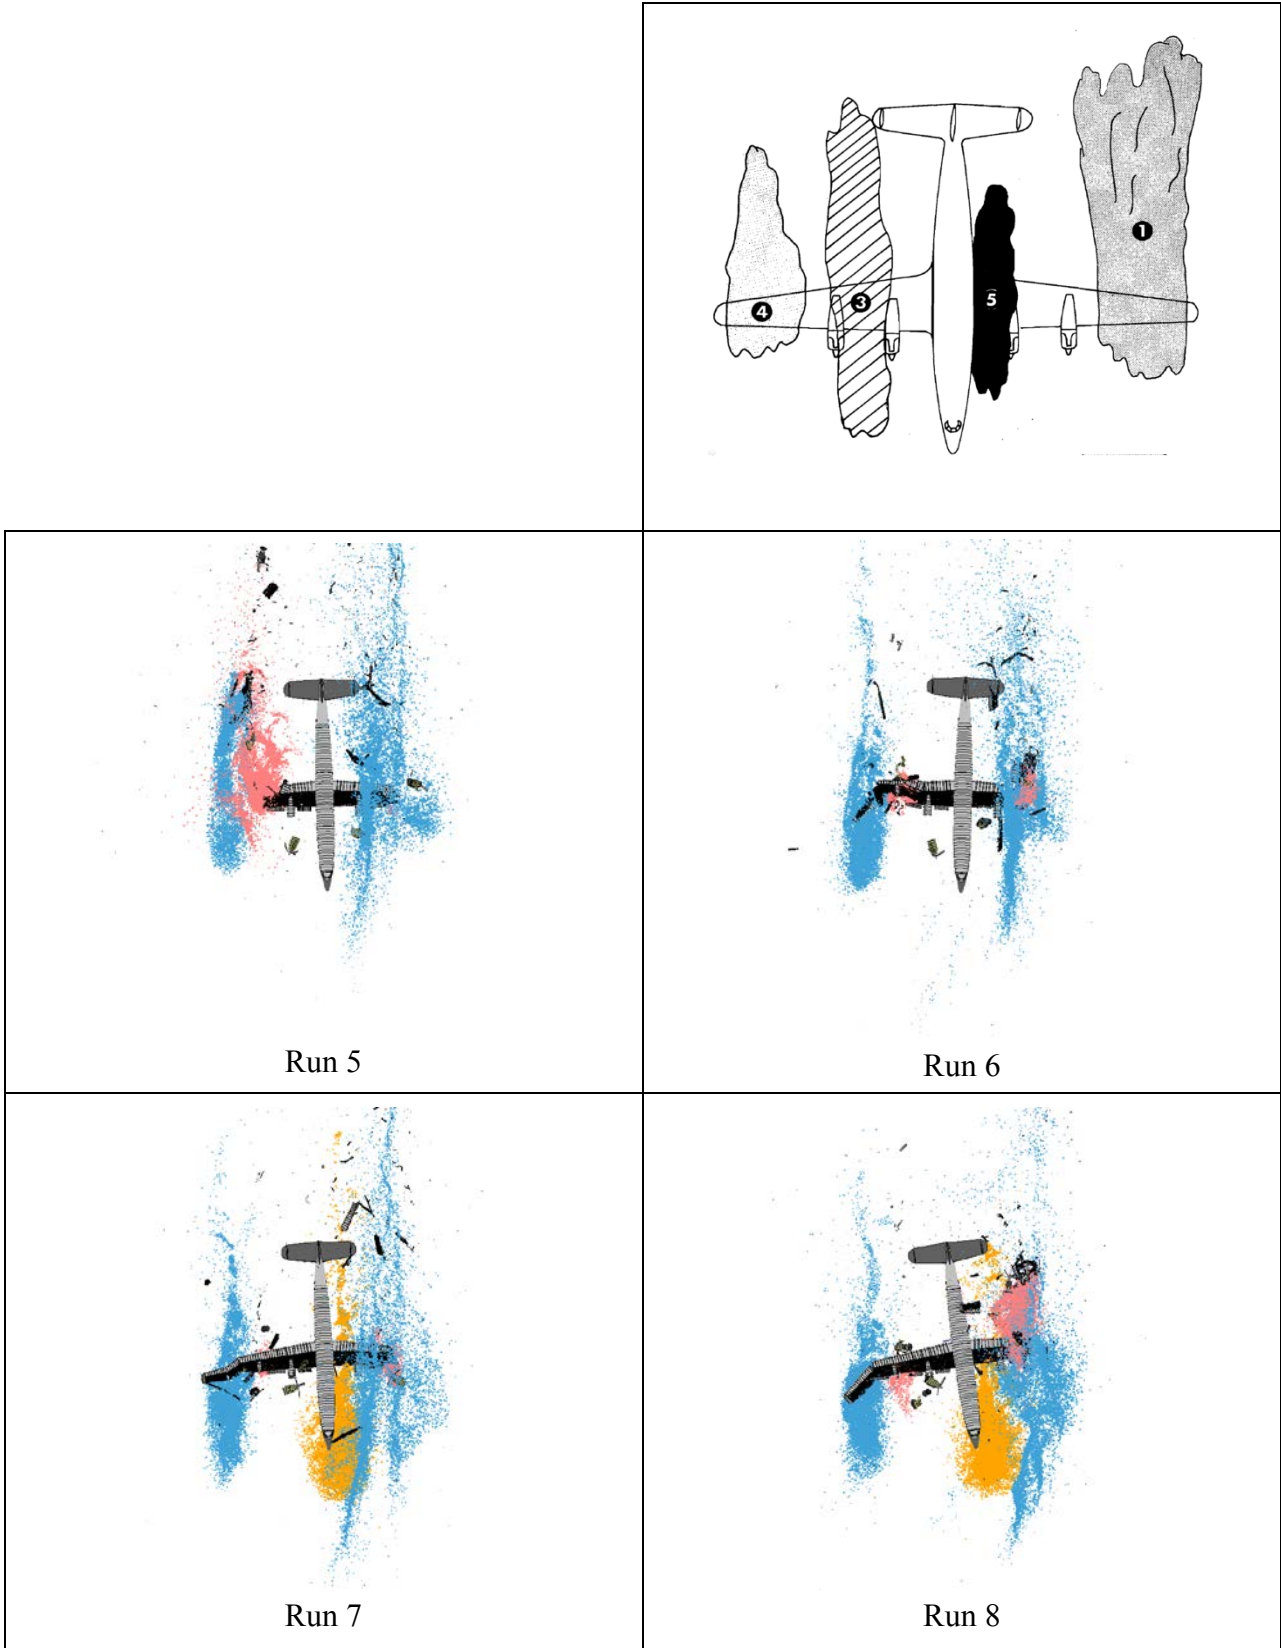
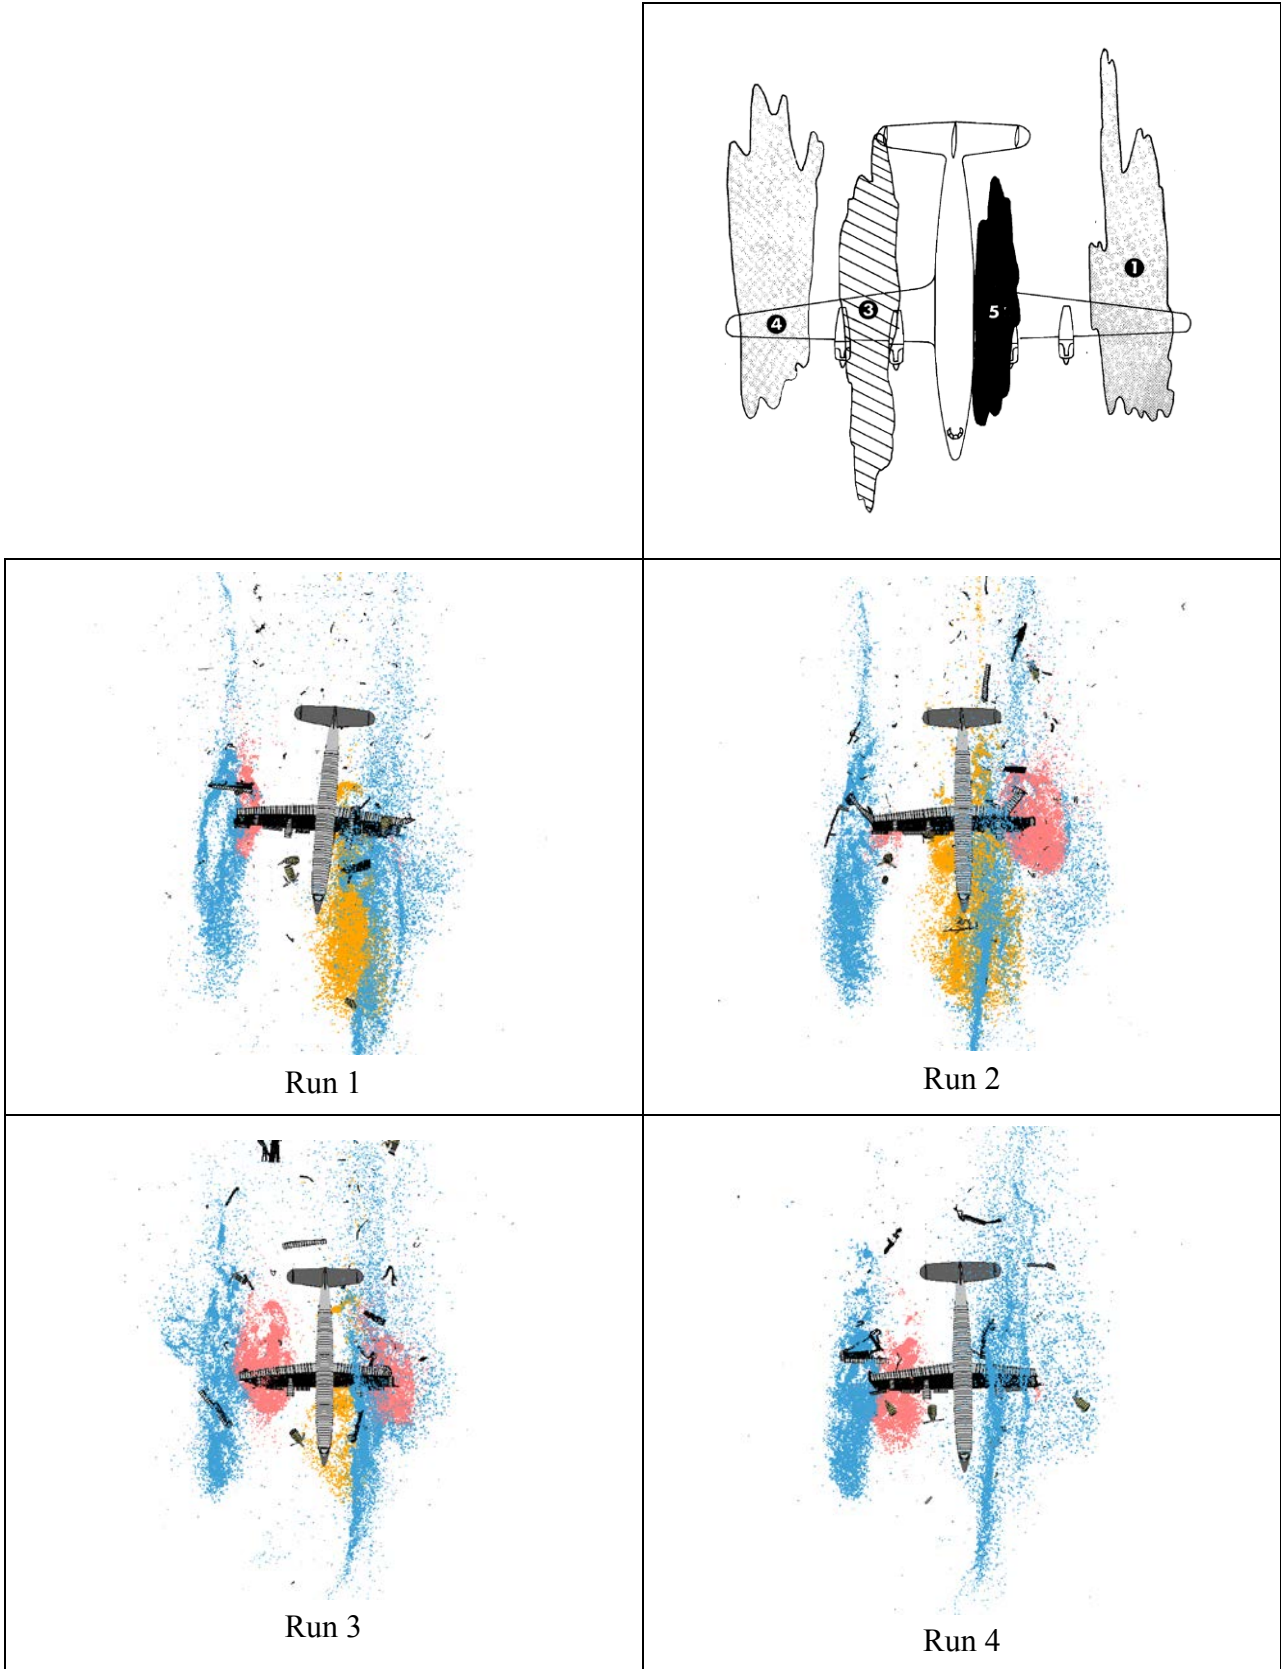
Figure 48. Fuel Spillage—Time = 2.49 s (Runs 1-4)

Figure 49. Fuel Spillage—Time = 2.49 s (Runs 5-8)

Figure 50. Fuel Spillage—Time = 2.90 s (Runs 1-4)

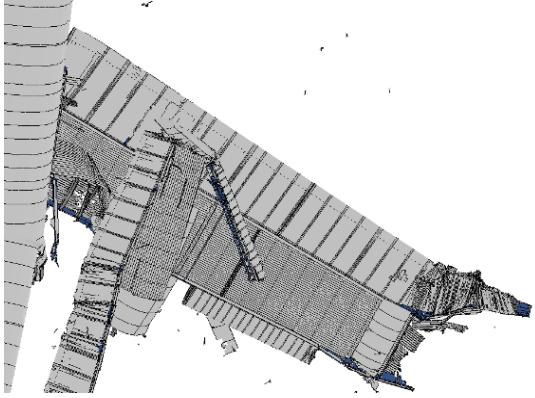
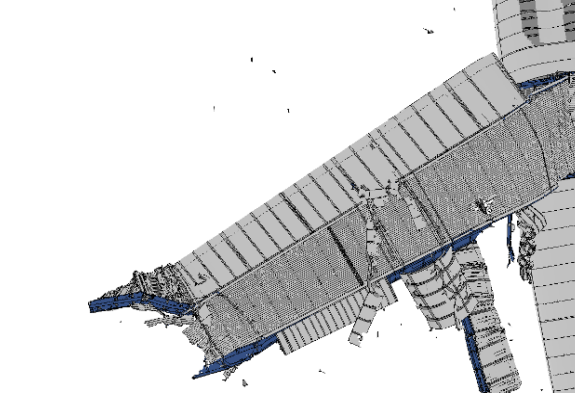
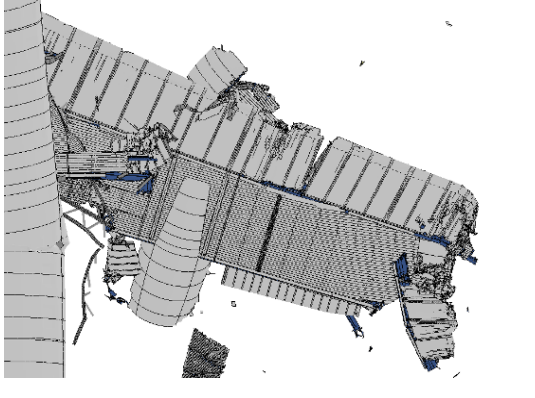
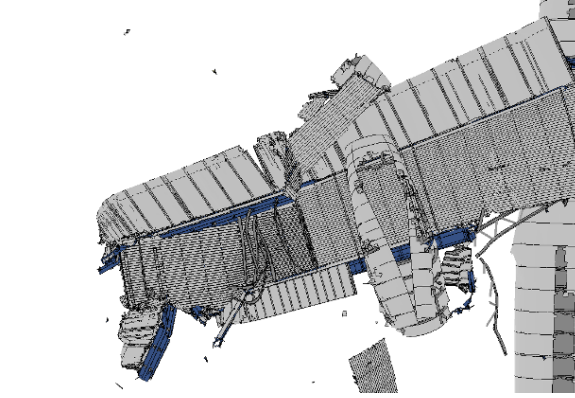
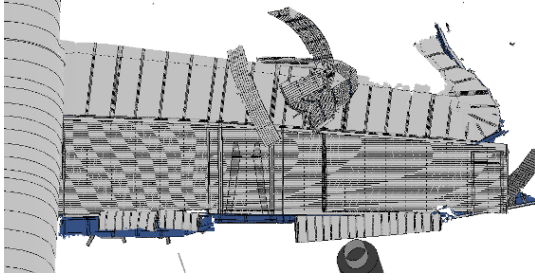
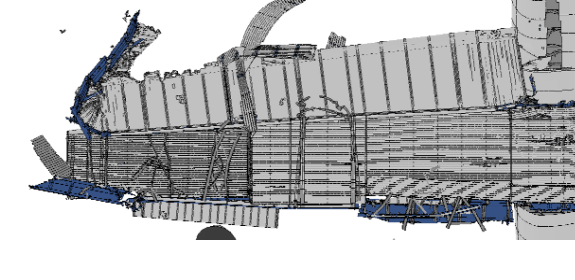
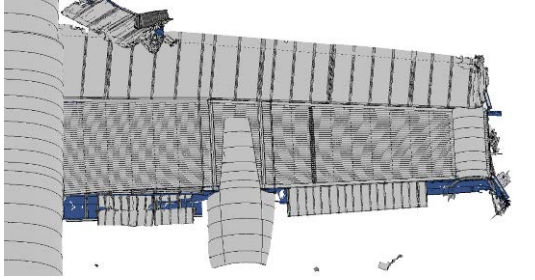
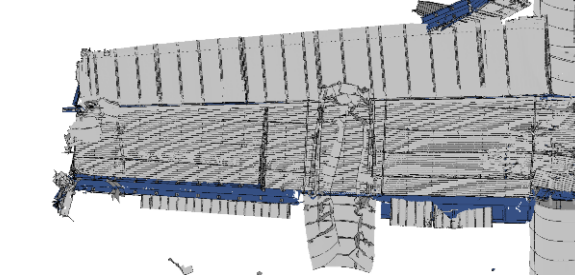
Table 9. Damage to Left (port) Wing—Runs 1-4

Tables 9 and 10 show the simulated damage to the left wing at the time the aircraft came to rest in the simulation. Keeping in mind that the impact conditions with the 20° slope were significantly different for half the runs, the similarities are quite good. For various runs, the wing was broken off at the root, as in the wreckage. This only occurred in the simulations when the inboard engine impacted the wing catastrophically. The portion of the wing outboard of the outboard engine nacelle was similarly completely removed. In some runs, the wing was compromised between the two engine nacelles, which was inconsistent with the test. However, this only occurred again from a large engine impact to the wing between the engines.

An engine impact was also consistent with the degree of reported damage to the wing, as shown in figure 52 in which the wing outboard of the inboard engine nacelle is completely failed. Simulated results also show this type of damage for runs in which there was significant engine impact with the wing, as shown in tables 9 and 10.

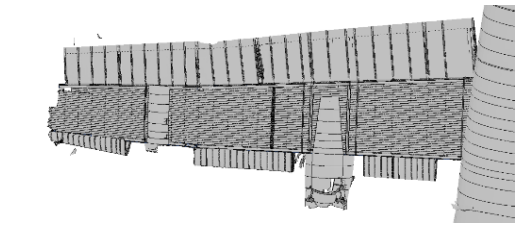
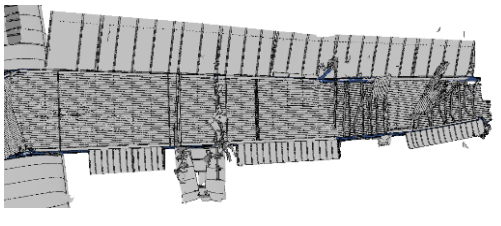
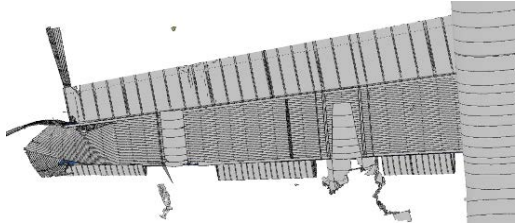
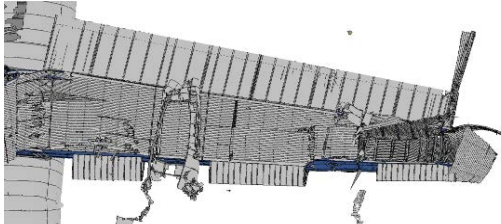
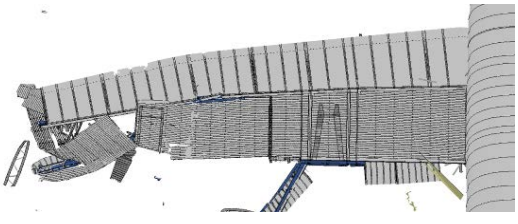
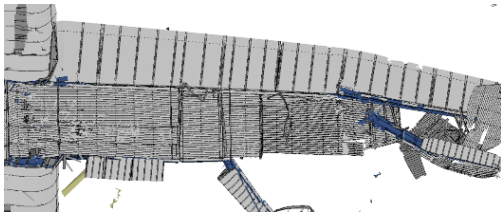
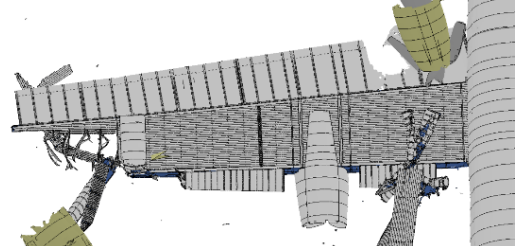
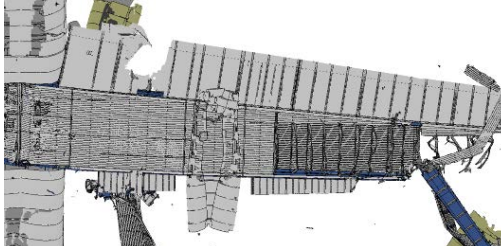
Table 11. Damage to Right (starboard) Wing—Runs 1-4

The right (starboard) wing in the wreckage was still attached at the root, but was compromised roughly halfway between the engine nacelles. A wing portion outboard of the impact point with telephone pole 1 appeared to be largely intact. Simulated damage to the right wing is shown in tables 11 and 12. In all runs, the wing root remained attached to the fuselage, albeit with varying levels of damage. The wing was also completely compromised or severely damaged between the two engine nacelles. Most runs also had a severed outboard wing segment with varying levels of damage.

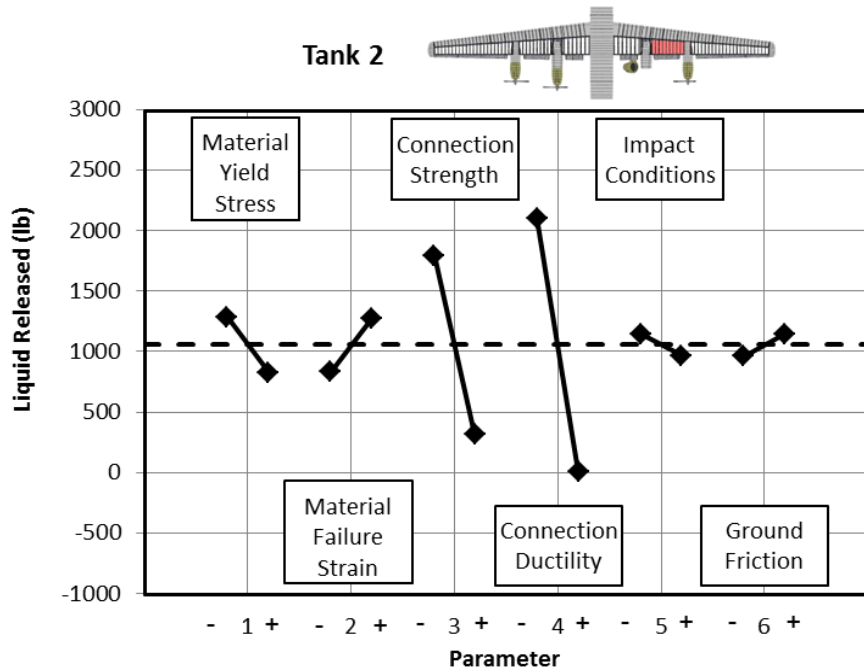
Figure 54. Main Effects Plot—Tank 2 Liquid Release at 1.79 s

To evaluate the relative effect of the various characteristics of the aircraft structure and impact conditions, a main effects plot was generated for the liquid released from Tank 2 at 1.79 s, as shown in figure 54. This time was selected because it preceded the catastrophic engine impact at 1.84 s in Run 8 so the release would not be affected by this unrealistic response. The strength and ductility of the connections have the largest effect on the gelled water release. As would be expected, the quantity of liquid released decreased as the strength and ductility were increased. The impact conditions and ground friction had a negligible effect on the liquid release, and material yield stress and strength had a small effect.

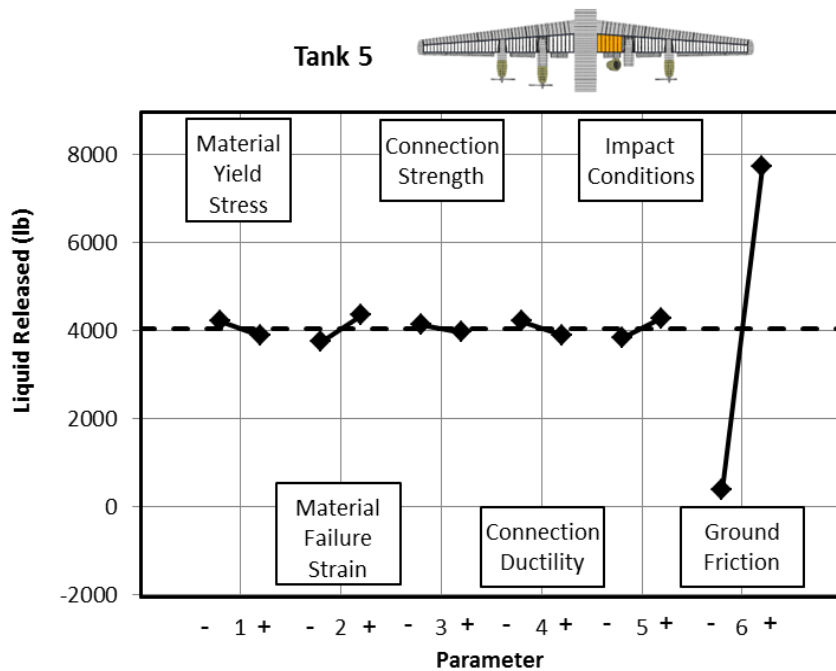
Figure 56. Main Effects Plot—Tank 5 Liquid Release at end of 6° Slope

The main effects for liquid release in Tank 5 are shown in figure 56 at the time the aircraft nose reached the end of the 6° slope. The dominant effect was friction with the ground. The reason this parameter had such an effect was that, for the high-friction runs, the engine was propelled back towards the wing at a much higher relative speed. The front spar and, frequently, the top skin were completely compromised, and fuel was released rapidly. This does not occur in any low-friction runs. Since the actual engine impact conditions are unknown because the impact event was obscured by debris in the high-speed photography, this event could not be simulated with any less uncertainty. Therefore, no further information can be gained.

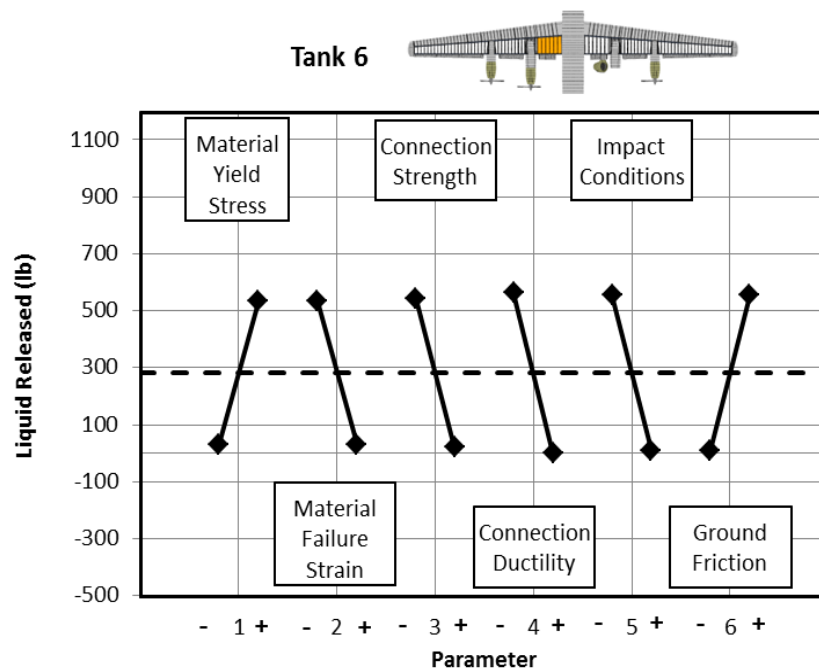
Figure 57. Main Effects Plot—Tank 6 Liquid Release at end of 6° Slope

The main effects for liquid release in Tank 6 are shown in figure 57 at the time the aircraft nose reached the end of the 6° slope. Since only one run had any significant release of water outside the wing, this plot provides little information. However, if the water that was released into Tank 7 was considered, those main effects are shown in figure 58. The impact conditions and friction with the ground have a significant effect on the release of water from the tank, second to the connection ductility. It is noteworthy that the release of water was reduced as the strength and ductility of the connections were increased.

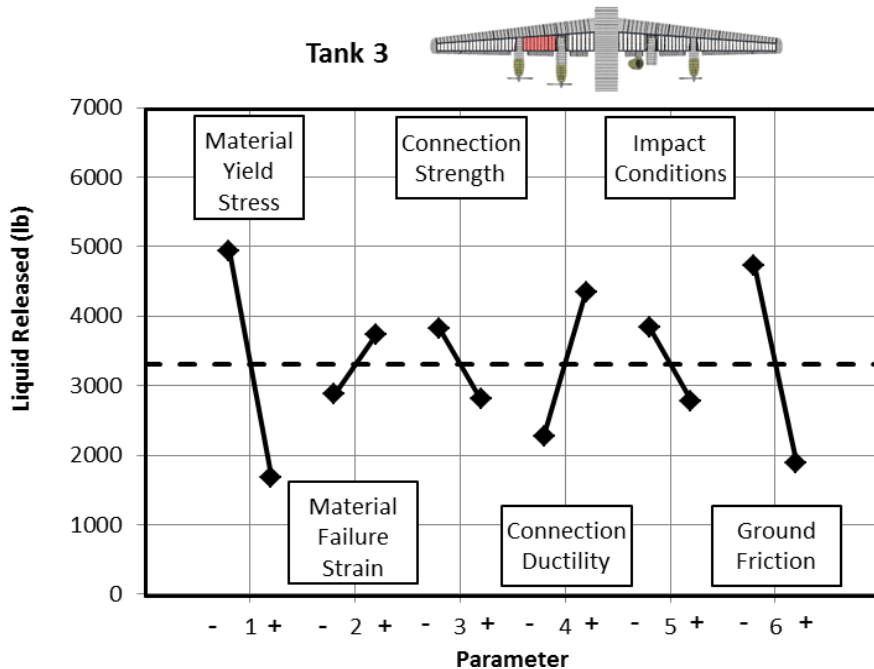
Figure 59. Main Effects Plot—Tank 3 Liquid Release at end of 6° Slope

The main effects for liquid release in Tank 3 are shown in figure 59 at the time the aircraft nose reached the end of the 6° slope. In several runs, Runs 3-6 and 8, the impact of the engine with the front spar dominated the release of liquid from this tank. In the other runs, there was either a small amount of damage or no impact at all. Because the impact conditions on this tank were not consistent between runs, the main effects plot provides little meaningful information.

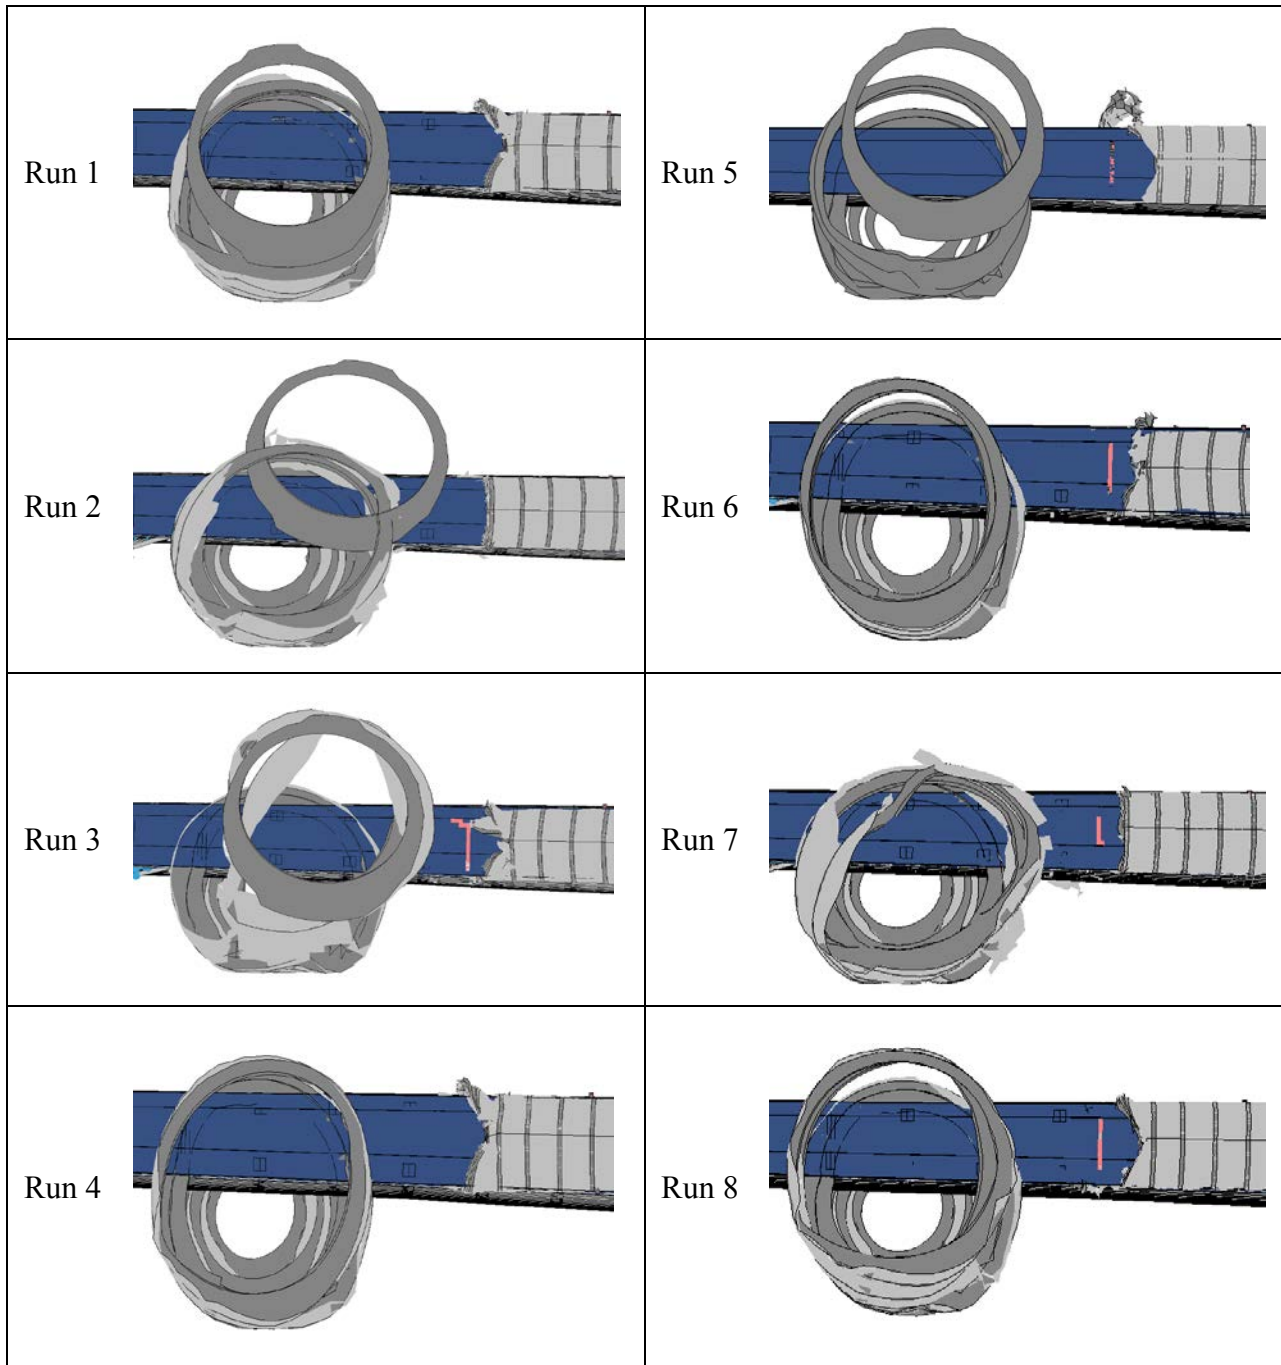
Figure 60. Simulated Damage From Inboard Telephone Pole Impact—Time = 1.250 s (view of wing leading edge with engine removed from view)

Figure 60 shows the simulated damage to the front spar shortly after impact with the inboard telephone pole. Note that there is a crack in the front spar in Runs 3, 5, 6, 7, and 8. Although such a crack would certainly release a small amount of liquid, consistent with the crash test, none is observed in the images because the crack size is too small to release the larger fluid particles used in the model. In no case is the spar severely damaged. And, as detailed in tables 14 and 15, there is no significant damage to the internal structures from the telephone pole impact. This result is consistent with that observed in the high-speed photography in which no liquid release is observed during the telephone pole impact, but it is observed once the wing hits the ground.

It is noteworthy that the runs in figure 60 that display spar damage are not the same set of runs with the lower bound for the strength of the telephone pole (Runs 2, 4, 5, and 7). This shows that the damage to the spar is significantly affected by more than just the telephone pole strength. Likewise, these runs are not the set for the lower bound on material strength or ductility. There is clearly a combination of factors affecting this result that may be compounded by varied damage to the internal structures that develops during the nacelle impact with the ground, which

occurs prior to the telephone pole impact. These effects on release of liquid cannot be quantified because of the overwhelming effect of the engine impact in many runs.

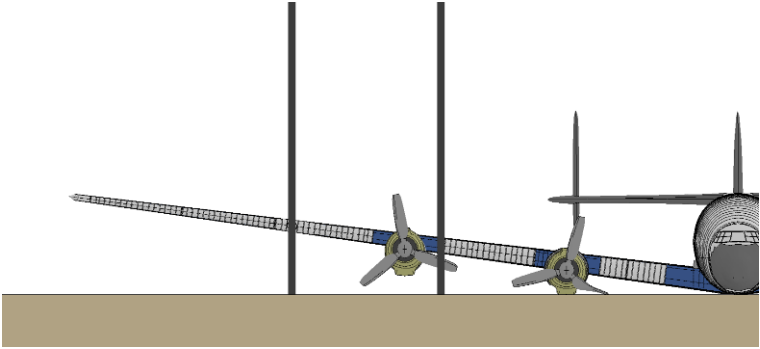
<p>1.10 s</p> <p>Telephone pole impacts Tank 4. Inboard nacelle impacts the ground. Fuselage nose begins to ride up the 6° slope.</p>

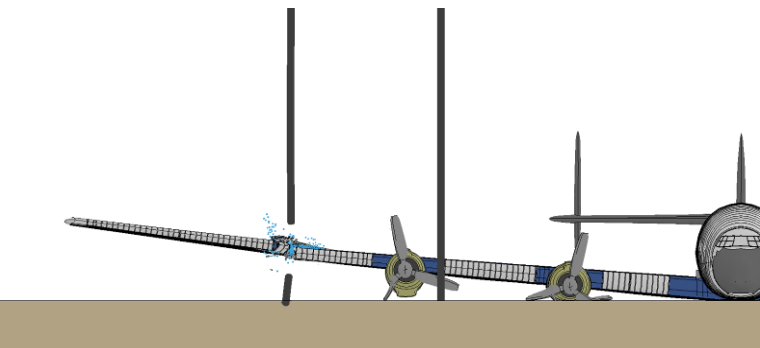
<p>1.19 s</p> <p>Outboard nacelle impacts the ground. Fuselage rides up the 6° slope. Wing begins to flex downward.</p>

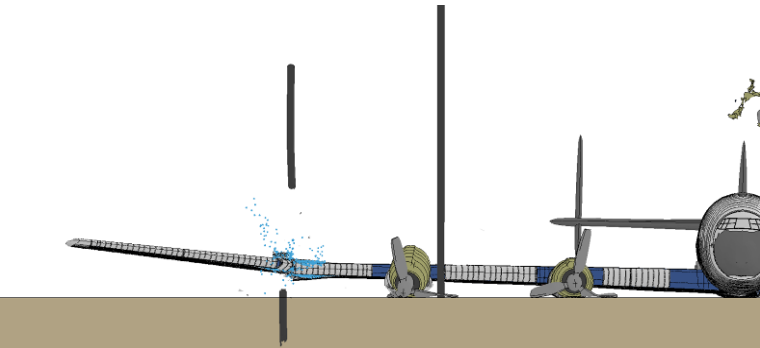
<p>1.30 s</p> <p>Fuselage rides further up the 6° slope, lifting the wing. Wing flexes downward, causing Tank 4 to impact the ground.</p>
