**DOT/FAA/TC-12/43**

# **Crash Simulation of Transport Aircraft for Predicting Fuel Release**

## **First Phase—Simulation of the Lockheed Constellation Model L-1649 Full-Scale Crash Test**

Final Report

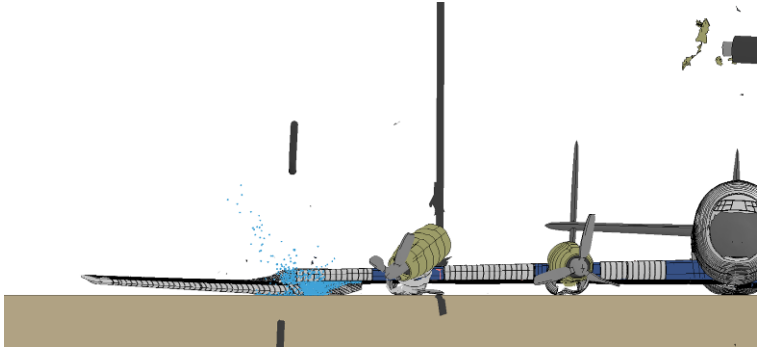
Figure 61. Impact of Telephone Pole 1 With Tank 4 (Run 1)—  
the 6° Slope was Hidden From View

Liquid release was measured at 1.10 s and 1.30 s, as shown in figure 61. At 1.10 s, the damage and water release was predominantly from the telephone pole impact. A top view of the wing damage and water release for each run is shown in figure 62 at 1.10s. At 1.30 s, the damage to the wing and subsequent water release was due to the flexing of the damaged wing. The main effects plots for liquid release in Tank 4 are shown in figures 63 and 64 at 1.10 s and 1.30 s, respectively. There are very different main effects shown.

<p>1.30 s</p> <p>Fuselage rides further up the 6° slope, lifting the wing. Wing flexes downward, causing Tank 4 to impact the ground.</p>

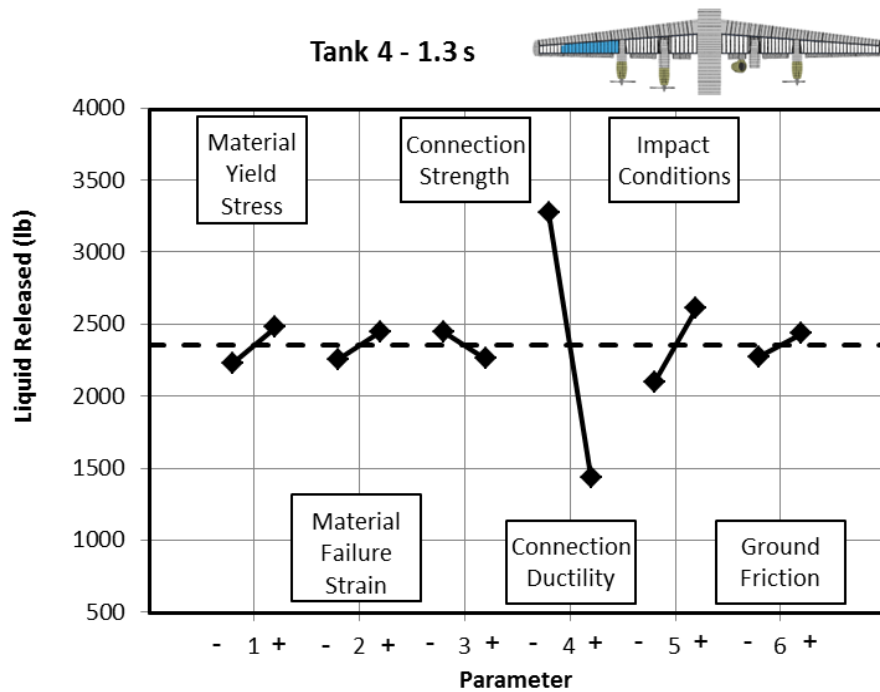
Figure 64. Main Effects Plot—Tank 4 at 1.30 s

At 1.30 s, shown in figure 64, the connection ductility has by far the most significant effect. Apparently, having more ductility in the wing where the connections do not fail greatly reduces the quantity released.

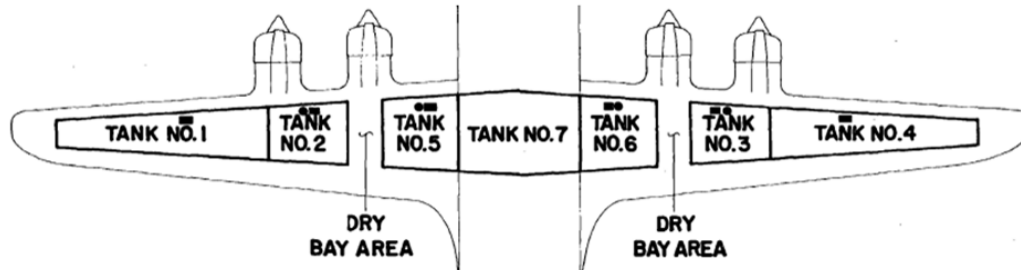
Figure 65. Wing Tank Diagram [5]

The following summarizes the evolution of damage, release of liquid, and the main parameters that affect the liquid release from each tank shown in figure 65.

- Tank 2 (Mid-Wing Port Tank): Simulated damage to Tank 2 was caused by a sequence of impact events. The first was typically some form of engine impact with the wing leading edge followed by nacelle impact with the 6° slope. Damage from each of these events varied between runs, mostly due to the inconsistent severity of the engine impact, which in some cases, caused catastrophic wing failure and in others it imparted negligible damage.

Prior to the catastrophic engine impacts, however, the strength and ductility of the connections have the largest effect on release of the gelled water. As would be expected, the quantity of liquid released decreased as the strength and ductility increased. The impact conditions and ground friction had a negligible effect on liquid release and material yield stress and strength had a small effect.

- Tank 5 (Inboard Port Tank): Damage to this tank appears to have been dominated by a catastrophic impact of the inboard port engine with the wing. In the simulations, catastrophic impact occurred only with high ground friction. Since the actual engine impact conditions were unknown because the impact event was obscured by debris in the high-speed photography, this event could not be simulated with any less uncertainty. Therefore, no further understanding of liquid released from this tank was gained.

- Tank 6 (Inboard Starboard Tank): Simulated damage to Tank 6 was predominantly from impact with the ground. Dyed water was not visibly released during the crash test, but leaked out once the aircraft was stationary. Simulated results closely match this degree of damage with liquid released into the empty center wing tank in several runs and only released externally in one run. Uncertainty in the ductility of the connections had the greatest effect on this release of liquid. The severity of the impact conditions and friction with the ground were also significant.
