# Evaluation of Wind-Loading on Airport Signs

June 2000

DOT/FAA/AR-TN00/32

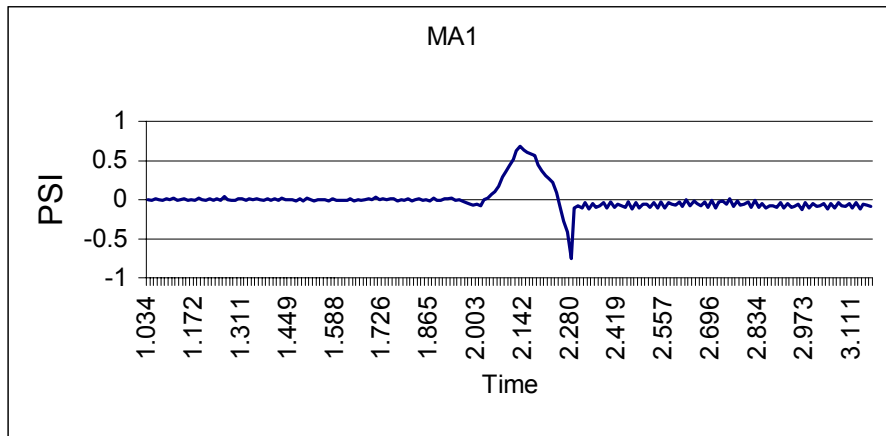
FIGURE 13. PRESSURE GAUGE ON SIGN FACE, MA1

The data also showed that the sign failed at the frangible point (couplings) under a load of only approximately 0.62 psi; which is less than the minimum frangibility requirements of the Advisory Circular. Moreover, the failure appeared to occur within the elastic limits of the laboratory tested couplings. It should be noted that the loading was applied to the sign over a time frame of less than 0.05 second, almost 200 times faster than in the laboratory tests. Although the measured wind speed was only 14.95 and 19.43 mph respectively, the data are considered to be unreliable since it was measured with a mechanical device that is not capable of providing accurate measurements over such a short period of time.

Further investigation of events prior to the total failure of the frangible couplings showed loads that exceeded the elastic limits of the couplings, causing permanent deformation of the couplings and actual failure (cracking) of the couplings well before the sign broke completely free of the couplings.

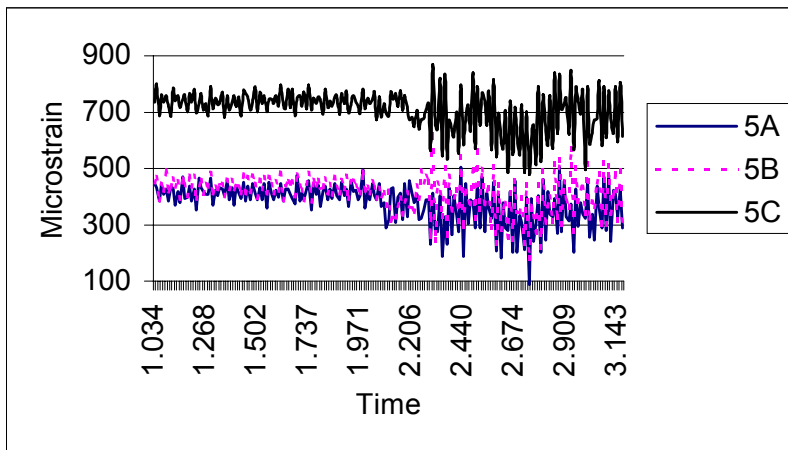
FIGURE 17. STRAIN GAUGE CLUSTER ON SIGN FACE, 5A, B, C

The sign was installed and data were collected for 3 months before the first sign was destroyed by the jet blast of a B747-200 which rotated adjacent to the sign. The sign failed at the frangible couplings as intended. The sign couplings broke between 2.12 and 2.13 seconds into the incident, which was consistent with the data obtained from the strain gauges on each of the couplings (MA1 and MA2). The force (from the wind) increased for 0.7 second; however, during the first 0.12 second of increased wind velocity, the measured force on coupling MA1 rose to 3,000 ft-lb. and dropped to zero. Similar conditions were observed on coupling MA1, 2248 ft-lb. and dropping to zero, within one hundredth of a second. Readings from the pressure and strain gauge clusters on the face (5A, B, C and 10A, B, C) of the sign did not record any significant change during the event.
