NASA Engineering and Safety Center Technical Assessment Report	Version: 1.0
Title:	National Highway Traffic Safety Administration Toyota Unintended Acceleration Investigation	Page #: 1 of 177

**Technical Support to the National Highway Traffic Safety
Administration (NHTSA) on the Reported Toyota Motor
Corporation (TMC) Unintended Acceleration (UA)
Investigation**

January 18, 2011

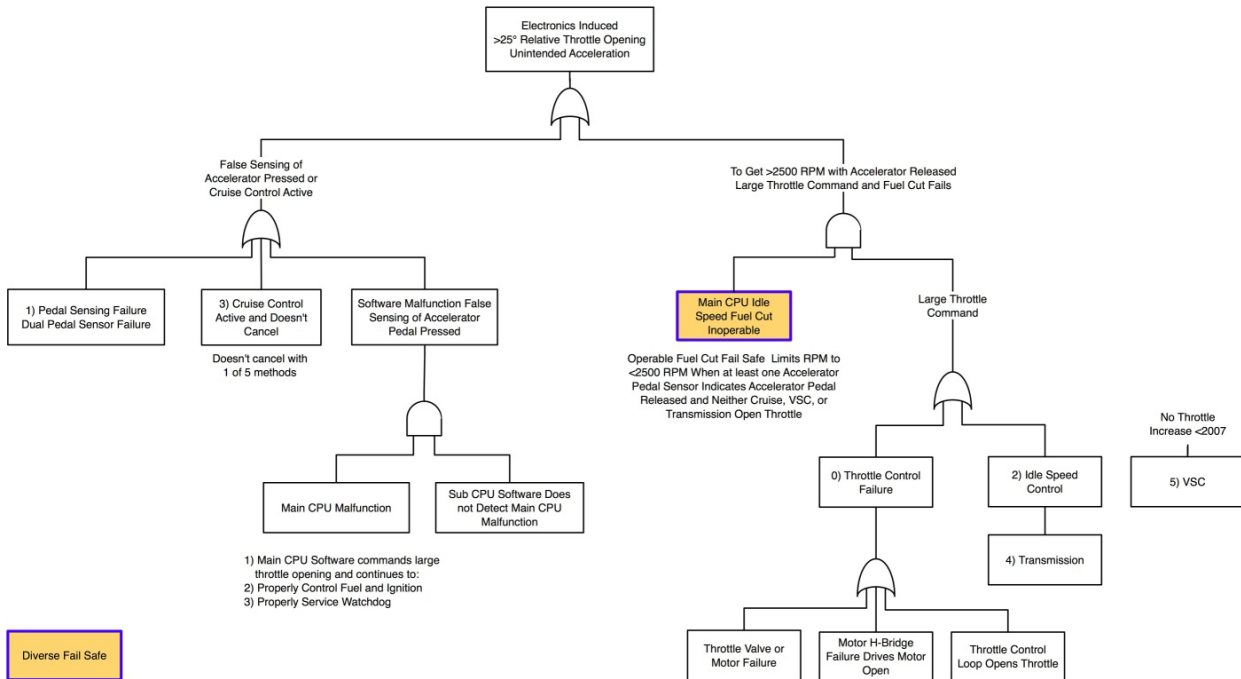
Figure 6.5.2.1-1. High Level Functional Fault Tree

The High Level Functional Fault Tree shown in Figure 6.5.2.1-1 shows the combinatorial logic and the system level fail-safe features that must fail for an electronics failure to unintentionally open the throttle a significant amount.

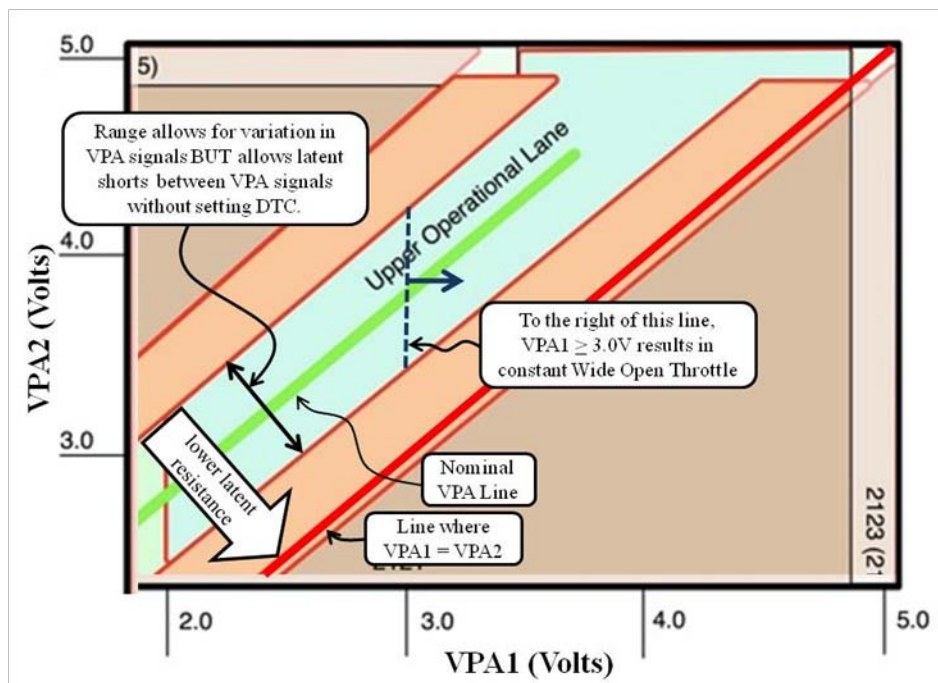
Figure 6.6.2.2-2. The upper operational lane with the latent fault influence and WOT location.

VPA signals if it were to occur can decrease the nominal line in the downward and right direction approaching the $VPA1 = VPA2$ line. In order to avoid generating a DTC, such a latent resistance must not result in the VPA signals going outside the operational lane. That is, a latent resistance can move the VPA signal from the current line position to the edge of the operational lane. For a Hall Effect sensor and nominal VPA signals (green line), the minimum latent resistance is approximately 200 ohms (to stay in the operational lane if a secondary VPA2 short to +V supply occurs). However, if the VPA signals were closer to the lower operational lane limit, then the minimum latent resistance would be greater, and conversely if the actual VPA signals were closer to the upper operational lane limit, then the minimum latent resistance would be lower.

The other key point of Figure 6.6.2.2-2 is the relationship between VPA1 and the throttle position. For nominal VPA signal voltages, VPA1 greater than or equal to 3.0V corresponds to WOT or 90 degree throttle opening. For VPA1 voltages greater than 3.0V, the throttle position maintains a constant WOT. This condition is true only for nominal idle voltages of VPA1 equal 0.8V and VPA2 equals 1.6V. For default learning where $VPA1=1.4V$, then the WOT VPA1 voltage would be 0.6V higher or VPA1 equal or greater than 3.6V.

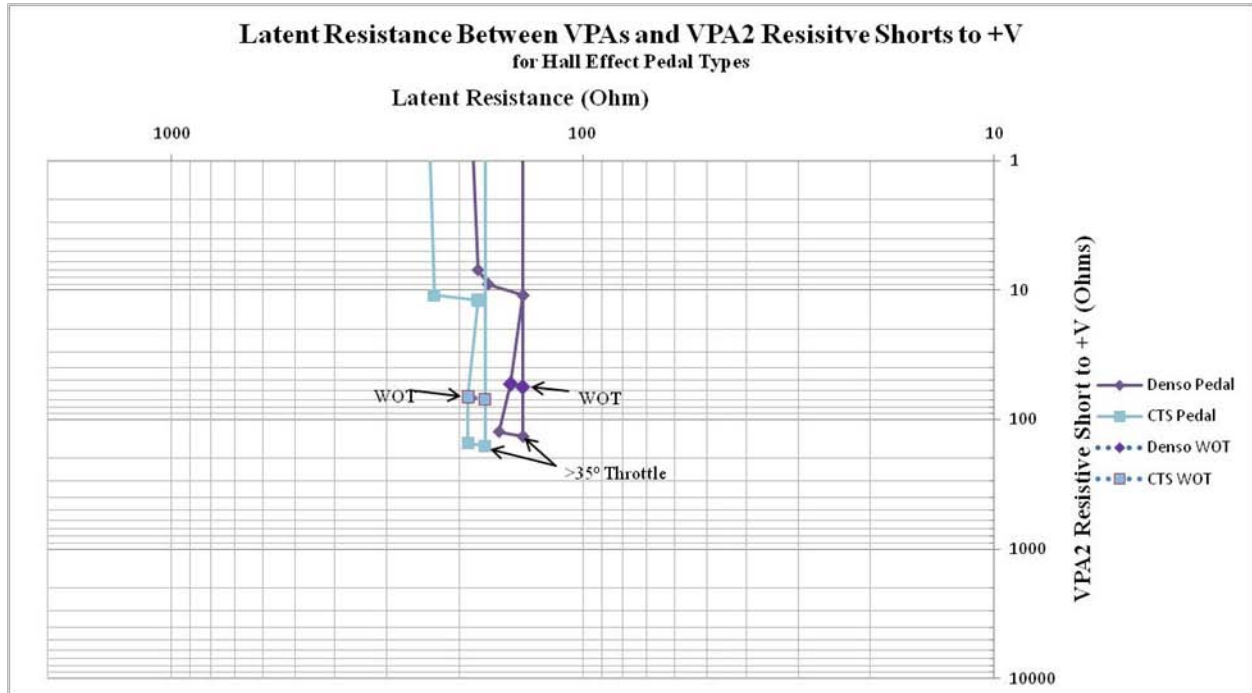
Figure 6.6.2.2-5. For Hall Effect type pedals, resistance range required for latent fault between VPA signals and second fault of VPA2 resistive shorted to +V

The other failure mode identified is a latent fault between the VPA signals with the second fault being a resistive open circuit on the VPA2 return line. The NESC team studied this effect (see Appendix C). For the CTS pedal tested, there was not a resistance range, but rather a single resistance of approximately 170Ω between the VPA signals which placed them in the upper operational lane with a VPA2 return line open circuit of $8k\Omega$ or greater (and not generate a DTC). Since the fault was at the edge of the operational lane, due to natural variances other CTS pedals may have a narrow resistance range allowing this fault to occur and not generate a DTC for the full range of pedal stroke.

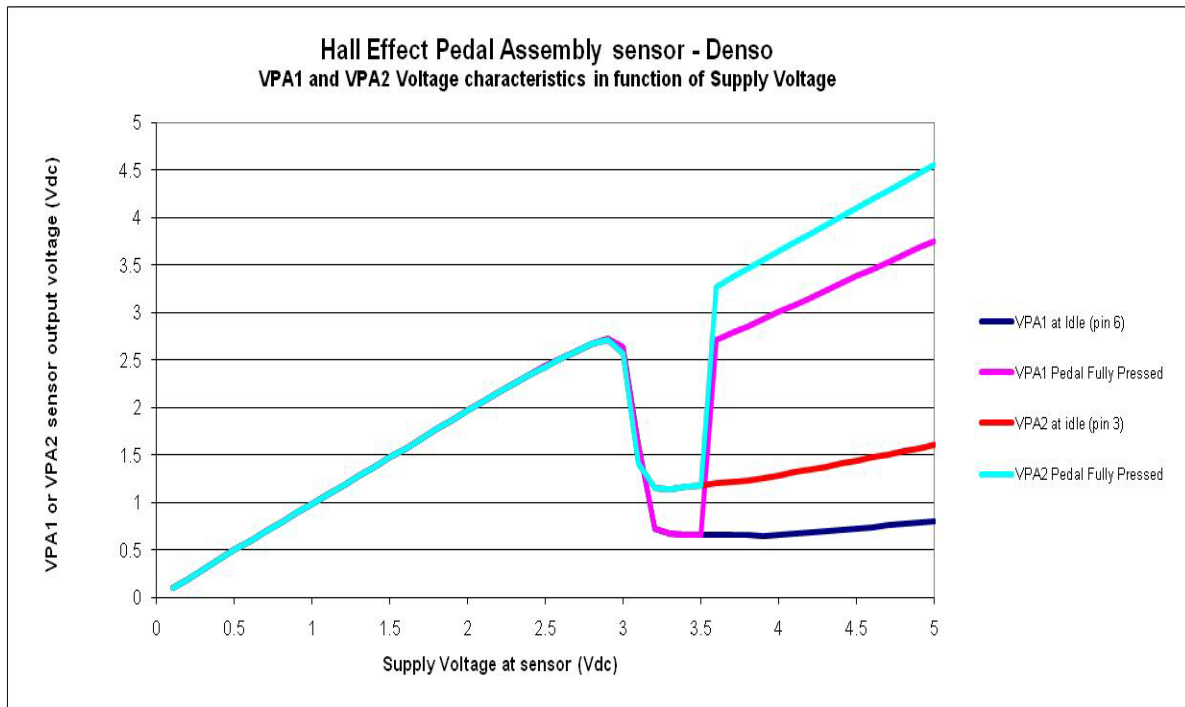
Figure 6.6.2.2-7. Denso Hall Effect sensor outputs as a function of the lower supply voltage

Before relating these Hall Effect sensor responses to the operational lane, a design characteristic of the Denso pedal will be described. This design characteristic is unique to the Denso Hall Effect sensor pedals where the signal outputs are affected in a unique manner by the reduction of the sensor +V supply voltage, which was demonstrated by introducing resistance in the supply lines.

As shown in Figure 6.6.2.2-7, for the Denso pedal, as the supply voltages drop the output voltages also drop concurrently, however, at approximately 3V range sensor output then jumps to the supply voltage and follows the supply voltage linearly to zero. If the VPA signals converge as shown (within $0.4V$) then a DTC is generated. However, depending on the fault conditions, there are voltage combinations which may put the VPA signals in the operational lane and not set a DTC. For these conditions, the Denso pedal would be subject to simultaneous dual resistive open circuit in the +V supply faults similar to the other postulated faults. However, the peak VPA signal voltage is approximately 2.7V. If VPA2 was at the maximum 2.7V, then to stay in the operational lane, then VPA1 can be no more than 2.2V or just inside the upper operational lane. This fault is similar to the postulated simultaneous resistive faults conditions in the return, but the maximum throttle opening is significantly less. Since the consequence is significantly less (just inside the upper operational lane) determining the exact resistance ranges was not explored for this unique case.

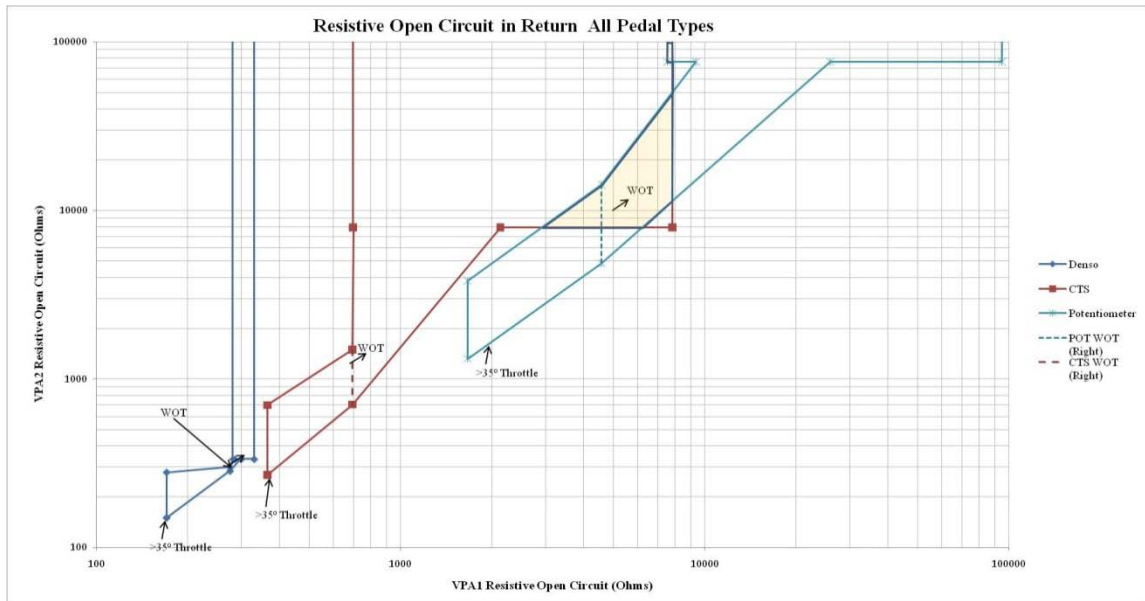
Figure 6.6.2.2-8. Resistance range required for simultaneous resistive open circuit in the VPA return line for all three pedal types

Again, assuming the pedal is at the physical idle position, Figure 6.6.2.2-8 shows the necessary resistance range required for resistive open circuits in the VPA signal return for all three pedal types to not generate a DTC. Note that resistance ranges do not overlap and therefore there is not one set of conditions common to all pedal types which could cause a large throttle opening UA. This implies that if this postulated fault was occurring, then the conditions in addition to the other restrictions previously described would need to be uniquely tailored for each pedal type rather than common across all pedal types to avoid generating DTCs.

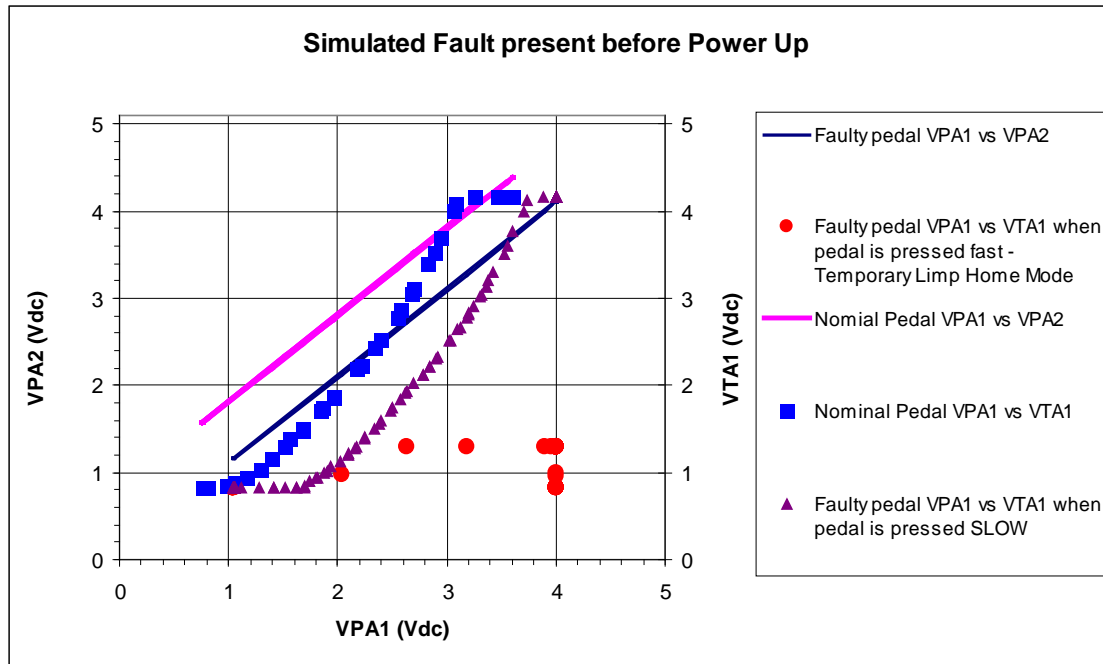
The following plot, Figure 6.6.2.3-3., was generated from tests performed on the MY 2006 V6 ETC simulator. A short of 248 ohms was introduced between VPA1 and VPA2.

Figure 6.6.2.3-3. Simulated Pedal Fault Behavior

The nominal pedal relationship between VPA1 and VPA2 is depicted in pink. The pedal relationship with the 248 ohm short is offset below and to the right in dark blue.

If the 248 ohms fault occurs after the system is powered up, a limp home mode will govern the throttle operation, thus limiting the throttle opening as described by the red dot curve of Figure 6.6.2.3-3. The throttle opens smoothly and is limited to approximately 15 degrees above idle. Also noted is the throttle closing as the throttle brake override activates when the brake pedal was applied after the pedal reached its fully pressed position.

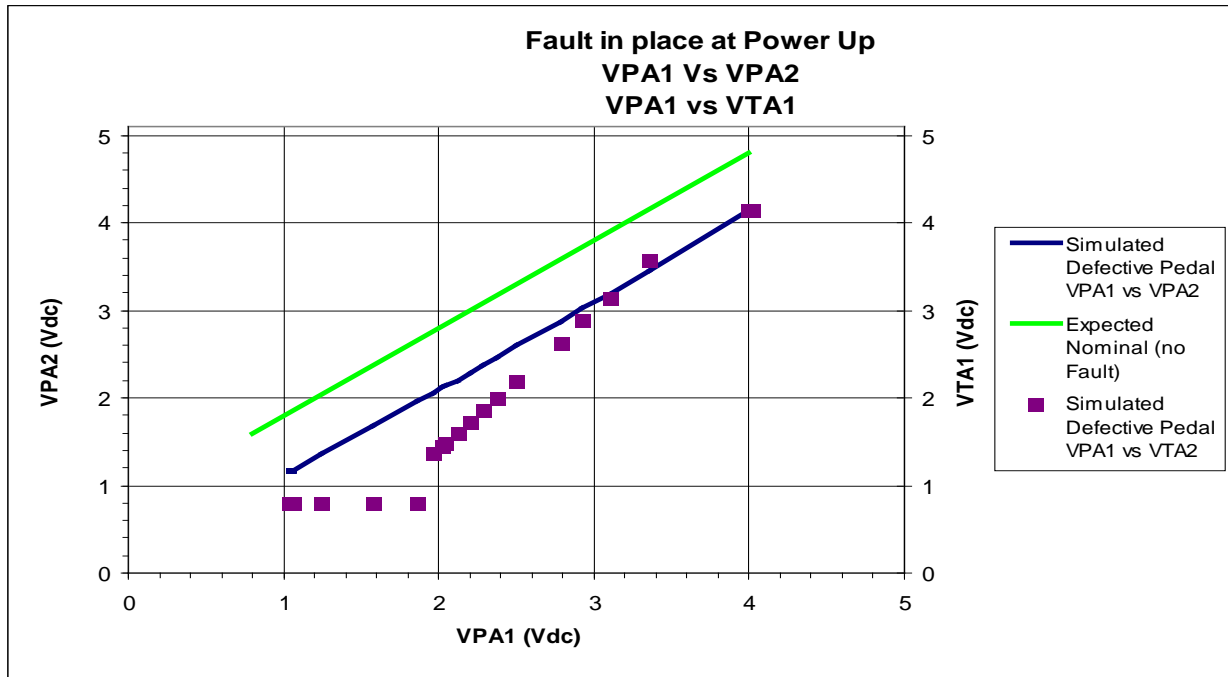
The following plot, Figure 6.6.2.3-4, was generated from tests performed on the 2005 L4 ETC simulator. A short of 248 ohms was introduced between VPA1 and VPA2.

Figure 6.6.2.3-4. Fault in Place at Power Up

The nominal pedal relationship between VPA1 and VPA2 is depicted in green. The pedal relationship with the 248 ohm short is offset below and to the right in dark blue.

When the pedal is pressed slowly, more than 0.5 seconds through the first 0.5 inches of pedal travel, no throttle opening occurs during the initial pedal travel. Then a sharp increase in throttle valve opening occurs. After this sharp increase, the throttle valve can be controlled by the pedal input up to the maximum throttle valve opening, where it limits and no longer increases. This is illustrated by the purple squares. Throttle brake override capability is not available under this condition.

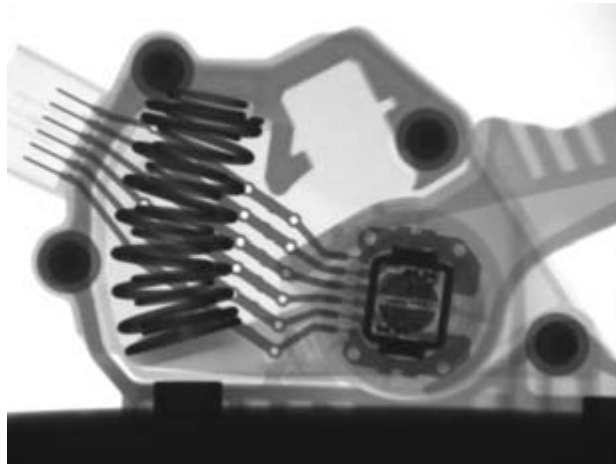
X-ray and destructive physical analysis of the Denso Hall Effect Sensor provided construction details as shown in Figure 6.6.2.3-11.

Figure 6.6.2.3-11. X-ray of Denso pedal assembly

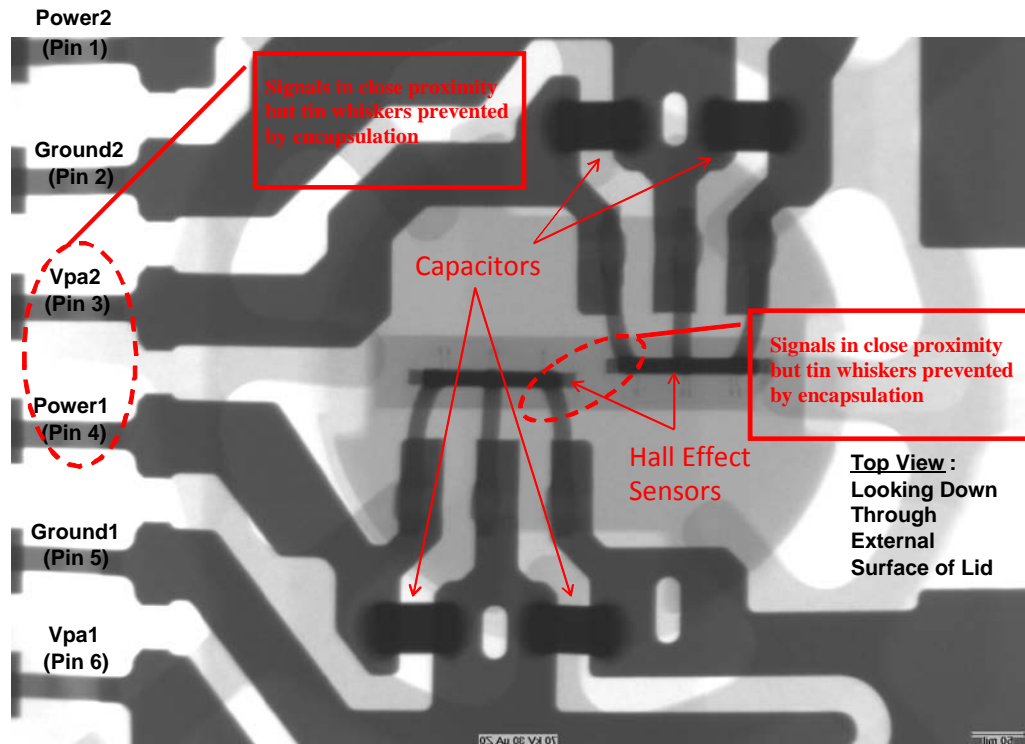
Figure 6.6.2.3-12. Denso Pedal Assembly Circuit Board X-ray Detail

The examination revealed that the solder used on the printed circuit board was a “lead free” tin alloy called Sn-Ag-Cu (“SAC”), which is less prone to formation of tin whiskers than pure tin solder. There were no traces of pure tin coating on connector pins and no solder cracks or cold solders. The examination found that the printed circuit board is not conformal coated and part of the enclosure of the ECM is made out of an aluminum-zinc alloy which can develop whiskers. However, the inspection of this ECM revealed no tin or zinc metallic whisker growth, nor precursors that sometimes predict the later growth of metal whiskers.

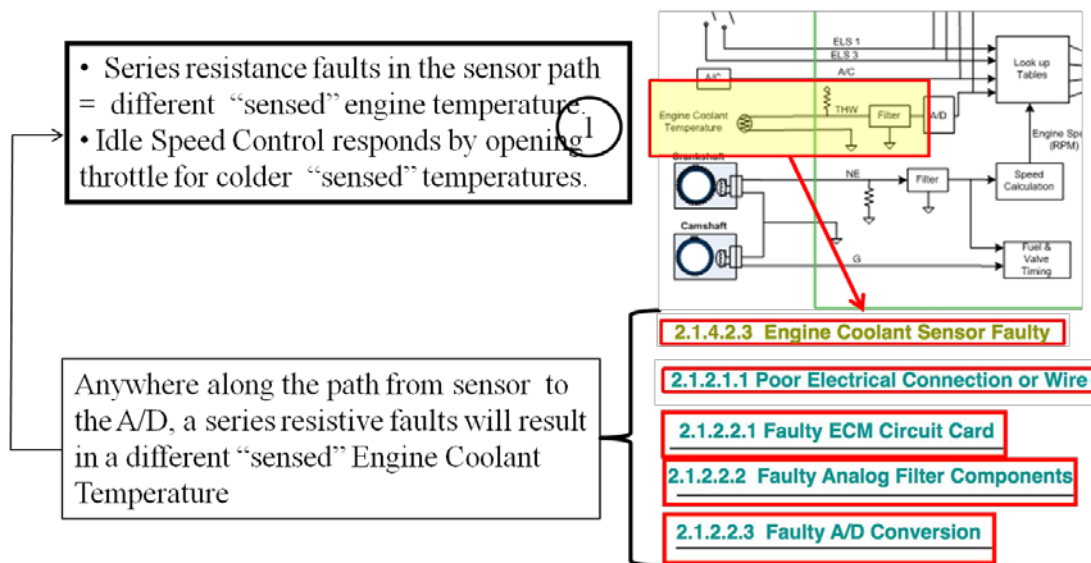
Figure 6.6.3.4-1 shows the summary of postulated faults identified by the fishbone for the ISC functional area. Based on the understanding of the ISC design as described, the ISC system was reviewed for sensitivities where a postulated fault could result in an increase in engine speed. The fishbone was used to identify potential sensitive entry points into the ISC loop. The fishbone identified a poor electrical connection, wiring or faulty engine coolant temperature sensor that may create the potential fault listed below. The next section details postulated faults and effects for the ISC.

Figure 6.6.3.4-1. Summary of postulated faults identified by Idle Speed Control Function Fishbone Diagram

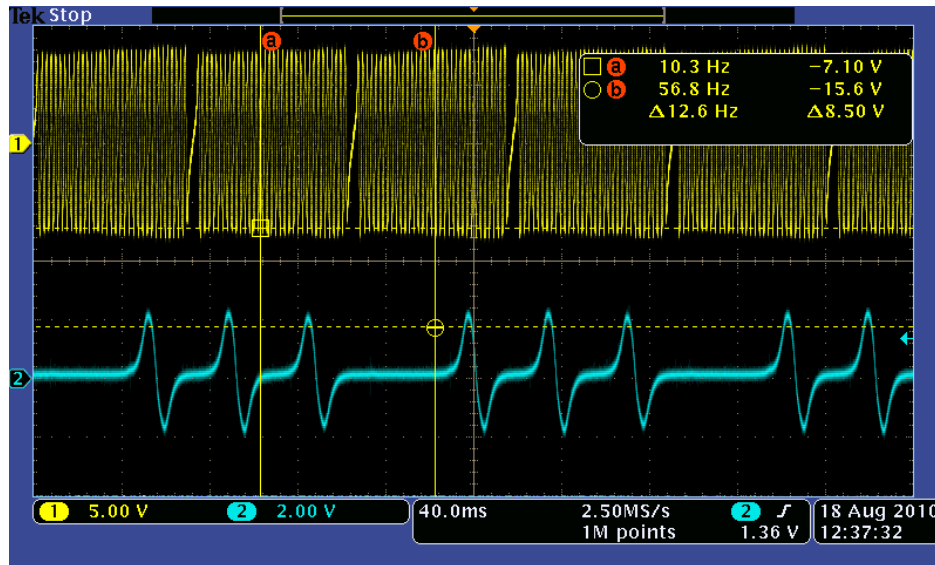
Figure 6.6.3.6-1. NE signal (Crankshaft, top yellow) and G (Camshaft, bottom blue) signal at idle

The crankshaft position (NE+) is used in conjunction with the camshaft position (G+) signal to set the proper timing of the engine intake/exhaust valves position and the fuel injection timing. Any corruption of these two signals that fails to maintain the proper timing relative to the actual engine speed will stall the engine. Therefore, the testing focused on creating small changes to the actual crankshaft sensor signals. The crankshaft signal is approximately 13V peak to peak, approximately 600 Hz at idle and increases in magnitude and frequency at higher engine speeds. The ECM converts this signal into a digital clock signal by a zero crossing detection circuit. Therefore, the zero crossing detection circuitry was tested to sensitivities to offsets. The result was that it was easy to stall the engine. No increase in engine speed was observed in the vehicle with an offset on the crankshaft signal induced by sine wave, square wave and saw tooth waveforms from 1 Hz up to approximately 90 KHz.

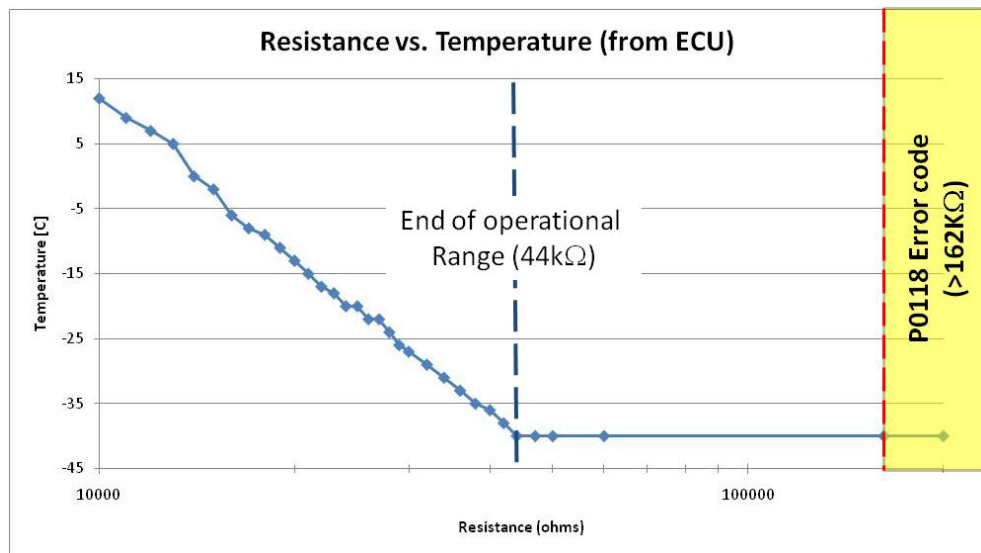
Figure 6.6.3.7-2. Upper resistance range of the Coolant Temperature Sensor including the DTC error range

For the coolant temperature sensor, the ECM software look-up table increases the target rpm directly proportional to the temperature reaching a maximum at -40C. When tested on a vehicle, the vehicle would not start when the engine was warm. Additionally, as the engine warmed the vehicle did not run smoothly, therefore the driver would have other indication the vehicle was not operating properly. These symptoms were not seen in the VOQs and there is no incidence of DTCs or repairs, therefore this postulated failure is not supported by the available data.
