KINGSTON FOSSIL PLANT (KIF) - ANNUAL ASH POND DIKE STABILITY INSPECTION

ANNUAL ASH POND DIKE
STABILITY INSPECTION

Prepared by: John Albright
Date: October 25, 2002

**KINGSTON FOSSIL PLANT
ANNUAL ASH POND DIKE STABILITY INSPECTION—2002**

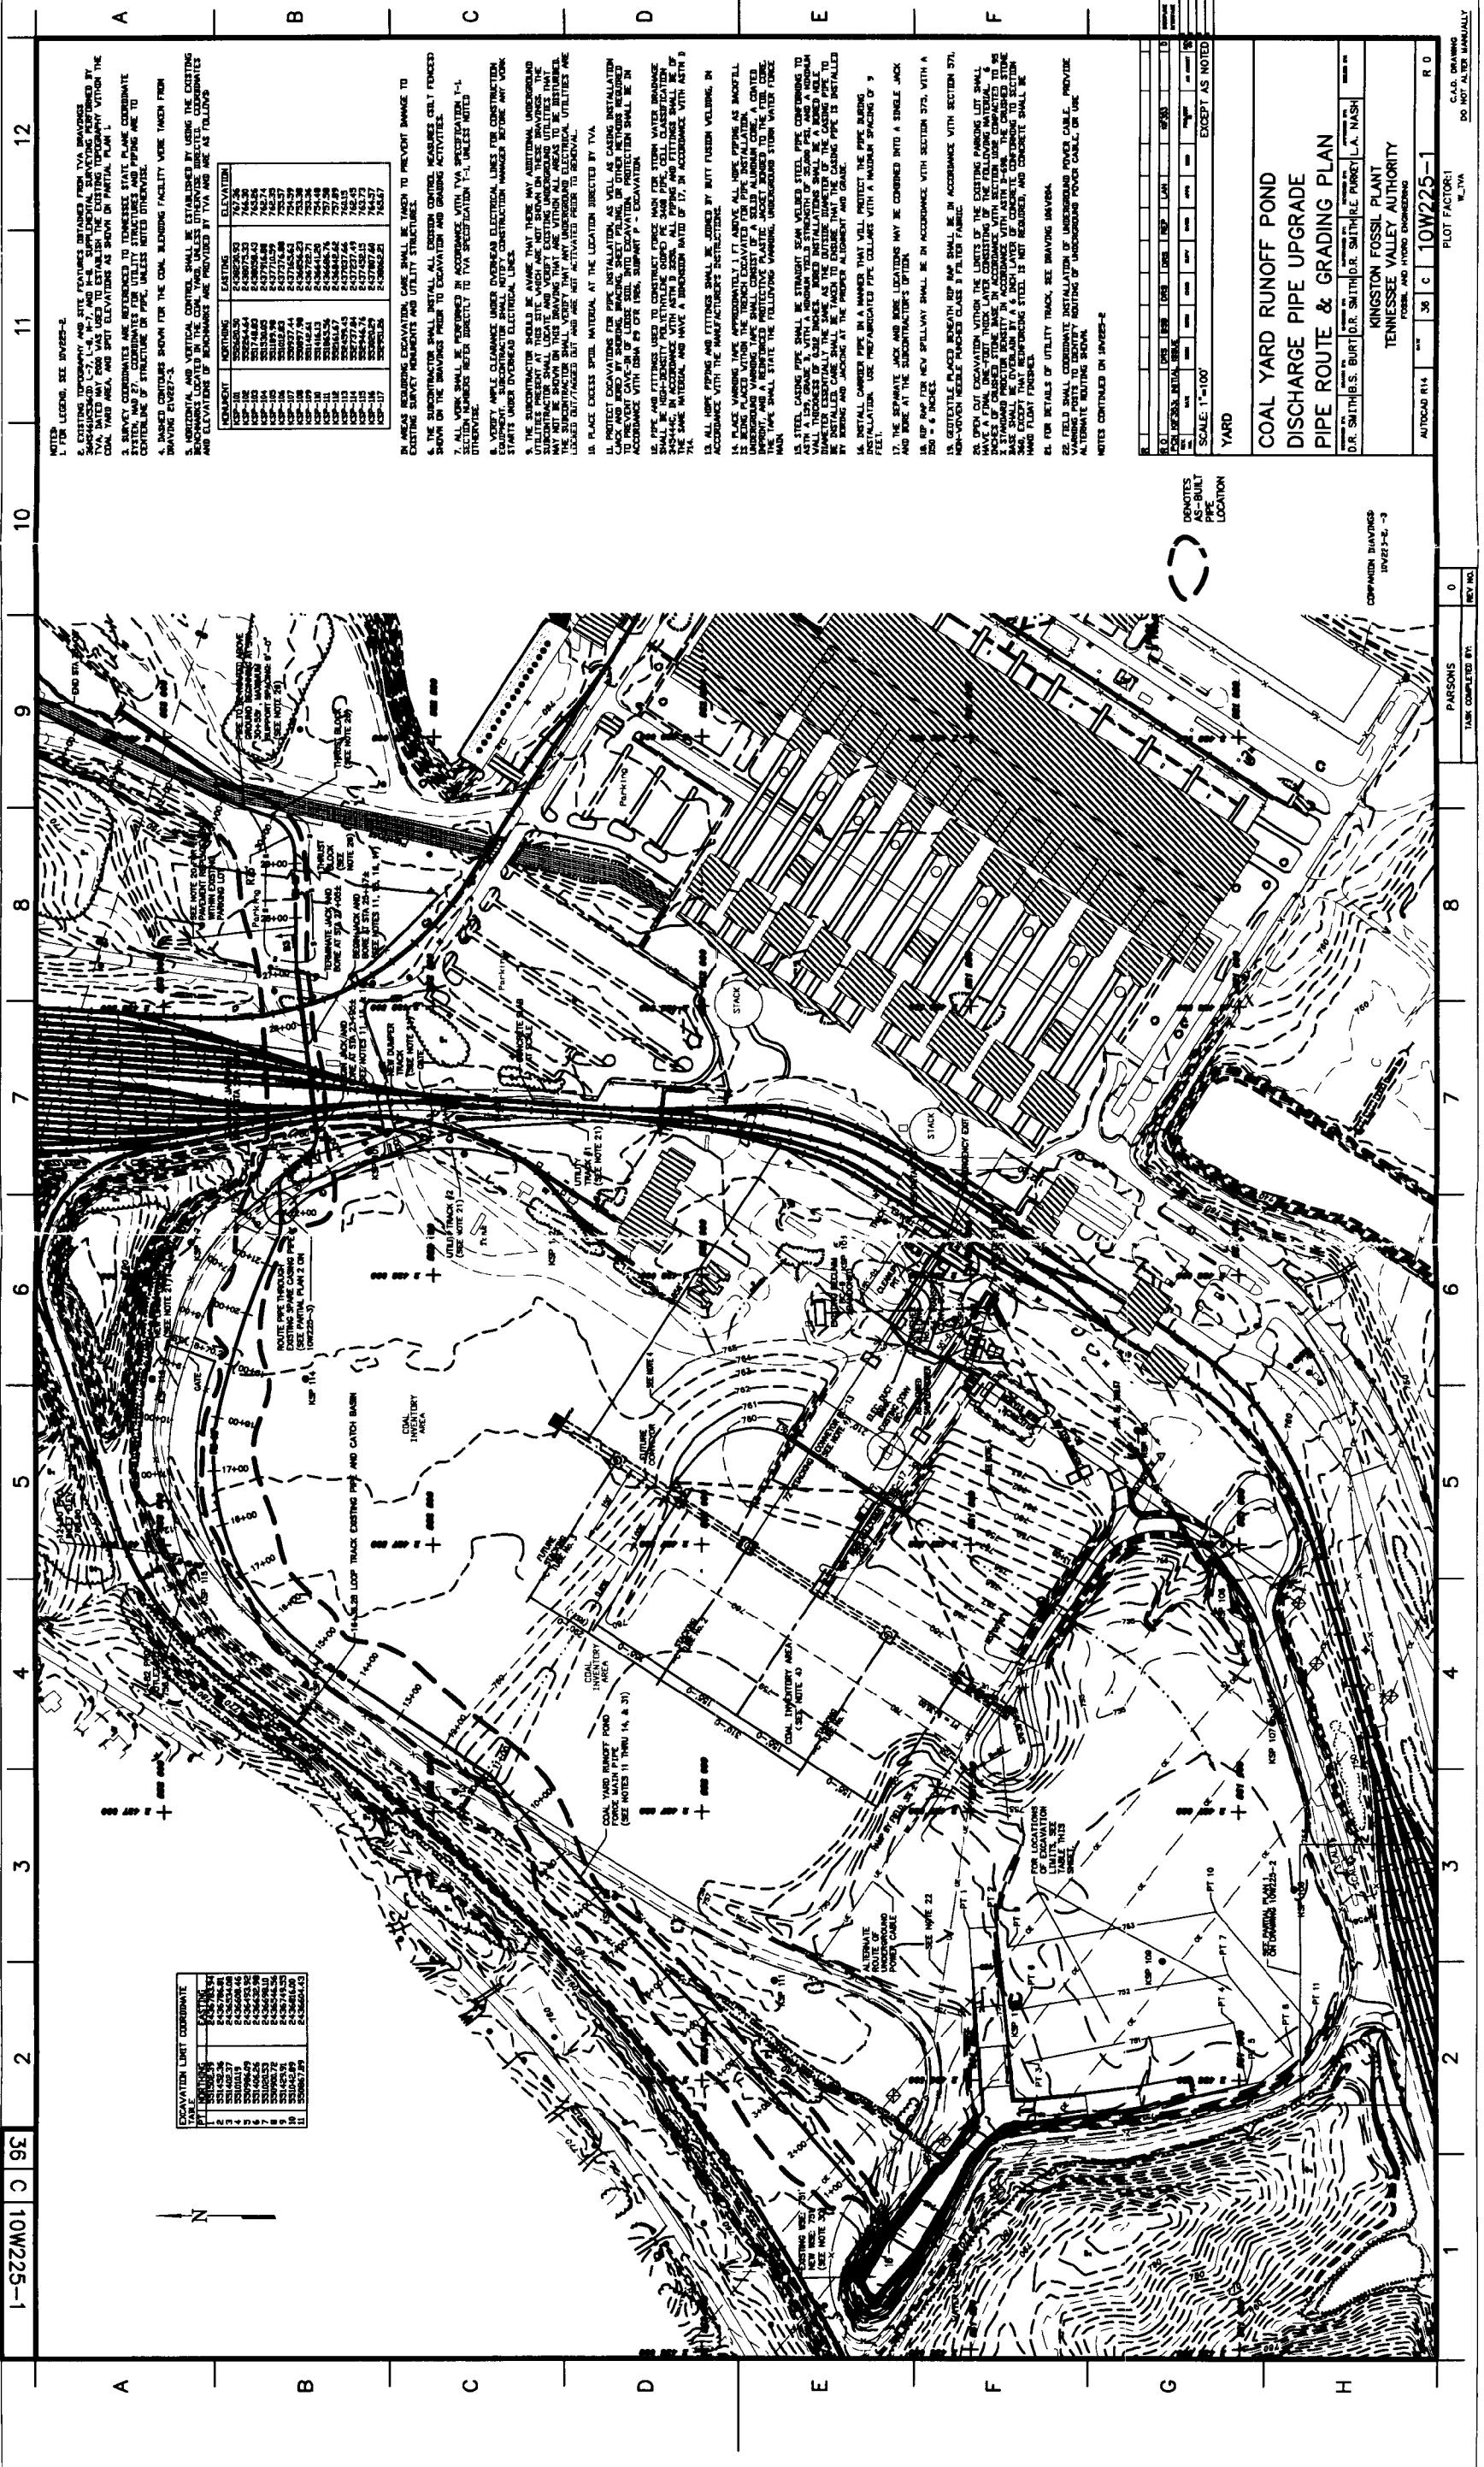
36 C 10W225-1

below the first pump start switch and the platform was grounded. The basin was sounded at 5 places and found to have a depth of 2.7 feet average when the water was at elevation 751. This indicates the sediment in the bottom occupies 3.3 feet of the basin's storage capacity. Since it was dredged just over a year ago, we forecast the basin will need to be dredged annually. The bottom of the pond should be no higher than elevation 745. Elevation 745 allows 2 feet of clearance below the pump intakes to prevent the pumps from pumping solids; the elevations indicate the pumps have been pumping solids for some time. In addition, the "V-shaped" pond extensions added during the summer of 2001 to increase the pond storage volume were visually undetectable. TVA drawing 10W225-1 shows the pond and its intended bottom contours.

- Future flow control of the ash pond discharge should only be done by raising the standpipes. The outlets must not be plugged. Plugging the outlets puts the joints in the concrete pipe under pressure they were not intended to withstand. This pressure could cause the joints to leak and wash out a portion of the dike causing the dike to fail.
- Dredge the Coal Yard Drainage Basin to restore its design contours and protect the pumps from further damage. There is an estimated 2,200 cubic yards of sediment in the original pond and an extra 2,750 cubic yards in the "V" section that needs to be removed as soon as reasonable. See the attached copy of 10W225-1.
