KINGSTON FOSSIL PLANT - ANNUAL ASH POND DIKE STABILITY INSPECTION

ANNUAL ASH POND DIKE
STABILITY INSPECTION
2007

Prepared by: John Albright and Jeff Gray
Date: January 31, 2007

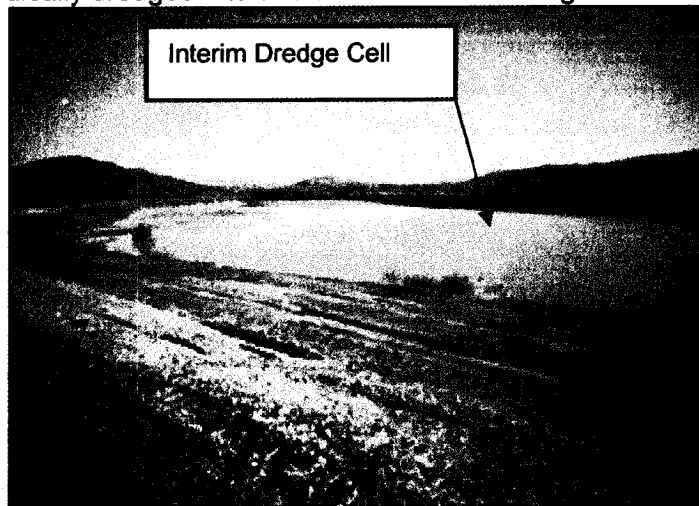
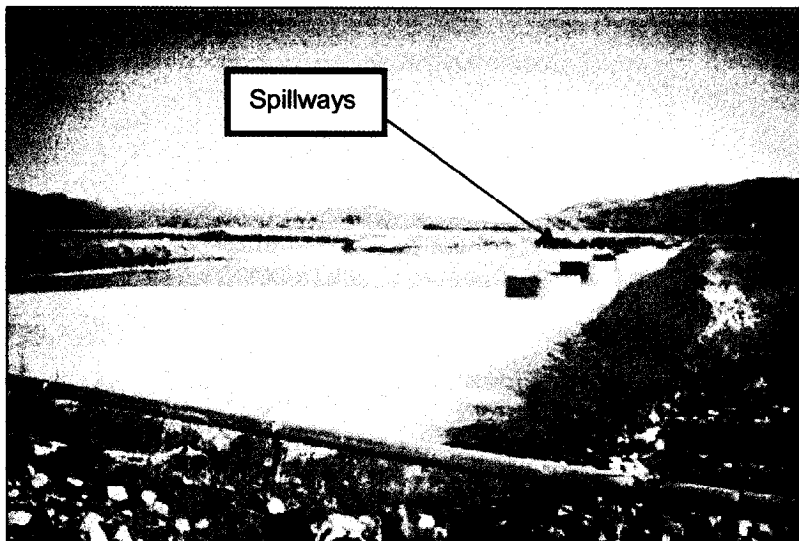
Sluice water flows from the active ash pond into the stilling pool through the five (5) new spillways constructed in 2005. The old plant constructed spillway (Kennedy Weir) were taken out of operation in 2005 as part a project to replace the Kennedy weir and allow more accurate accounting of free water volume. From the stilling pool, the water discharges into the plant intake channel via six standard spillways equipped with discharge diffusers constructed in November 2003.

All exterior dike slopes around this area appeared to be in sound condition with excellent vegetative cover. The dikes had been mowed recently and were in very good condition. As shown to the left, some of the benches don't drain well. As much as practical, these ditches should be graded so they will drain, even if slowly. Wheel ruts that hold water should be filled with soil and covered with stone if they are in a road.
