KINGMAN CREEK PLANT - ANNUAL AND DUNE INSPECTION

KINGMAN STEAM PLANT - ANNUAL ASH DIKE INSPECTION

On October 13, 1969, J. L. Hall of BFW; A. G. Spencer, Plant Superintendent; L. E. Kennedy, Assistant Plant Superintendent; B. J. Hunt, Operating Supervisor; and H. G. Bantala and I of BFD inspected the ash dikes at Kingman Steam Plant.

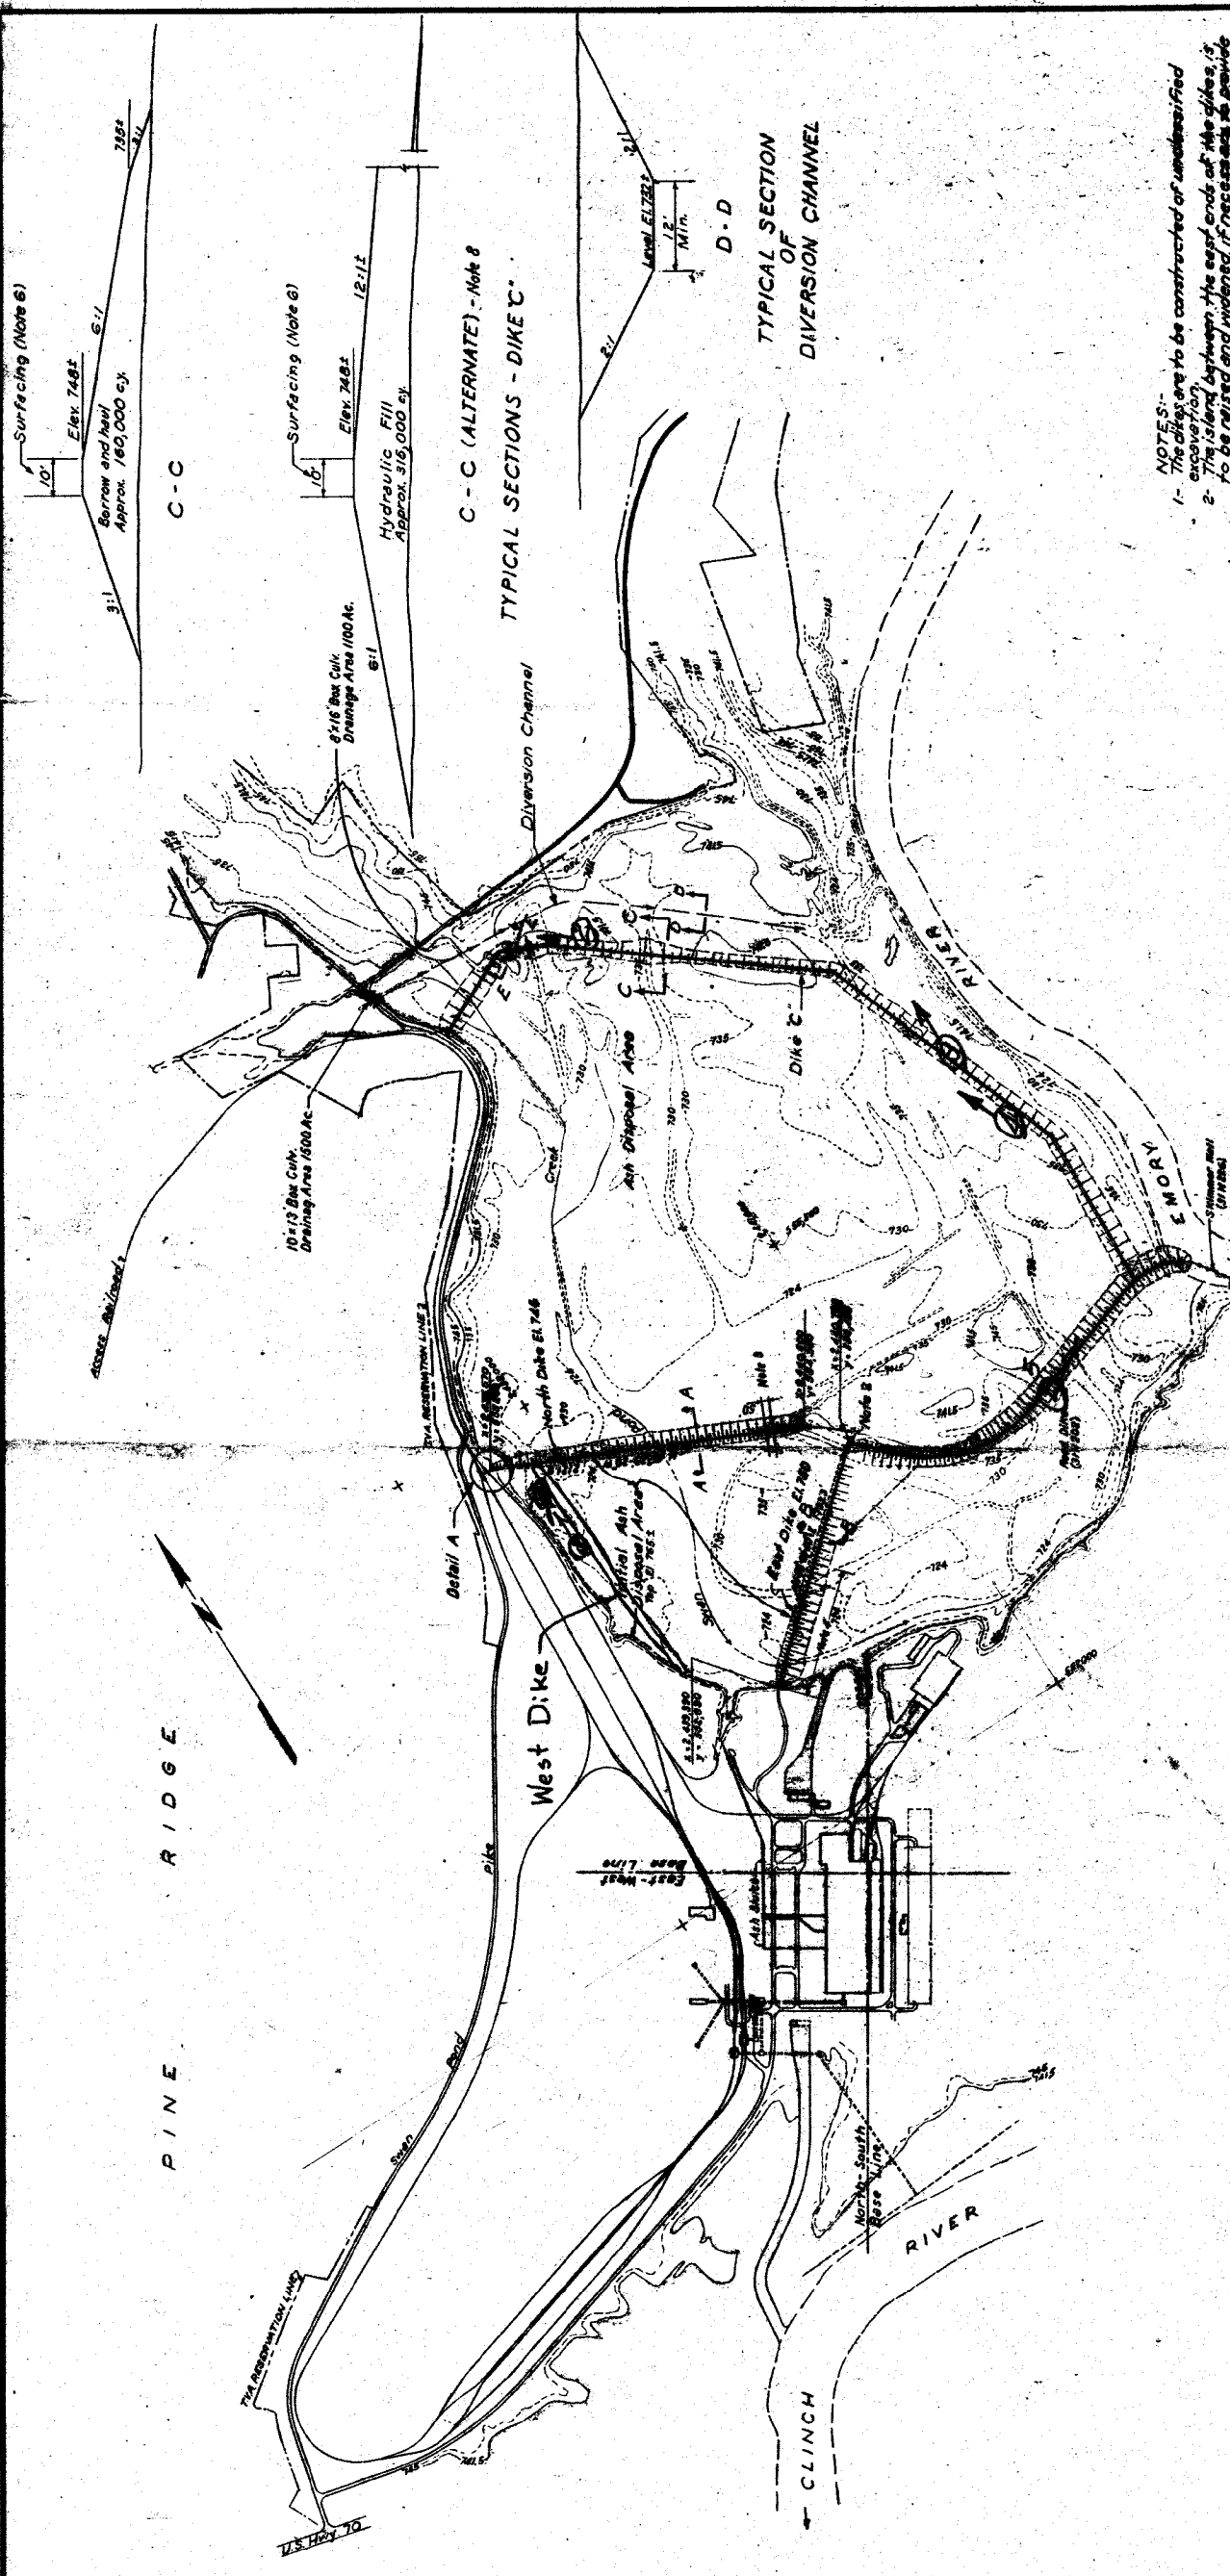
Plant personnel have completed raising the dikes around the initial ash area with heavy ash to approximately elevation 768. The outside slope of the east dike is approximately 6:1 and is in very good condition. The outside slopes of the north and west dikes are approximately 2:1 with the outside slope of the west dike developing some erosion gullies (picture 1). The top width of the dikes is approximately 30 feet. The north dike is having ash deposited against it. The outside slope of the west dike will be flattened. The dikes are named on the attached print of drawing 10N400.

1. Dress up the outside slope of the west dike and slope to 3:1, maintaining a top width of at least 16 feet.
2. On the outside slopes of the east and west dikes of the initial area, establish two experimental plots, on each slope, about 50 feet long. One plot shall be covered with 6+ inches of soil fertilized and seeded; the other plot shall be lined to neutralize the ash, then fertilized and seeded. We recommend type 7 grass mixture for seeding. Seeding and fertilizing shall be in accordance with section 100 of the T-1 Specifications. Design shall be notified of the results of these experiments.
