KINGSTON STEAM PLANT - ANNUAL ASH DISPOSAL AREA INSPECTION

On the attached marked print of drawing 10N400, the different ash disposal areas and dikes are designated.

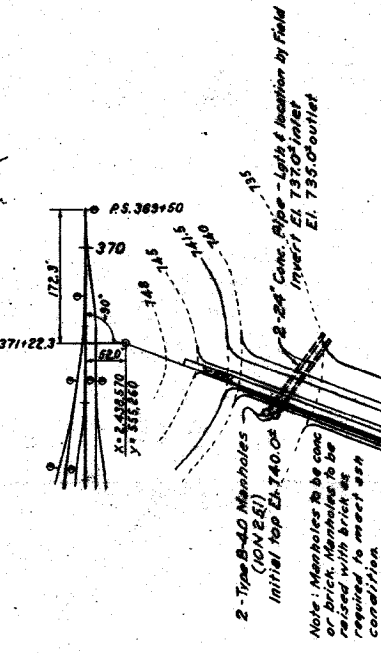
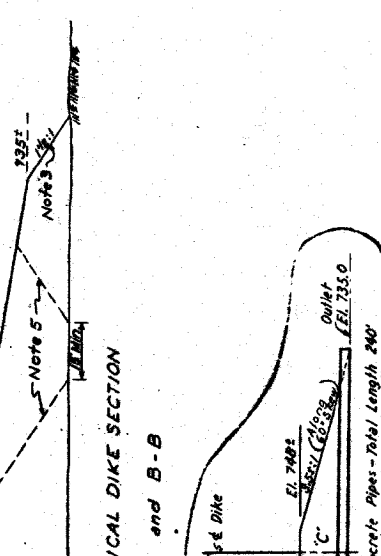
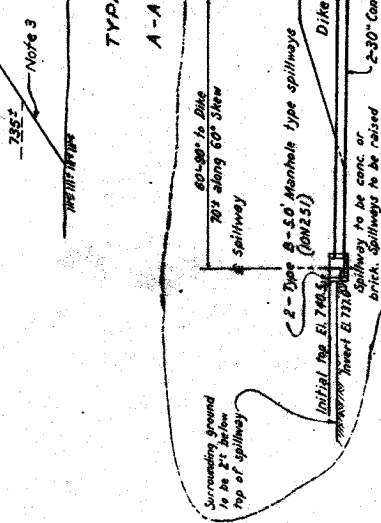
GENERAL	
ASH DISPOSAL AREA	
KINGSTON STEAM PLANT TENNESSEE VALLEY AUTHORITY	
DIVISION OF DESIGN	APPROVED
SUBMITTED	RECOMMENDED
J. B. [Signature]	C. C. [Signature]

During the 1969 inspection, an area which eroded due to wave erosion was found on the outside toe of dike C, as shown on the print of drawing 10N400. This area was repaired in 1970 by rebuilding the toe with rockfill, and no further erosion of this area has taken place. Since 1970 the toe of dike C south of the original erosion has shown some small amounts of wave erosion, but none of any consequence until this inspection. The high flood waters and heavy rainfall of the past year have increased the erosion of the outside toe of dike C. The toe of the outside slope has eroded away leaving vertical slopes varying in height from one foot to approximately four feet. This area extends from the original (1969) erosion south to the junction of dike C with the road dikes. The new erosion will have to be repaired. Although the erosion is now not serious enough to be an immediate danger to the dike, further erosion can become so; and a long delay will only add to the expense of the repair. When Watts Bar Lake is drawn to coming winter elevation, another inspection of the erosion should be made to determine the full extent of repair needed. The plant personnel will coordinate the time of inspection with the Divisions of Power Production and Engineering Design.

With the above exception, all the dikes are in good condition with the tops smooth and sloped to the inside. The vegetation on the outside slopes is good with few exceptions. The main exception is the portion of dike C that was built with heavy ash, noted on the print of drawing 10N400. Seeding of this area is not planned at this time. The other exceptions are small isolated areas that are being worked on by plant personnel.
