KINGSTON STEAM PLANT - ANNUAL ASH DISPOSAL AREA INSPECTION

September 27, 1974

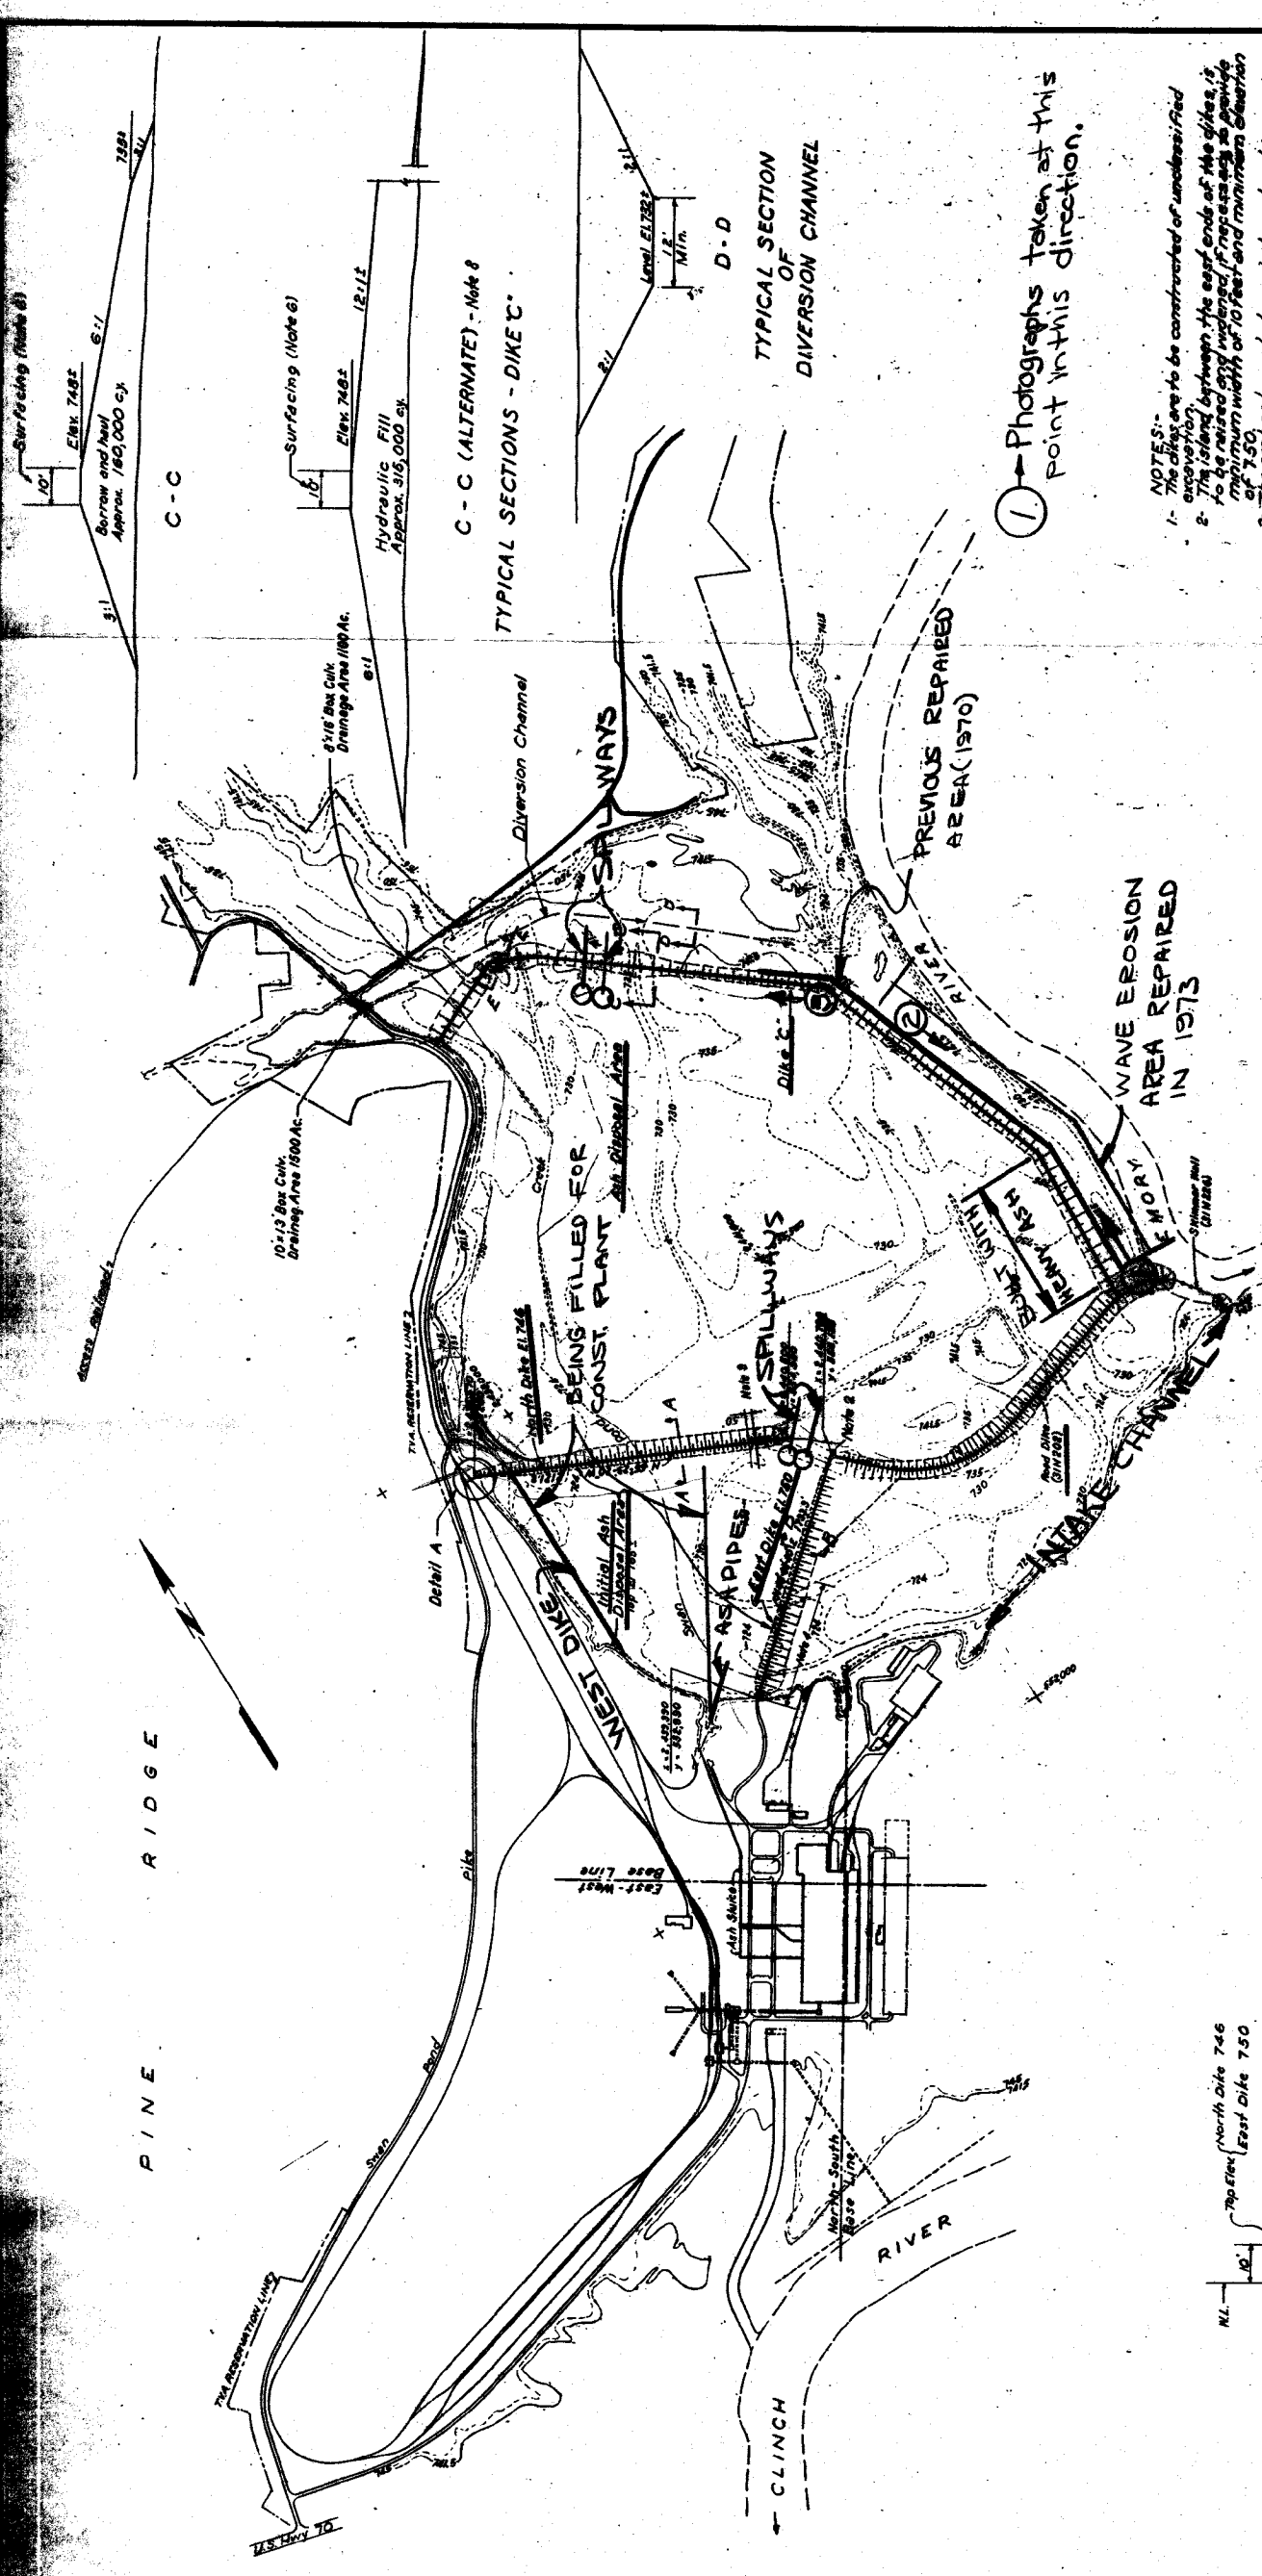
On the attached print of drawing 108400, the different ash disposal areas and dikes are designated.

① Photographs taken at this point in this direction.
