KINGSTON FOSSIL PLANT (KIF) - ANNUAL INSPECTION OF WASTE DISPOSAL AREAS

**TENNESSEE VALLEY AUTHORITY  
KINGSTON FOSSIL PLANT**

***ANNUAL INSPECTION OF  
WASTE DISPOSAL AREAS***

KINGSTON FOSSIL PLANT  
NPDES PERMIT NO. TN0005452  
ANNUAL ASH POND DIKE INSPECTION  
1997

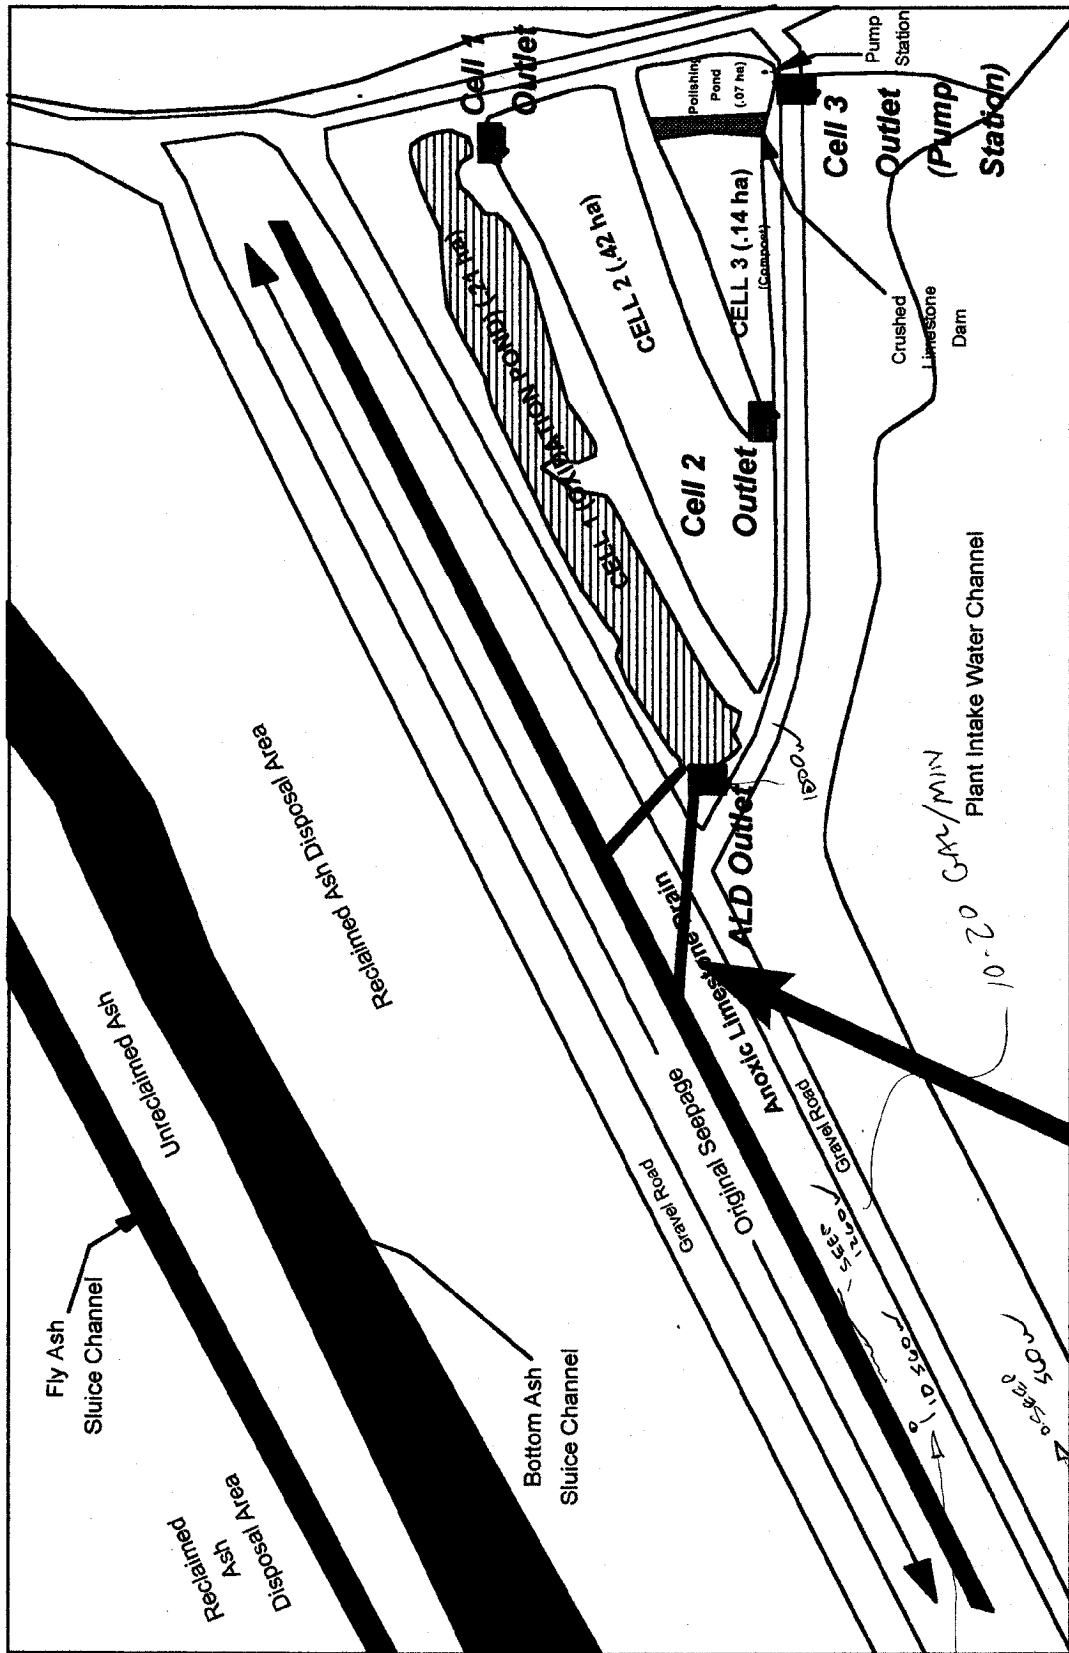
**ALD Location**

WEL #10 - Aeration Flow < 1 gal/min 1/7/98

NOTE:  
 SECOND DRAIN OUTLET  
 FOR ALD SYSTEM ADDED  
 IN 1994 PER R.L. POPE.  
 H.P. PETTY

5-10  
 GPM/MIN
