TVA – Kingston Fossil Plant and Bull Run Fossil Plant

Presentation to TDEC

December 5, 2007

Swan Pond Road Dike – Seepage Issues (2006)

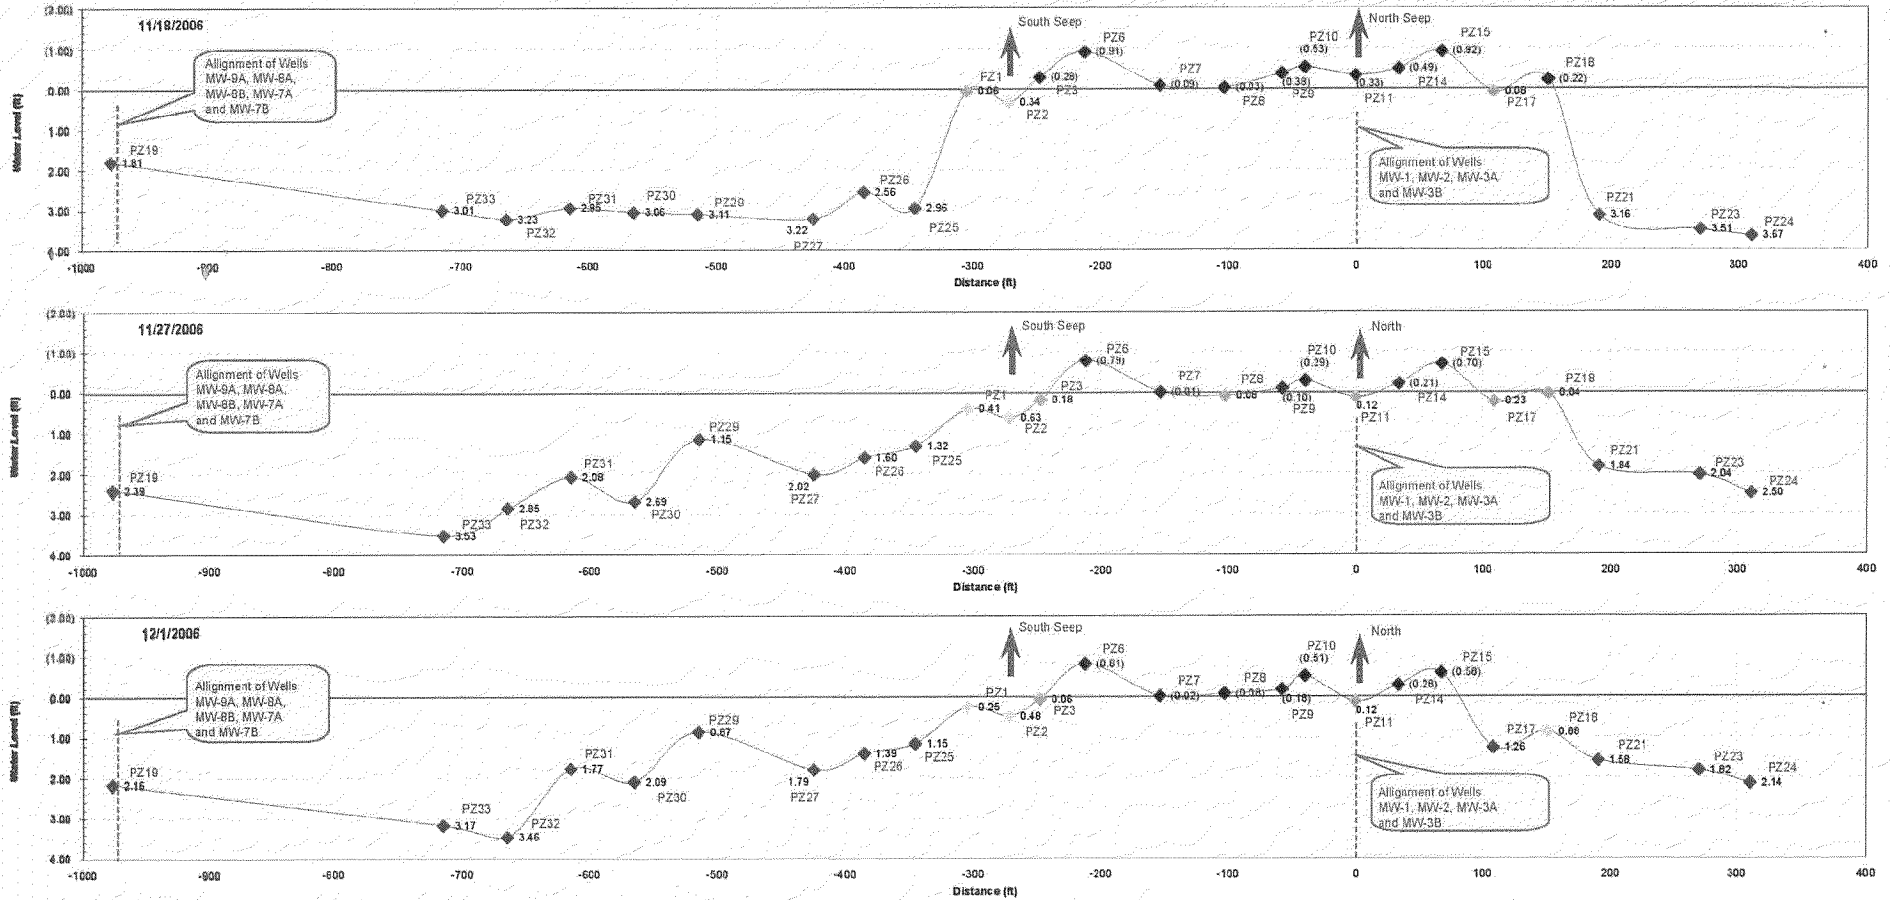
- Installed 33 drive-point piezometers along the toe of the slope
- Measured water levels and developed a water level profile
- Identified the area of concern based on the water levels that are within a foot or less of the ground surface
- In some instances water levels in piezometers were above the ground surface

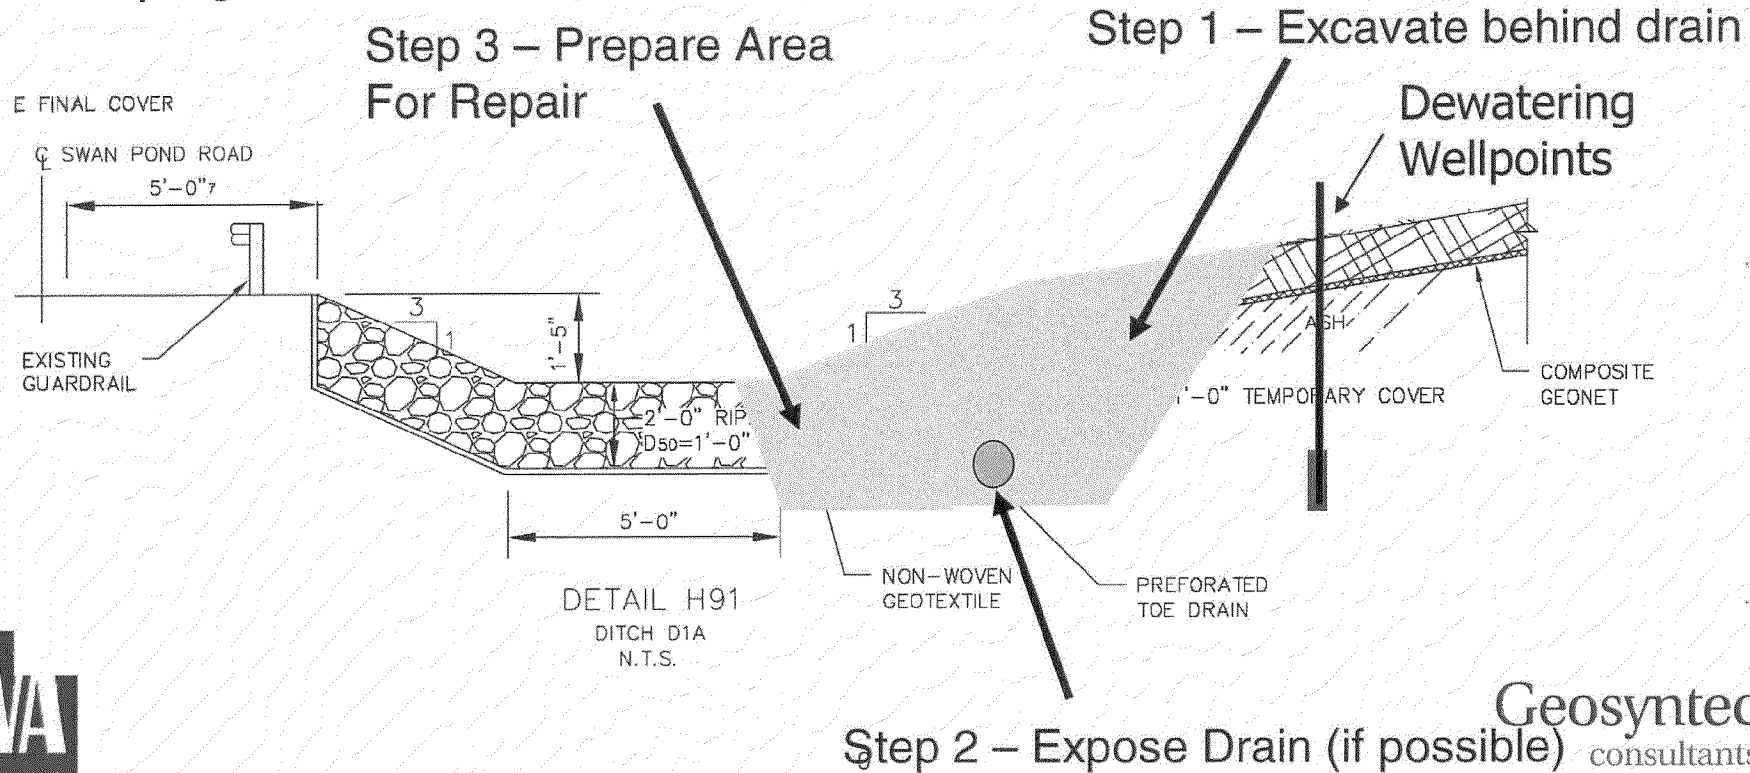
- Developed an intrusive investigation plan that could be coupled with temporary or permanent repair activities
- Identified southern seep area as the preferred location for the intrusive investigation due to continued observation of seepage, ash piping and high water levels

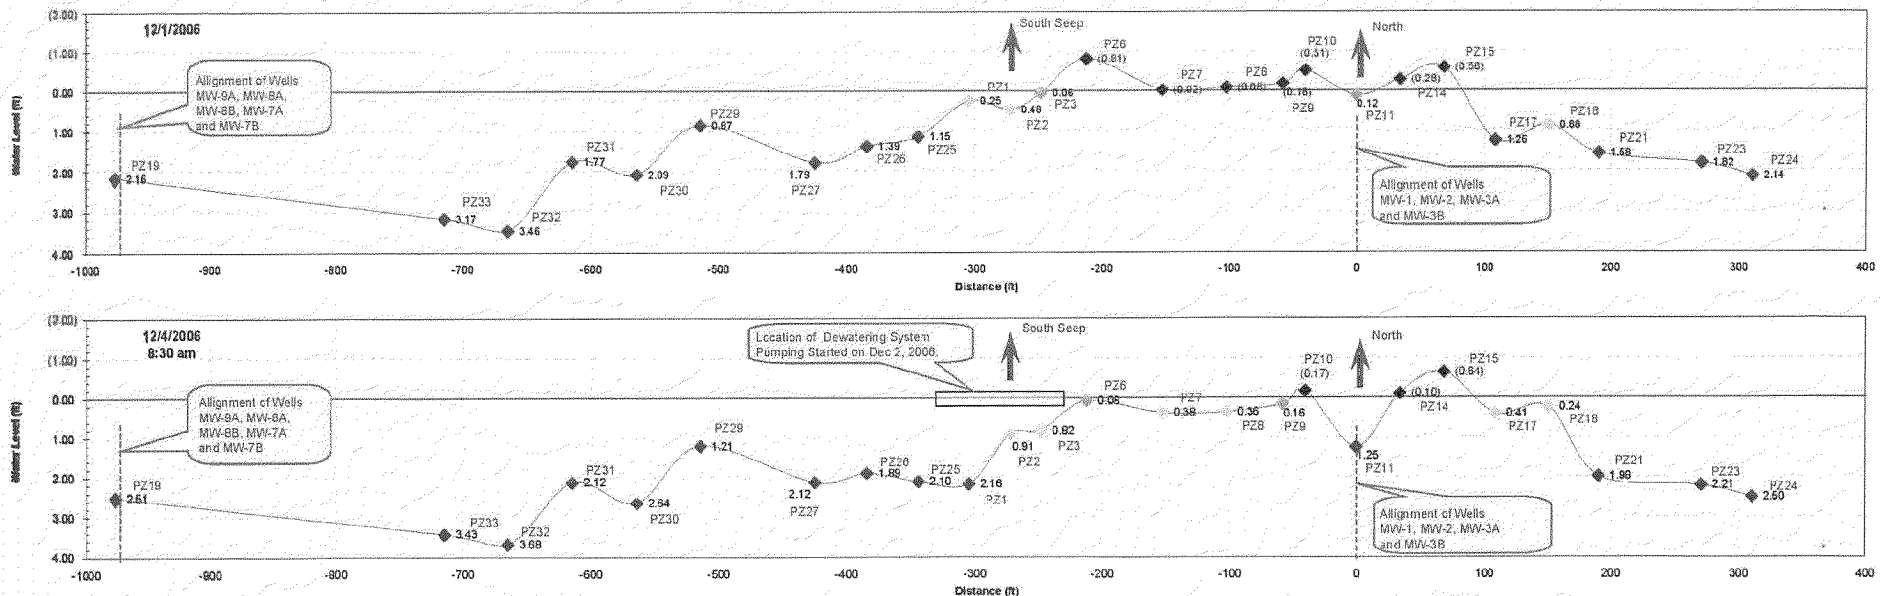
- Monitored water level response to dewatering
- Initiated intrusive investigation once water levels were below ground surface

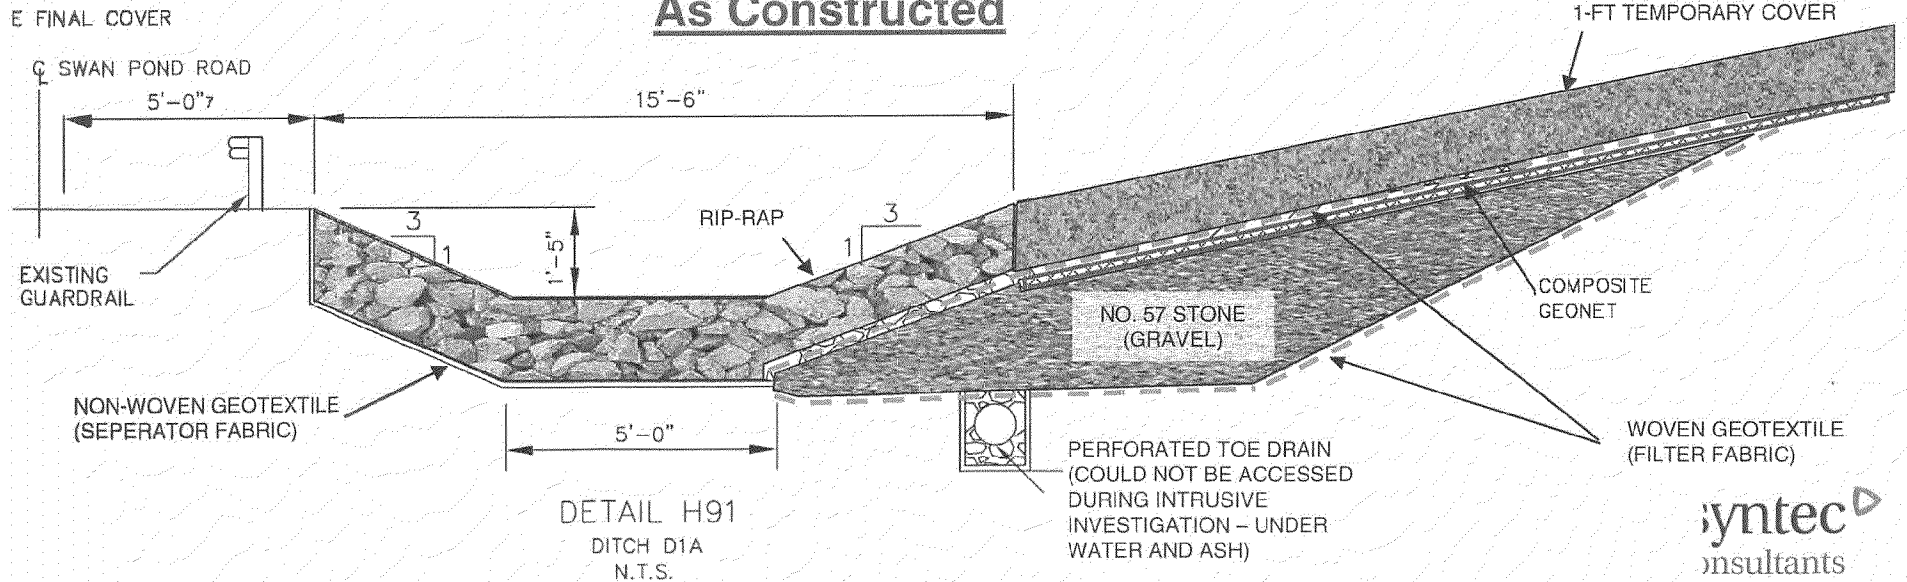
As Constructed

- **Drainage pipe – ineffective**
 - No free outlet
 - Almost flat gradient
 - Poor water conductivity between ash and drain/ditch
 - Ash possibly present in pipe trench
- **Small surface area of the drain as designed was not adequate to capture flow from lenses and anomalies identified during the investigation**
- **Zones of variable material observed**
 - Results in preferential flow paths and wet areas
 - Original fix (global) did not anticipate local anomalies
- **Standing water observed on benches**
 - Provides a constant source of water to infiltrate dike
 - Some underdrains discharge to benches

- ***Rehabilitation procedure continued similar to other areas***
 - Geotextile was placed over the slope.
 - Gravel blanket layer was placed over geotextile starting from the toe and progressing up slope to buttress ash and minimize movement
- ***Approximately 500 Linear feet of dike along Swan Pond Road was rehabilitated***

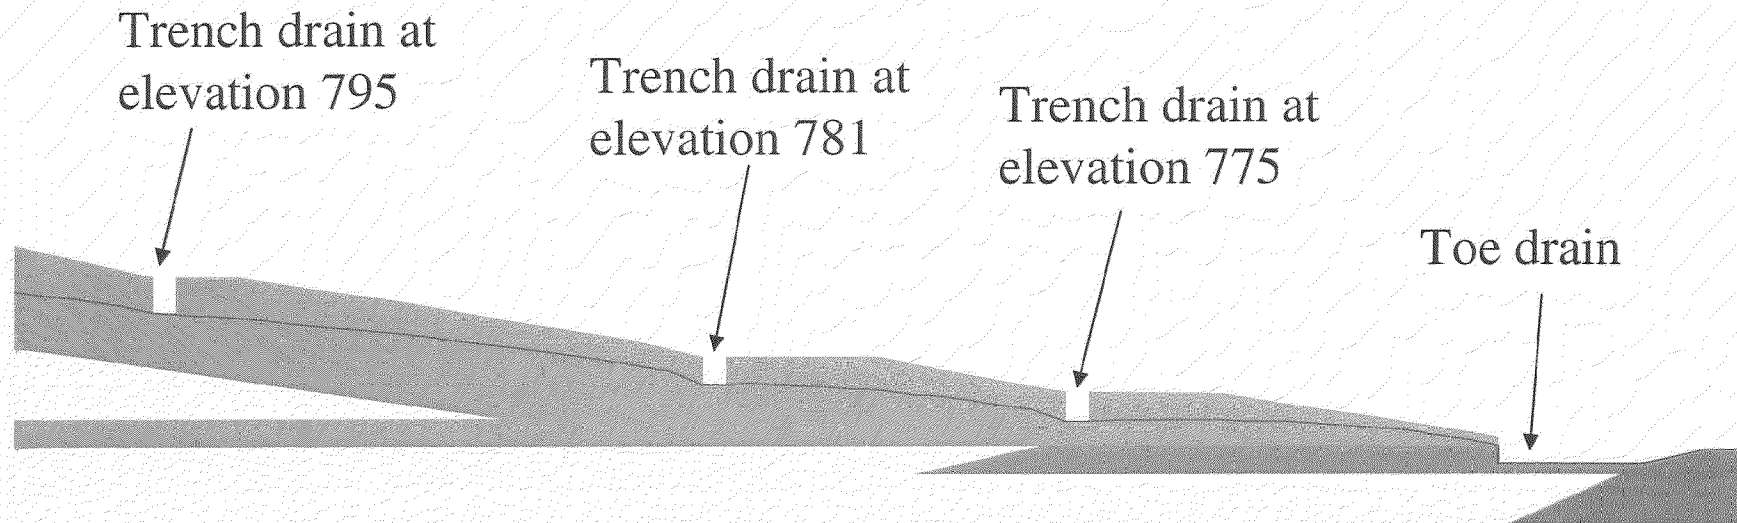
Proposed Improvements (2005)

Why did the 2005 recommended drainage improvements not solve the problem?

A series of drainage improvements were developed, analyzed, and implemented (2005) with the goal of lowering the phreatic surface and controlling seepage at the toe

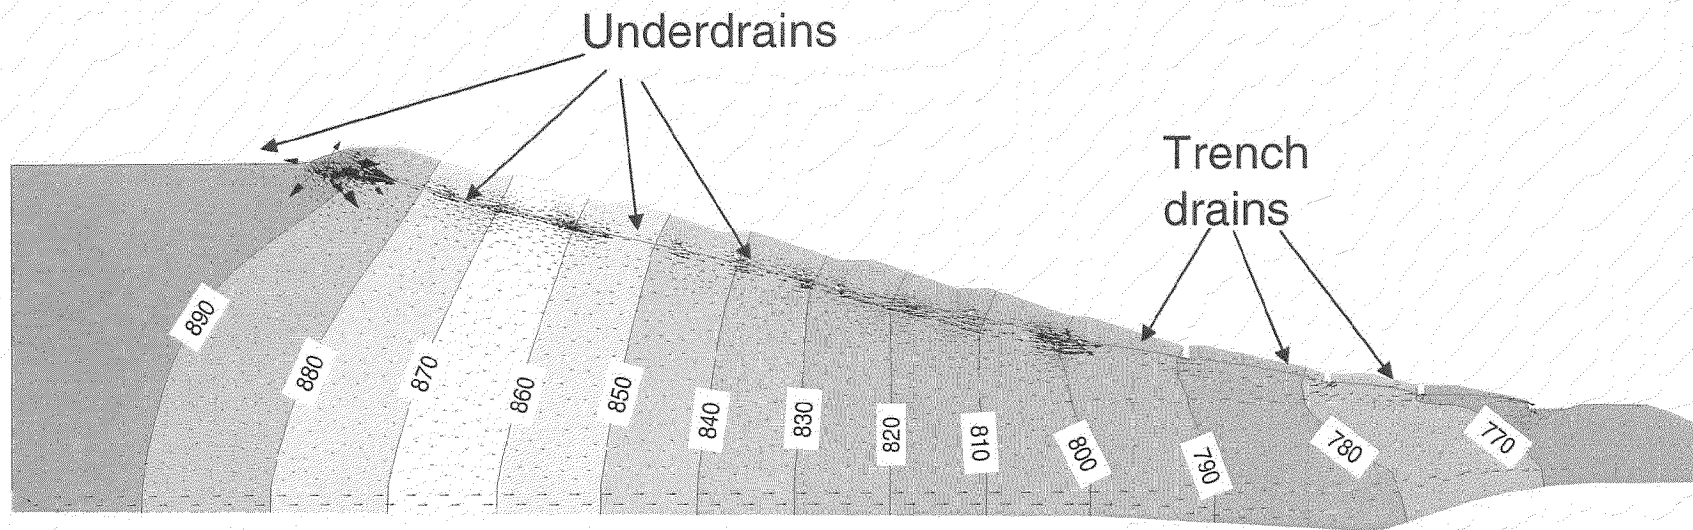
Model-predicted Total Head Distribution (Future Conditions)

Model simulations indicated that the phreatic surface would be reduced and seepage will be controlled effectively

- Model prediction indicates that seepage can be effectively controlled with a system of properly functioning trench drains and toe drain
- More monitoring points and periodic maintenance required to ensure proper function
