July 12, 1967

KINGSTON STEAM PLANT - ASH DIKES

On July 3, 1967, J. P. Hillier Stivers and Robert J. Bowman met with Meigs Brewer, Jr., and Shelton Johnson of Power Production and Buford Cross, Assistant Superintendent, and Buford Street, Mechanical Supervisor, of the Kingston Steam Plant at Kingston Steam Plant for an inspection of the ash dikes.

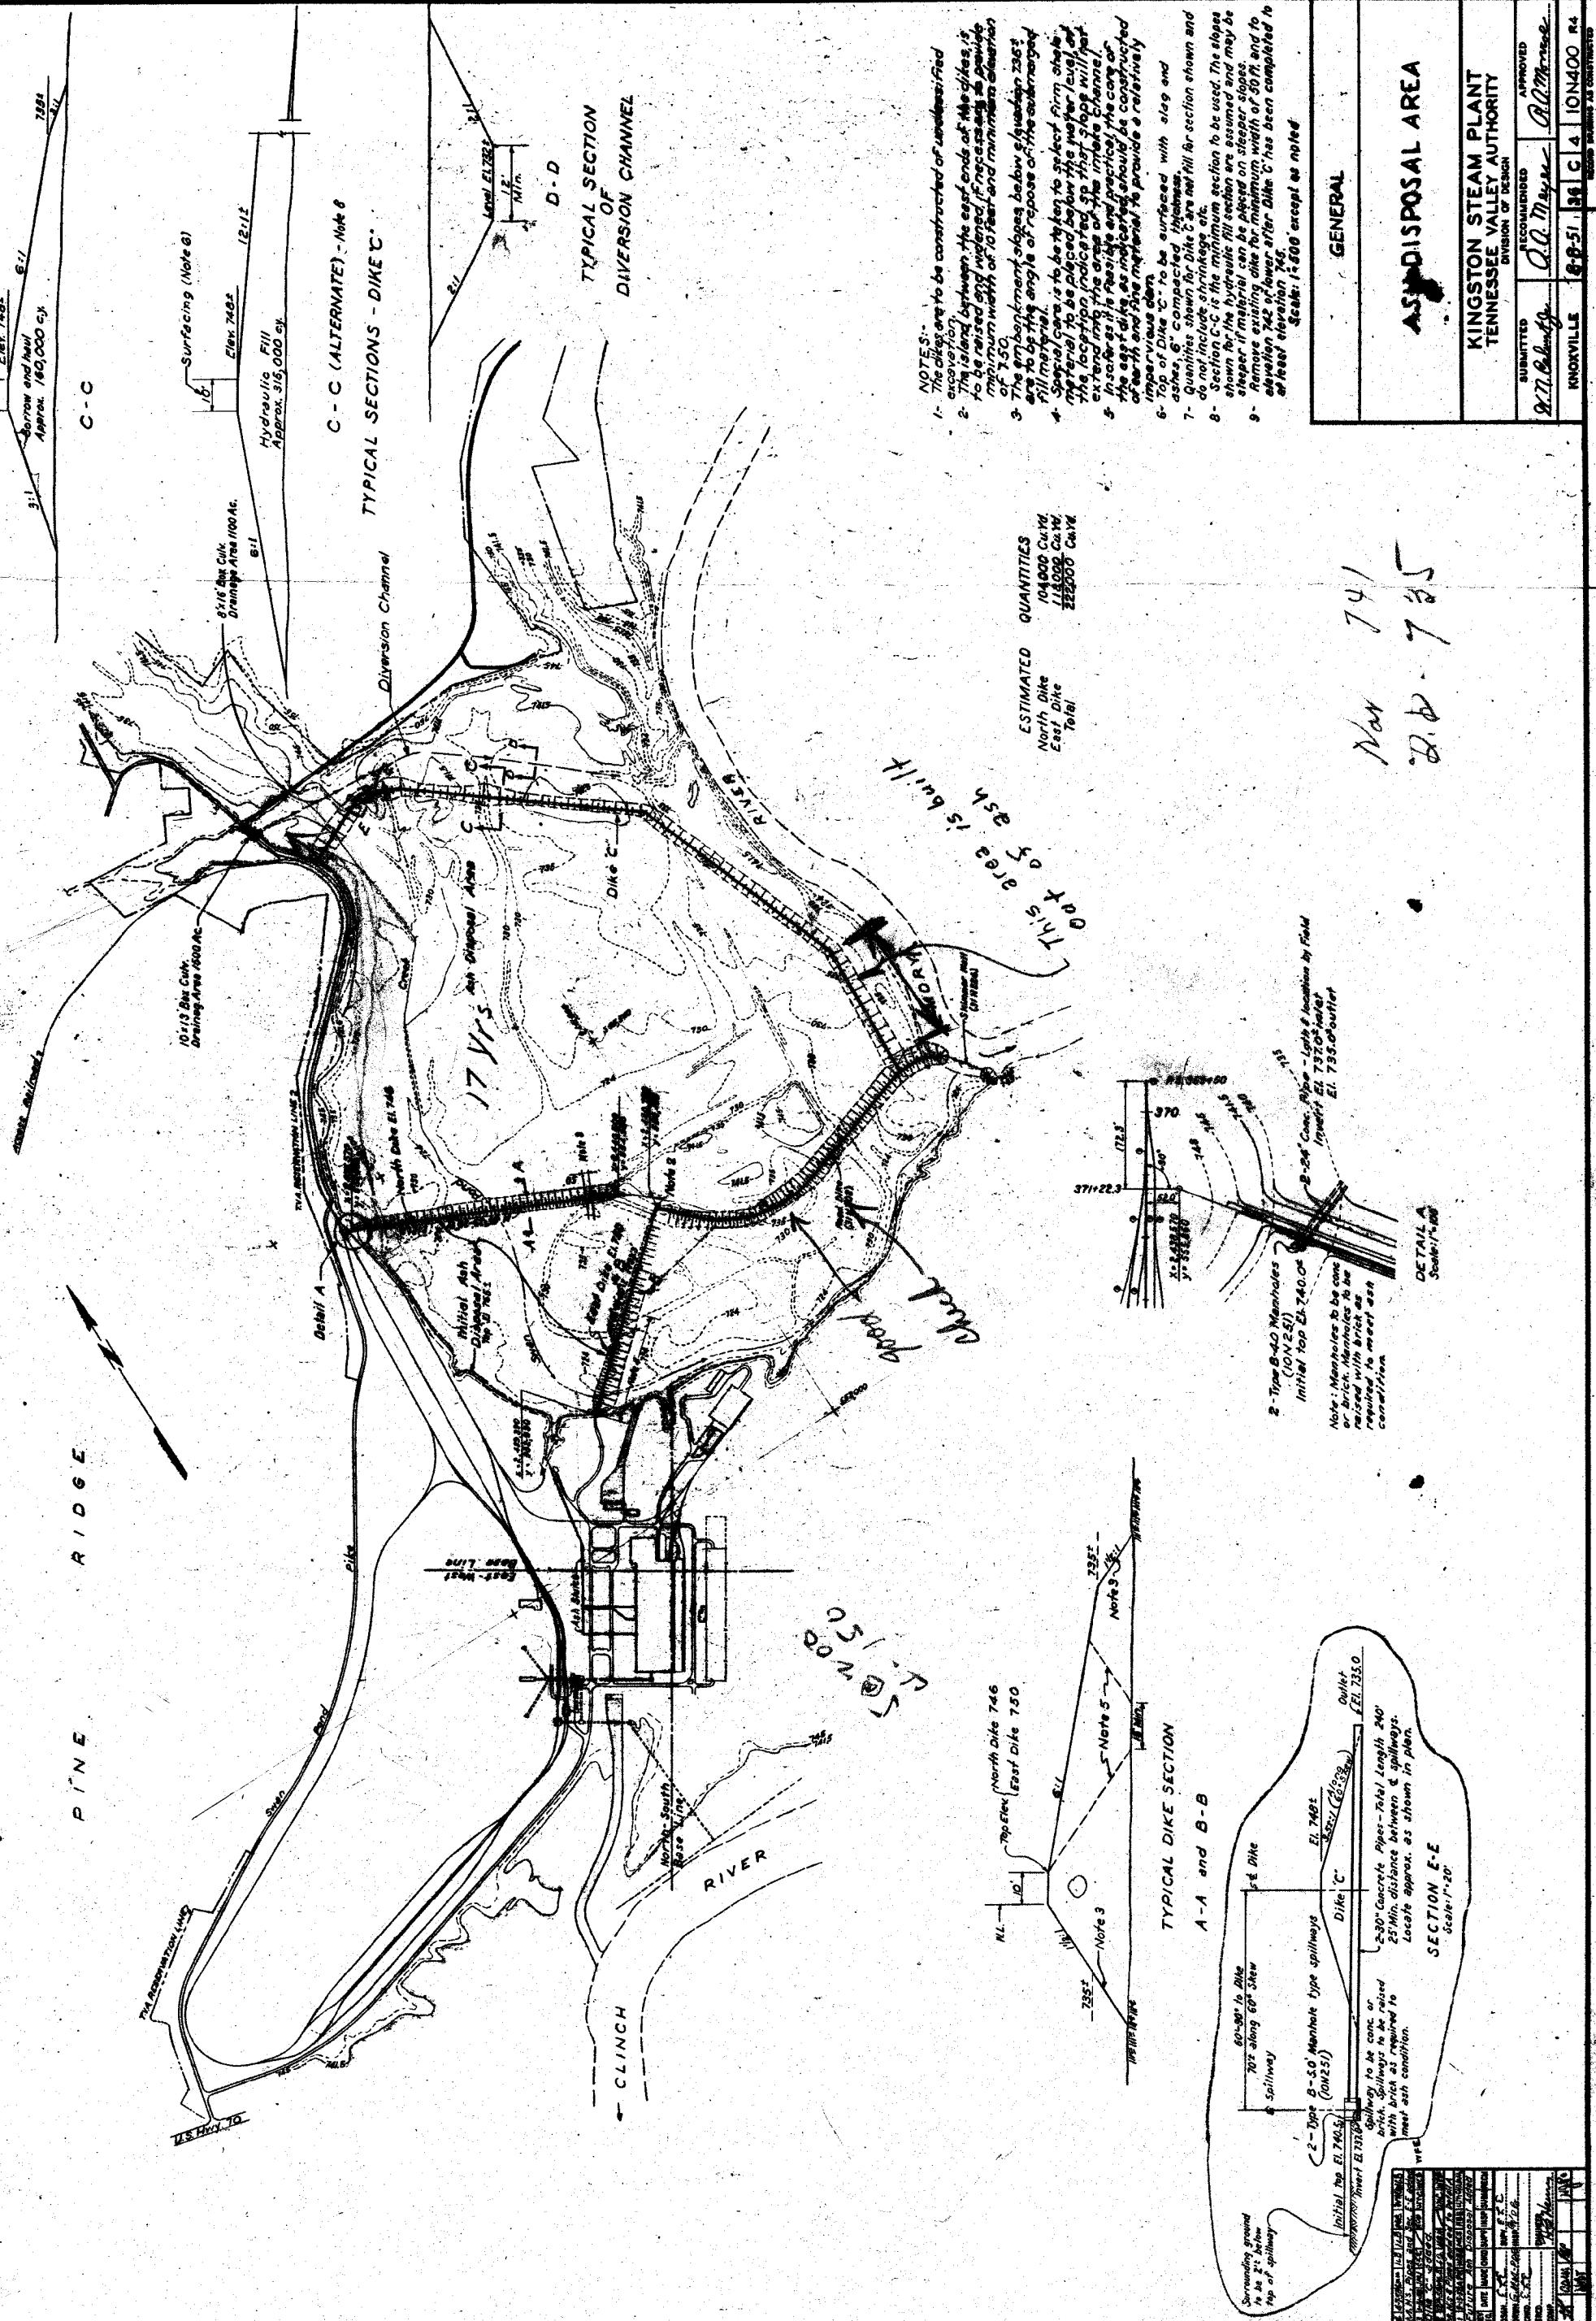
An inspection of the pavement was made along the access highway and truck roads. The pavement was in fair shape with the asphalt concrete showing signs of impending failure at places where lumps and valleys were present. The Portland cement concrete pavement was in excellent condition except at the point where the asphalt concrete ends and the Portland cement concrete begins (see attached photos). One corner of the concrete pavement is badly broken.
