TENNESSEE VALLEY AUTHORITY

KINGSTON FOSSIL PLANT

ANNUAL ASH POND DIKE
STABILITY INSPECTION
2009

Prepared by: Chris Buttram
Date: January 12, 2009

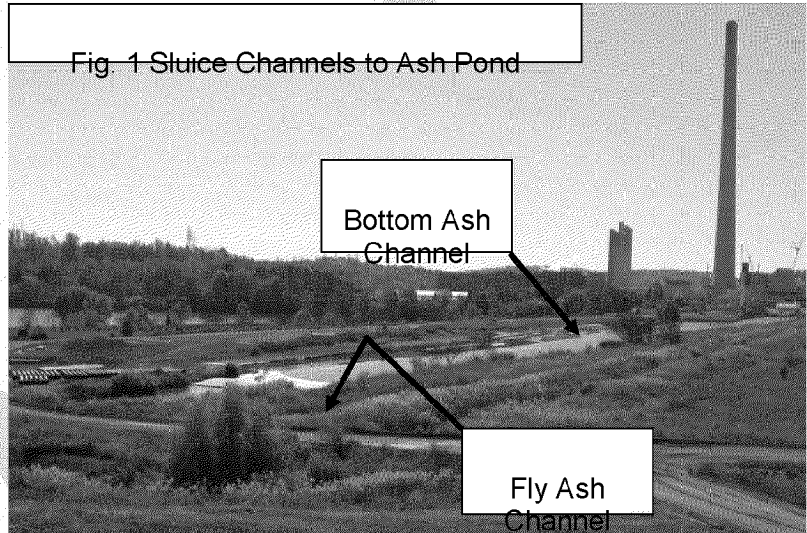
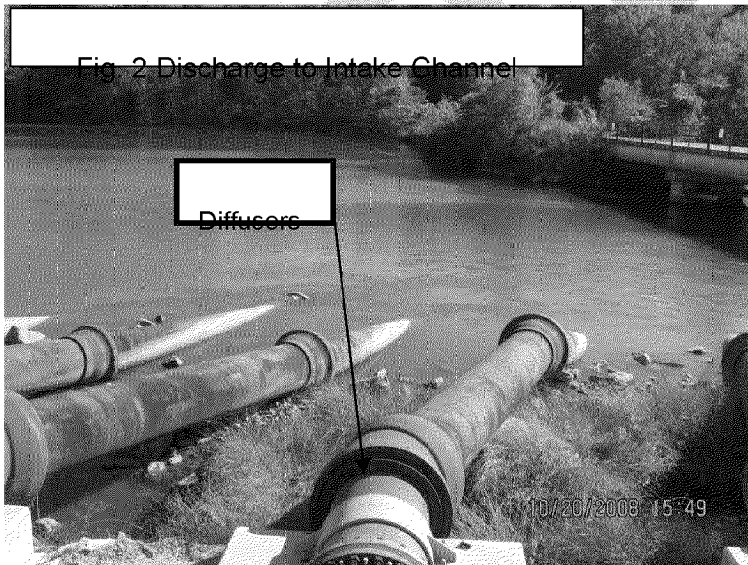
Fly ash is sluiced to a channel adjacent to the bottom ash channel and flows into the main ash pond. The fly ash channel was cleared of vegetation last year. Both channels flow northeast into the active ash pond. See Figure 1 and drawing API 2009.
