TENNESSEE VALLEY AUTHORITY

## KINGSTON FOSSIL PLANT

ANNUAL ASH POND DIKE  
STABILITY INSPECTION  
2009

Prepared by: Chris Buttram  
Date: January 12, 2009

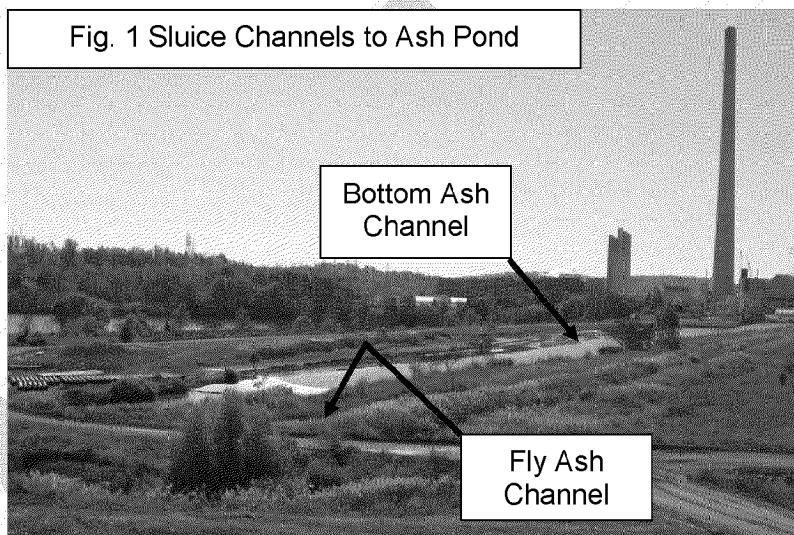
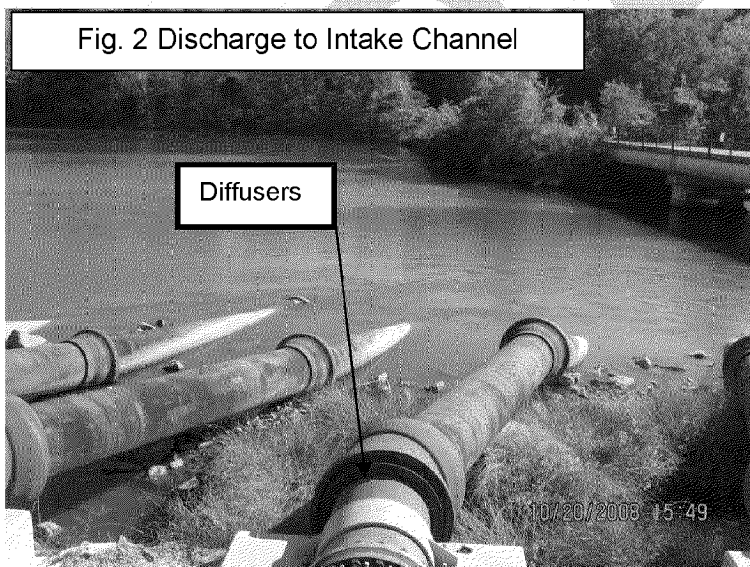
Bottom ash is sluiced into a channel southwest of the active ash disposal area. The bottom settles out in the channel and is removed by dragline, which is subsequently used for dike construction.

Fly ash is sluiced into an adjacent channel to the bottom ash channel where it flows into the main ash pond. The fly ash channel was cleared of vegetation last year. Both channels flow northeast into the active ash pond. See Figure 1 and drawing API 2009.
