TVA – Kingston Fossil Plant

Presentation to Plant Manager - Kingston Fossil Plant

Summary of Actions Taken
To Address Seepage through
Dredge Cell Dike And Recommended
Path Forward

27 March 2007

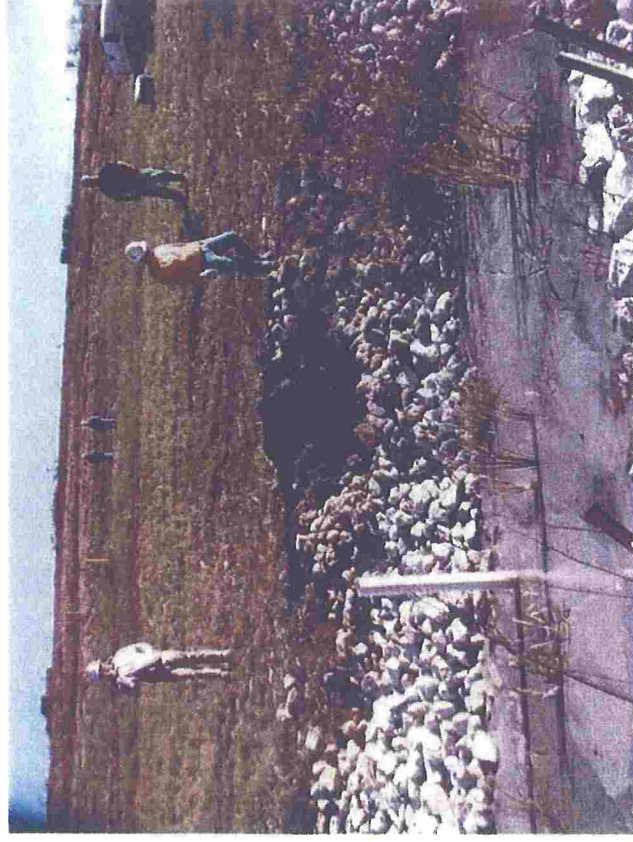
- Excessive seepage and piping observed near toe of dike on November 1, 2006 (two locations, similar location to 2005)
- Decision made to lower water levels in Ash Pond, conduct dye test, install “temporary patch”
- The patch coupled with weather improvements minimized the immediate threat
- Suspended Dredging Operations
- Lowered Water Table

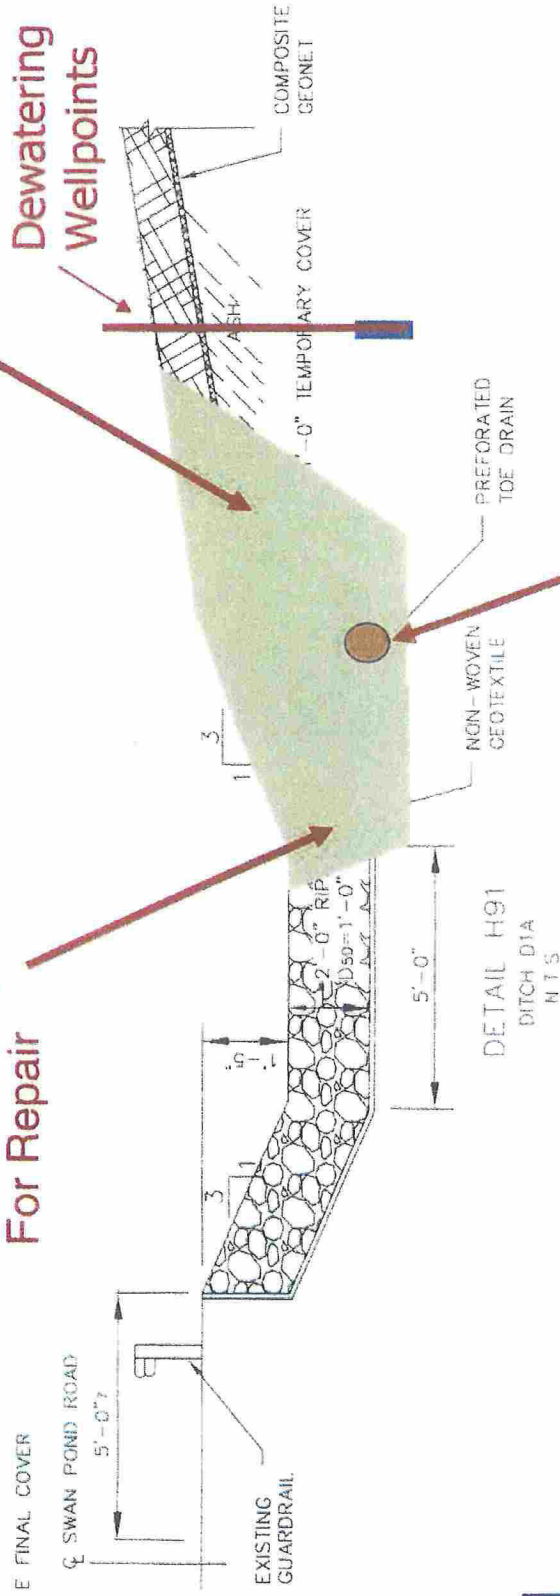
Step 3 – Prepare Area For Repair

- Developed an intrusive investigation plan that could be coupled with temporary or permanent repair activities
- Identified southern seep area as the preferred location for the intrusive investigation due to continued observation of seepage, ash piping and high water levels

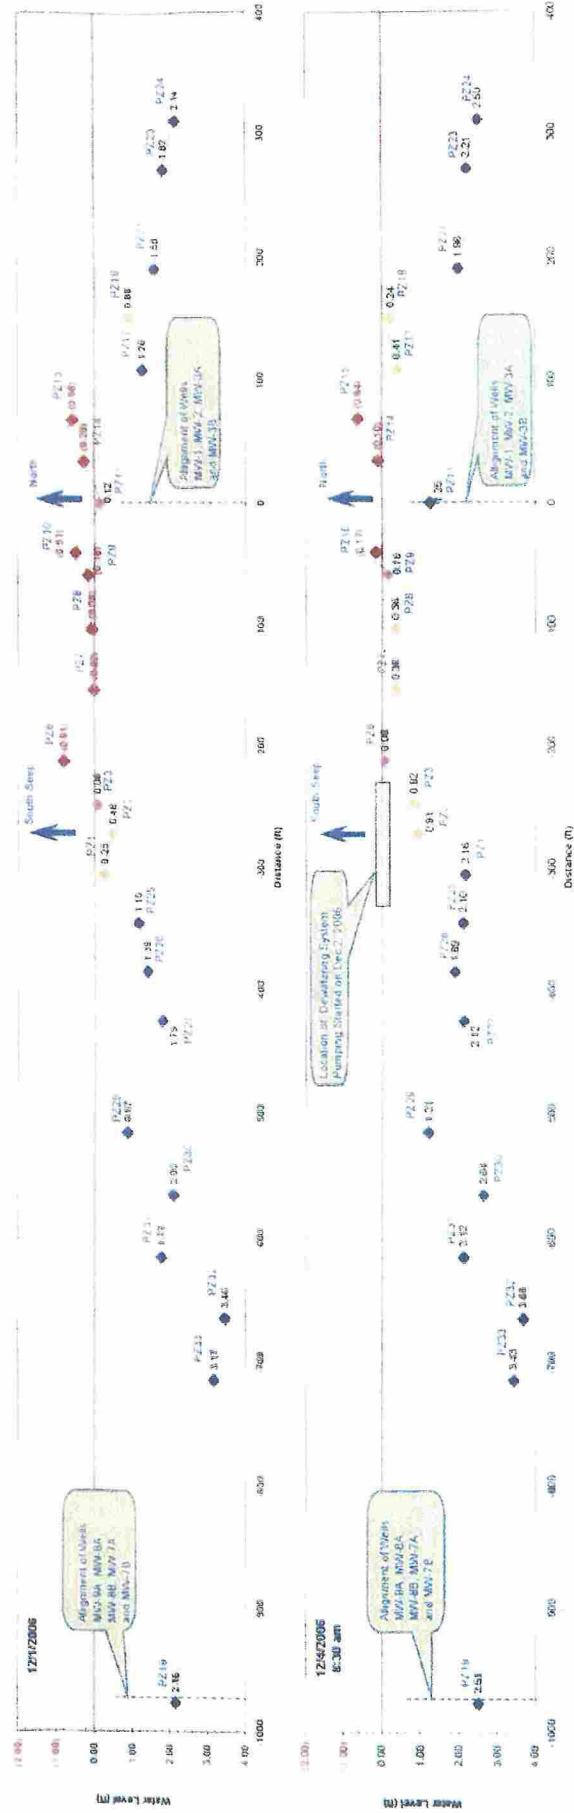
- Monitored water level response to dewatering
- Initiated intrusive investigation once water levels were below ground surface

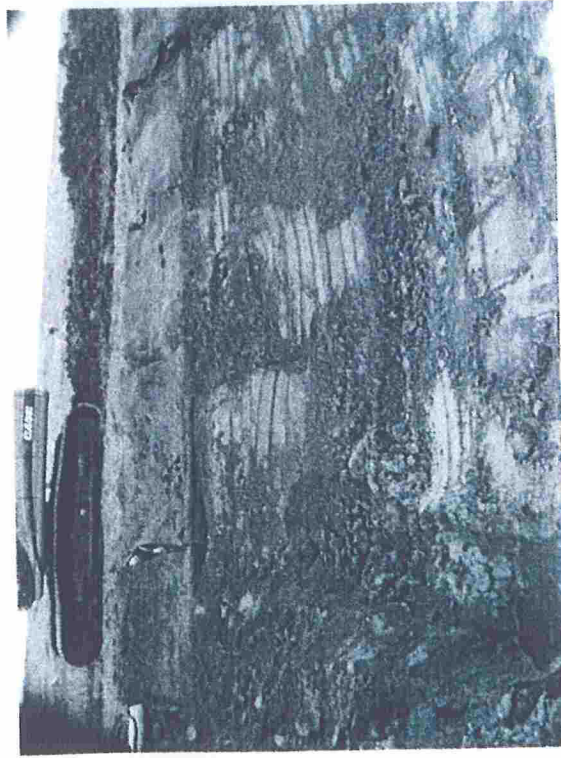
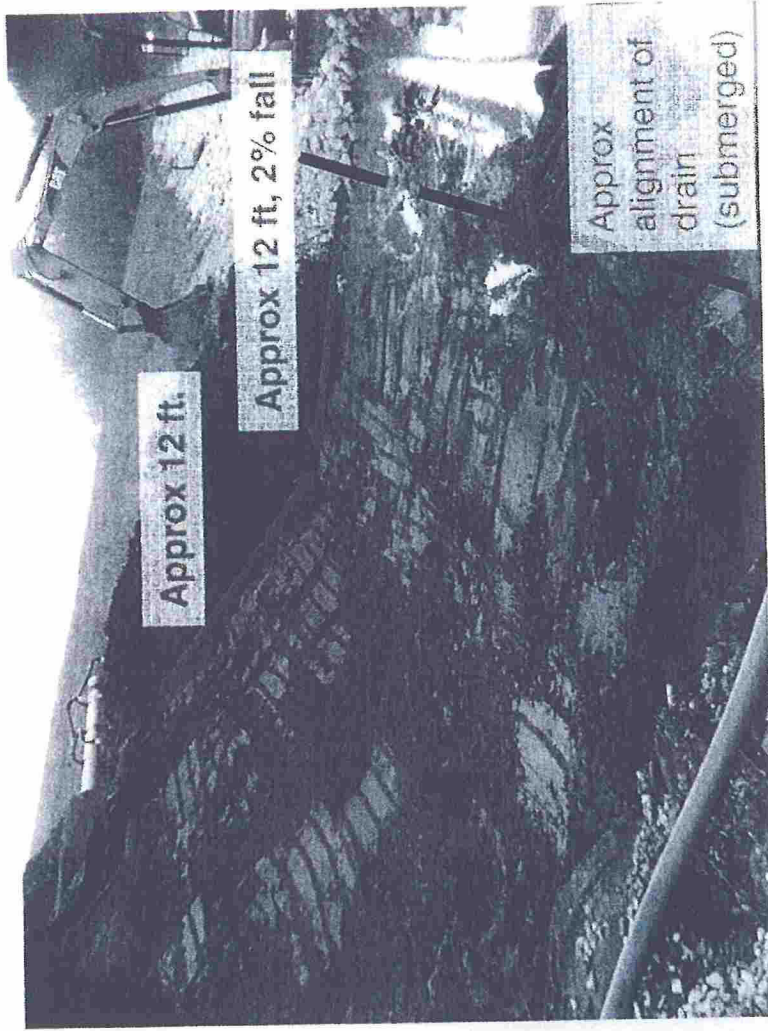
- Conditions immediately prior to repair/placement of new buttress drain

- Overall goal:
 - Improve toe drain
 - Contain ash to prevent piping

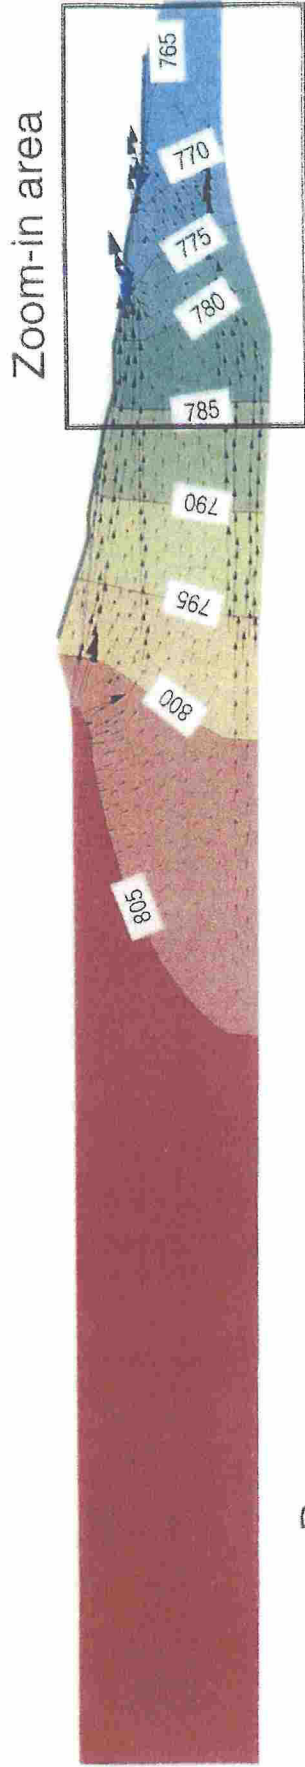
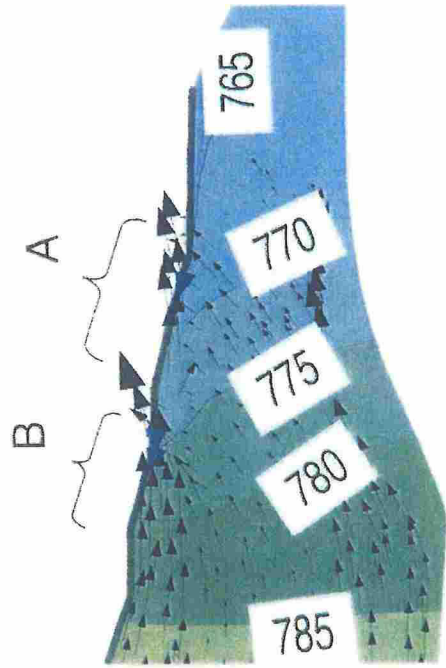
Model-predicted Total Head Distribution (equipotential lines)

Model clearly illustrates that without adequate drainage, seepage water will exit the lower portion of the slope. The exact location is difficult to predict and is highly sensitive to localized zones of more permeable material (e.g., bottom ash which had been identified in borings)

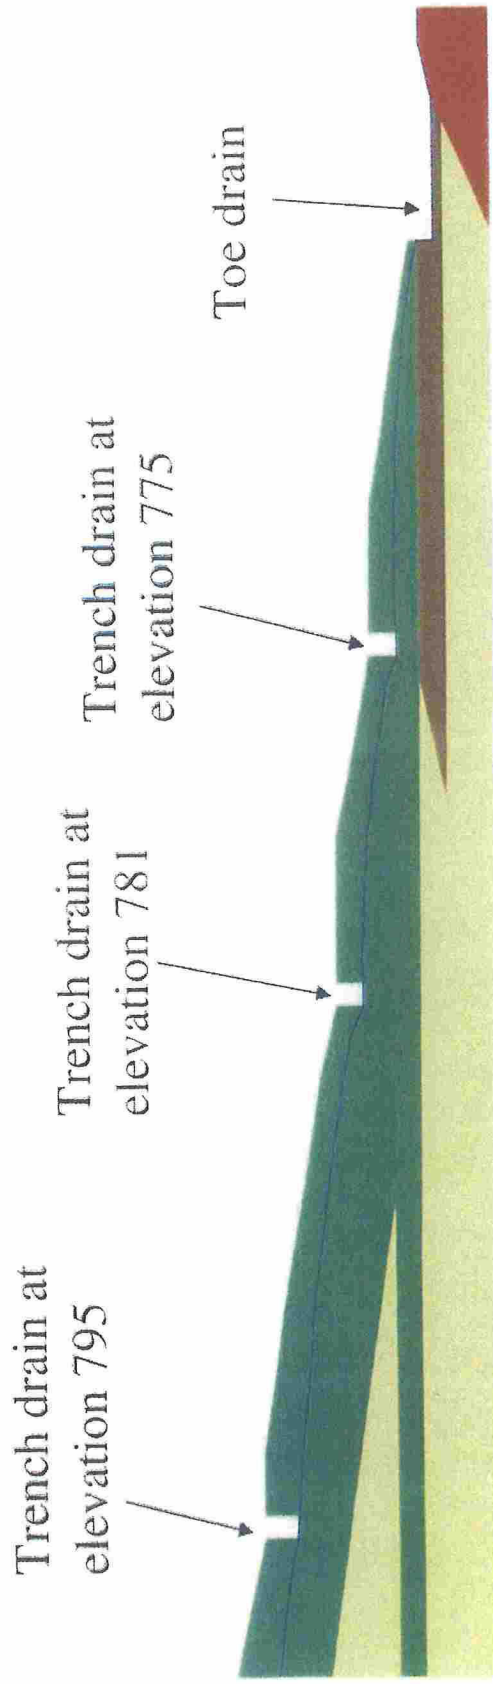
Proposed Improvements (2005)

A series of drainage improvements were developed, analyzed, and implemented (2005) with the goal of lowering the phreatic surface and controlling seepage at the toe

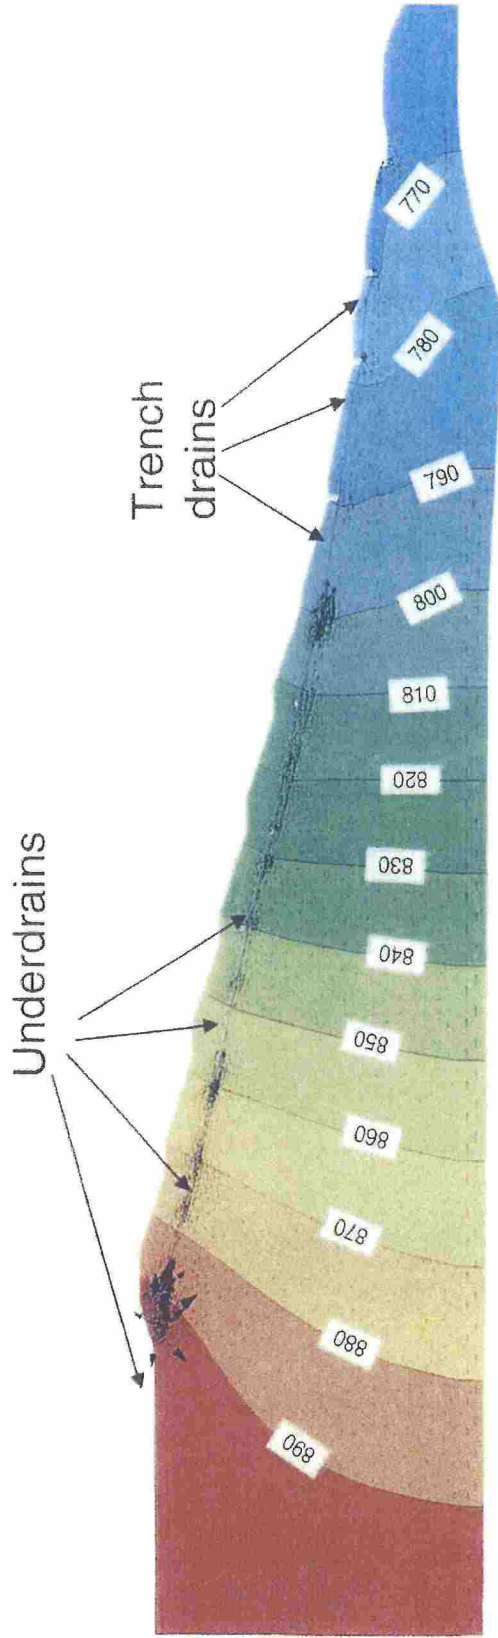
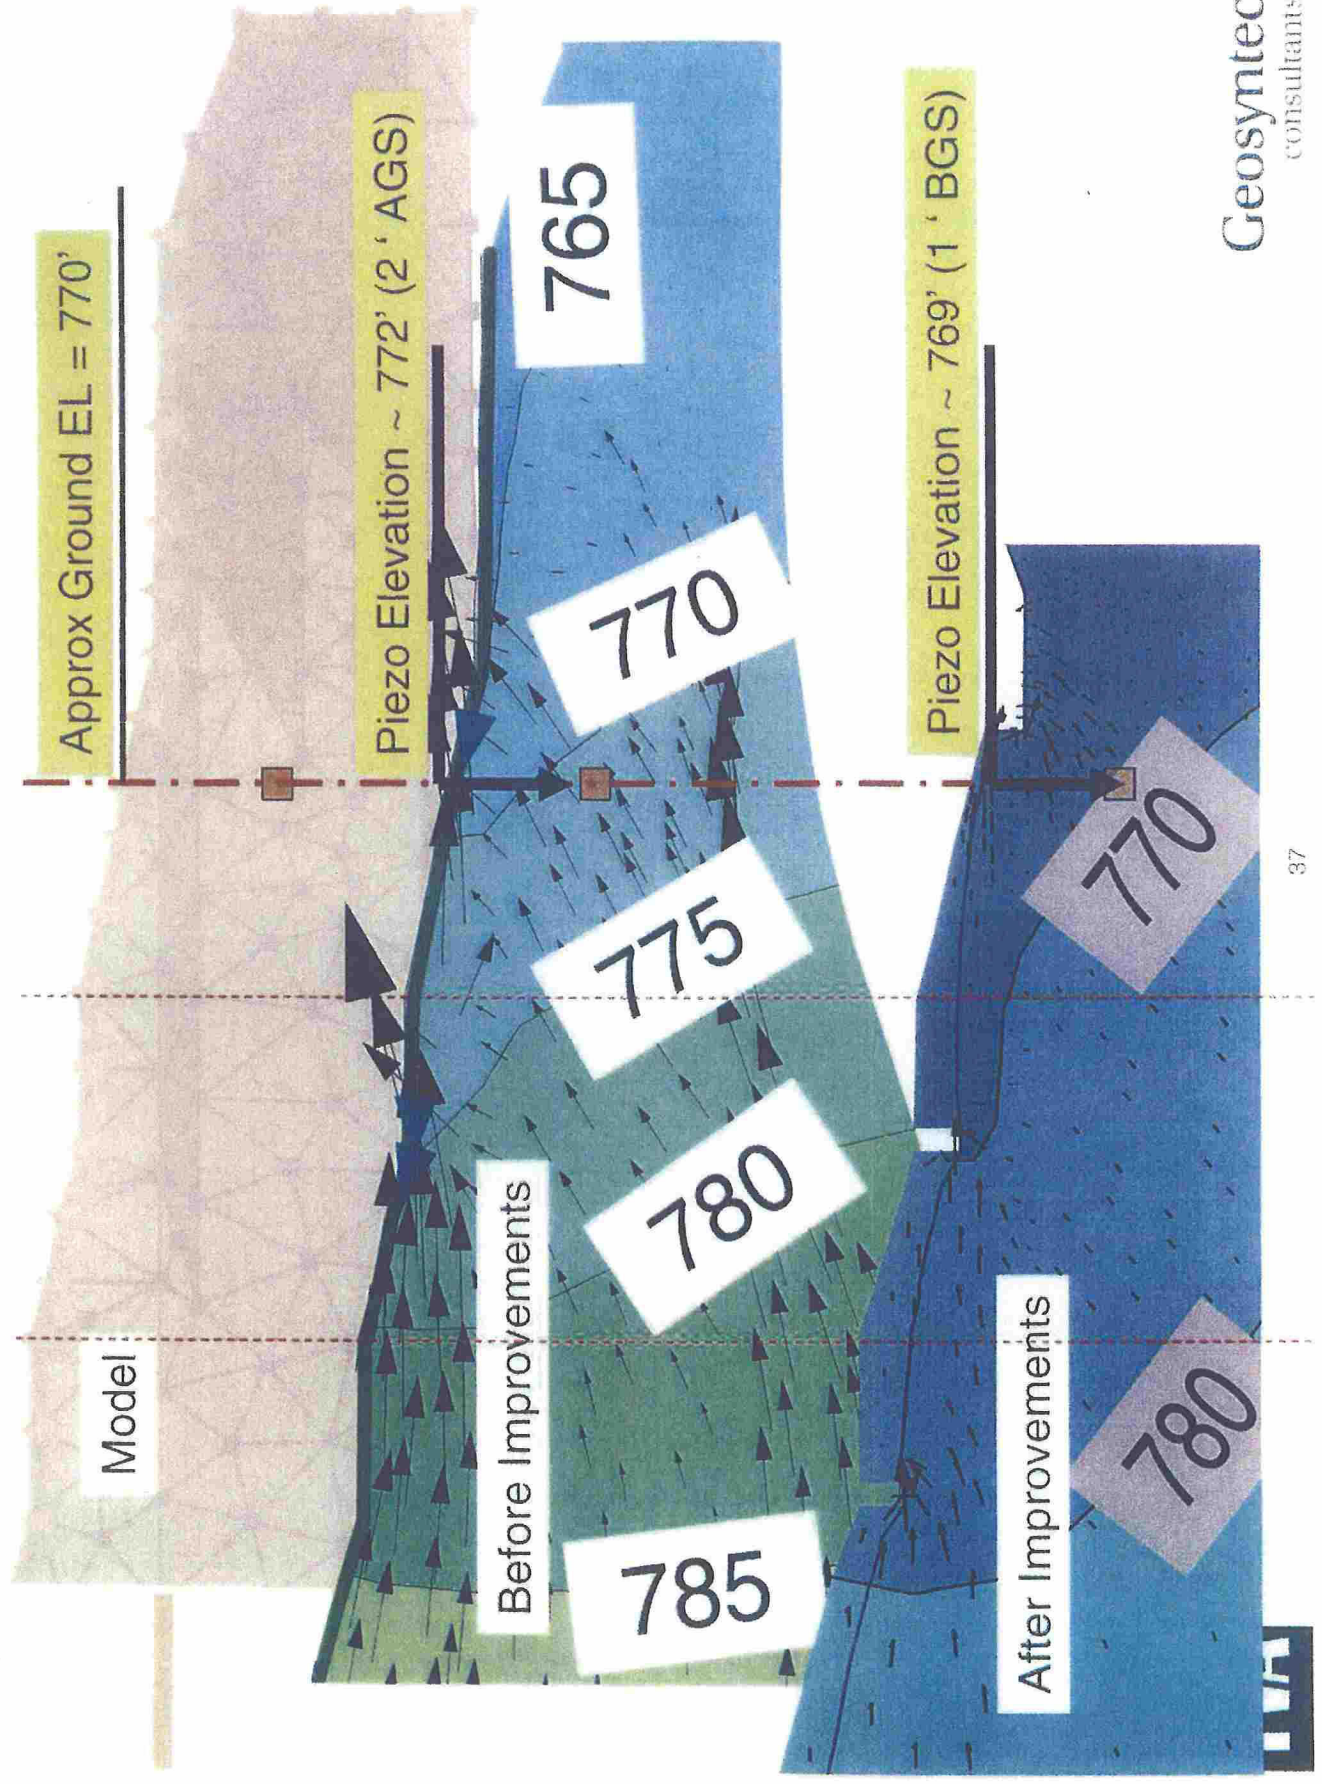
Model-predicted Total Head Distribution (Future Conditions)

Model simulations indicated that the phreatic surface would be reduced and seepage will be controlled effectively

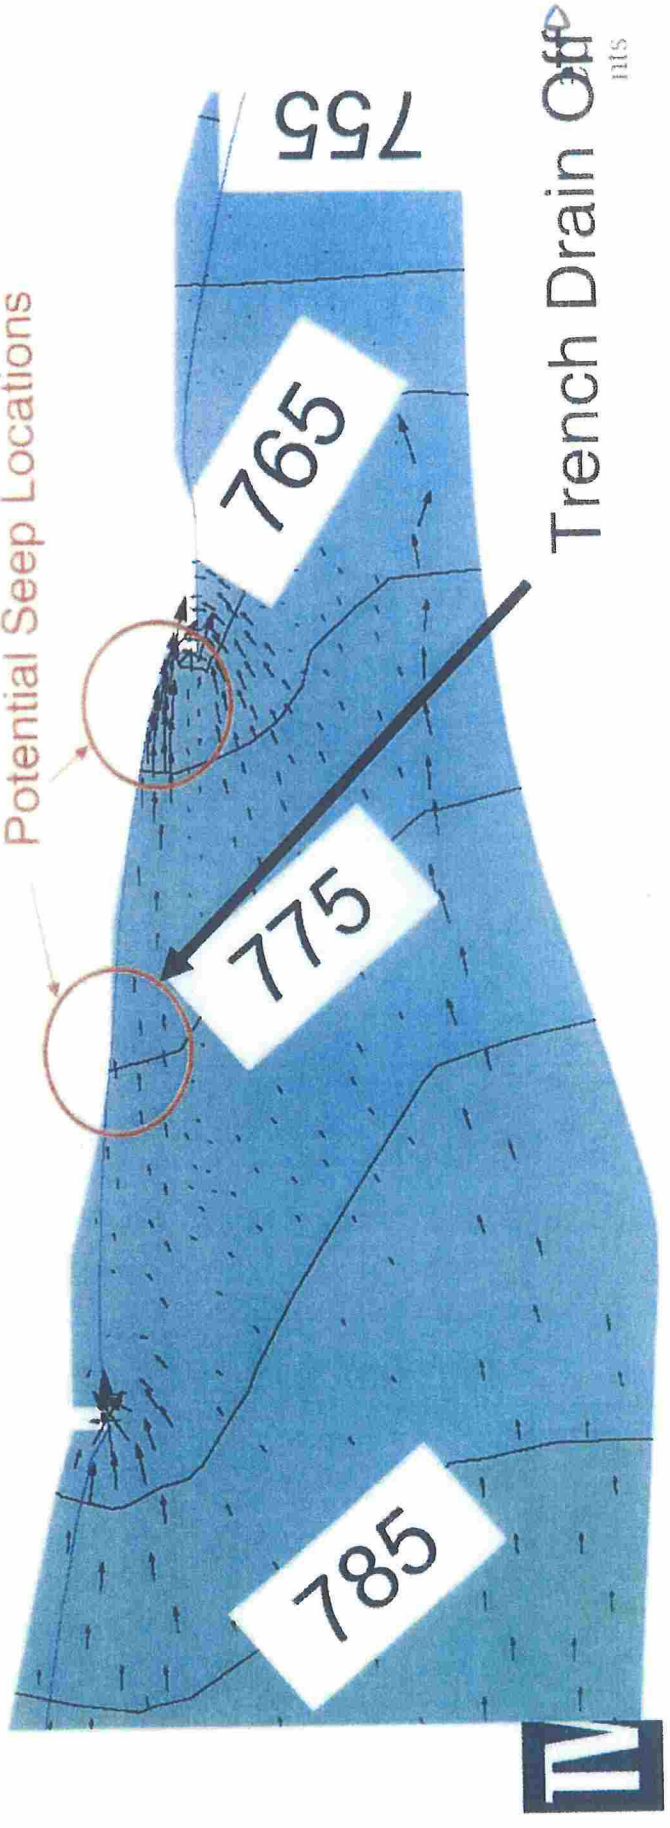
Trench Drain Off

Potential Seep Locations
