JOHN SEVIER FOSSIL PLANT - ANNUAL INSPECTION OF WASTE DISPOSAL  
AREAS

**JOHN SEVIER FOSSIL PLANT (JSF)  
NPDES PERMIT NO. TN0005436  
ANNUAL ASH POND DIKE INSPECTION  
2000**

# JOHN SEVIER FOSSIL PLANT ANNUAL ASH POND DIKE STABILITY INSPECTION 2008

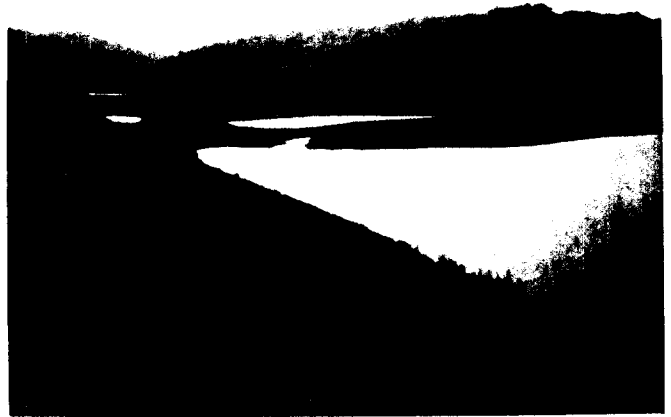
② POND 2 - ASH AT DISCHARGE  
PIPES (NOT REMOVED) LOOKING  
SOUTH EAST.
