**WIDOWS CREEK FOSSIL PLANT
ANNUAL ASH POND DIKE STABILITY INSPECTION
FY 2009**

The waste disposal areas at Widows Creek Fossil Plant (WCF) were inspected for dike structural stability on October 15 and 16, 2008 by Kelly Evans of TVA Fossil Engineering Design Services (EDS) and Jamie Dotson of TVA Fuel By-products. The previous annual inspection was performed on December 5 and 6, 2007. The results of the inspection of the Coal Yard Drainage Basin, Coal Yard Perimeter Ditch, Limestone Pile Drainage Basin, Wet Gypsum Stacking Area, Stilling Pond for the Wet Gypsum Stacking Area, Active Ash Pond, Stilling Pond for Active Ash Pond, Dredge Cell, Perimeter Dikes, Red Water Pond, Chemical Treatment Pond, and the Abandoned Ash Disposal Area are listed below. A summary of recommendations is also provided. Estimated costs are based on the 2009 RSMEANS Building Construction Cost Data (quotes are advised for more accurate estimate).

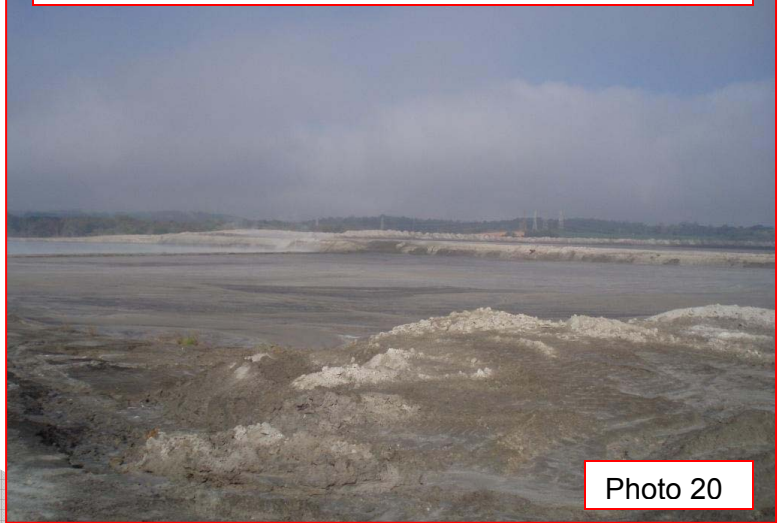
Photo 20

Gypsum Stack -southeast side - looking west

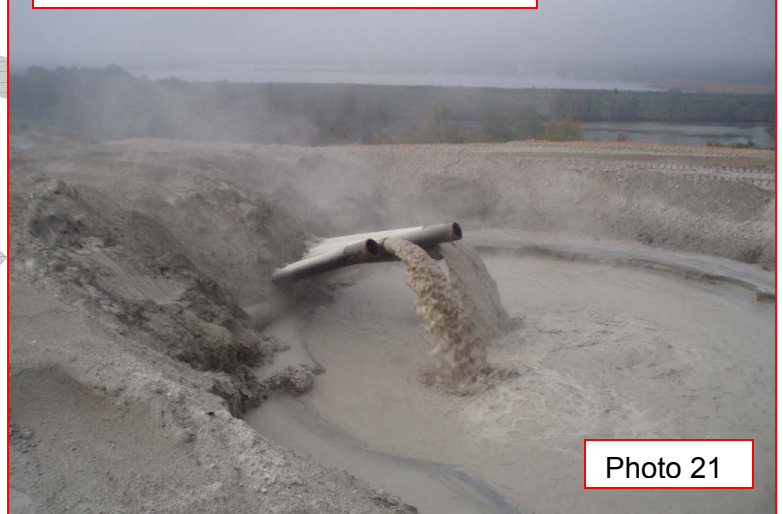
Photo 21

Slurry Pipes near northwest corner

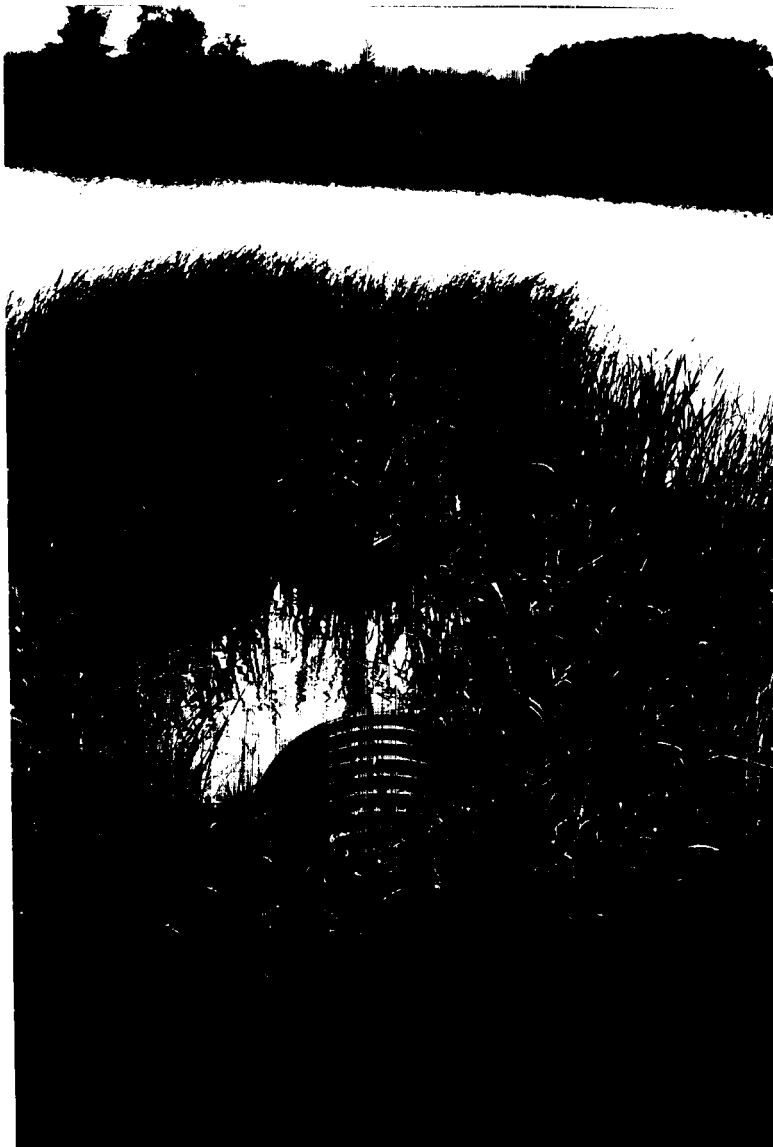
Picture 5. Sediment buildup at the outlet of the pipe which discharges the perimeter ditches of the Active Gypsum Stacking Area into the Stilling Pool.

- Remove the area of sediment buildup that has developed at the outlet of the pipe which discharges the perimeter ditches of the Active Gypsum Stacking Area into the Stilling Pool.

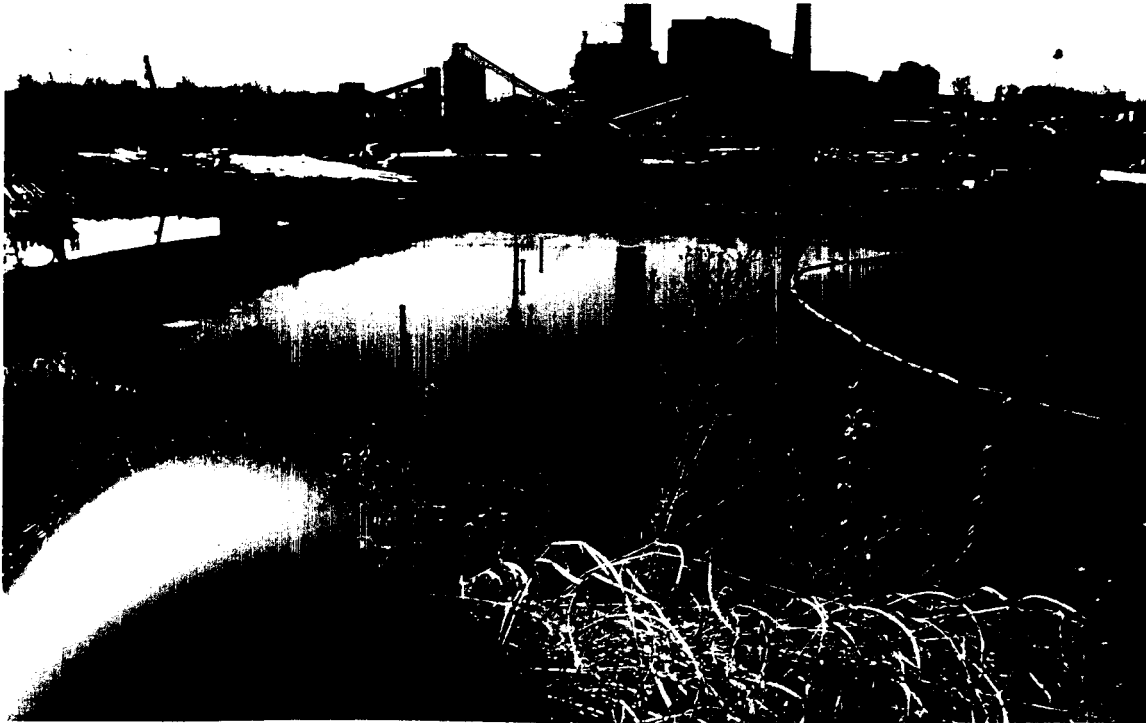
Picture 1. Active Ash Disposal Area - South end of Stilling Pond. Note high water level completely submerging the skimmers for the standard spillways.

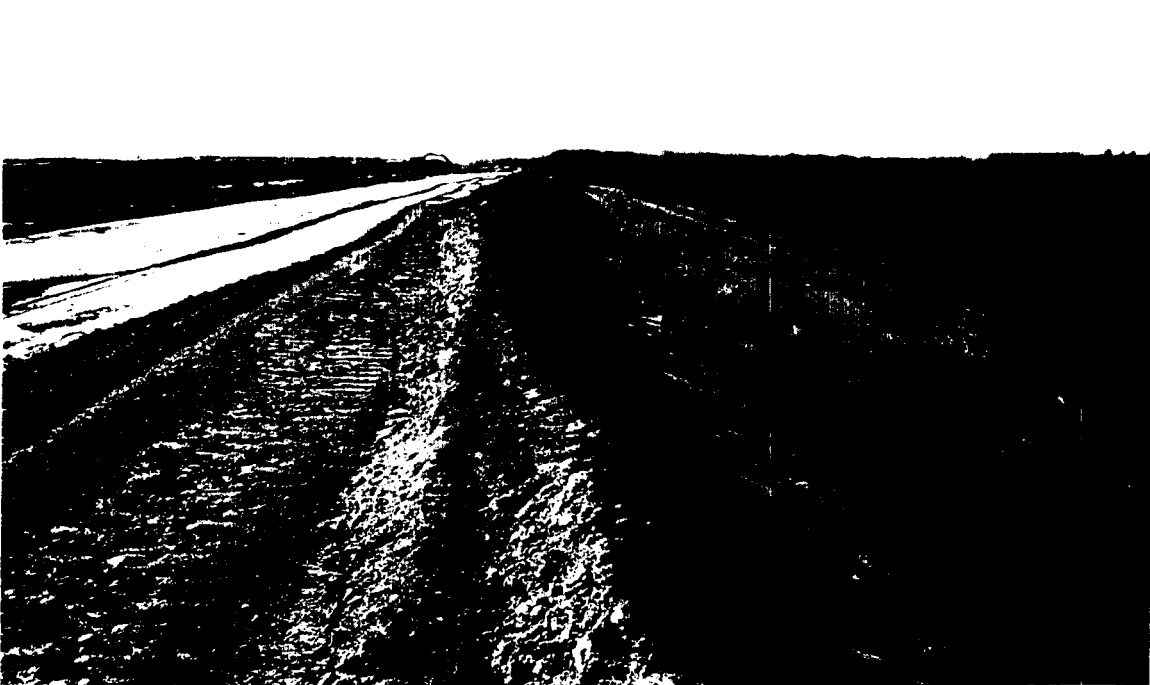
Picture 4. Active Gypsum Stacking Area - Exterior slope of gypsum stack along north dike. Note uncovered gypsum material at top of slope.

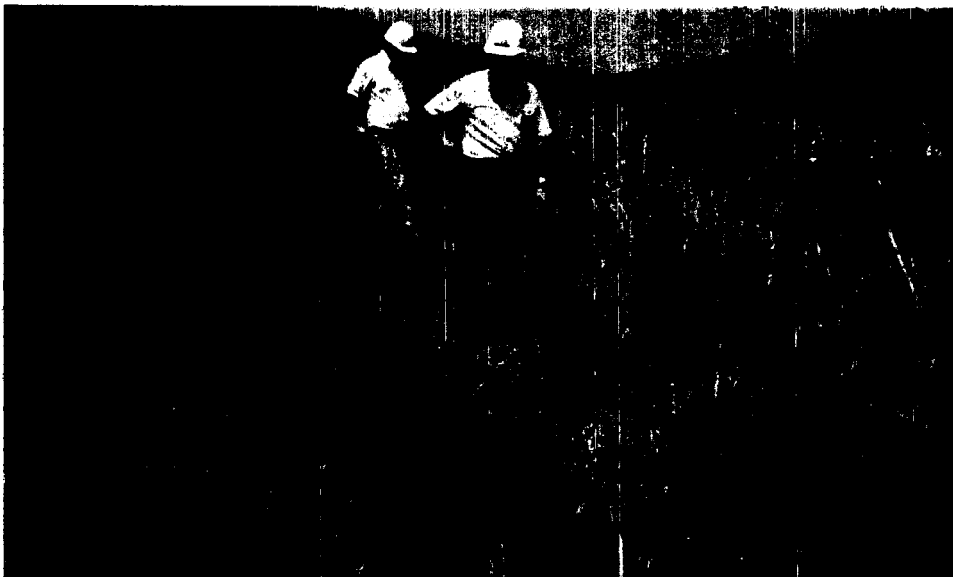
11. Gypsum Stacking
Area. Looking south
from the top of the
south dike.

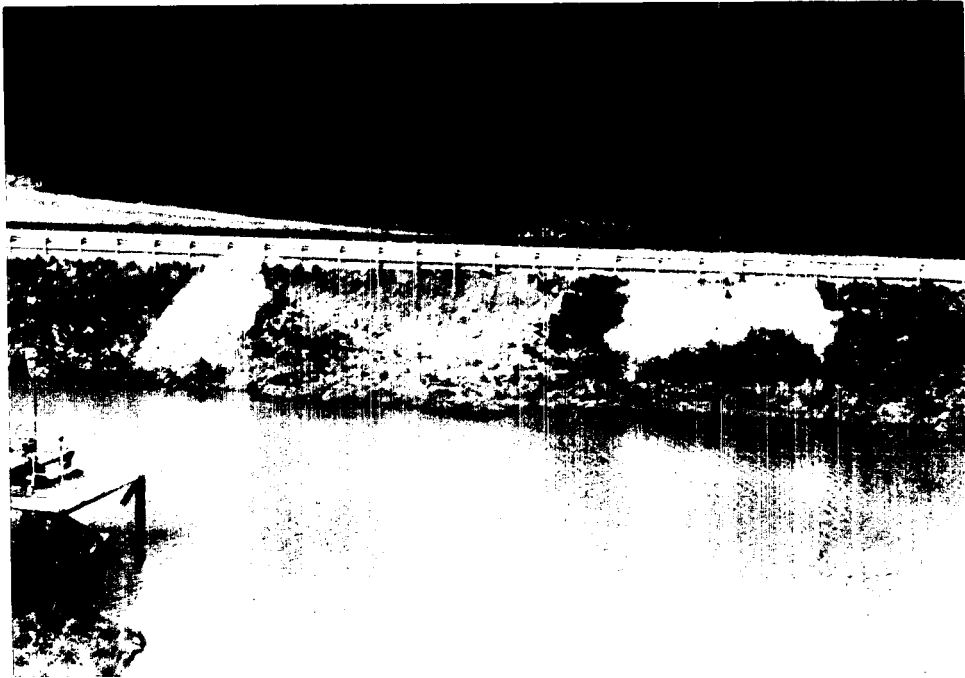
3. Slide on north side of redwater containment pond.
