16.0 Shiprock, New Mexico, Disposal Site

16.1 Compliance Summary

The Shiprock, New Mexico, Uranium Mill Tailings Radiation Control Act (UMTRCA) Title I Disposal Site was inspected on June 16, 2010. The disposal cell and all associated surface water diversion and drainage structures remained in good condition and were functioning as designed.

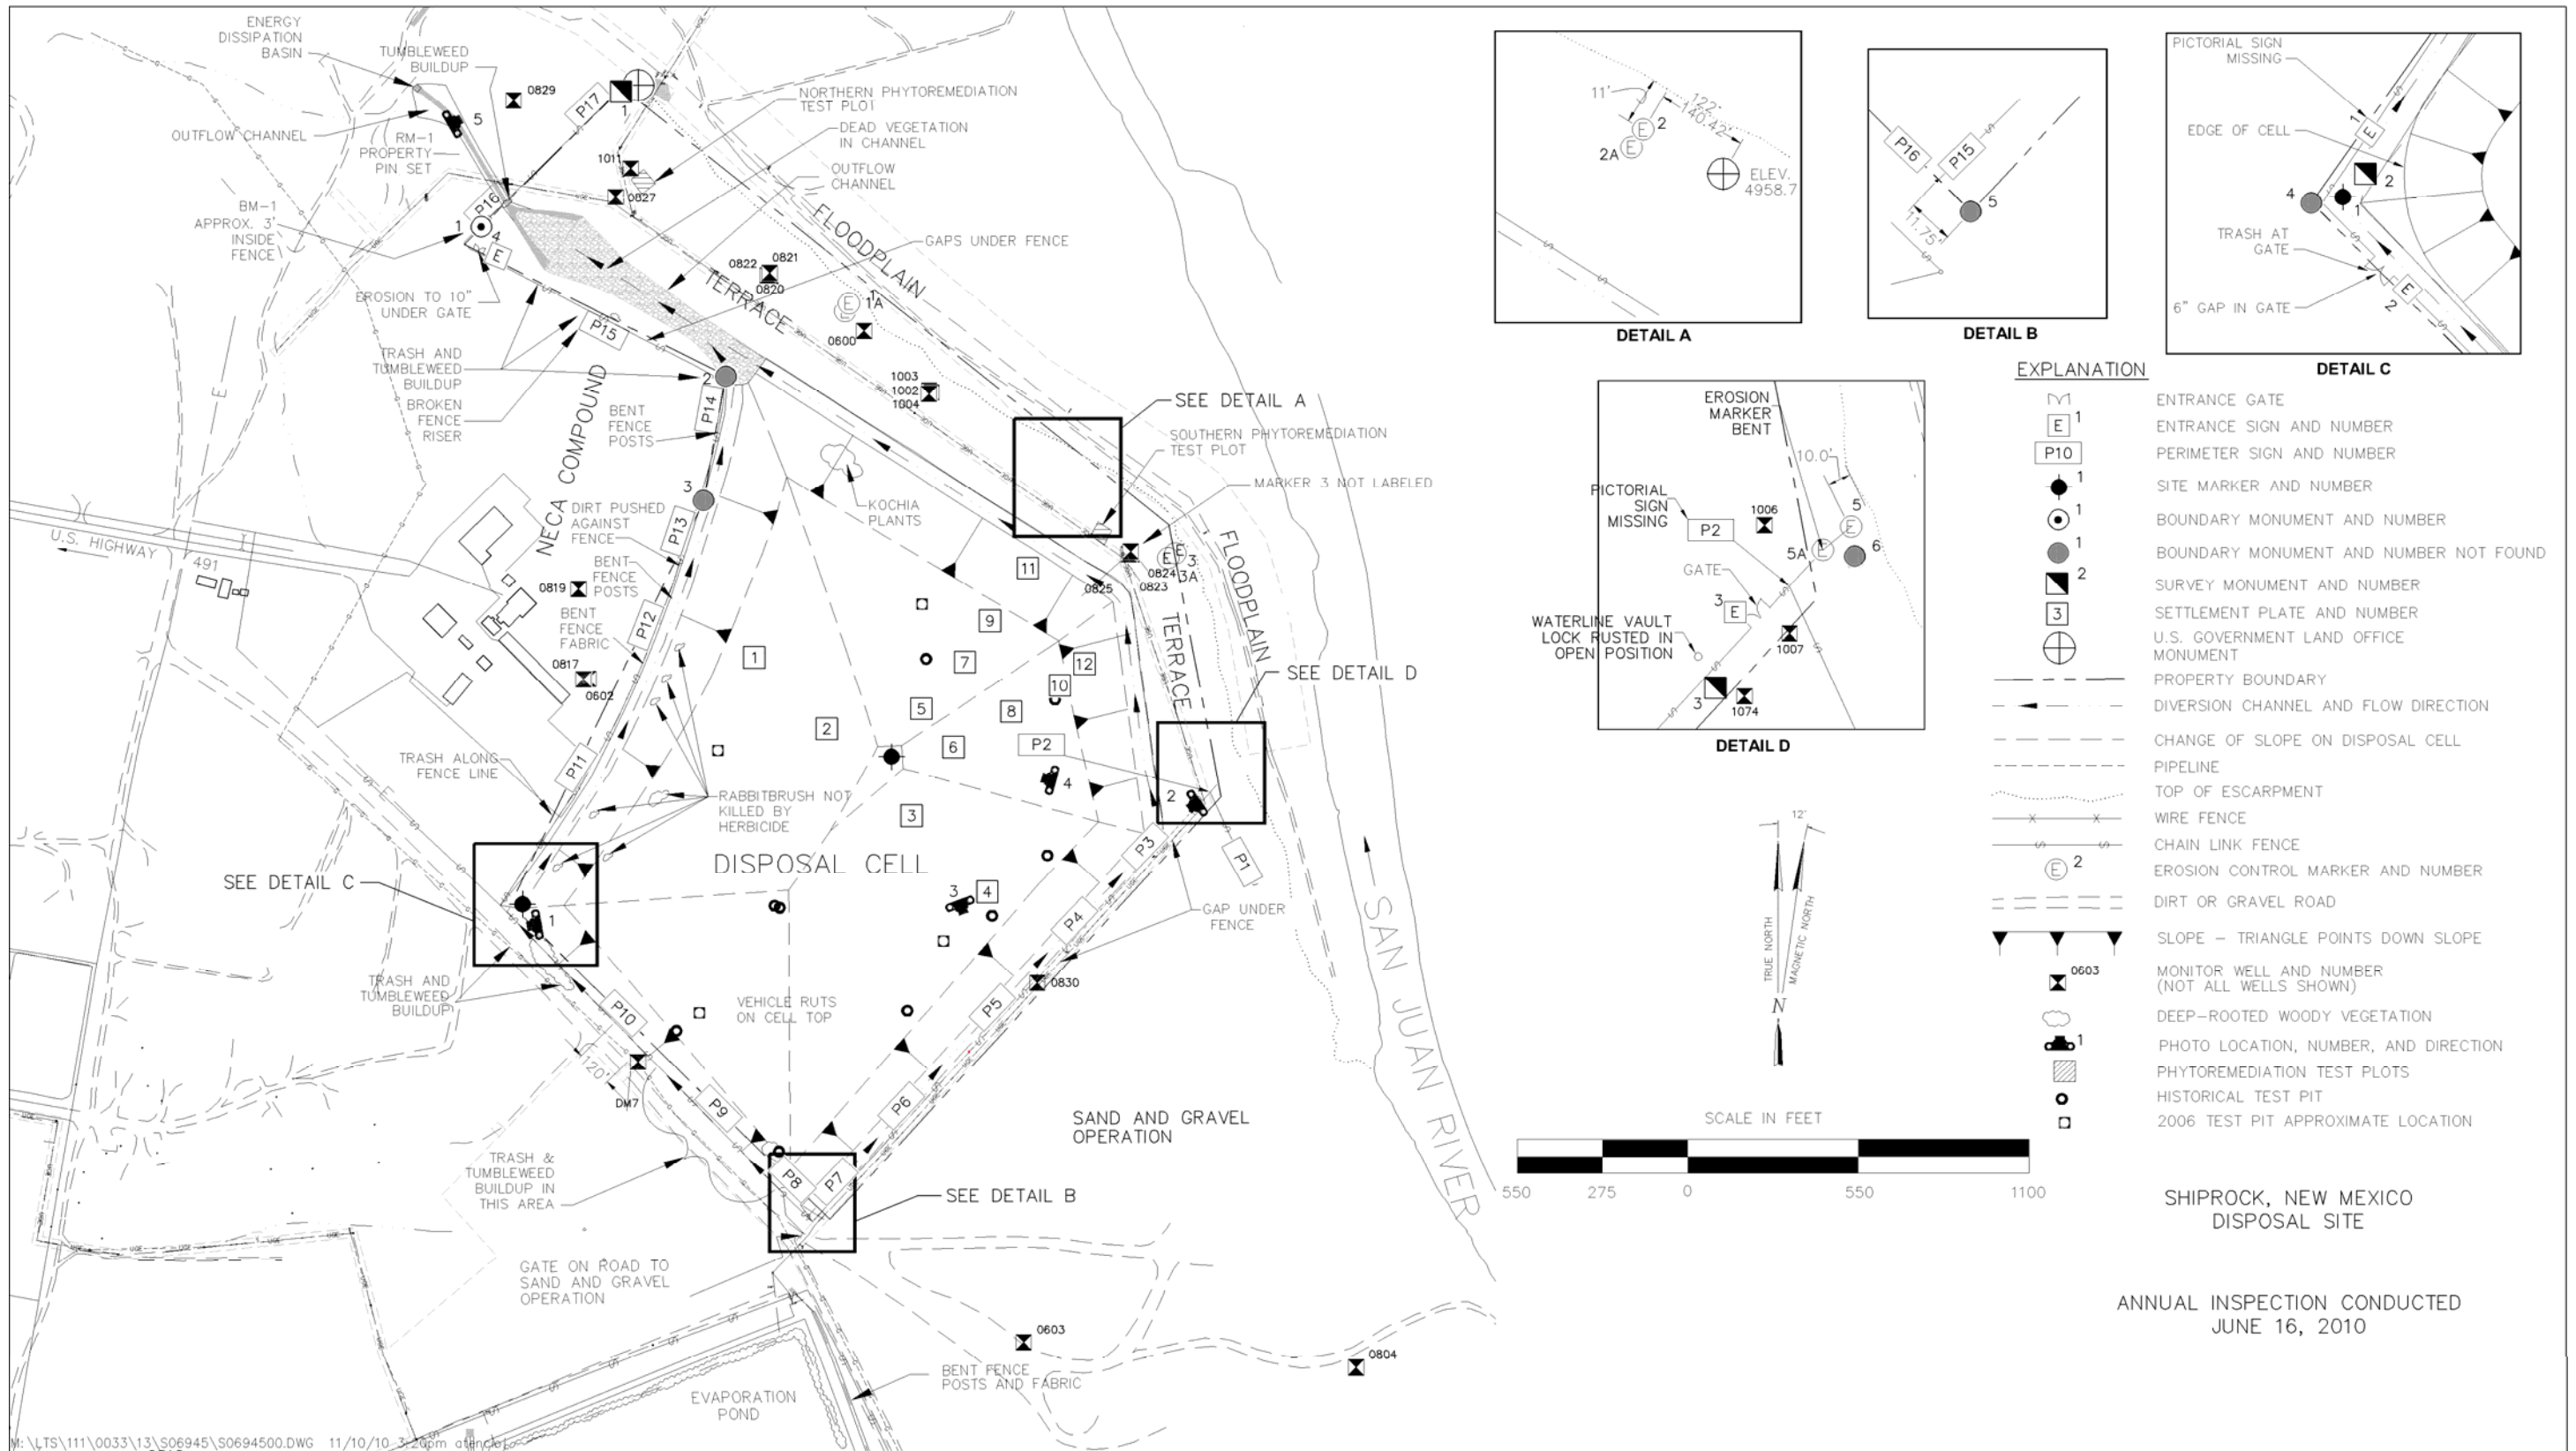
Figure 16-1. 2010 Annual Compliance Drawing for the Shiprock Disposal Site

Erosion Control Markers—The four sets of erosion control markers (ECMs) along the edge of the terrace escarpment were in good condition except for the marker near the east entrance gate (ECM-5A on Figure 16-1). This marker was previously damaged by a vehicle, but the marker is still functional and does not require repair at this time.
