16.0 Annual Inspection of the Shiprock, New Mexico, UMTRCA Title I Disposal Site

16.1 Compliance Summary

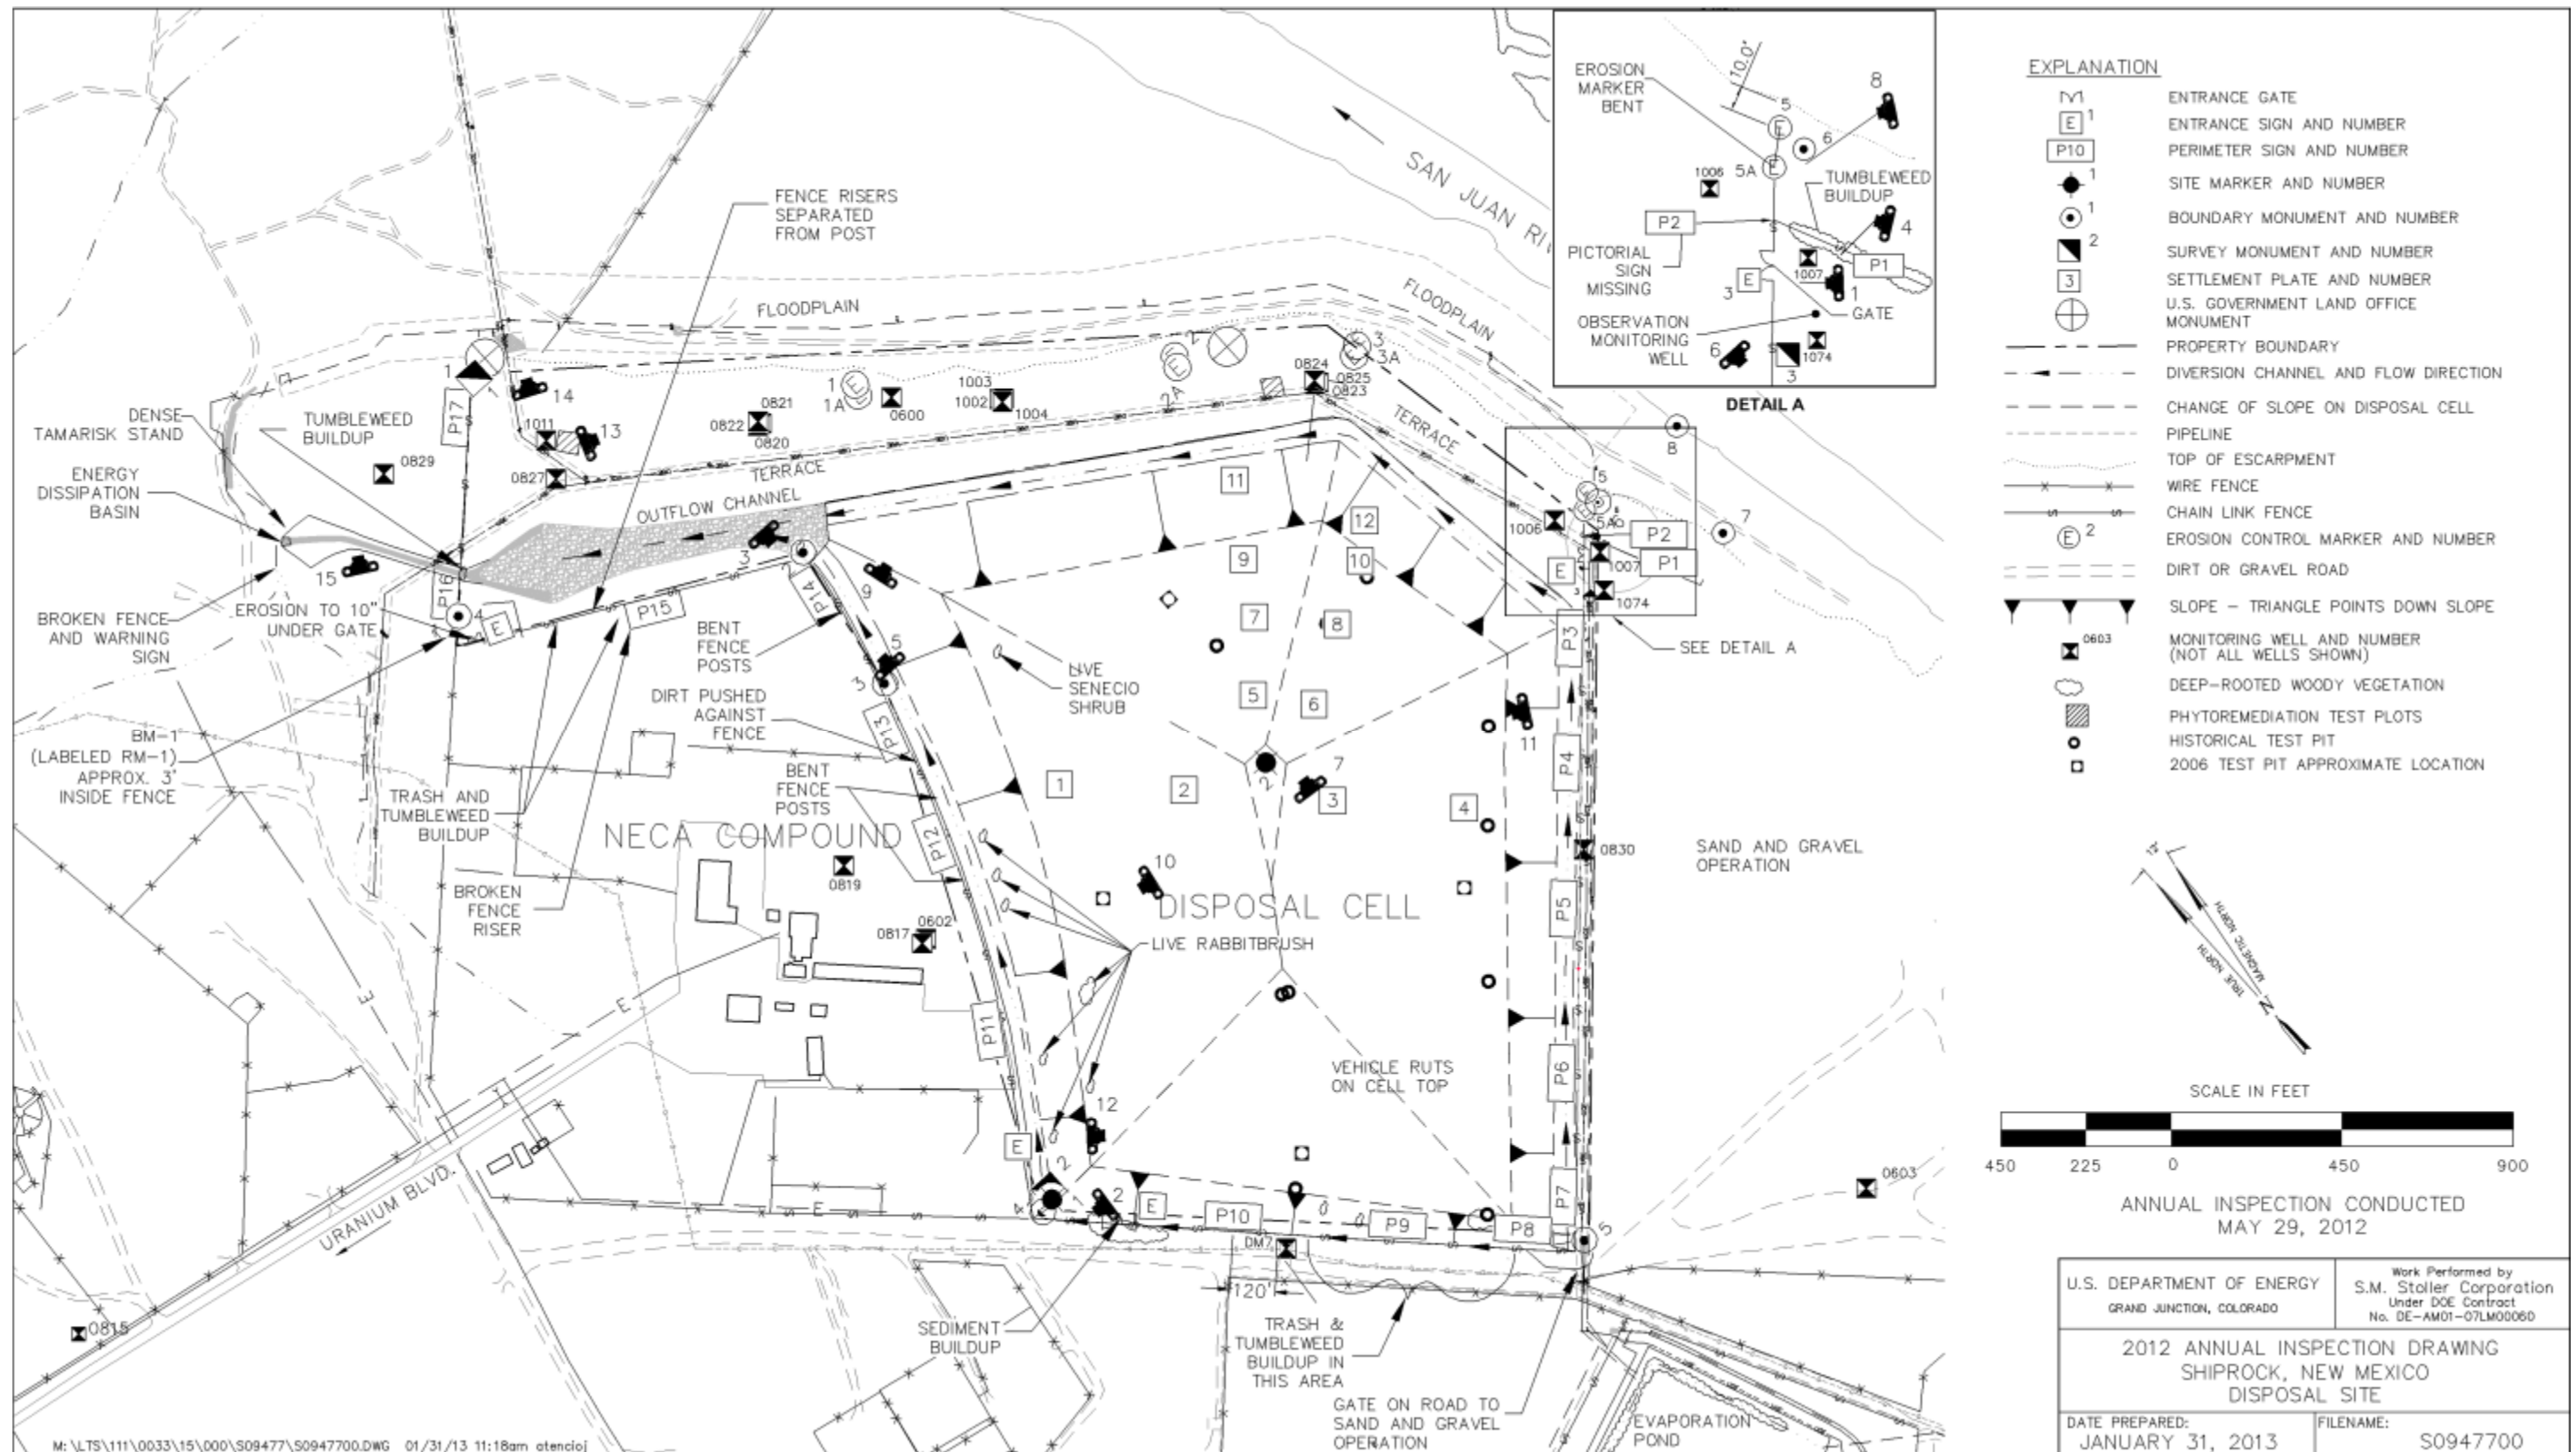
Figure 16-1. 2012 Annual Compliance Drawing for the Shiprock Disposal Site

The locations of site surveillance features are shown on Figure 16–1. Inspection results and recommended maintenance activities associated with site surveillance features are included in the following subsections. Photographs to support specific observations are identified in the text and on Figure 16–1 by photograph location (PL) numbers.
