# 2001 Annual Site Inspection and Monitoring Report for Uranium Mill Tailings Radiation Control Act Title I Disposal Sites

January 2002

# 2001 Annual Compliance Report Shiprock, New Mexico, Disposal Site

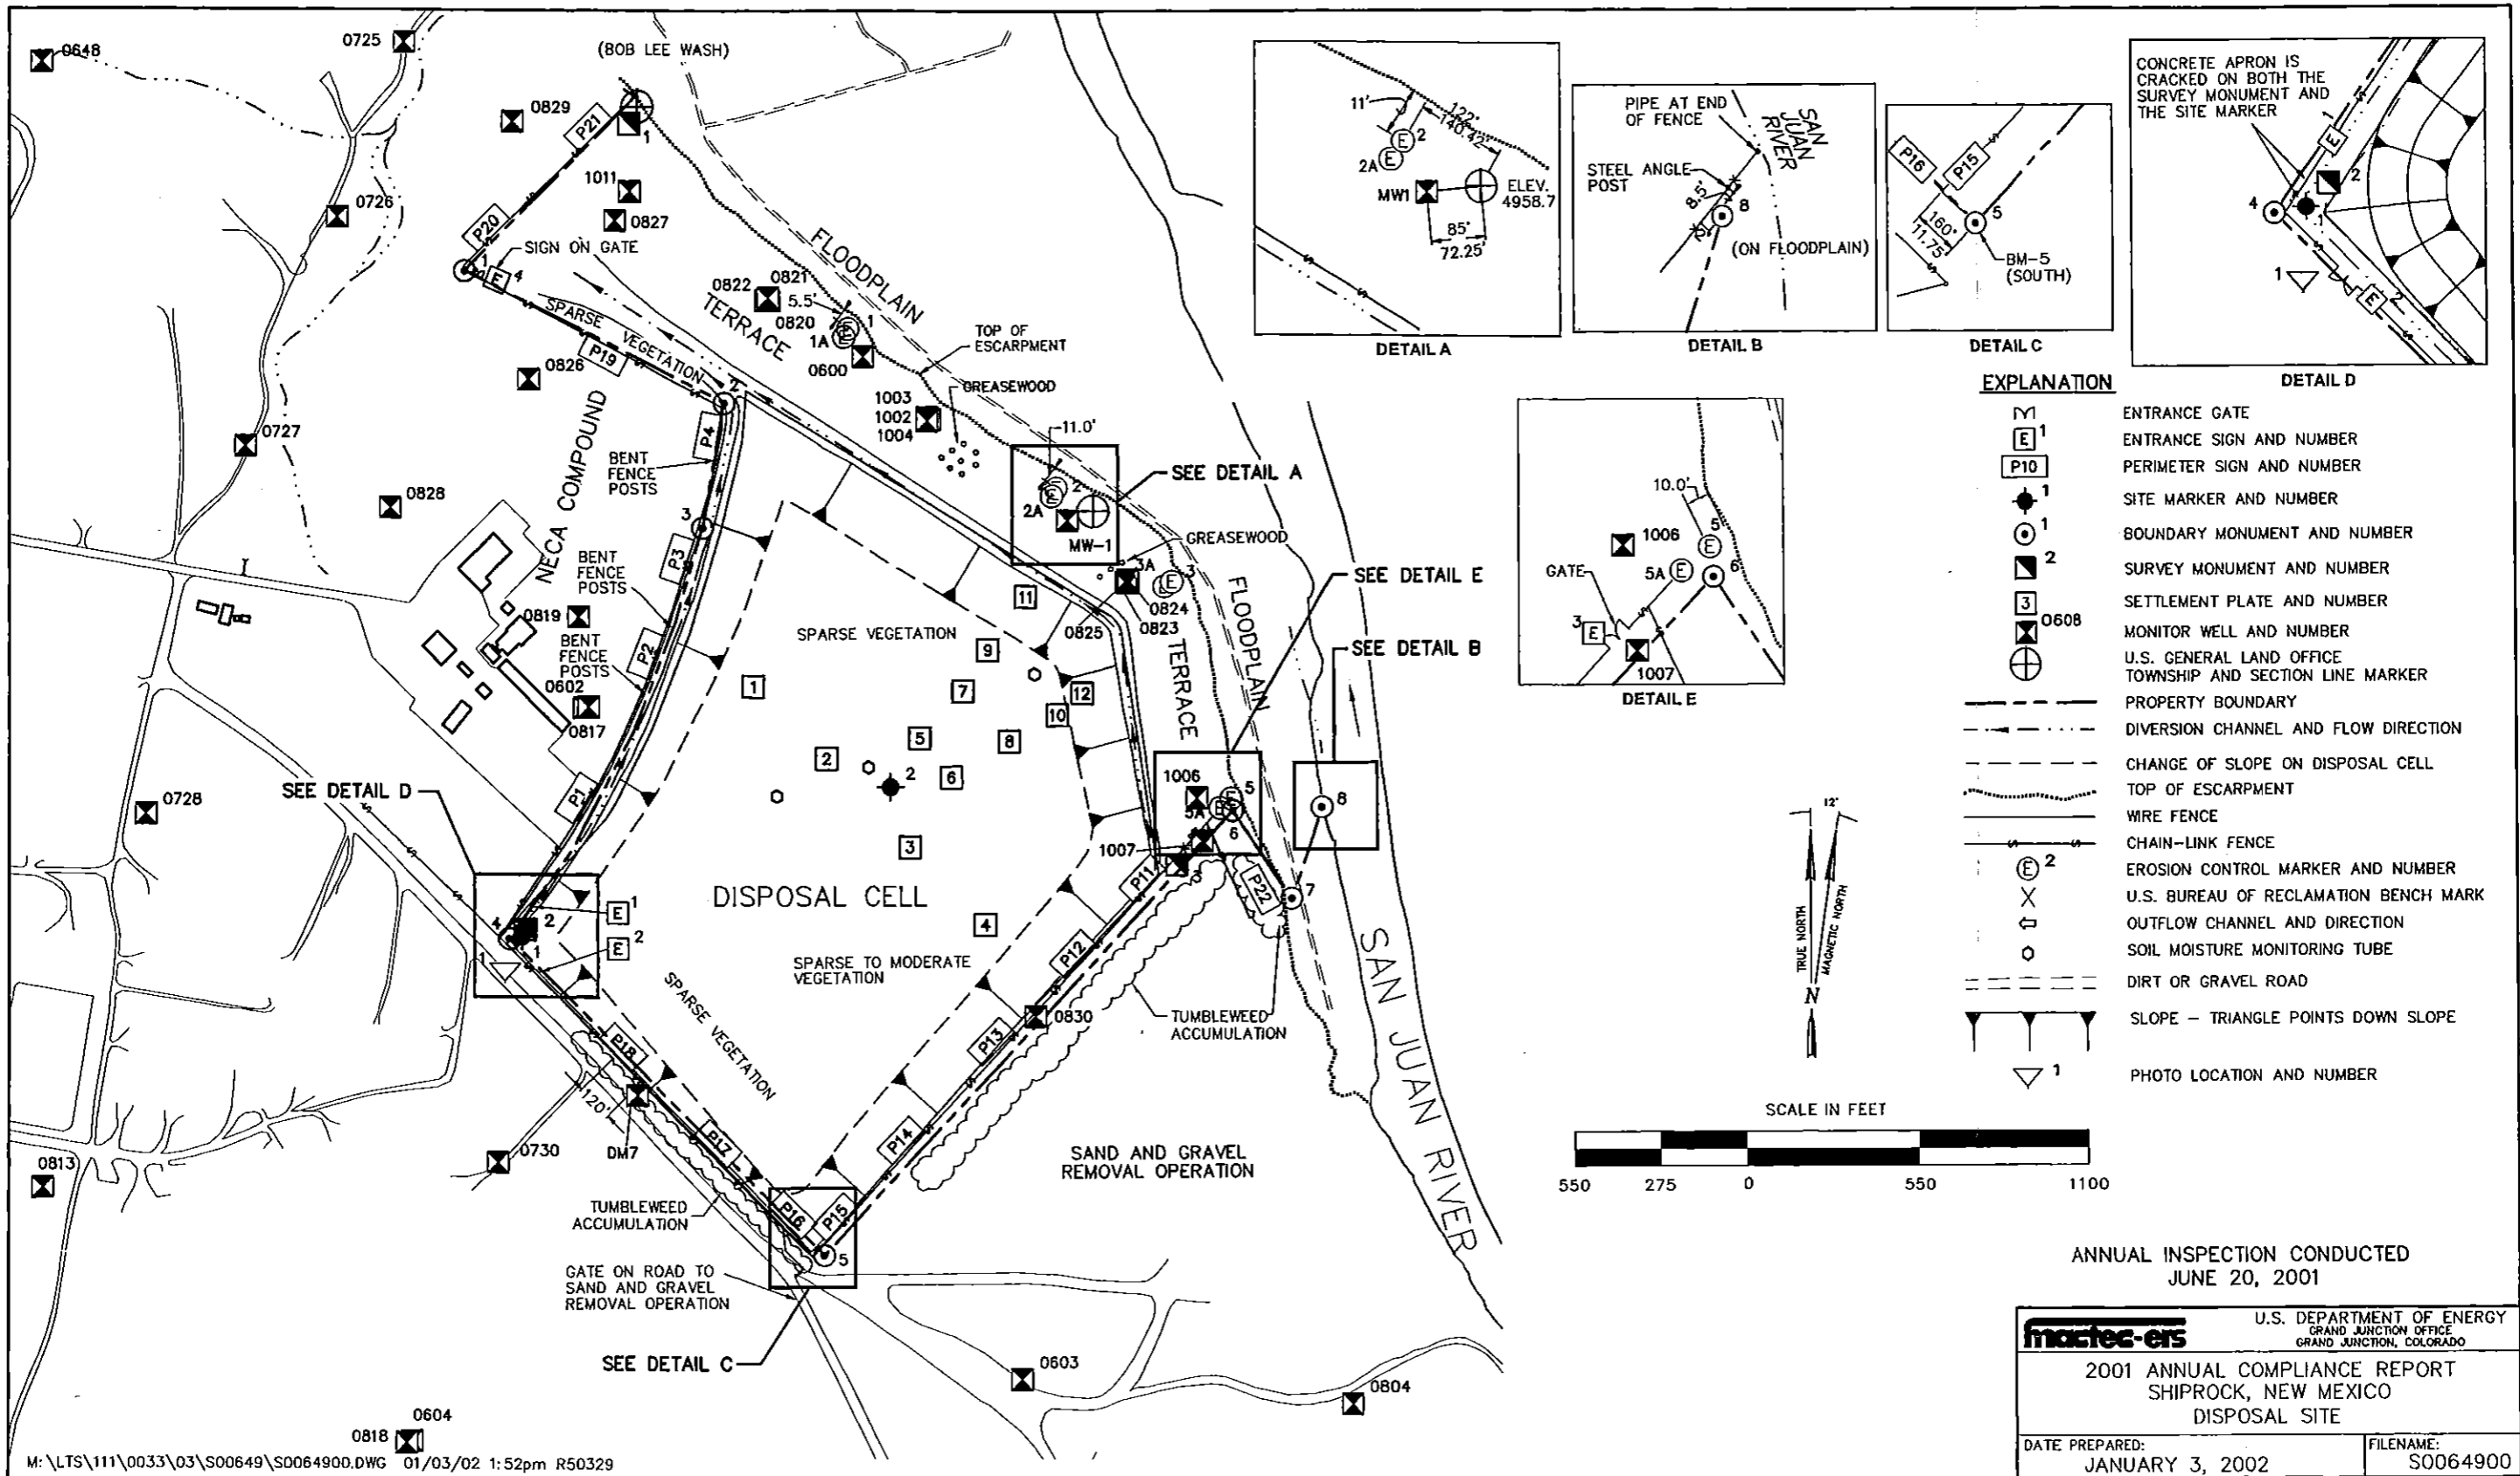
Figure 16-1. 2001 Compliance Drawing for the Shiprock, New Mexico, Disposal Site

The site, south of Shiprock, New Mexico, was inspected on June 20, 2001. Results of the inspection are described below. Features and photo locations (PLs) mentioned in this report are shown on Figure 16-1. Numbers in the left margin of this report refer to items summarized in the Executive Summary table.
