# Annual Performance Report April 2005 Through March 2006 for the Shiprock, New Mexico, Site

July 2006

## Office of Legacy Management

Work Performed by S.M. Stoller Corporation under DOE Contract No. DE-AC01-02GJ79491  
for the U.S. Department of Energy Office of Legacy Management, Grand Junction, Colorado

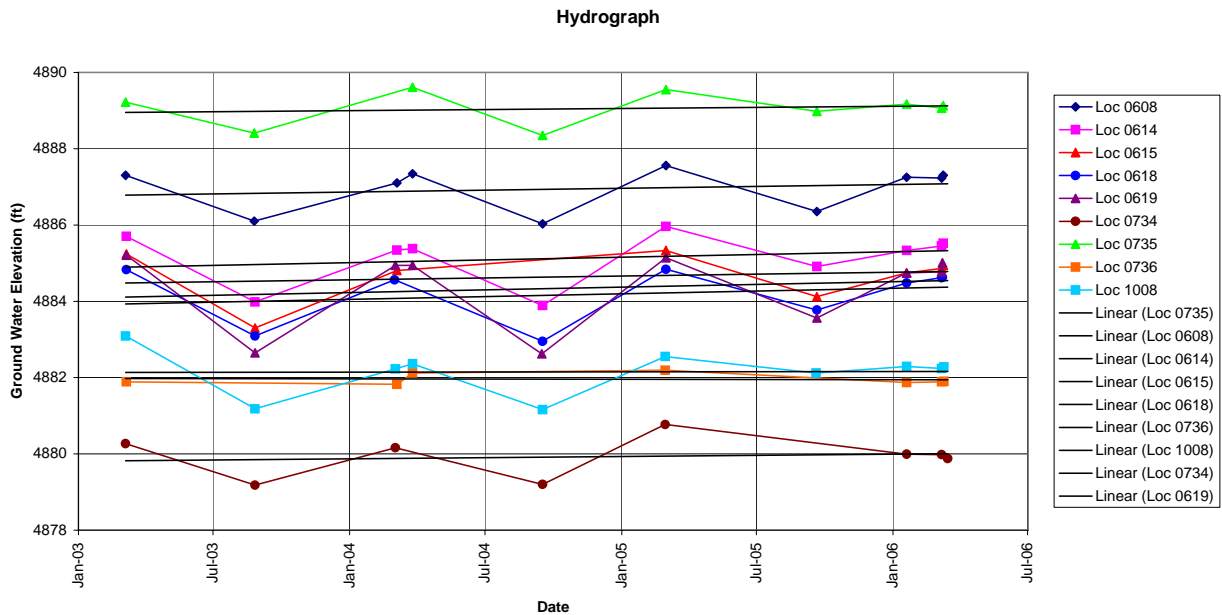
Figure 2–2. Floodplain Ground Water Elevations from Manual Measurements

Ground water levels in the floodplain aquifer are manually recorded every 6 months during routine ground water sampling events (Figure 2–2). Ground water level fluctuations in the floodplain wells over the past 3-year period have been on the order of 2 ft. Higher ground water levels appear to have coincided with elevated flows in the San Juan River during the March sampling event. Ground water levels declined throughout the remainder of the growing season, lower ground water levels occur in conjunction with minimum flows in the San Juan River. Ground water levels recovered throughout the balance of the dormant season. Over the 3-year period, ground water elevations have risen slightly in the floodplain, which is likely related to regional phenomena.

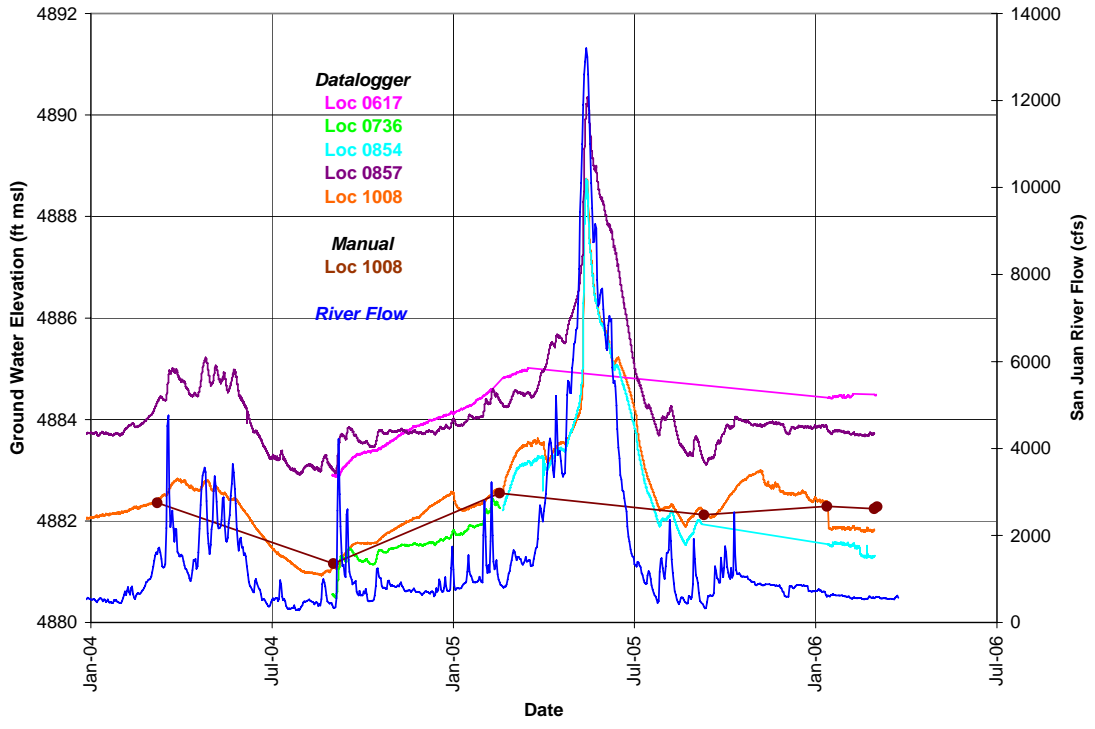
Figure 2–3. Floodplain Ground Water Elevations from Datalogger Measurements

Ground water elevations in the floodplain aquifer are also measured every 4 hours by pressure transducers installed in five monitor wells (0617, 0736, 0854, 0857, and 1008) and connected to dataloggers (Figure 2–3). Datalogger information is available starting in early January 2004 and beyond. Manual ground water level measurements recorded during routine ground water quality sampling events every 6 months for monitor well 1008 are shown for comparison with datalogger information (Figure 2–3).

Flow data from the U.S. Geological Survey Gaging Station 09368000 in the San Juan River at Shiprock, NM, are plotted on Figure 2–3. The river flow on the day the March 2003 water level data were measured was 649 cubic feet per second (cfs), while the flow on the day the March 2006 data were measured was 551 cfs. In terms of stage, or water surface elevation, the San Juan River flows measured in 2006 and the 2003 flows are approximately the same.

The datalogger plots show very close correlation between ground water levels with the flow patterns of the San Juan River, indicating relatively rapid recharge and discharge of the aquifer related to change in river flow and surface water levels (Figure 2–3). It is known that most of the water entering the floodplain aquifer does so via San Juan River losses along the southernmost tip of the aquifer. Thus, it is logical to assume that inflow from the river increases during high runoff, and that this produces flow directions east of the disposal cell that are in a more northward to northwestward direction than normal. The potential for greater mixing of relatively clean water from the river with contaminated ground water emanating from the Mancos Shale would likely increase under such circumstances, which possibly leads to greater dilution of ground water contaminants in the aquifer and enhances natural flushing of contaminants from the floodplain aquifer.

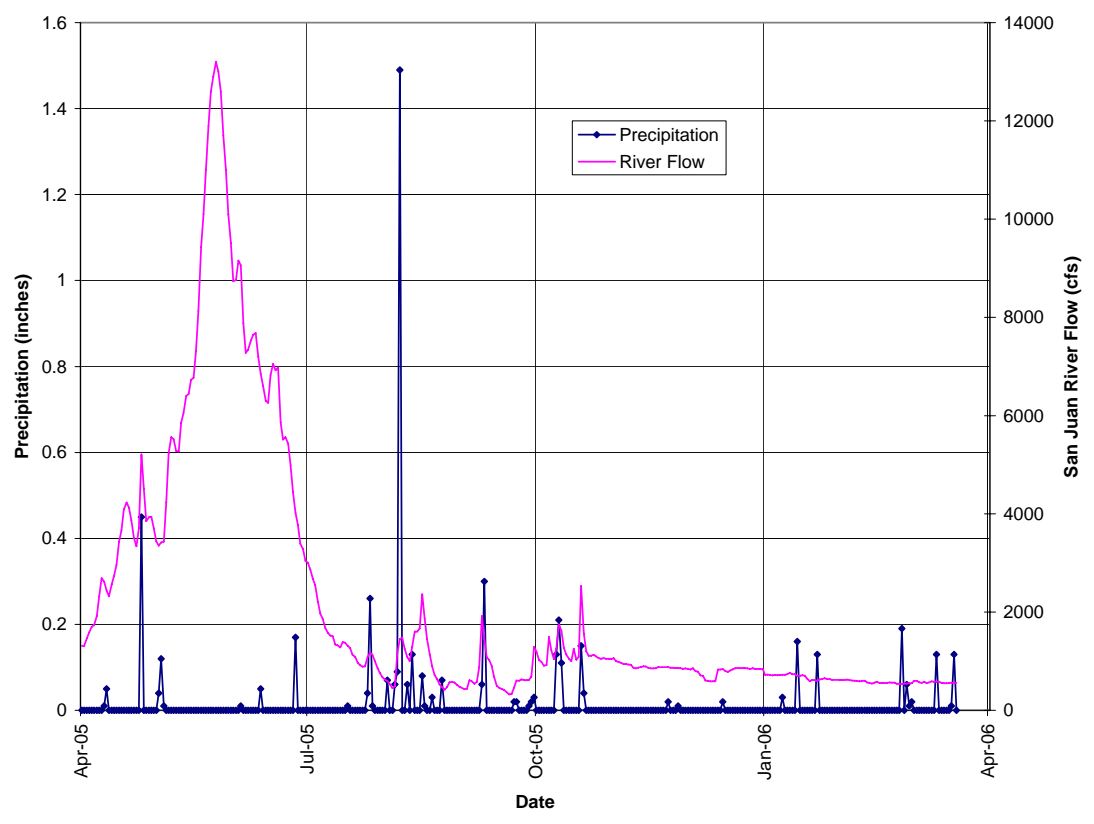
Figure 2–4. Precipitation and San Juan River Flow

Precipitation data showing the influence of rainfall in the area are also available from the site and region. During this performance period, the ground water recovery was aided by a 13,200-cfs spike in the flow of the San Juan River, which occurred on May 25, 2005 (Figure 2–4). This flow spike in the San Juan River probably occurred in response to above average precipitation measured at Farmington, New Mexico, and at Durango, Colorado, during April and May 2005. (<http://www.wunderground.com/history/airport/KFMN/2004/9/19/DailyHistory.html>; <http://www.wunderground.com/history/airport/KDRO/2004/9/19/DailyHistory.html>). Precipitation data from the meteorological station at the Shiprock site are shown along with flow data from the San Juan River (Figure 2–4).

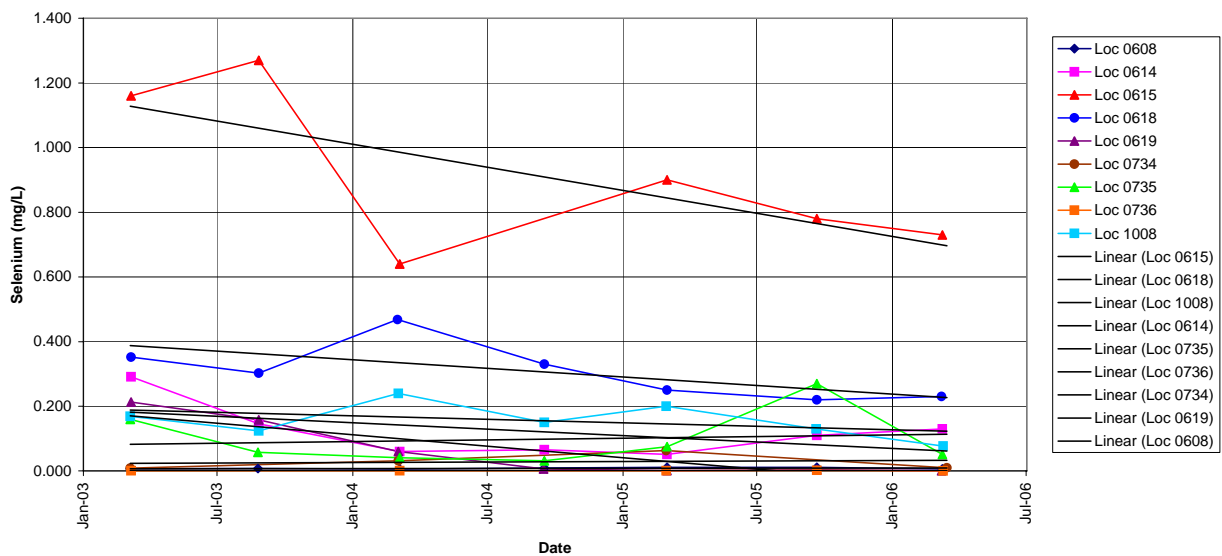
Figure 2–15. Floodplain Selenium Ground Water Concentrations Versus Time

Concentrations of selenium in ground water have generally been decreasing over the past 3 years (Figure 2-8). The maximum concentration during the March 2006 sampling event was 0.73 mg/L; levels were greater than 0.05 mg/L in five of the nine monitor wells (Figure 2-15).

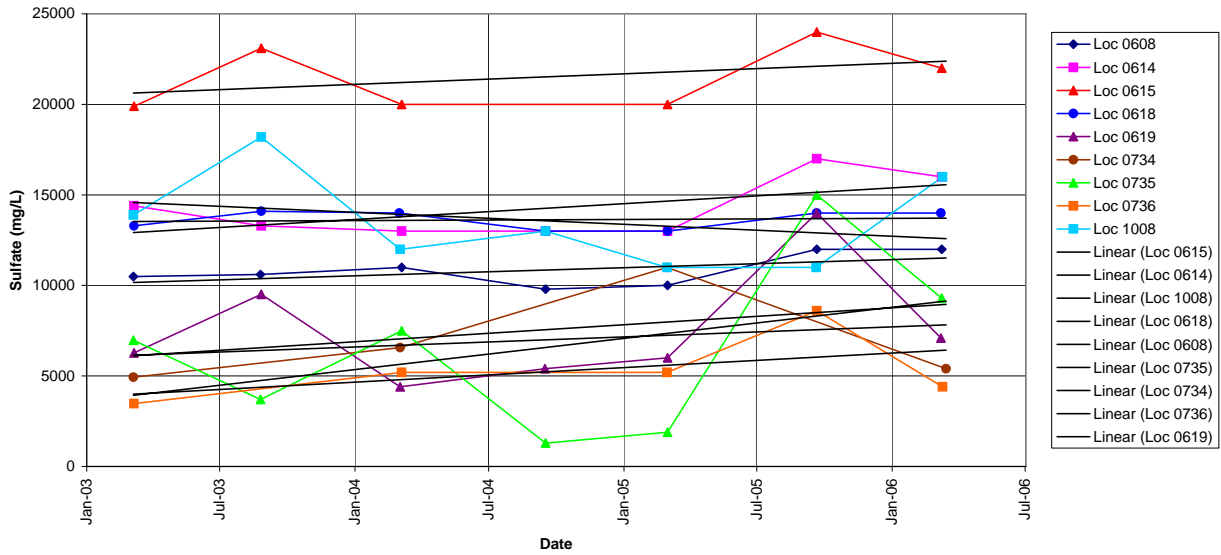
Figure 2–17. Floodplain Sulfate Ground Water Concentrations Versus Time

Sulfate concentrations in ground water have generally increased over the past 3 years (Figure 2-10). Again, variability is noted in some wells with recent decreases but overall upward trends, which may be the effect of seasonal variation and interaction with surface water from the San Juan River (Figure 2-17).

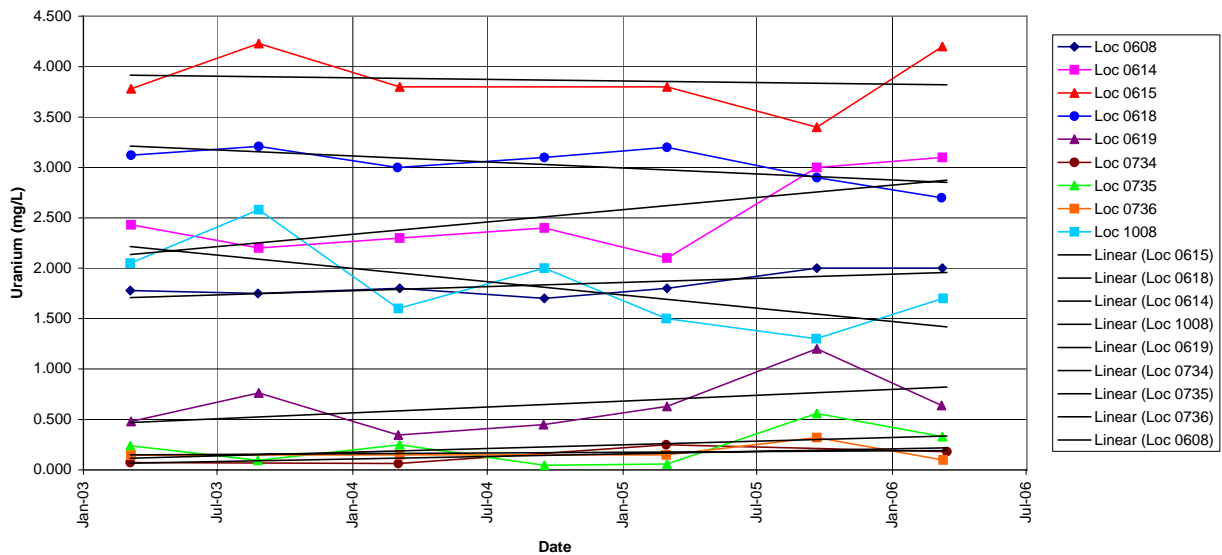
Figure 2-18. Floodplain Uranium Ground Water Concentrations Versus Time

Uranium concentrations in ground water ranged from 0.099 mg/L to 4.200 mg/L during the March 2006 sampling event (Figure 2-11). Trends over the past 3 years have been variable; concentrations increased in some wells and decreased in others. Again, seasonal variations may be contrary to longer-term trends (Figure 2-18).
