16.0 Shiprock, New Mexico, Disposal Site

16.1 Compliance Summary

The Shiprock, New Mexico, Uranium Mill Tailings Radiation Control Act (UMTRCA) Title I Disposal Site was inspected on May 29, 2008. The disposal cell and all associated surface water diversion and drainage structures remained in good condition and were functioning as designed. Erosion along the southwest bank of the outflow channel was repaired and in good condition. Scattered deep-rooted shrubs on the top and side slopes of the cell, along with tamarisk in the outflow channel, were treated with herbicide. Halogeton, a noxious weed present on the terrace and along site access roads, was also treated. Tumbleweeds and trash continue to accumulate along the perimeter fence and in the outflow channel area; these accumulations were removed in 2008.

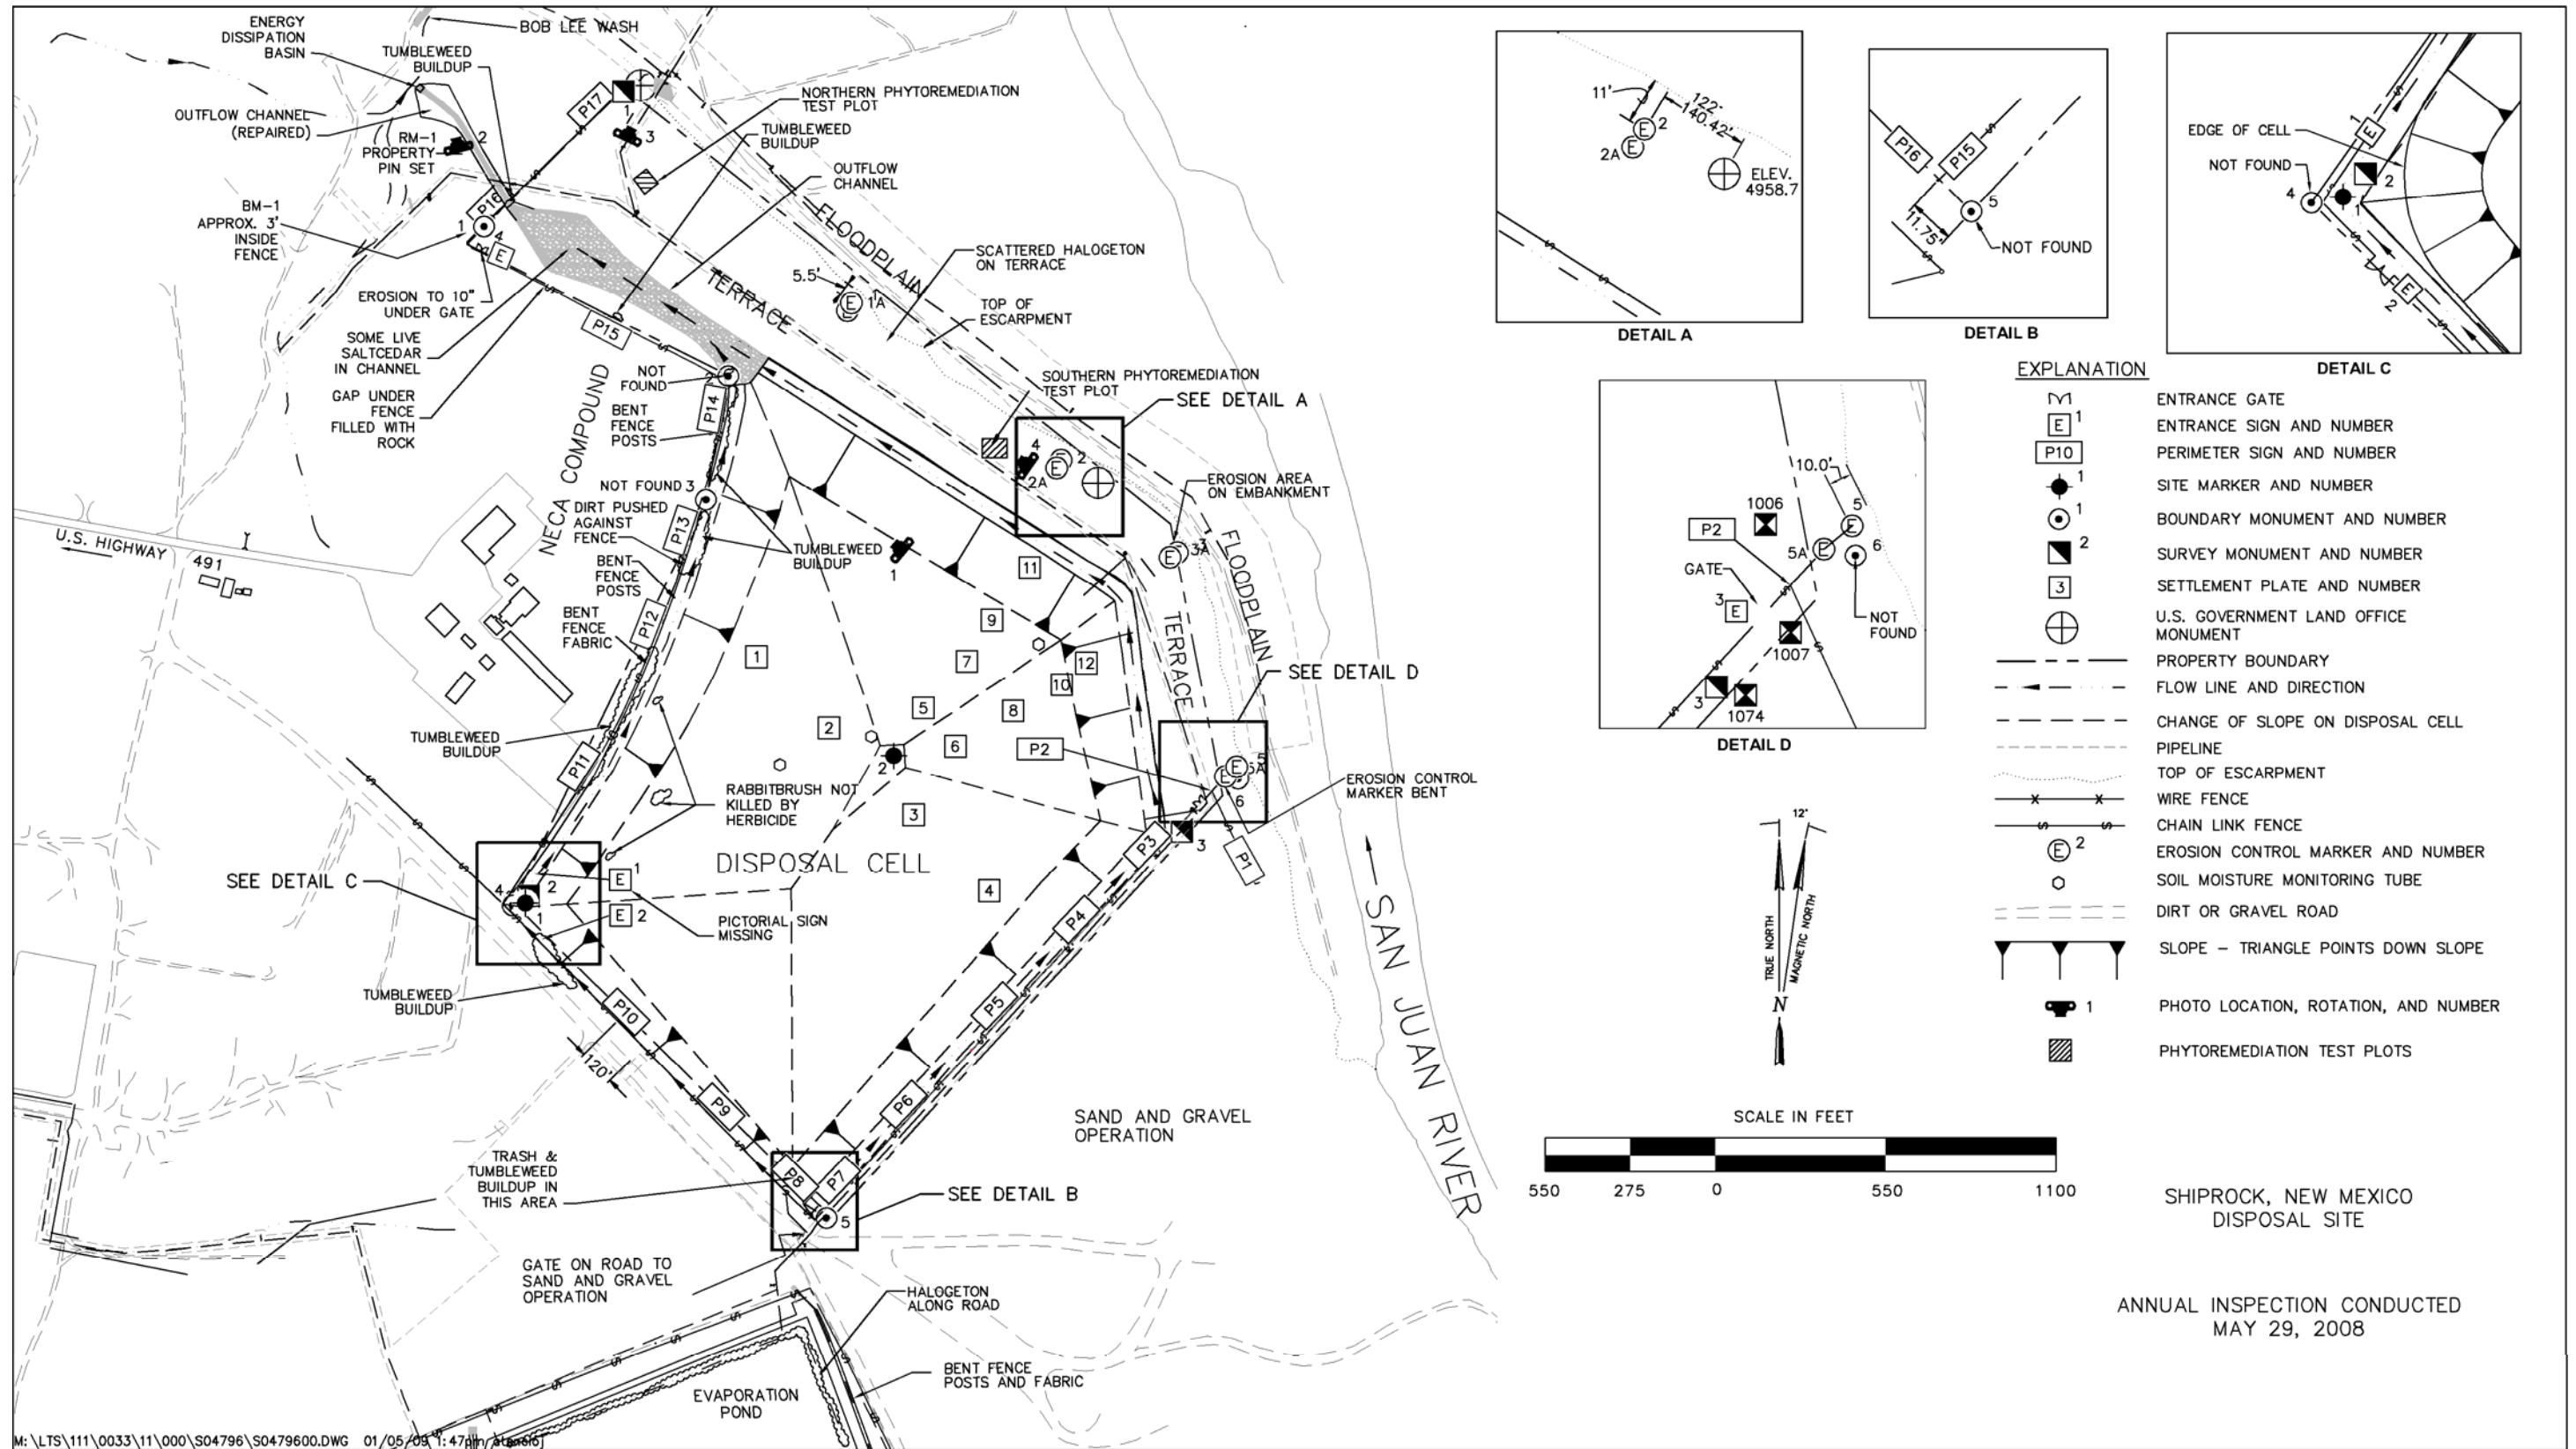
Figure 16-1. 2008 Annual Compliance Drawing for the Shiprock Disposal Site

The security fence along the perimeter was in good condition except for isolated sections between perimeter signs P11 and P13. Past bulldozing activity within the NECA yard resulted in dirt being pushed up against the fence fabric near perimeter sign P13. Also, there are several bent poles and a section of bent fence fabric between perimeter signs P11 and P12. Although damaged, the fence continues to prohibit access into the DOE-controlled area. Inspectors will continue to monitor this area to ensure that the fence remains intact and functional.

16A Tumbleweeds and windblown trash continue to accumulate along the outside and inside of the southwest perimeter fence and along the fence in the outflow channel. These accumulations were removed in 2008, as they could have presented a fire hazard or impeded water flow in the channel. Windblown sand continues to accumulate along the southwest side of the disposal site and, to a lesser extent, in other areas, facilitating the growth of annual weeds and shrubs. DOE will continue to monitor and remove significant tumbleweed, trash, and windblown sand accumulations on site.

Four entrance signs and 17 pairs of numbered perimeter signs (one standard warning sign with text and one Navajo danger-pictorial sign) are attached to the security fence. Three of the four entrance signs were present and in good condition. One pictorial entrance sign (E1) in the southwestern corner of the site was missing and will be replaced.
