| Tab Number | Document Name and Date | Document Type | Author | Recipient | Description |
|---|--|---|---|---|--|
| 1 | Investigation of Mold and Moisture at the FAA Detroit Metropolitan ATCT Facility | Report | OST | FAA | This investigation was performed to determine if mold and moisture issues still affected the DTW ATCT as was alleged by some employees. It determined that fungal growth and water intrusion still affected the building. The report contained a recommendation to perform water damage assessments at other Leo Daly ATCTs. |

**INVESTIGATION OF MOLD AND MOISTURE AT THE
FEDERAL AVIATION ADMINISTRATION
DETROIT METROPOLITAN AIR TRAFFIC CONTROL TOWER FACILITY**

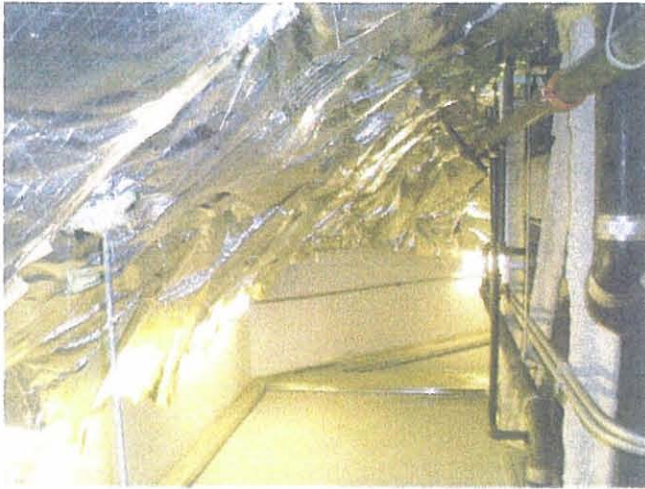
EWR – Newark, New Jersey
Junction Level Exterior Wall Insulation

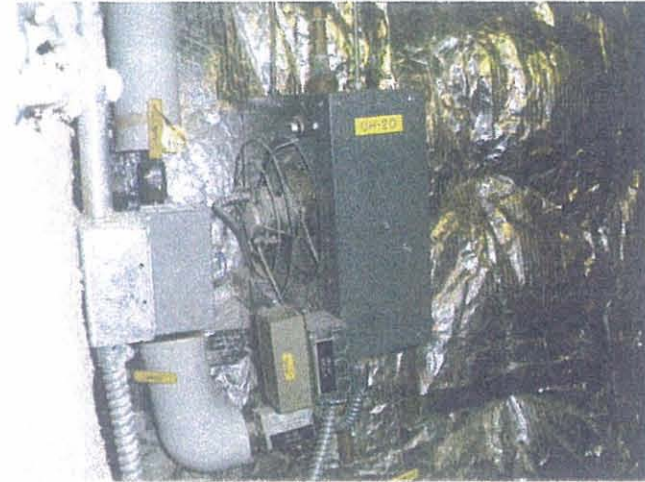
EWR – Newark, New Jersey
Convective Heating Unit in Utility Chase

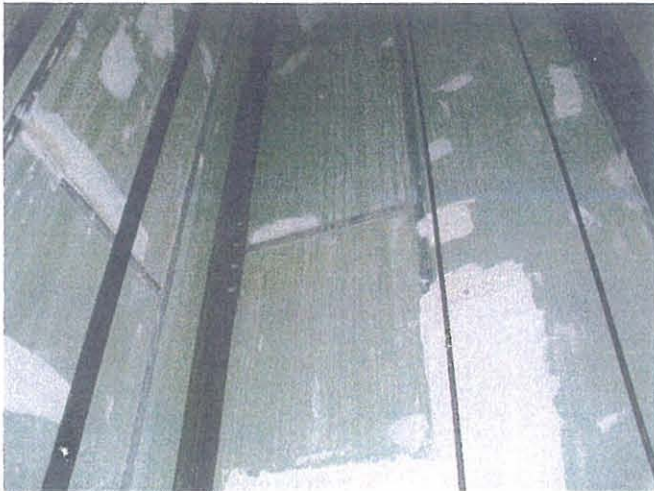
EWR – Newark, New Jersey
View of Elevator Shaft Interior

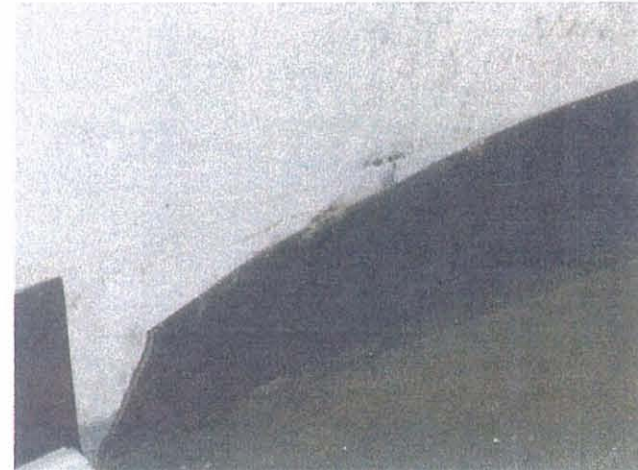
EWR – Newark, New Jersey
Suspect Mold Growth Under Cove Base, Ground Floor

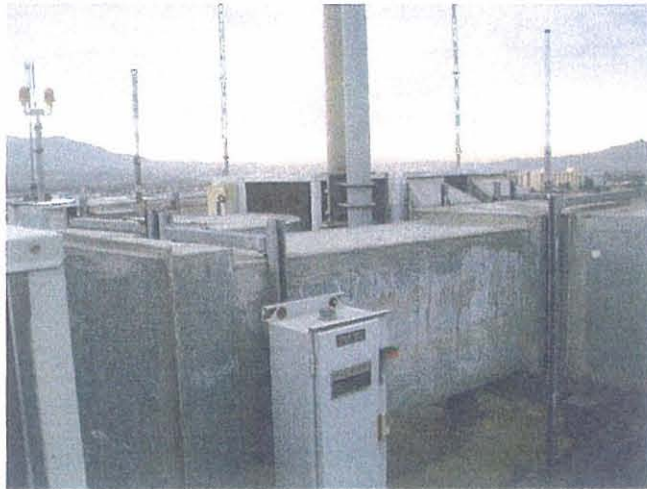
BUR – Bob Hope Burbank Airport
Cab Roof HVAC Equipment – Clean and Well Maintained

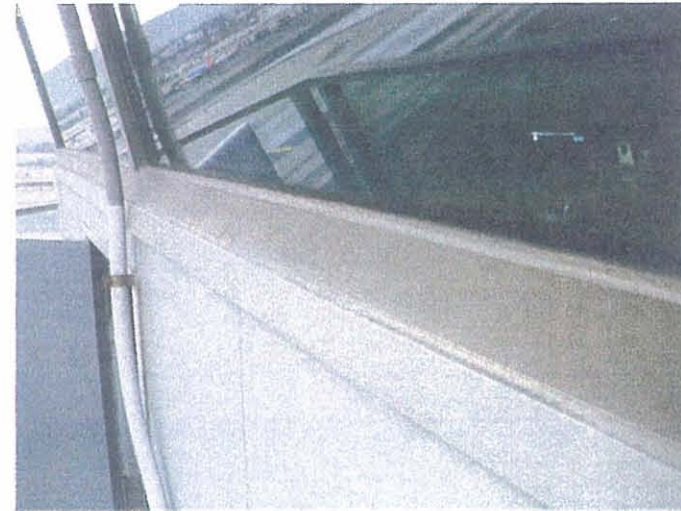
BUR – Bob Hope Burbank Airport
Cab Exterior Window Caulk – Good Condition

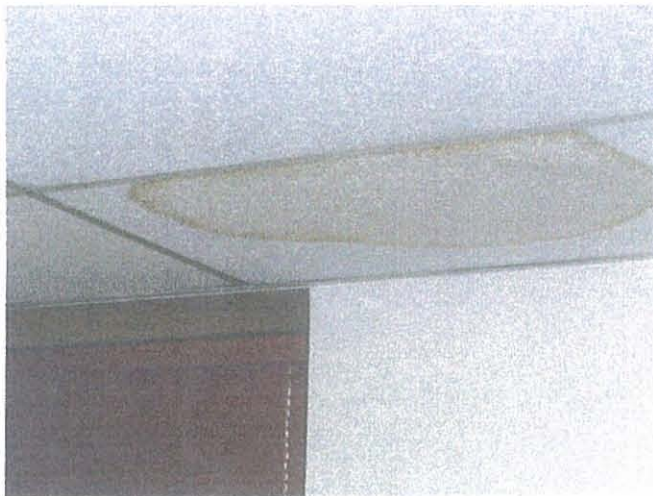
BUR - Bob Hope Burbank Airport
6th Level Ceiling Tile Stain From Sanitary Drain Line

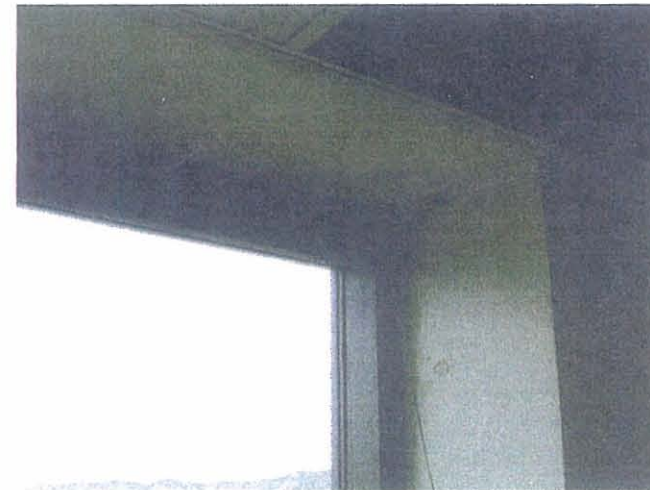
BUR - Bob Hope Burbank Airport
3rd Level – Small Amount of Mold Growth Near Window Which Was Re-caulked

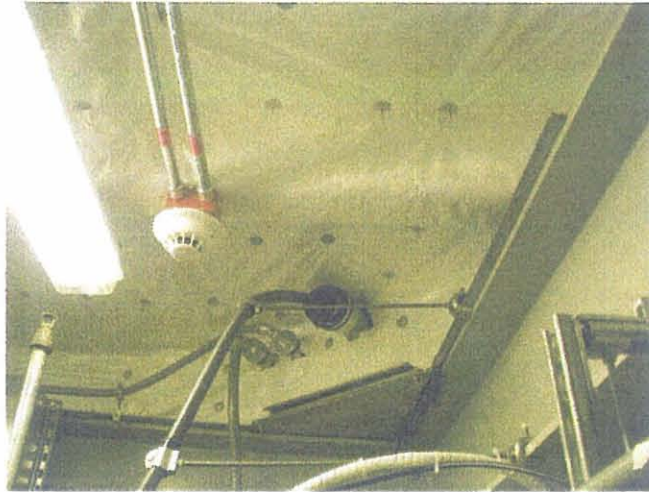
SEA – Seattle Tacoma
Cab Penthouse Ceiling is Insulated

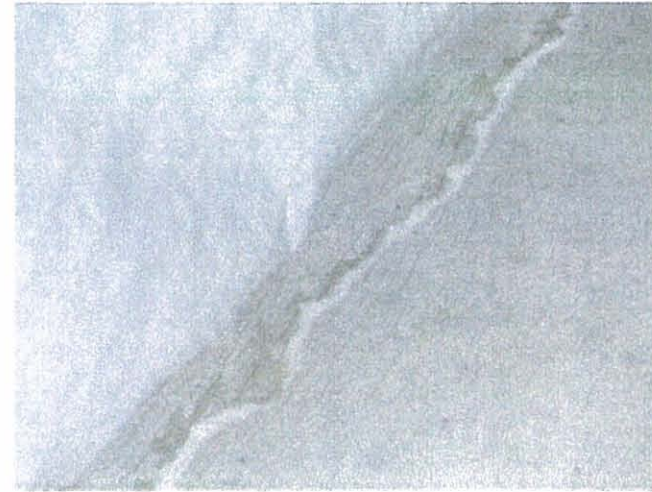
SEA - Seattle Tacoma
13th Level Floor Staining Under Existing
Fiberglass Insulation on Exterior Wall

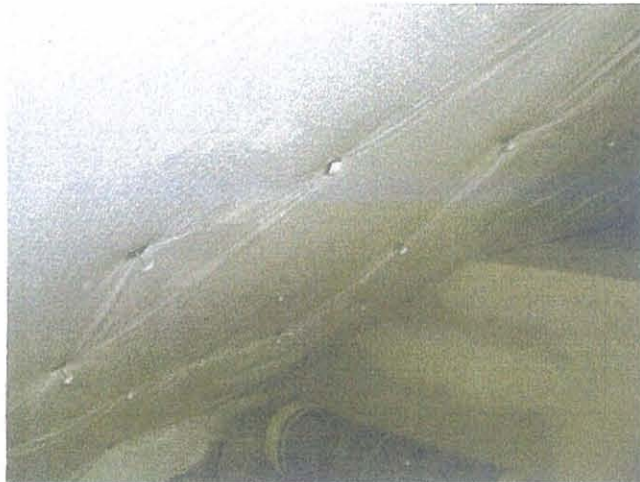
SEA – Seattle Tacoma
Typical Slanted Exterior Wall Insulation Detail

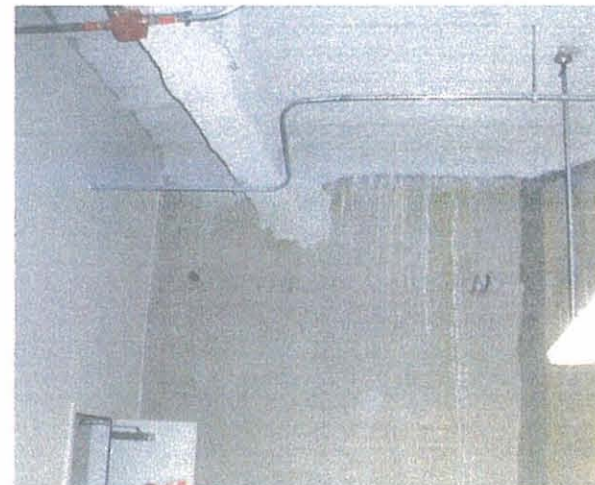
SEA – Seattle Tacoma
10th Level Typical Wall Staining Likely From
Original Fireproofing Application

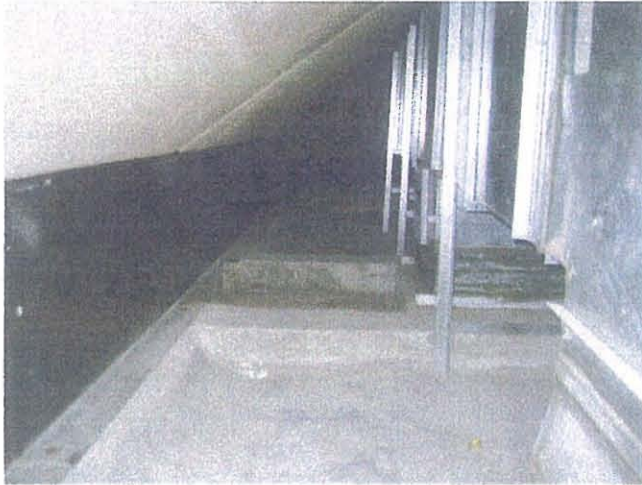
MCI – Kansas City
Junction Level Typical Exterior Wall

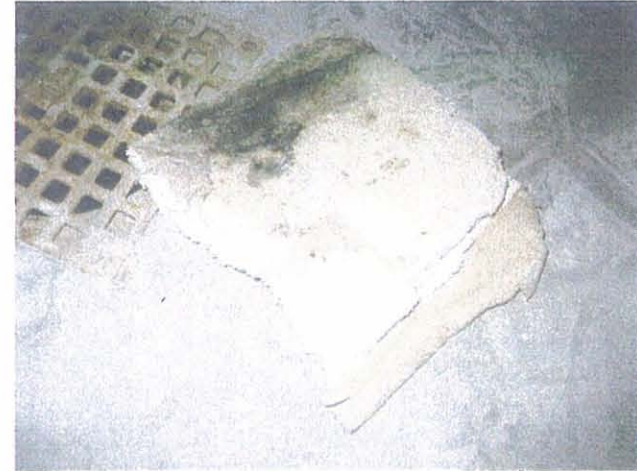
MCI – Kansas City
Cable Access Level Mold Contaminated Drywall Scrap (Removed and Discarded During Survey)

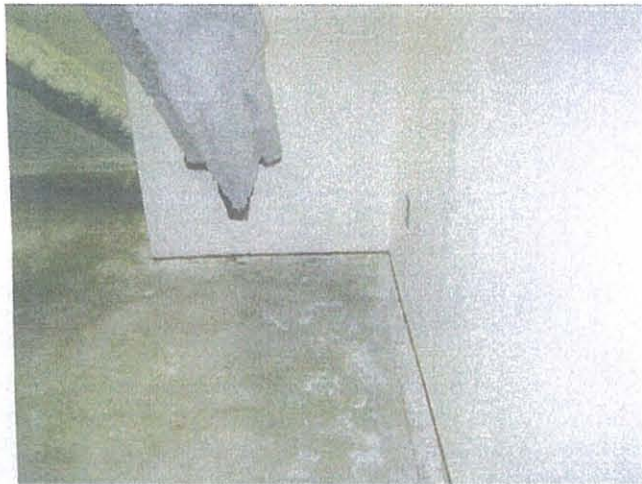
MCI – Kansas City
Typical Mold Abated Wall Area

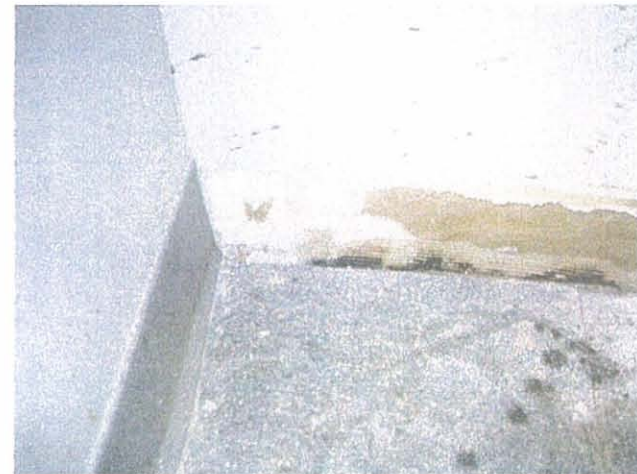
MCI – Kansas City
Junction Level Room J10 Small (<6 in²) Patch of Visible Mold Growth

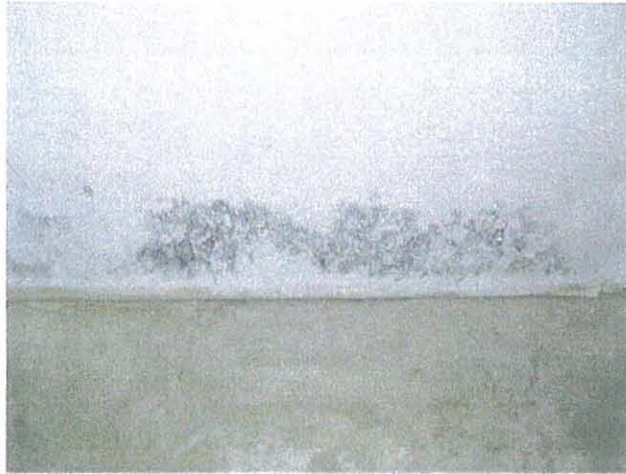
IAH – Houston
Room 2S3 Mold Below HVAC Duct

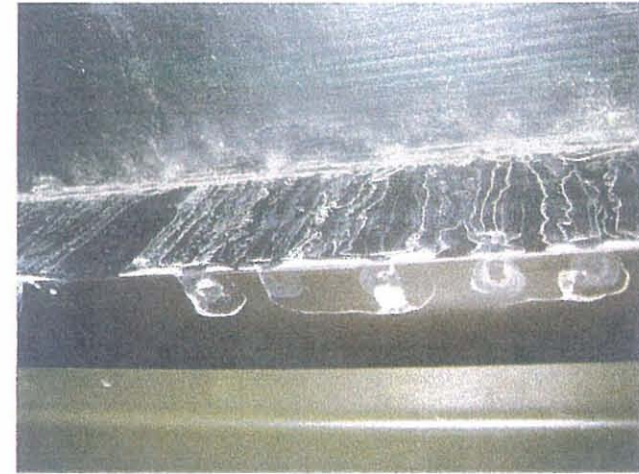
IAH – Houston
Junction Level Water Drip Residue on Restroom
Upper Window Frame

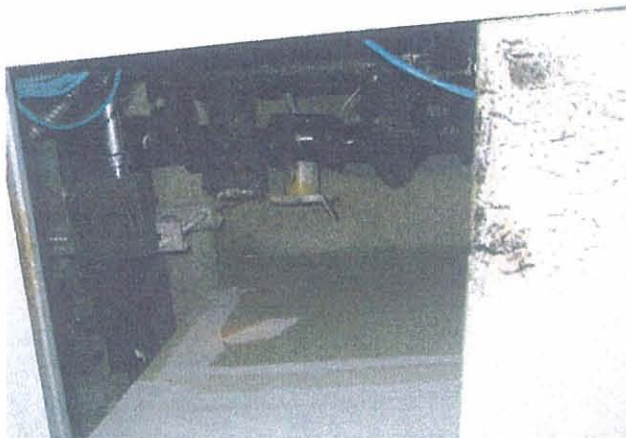
IAH – Houston
11th Level Fitness Room Condensation on Chilled
Water Valve and Affected Ceiling Tile

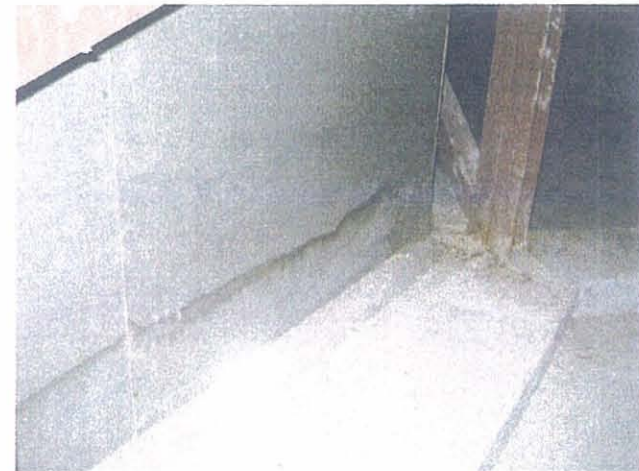
IAH – Houston
Cable Access Level Typical Interior Wall

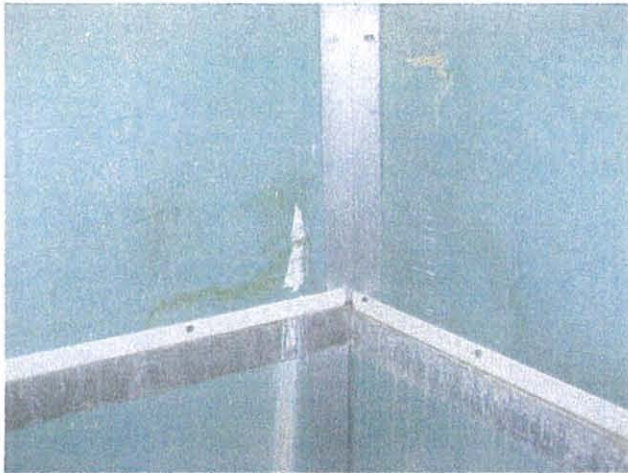
DFW – East Tower Dallas/Fort Worth
Elevator Shaft Mold Spotting and Water Stain

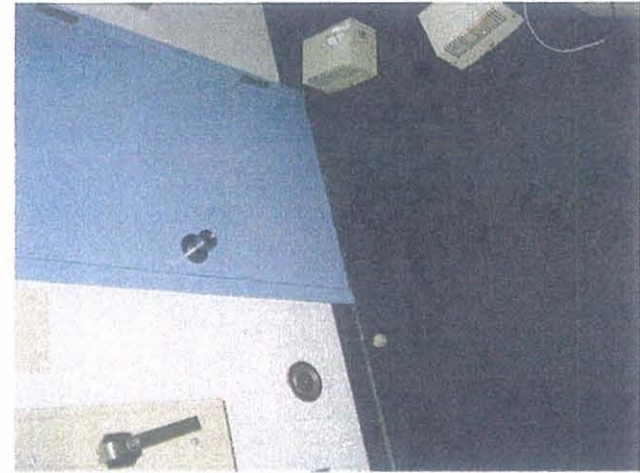
DFW – East Tower Dallas/Fort Worth
Subjunction Level Water Stained Carpet Below
Airshaft Door

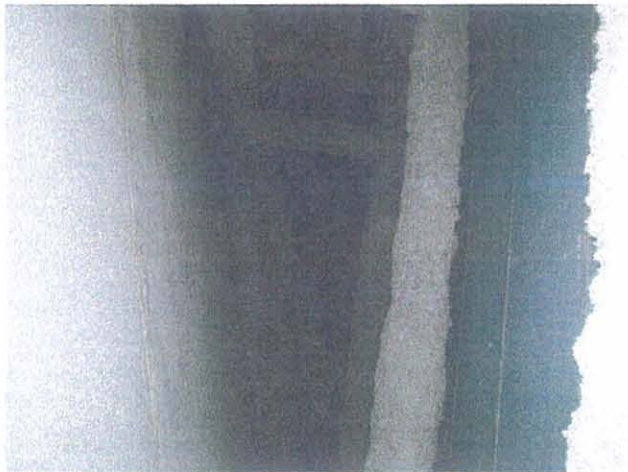
DFW – East Tower Dallas/Fort Worth
Typical Exterior Wall

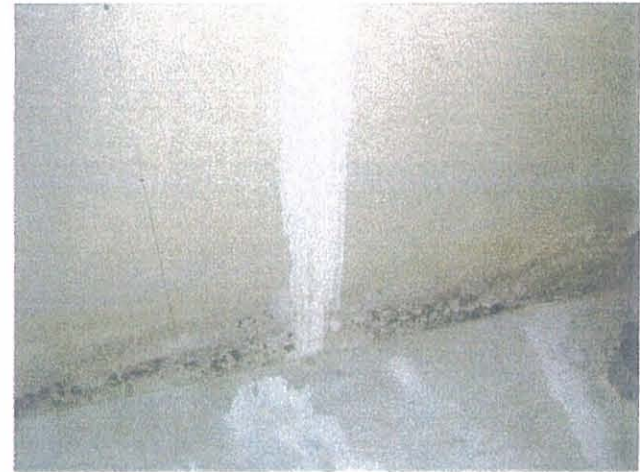
DFW – East Tower Dallas/Fort Worth
Non-functional Area Mold Growth

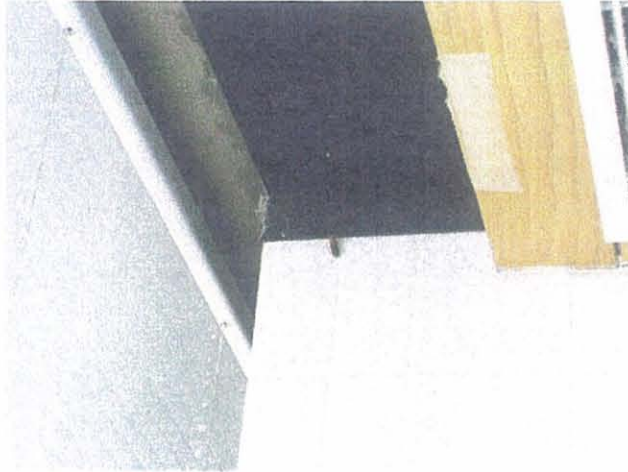
DFW – West Tower Dallas/Fort Worth
Junction Level Insect Gains Entrance to Restroom Through Unsealed Crevice

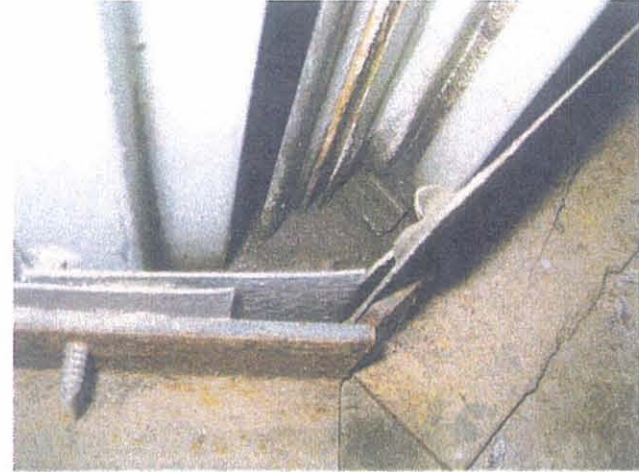
DFW – West Tower Dallas/Fort Worth
Cable Access Level Unsealed Walls and Flashing Below Cab Balcony Allows Moisture Into Level.

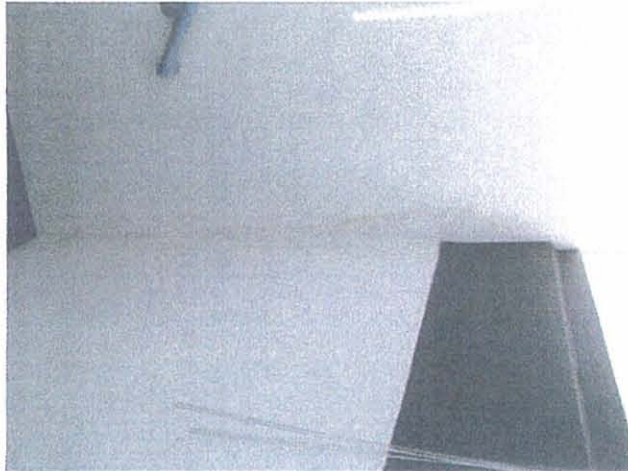
DFW – West Tower Dallas/Fort Worth
Stairwell Window Exterior Deteriorated Caulk Identified as Source of Water Stain

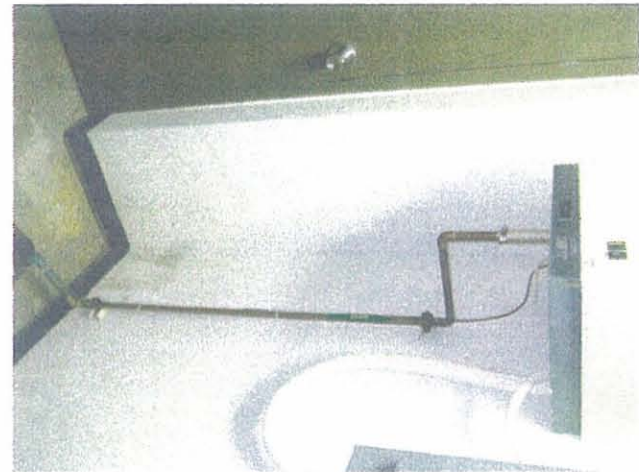
DFW – West Tower Dallas/Fort Worth
Junction Level Mold Below Humidifier

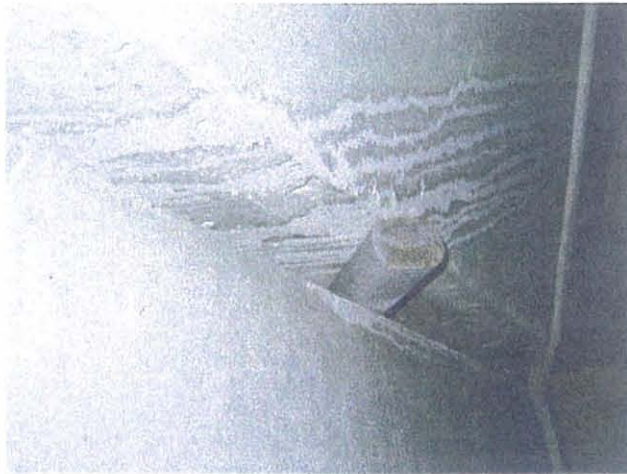
CVG – Cincinnati/North Kentucky
Cable Access Level Exterior Wall With Water
Stains

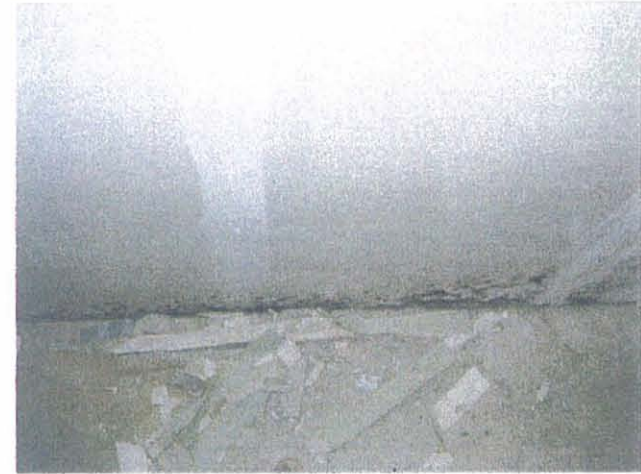
CVG – Cincinnati/North Kentucky
Ground Level 8ft² Mold Growth in Plenum

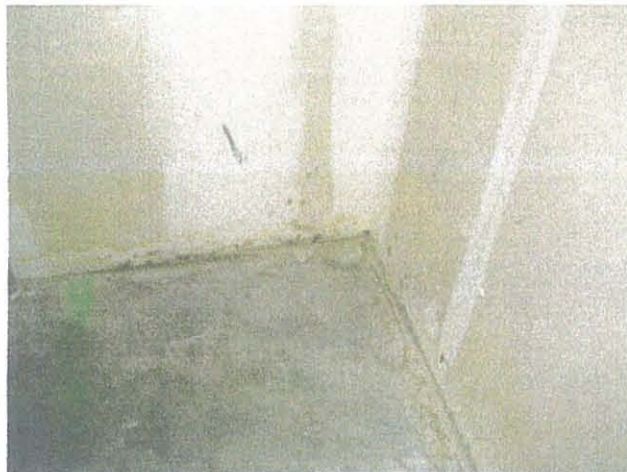
CVG – Cincinnati/North Kentucky
Room 8TS3 Mold Growth and Water Stained
Wall

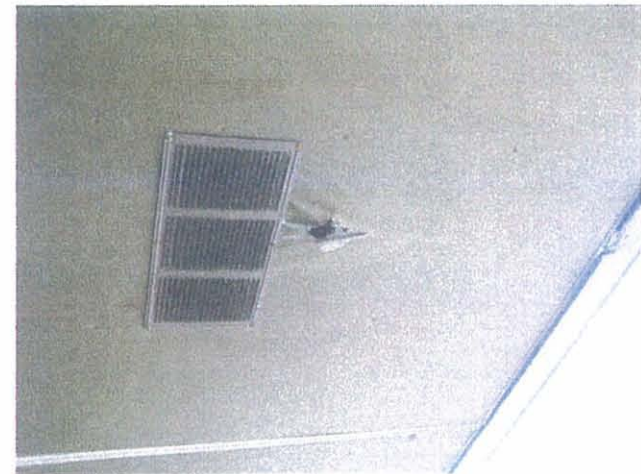
CVG – Cincinnati/North Kentucky
Junction Level Balcony Water Damaged Soffit

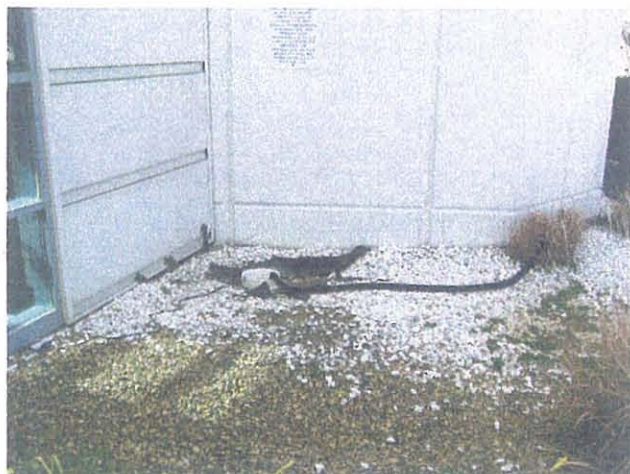
SDF – Louisville
NE Base of Tower Makeshift French Drain and Sump Pump

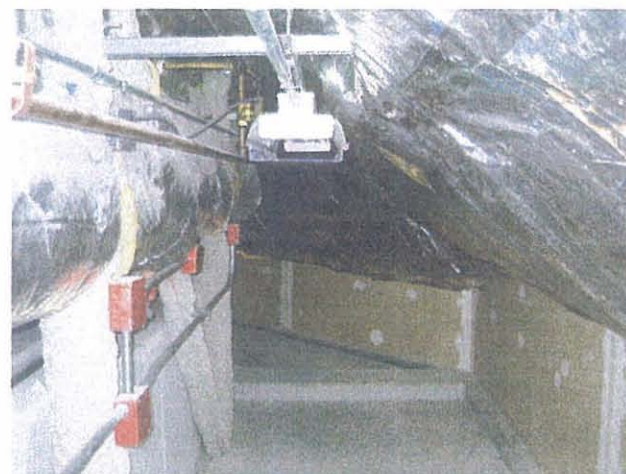
SDF – Louisville
Cable Access Level Insulated Exterior Wall and Metal Structural Members

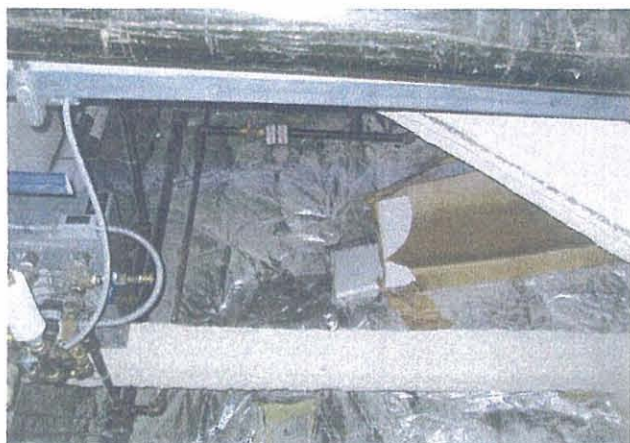
SDF – Louisville
Tower Shaft Typical Insulated Pipe Chase Room

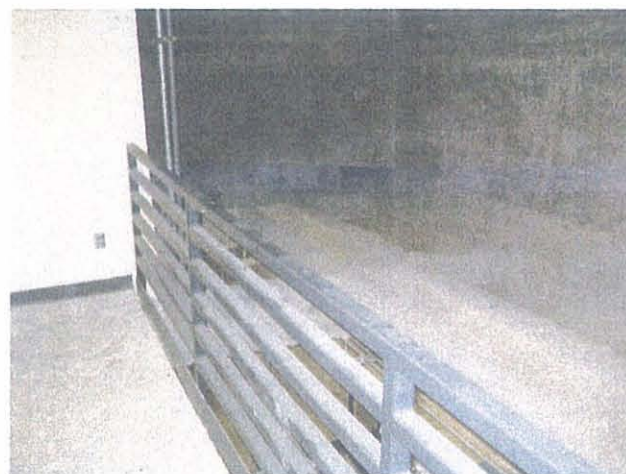
SDF – Louisville
Tower Shaft Typical Mezzanine Level Overlooking Full Level Below

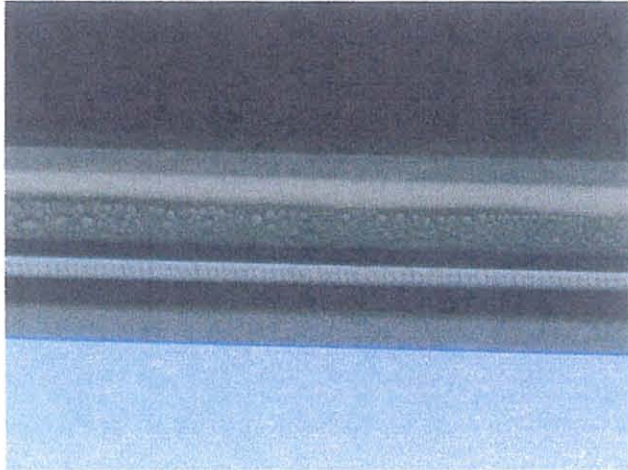
ORD – Chicago
Cab Level Condensation at Top of Window Frame

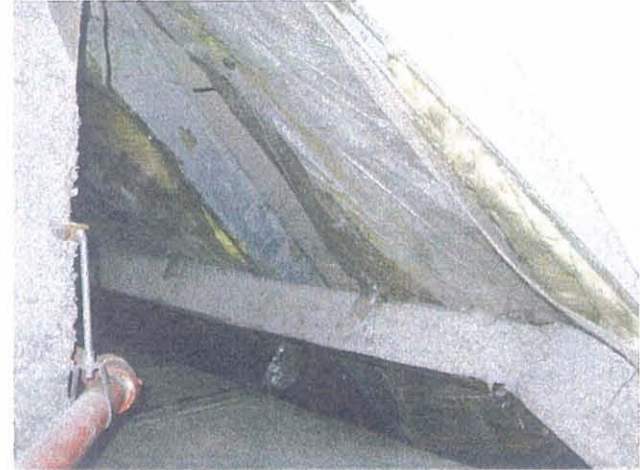
ORD – Chicago
Cable Access Level Exterior Wall with Insulation

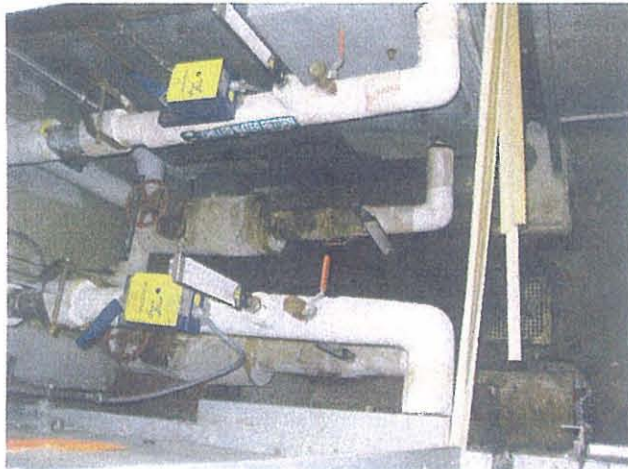
ORD – Chicago
Mechanical Room Leaking Valve Repaired During Survey

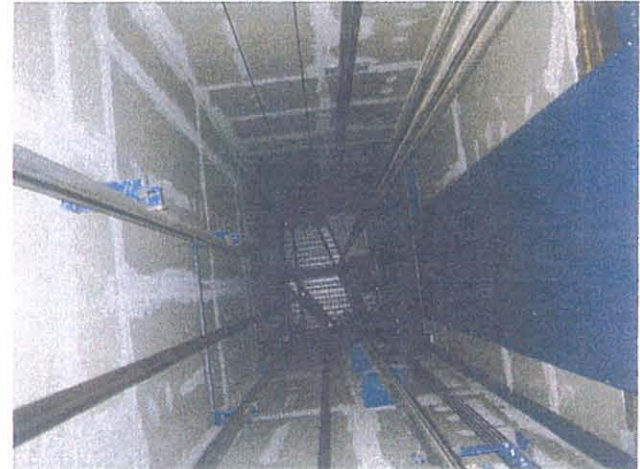
ORD – Denver
Elevator Shaft Interior

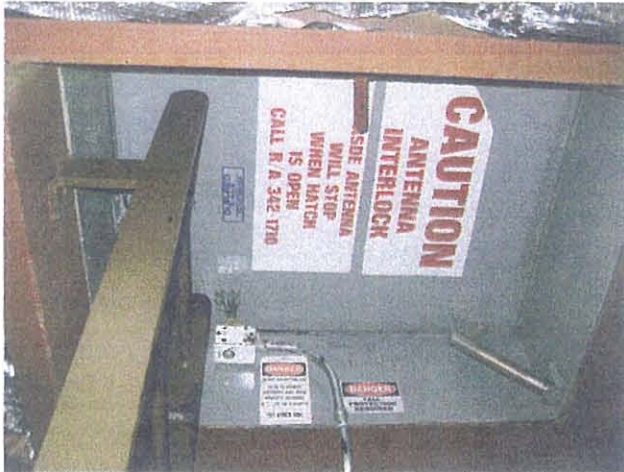
DIA – Denver
Penthouse Roof Hatch With Condensation

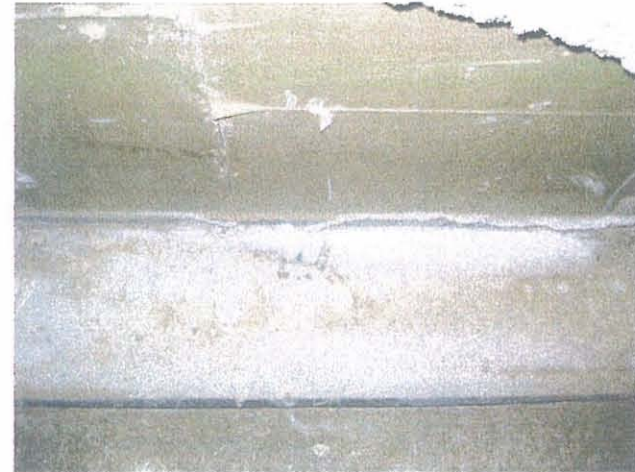
DIA – Denver
Snow in Exterior Plenum of Cable Access Level

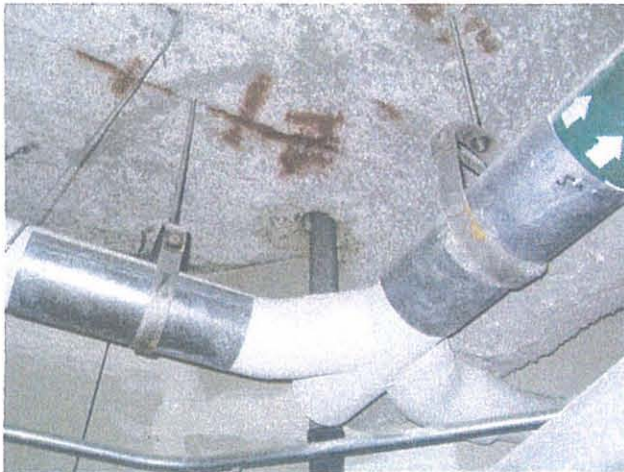
DIA – Denver
Subjunction Level Penetration to Microwave
Balcony Allows Rainwater to Enter

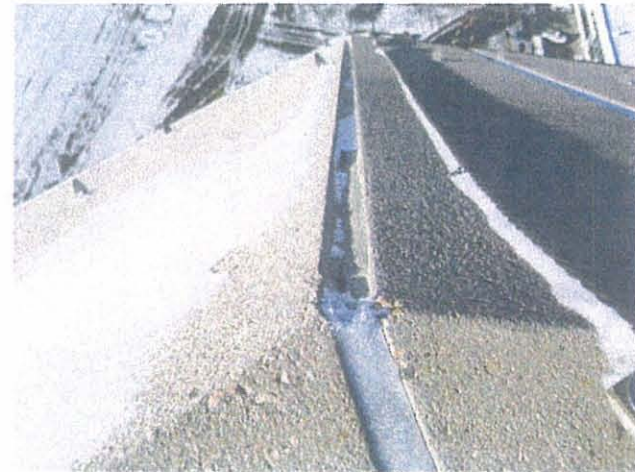
DIA – Denver
Cab Balcony Deteriorated Seam Caulk

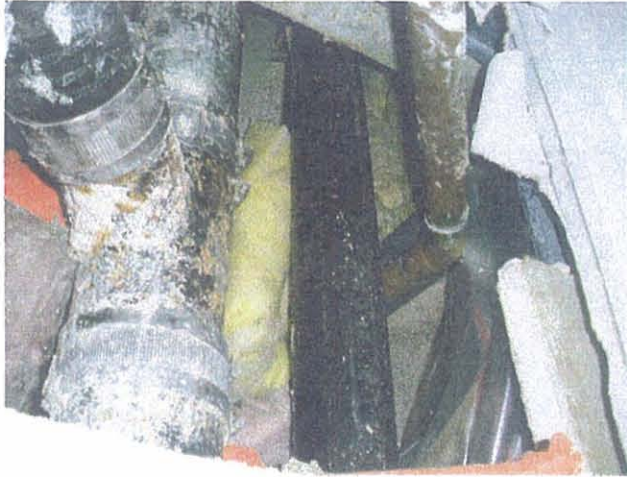
UGN – Chicago Waukegan Regional
Opened Vertical Pipe Chase With Inadequate
Thermal Insulation

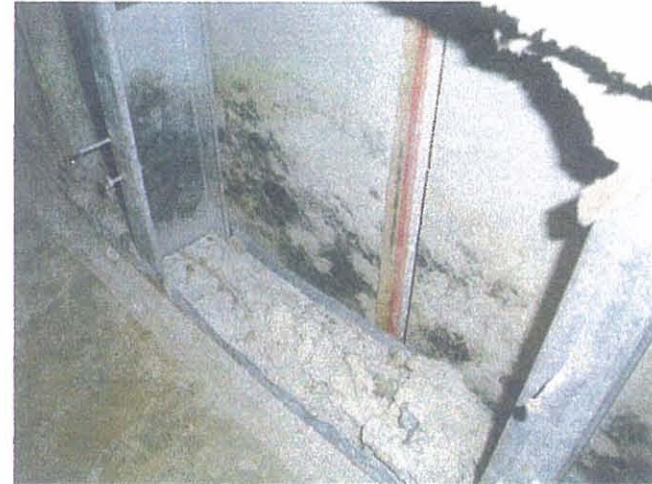
UGN – Chicago Waukegan Regional
Visible Mold Growth Inside of Wall – First Floor
Elevator Lobby

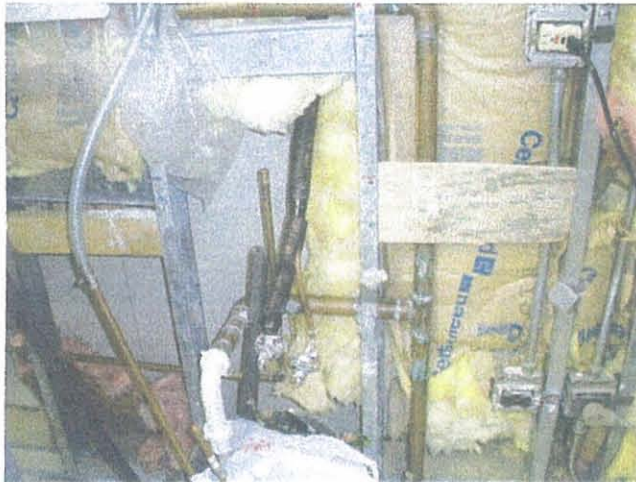
UGN – Chicago Waukegan Regional
5th Level Domestic Water Line Burst Creating
Flooding of Tower

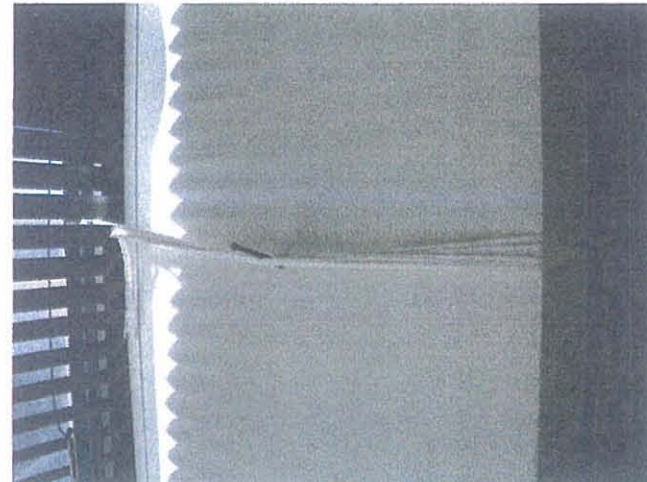
UGN – Chicago Waukegan Regional
Window Held In Place With String

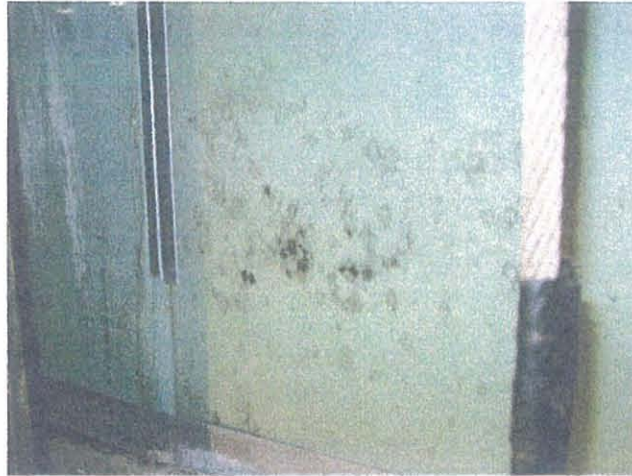
AUS – Austin
Mold on Green Board Paper in Elevator Shaft

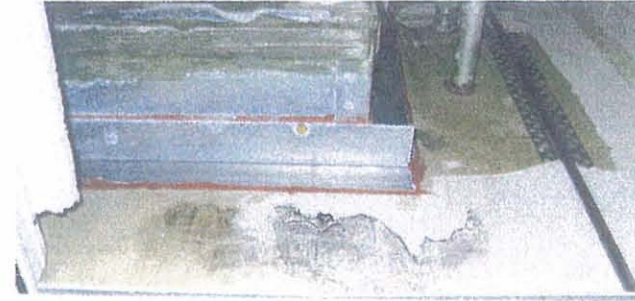
AUS – Austin
Junction Level Mold Contaminated Drywall
Below Supply Air Ductwork

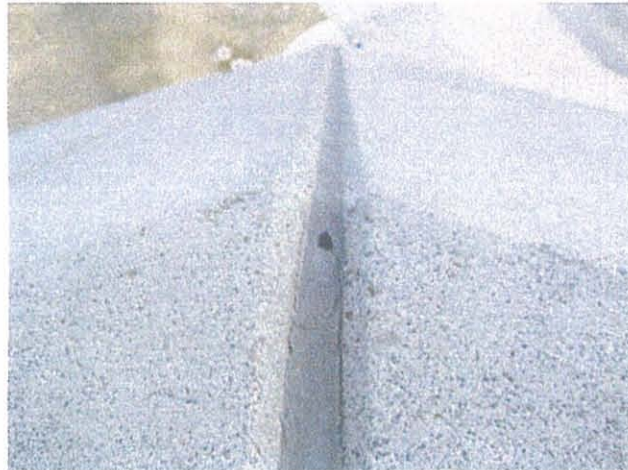
AUS– Austin
Cab Balcony Deteriorated Seam Caulk

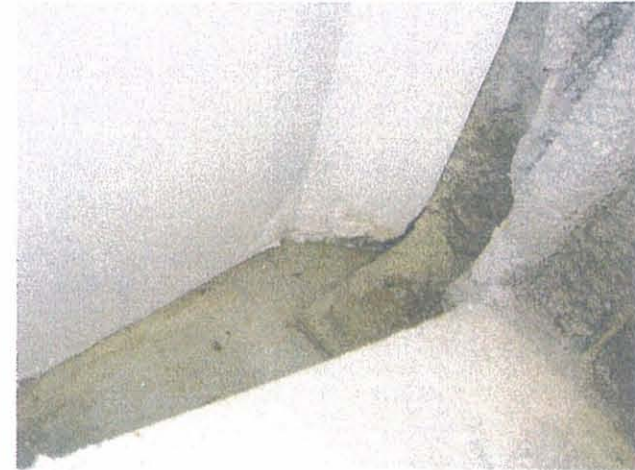
AUS – Austin
8th Level Mold Near Cement Floor

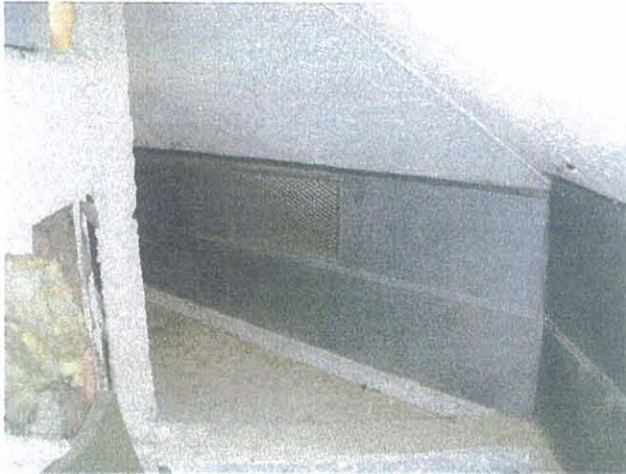
STL – Lambert St. Louis
Cable Access Level – Uninsulated Perimeter
Walls with Vents to Outdoors

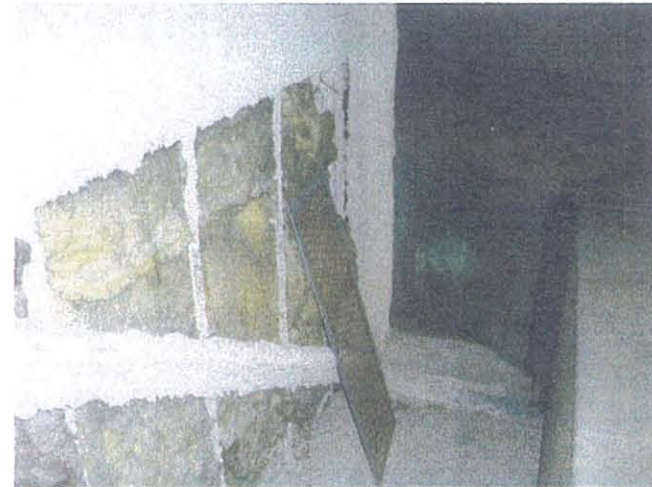
STL – Lambert St. Louis
Cable Access Level – Wallboard and Insulation
on Inner Ring

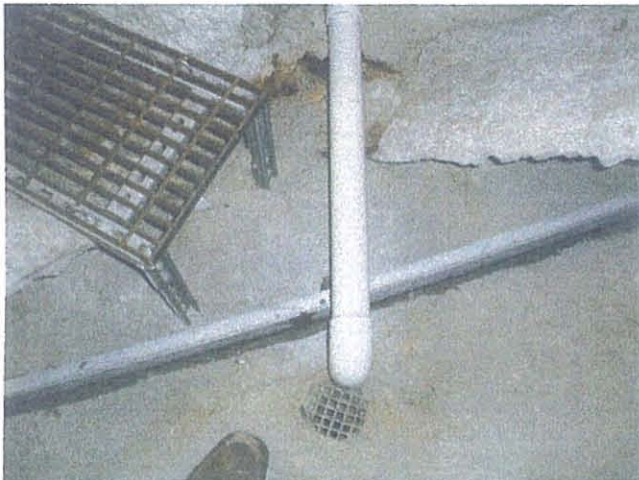
STL – Lambert St. Louis
Drain in Air Shaft Modified to Prevent Pooling

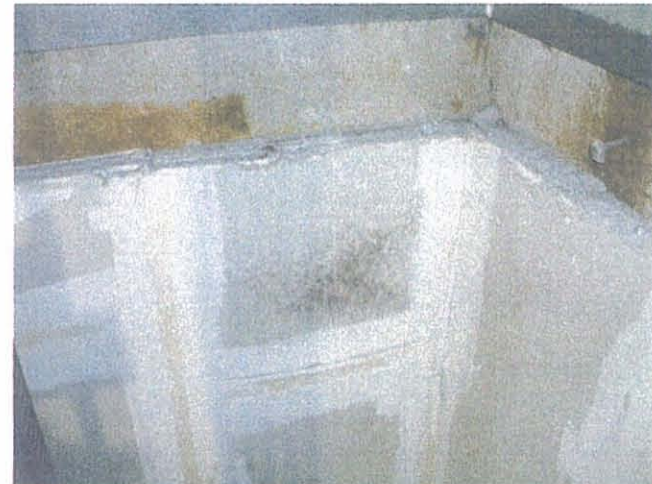
STL – Lambert St. Louis
Suspect Mold Growth in Elevator Shaft

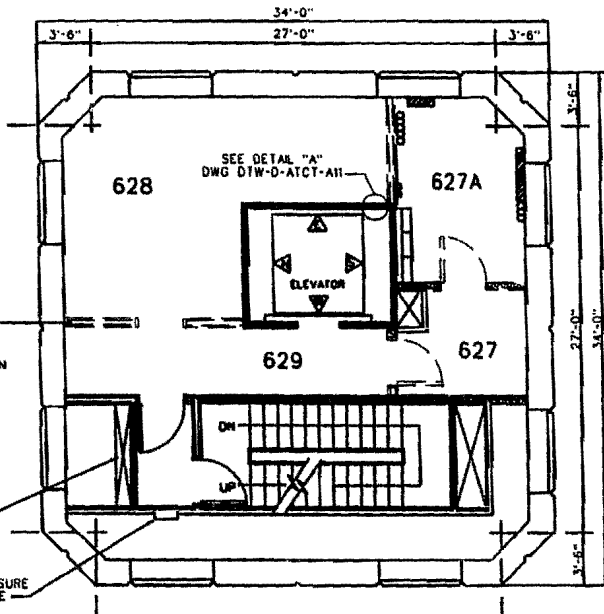
SIXTH FLOOR SHAFT PLAN

2. APPROXIMATELY 20 LINEAR FEET OF 1" AND 25 LINEAR FEET OF 1/2" WATER STAINED AND/OR CONTAMINATED CHILLED AND HEATING WATER PIPE INSULATION SHALL BE REMOVED AND REPLACED.

5. ONCE THE MOLD HAS BEEN REMOVED AND CLEARANCE HAS BEEN ACHIEVED, AND THE STAINED SURFACES HAVE BEEN CLEANED, THEN REMOVE ALL PARTITION WALLS, DOORS AND DOOR FRAMES, EXCEPT THOSE AROUND THE ELEVATOR CORE AND STARWELL.

1. THE CONTRACTOR SHALL PROVIDE ADDITIONAL CLEANING PROCEDURES AND PIPE INSULATION REMOVAL/REPLACEMENT.

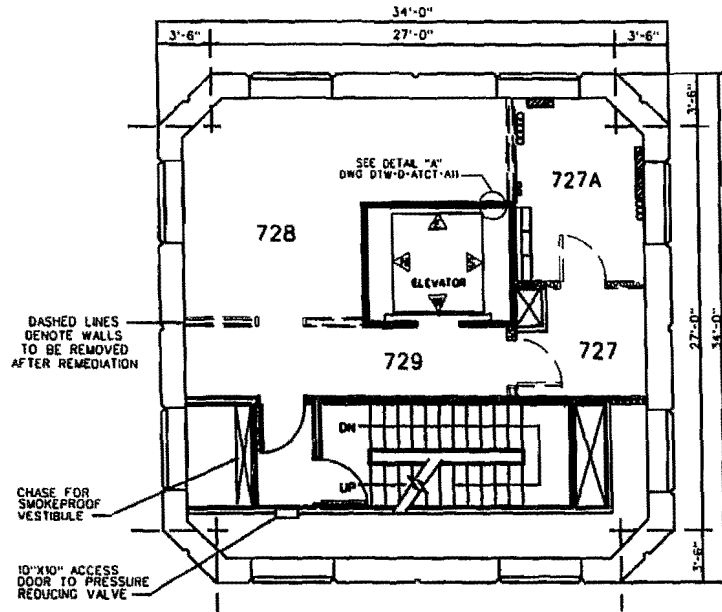
SEVENTH FLOOR SHAFT PLAN

1. THE CONTRACTOR SHALL PROVIDE ADDITIONAL CLEANING PROCEDURES AND PIPE INSULATION REMOVAL/ REPLACEMENT.
2. APPROXIMATELY 3 LINEAR FEET OF 18" WATER STAINED AND/OR CONTAMINATED CHILLED AND HEATING WATER PIPE INSULATION SHALL BE REMOVED AND REPLACED.

5. ONCE THE MOLD HAS BEEN REMOVED AND CLEARANCE HAS BEEN ACHIEVED, AND THE STAINED SURFACES HAVE BEEN CLEANED, THEN REMOVE ALL PARTITION WALLS, DOORS AND DOOR FRAMES, EXCEPT THOSE AROUND THE ELEVATOR CORE AND STAIRWELL.

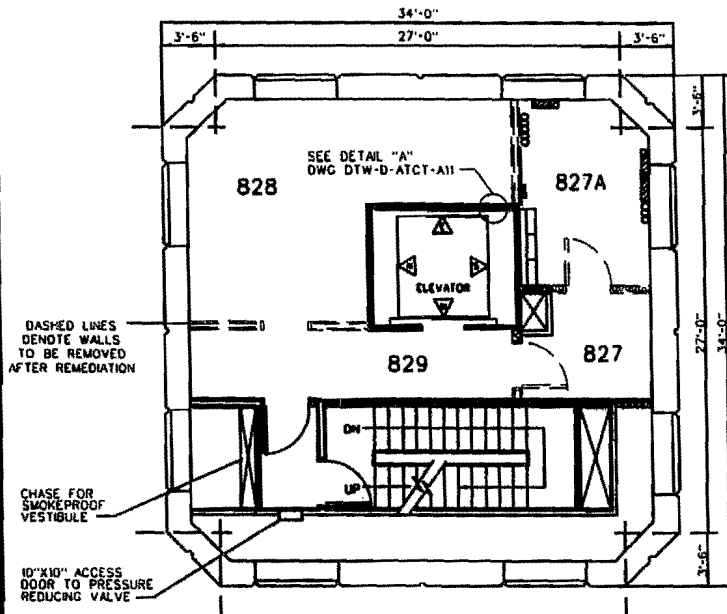
FLOOR 8:

1. THE CONTRACTOR SHALL PROVIDE ADDITIONAL CLEANING PROCEDURES AND PIPE INSULATION REMOVAL/REPLACEMENT.
2. APPROXIMATELY 4 LINEAR FEET OF 1" WATER STAINED AND/OR CONTAMINATED CHILLED AND HEATING WATER PIPE INSULATION SHALL BE REMOVED AND REPLACED.

1. PRIOR TO PERFORMING MICROBIOLOGICAL REMEDIATION PROCEDURES, THE CONTRACTOR SHALL SEAL ALL CRITICAL PENETRATIONS AND OPENINGS TO THE WORK AREA WITH A MINIMUM OF TWO LAYERS OF 6-MIL POLYETHYLENE, AND SHALL BE RESPONSIBLE FOR ENSURING ADJOINING AREAS ARE NOT EXPOSED TO THE MICROBIOLOGICAL CONTAMINATION DURING THE REMEDIATION.

5. ONCE THE MOLD HAS BEEN REMOVED AND CLEARANCE HAS BEEN ACHIEVED, AND THE STAINED SURFACES HAVE BEEN CLEANED, THEN REMOVE ALL PARTITION WALLS, DOORS AND DOOR FRAMES, EXCEPT THOSE AROUND THE ELEVATOR CORE AND STAIRWELL.

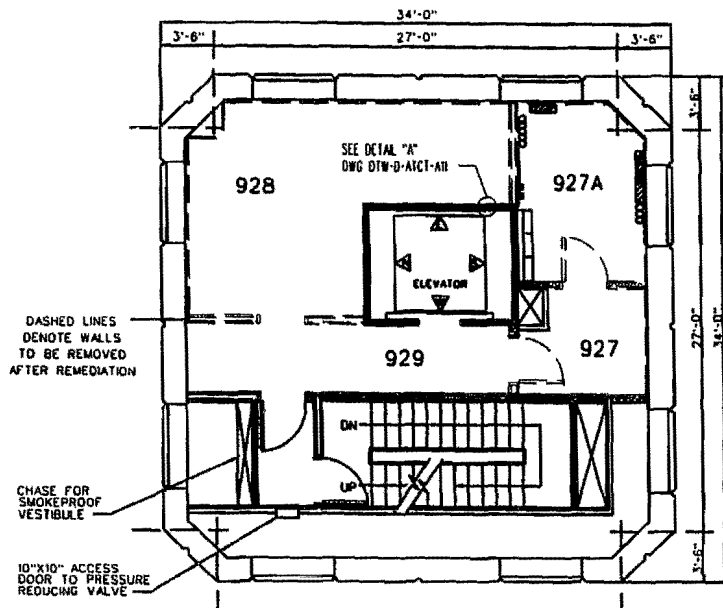
NINTH FLOOR SHAFT PLAN

2. APPROXIMATELY 4 LINEAR FEET OF 1" WATER STAINED AND/OR CONTAMINATED CHILLED AND HEATING WATER PIPE INSULATION SHALL BE REMOVED AND REPLACED.

2. CLEANUP AND REMOVAL OF MOISTURE AND MICROBIOLOGICAL CONTAMINATED GYPSUM BOARD, SHAFT LINER, AND INSULATION IN THE DTW ATCT ROOMS 928, IN ACCORDANCE WITH THE GUIDELINES ESTABLISHED BY THE NEW YORK CITY DEPARTMENT OF HEALTH ENTITLED GUIDELINES ON ASSESSMENT AND REMEDIATION OF FUNGUS INDOOR ENVIRONMENTS (GARFIE) (SEE ATTACHMENT D).

5. ONCE THE MOLD HAS BEEN REMOVED AND CLEARANCE HAS BEEN ACHIEVED, AND THE STAINED SURFACES HAVE BEEN CLEANED, THEN REMOVE ALL PARTITION WALLS, DOORS AND DOOR FRAMES, EXCEPT THOSE AROUND THE ELEVATOR CORE AND STAIRWELL.

1. THE CONTRACTOR SHALL PROVIDE ADDITIONAL CLEANING PROCEDURES AND PIPE INSULATION REMOVAL/REPLACEMENT.

3. REMOVE AND REPLACE GYPSUM BOARD, SHAFT LINER, AND INSULATION TOTALING APPROXIMATELY 311 SQUARE FEET

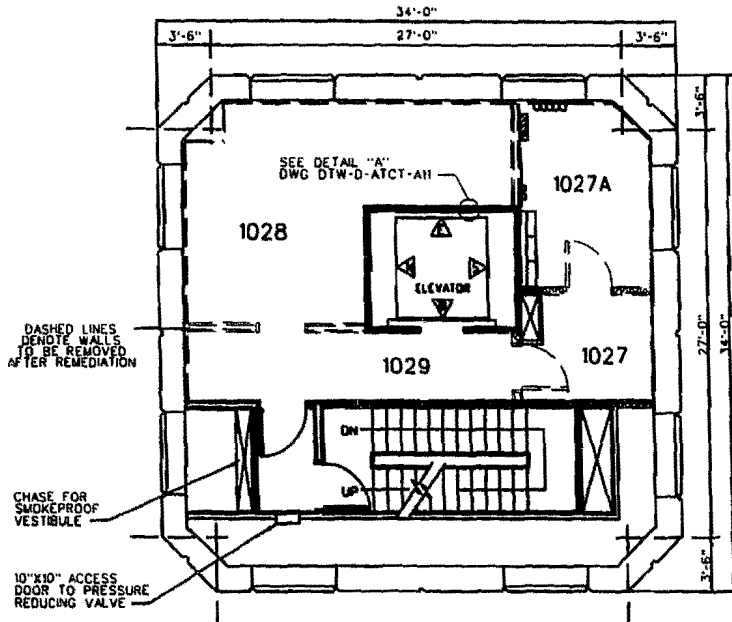
TENTH FLOOR SHAFT PLAN

2. CLEANUP AND REMOVAL OF MOISTURE AND MICROBIOLOGICAL CONTAMINATED GYPSUM BOARD, SHAFT LINER, AND INSULATION IN THE DTW ATCT ROOM 1028, IN ACCORDANCE WITH THE GUIDELINES ESTABLISHED BY THE NEW YORK CITY DEPARTMENT OF HEALTH ENTITLED GUIDELINES ON ASSESSMENT AND REMEDIATION OF FUNGI IN INDOOR ENVIRONMENTS (GARFE) ATTACHED AND INCORPORATED HEREIN BY REFERENCE (SEE ATTACHMENT 1).

5. ONCE THE MOLD HAS BEEN REMOVED AND CLEARANCE HAS BEEN ACHIEVED, AND THE STAINED SURFACES HAVE BEEN CLEANED, THEN REMOVE ALL PARTITION WALLS, DOORS AND DOOR FRAMES EXCEPT THOSE AROUND THE ELEVATOR CORE AND STARWELL.

3. THE NORTH WALL SHAFT LINER IN ITS ENTIRETY SHALL BE HEPA VACUUMED AND THEN WET WIPED WITH AN APPROVED CLEANING SOLUTION.
4. REMOVE AND DISPOSE OF EXISTING CARPET.

5. REMOVE AND REPLACE GYPSUM BOARD, SHAFT LINER, AND INSULATION TOTALING 792 SQUARE FEET. THE NORTH ELEVATOR SHAFT WALL, 22" WIDE FOR THE FULL HEIGHT, (SURFACE LAYER, CONCEALED LAYER AND SHAFT LINER).

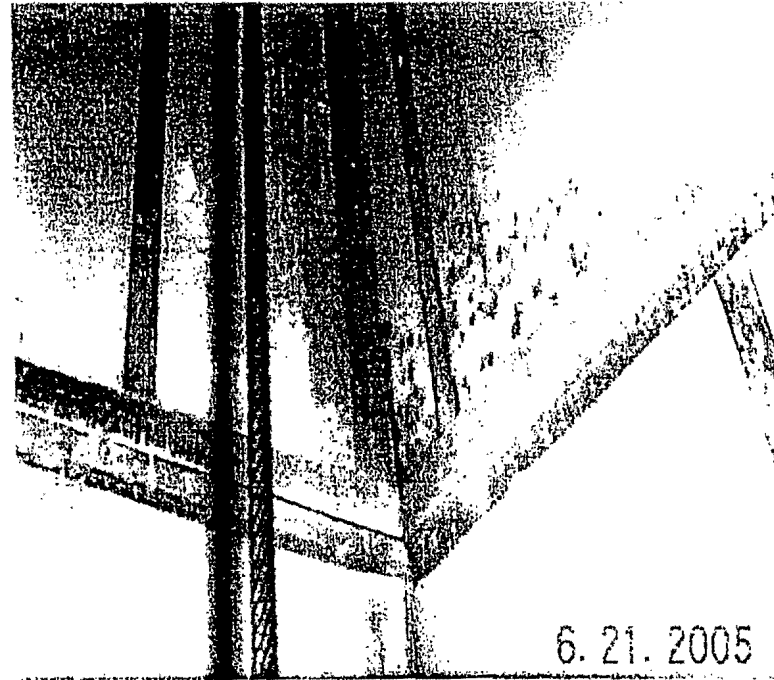
Minor mold on surface of elevator shaft GWB liner, just above the floor line.

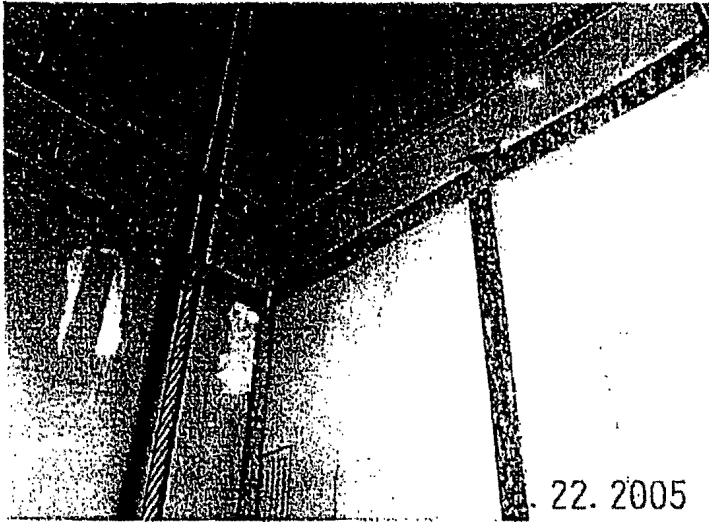
Water stains on elevator gypsum shaft liner panel below location of floor slab.

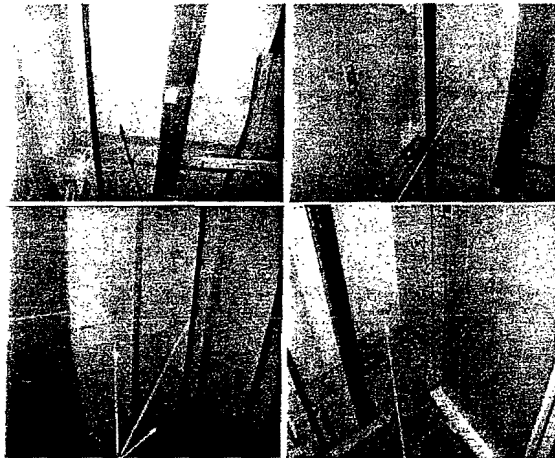
- **Top Left:** Spots of visible mold growth on east wall of shaft of the third floor.
- **Top Right:** Visible mold growth on shaft on west wall of seventh floor.
- **Bottom Left:** Visible mold growth on shaft on west wall of eighth floor.
- **Bottom Right:** Visible mold growth on east wall of shaft of sixth floor.

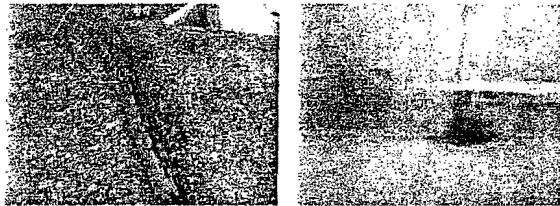
Pictured:
Near right - Exterior caulking failure.
Far right - Moisture seeping into unoccupied space in the tower from the exterior wall.

- July - October 2006 - Exterior sealing and caulking to eliminate water infiltration.
- August - September 2006 - Interior work that may include removal of walls/wallboard and changes to accommodate HVAC duct modifications if needed.
- August - November 2006 - Mechanical/electrical work including HVAC (Heating/Ventilation/Air Conditioning) work to control and manage humidity within the tower and elevator shafts.
