| Tab Number | Document Name and Date | Document Type | Author | Recipient | Description |
|---|--|---|---|---|--|
| 1 | Investigation of Mold and Moisture at the FAA Detroit Metropolitan ATCT Facility | Report | OST | FAA | This investigation was performed to determine if mold and moisture issues still affected the DTW ATCT as was alleged by some employees. It determined that fungal growth and water intrusion still affected the building. The report contained a recommendation to perform water damage assessments at other Leo Daly ATCTs. |

**INVESTIGATION OF MOLD AND MOISTURE AT THE
FEDERAL AVIATION ADMINISTRATION
DETROIT METROPOLITAN AIR TRAFFIC CONTROL TOWER FACILITY**

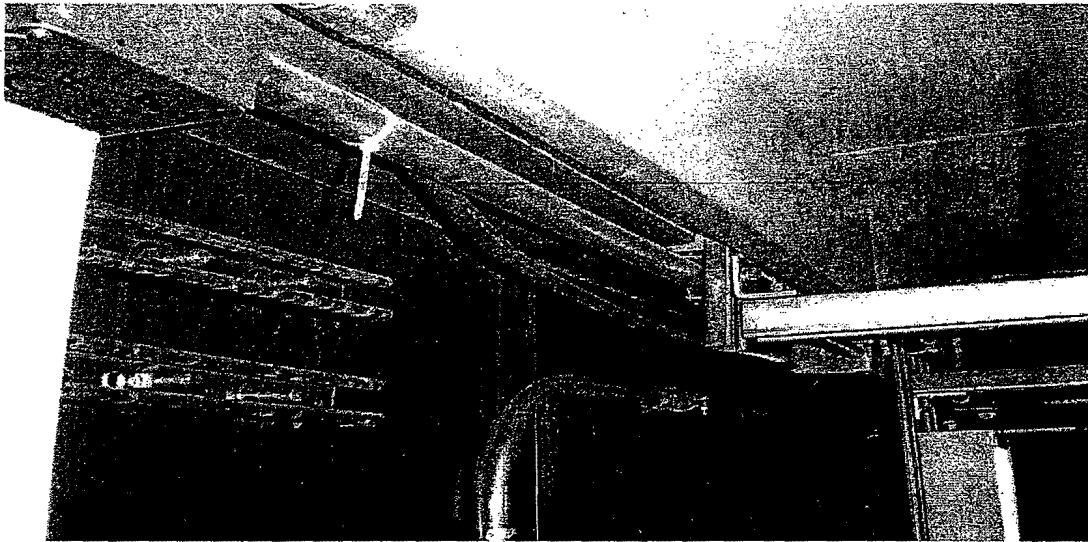
Photo 1: ASDE Penthouse, North Wall at Roof Beam.

There is no insulation on the bottom and backside of the beam or the $\frac{1}{4}$ " steel roof deck adjacent to the insulated panel wall. The gap between the beam and the wall allows warm air to contact the cold steel surfaces. The uninsulated steel is the likely point where condensation is occurring as shown by the heavy white residue visible on the wall near the bottom of the beam in the ASDE Penthouse.

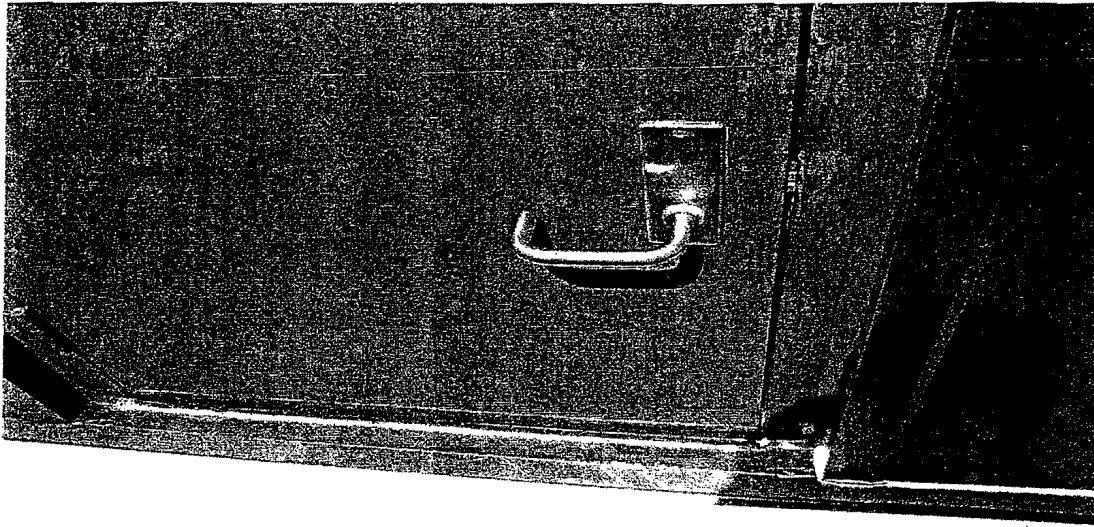
Photo 7: Cab Level, Exterior of Door by Outside Walkway.

An excessive gap is shown on the latch side of the door that allows water to enter the building. The metal flashing also has a slight slope towards the door and threshold instead of towards the exterior.

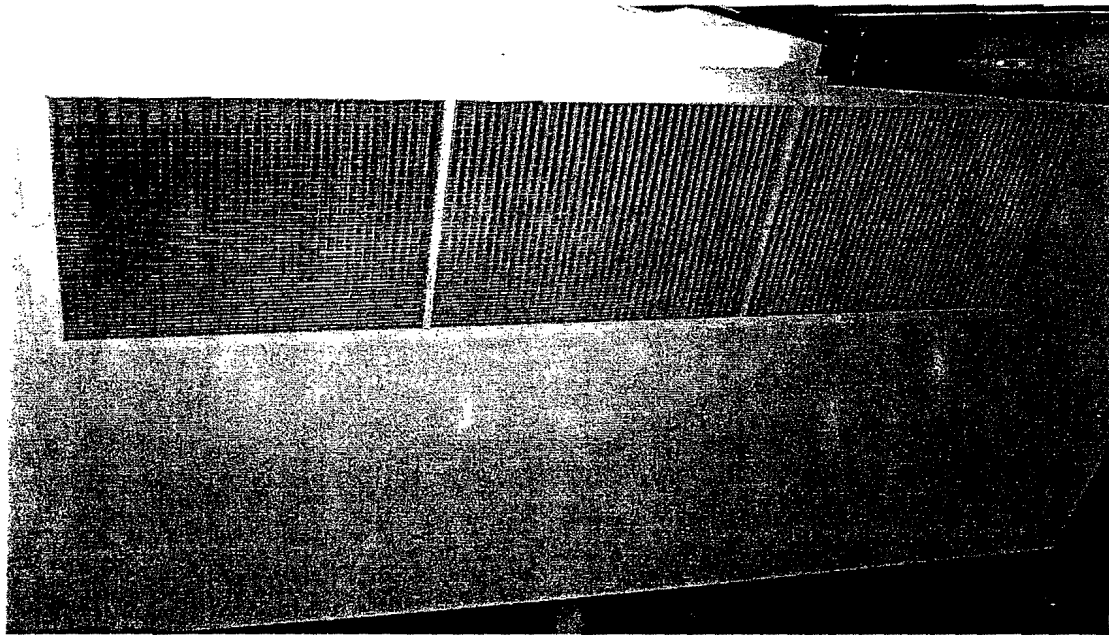
Photo 12: Below Cable Access Level, Return Air Grill.

Debris from this return air grill has contaminated adjacent walls as shown in Photo 8. Dust provides a food source, which sustains the growth of mold.

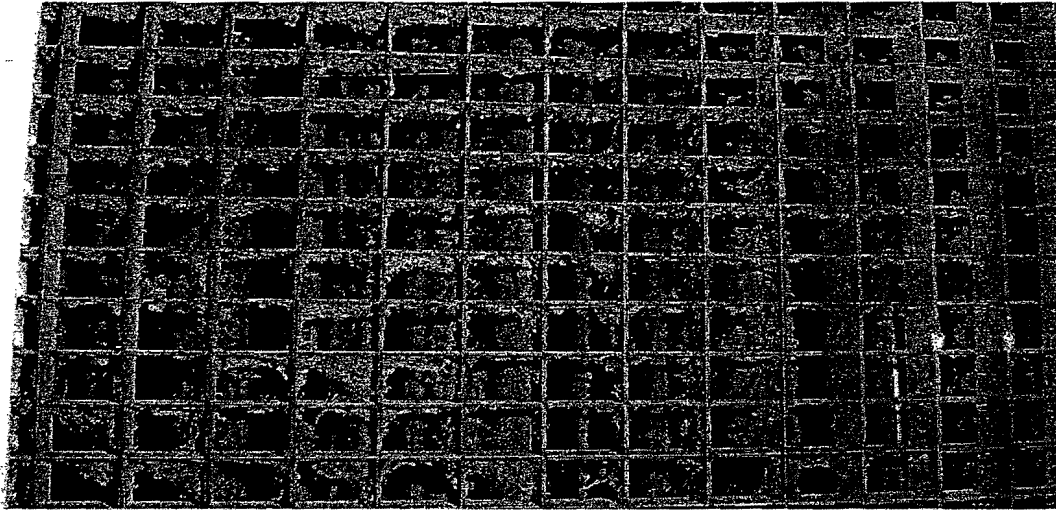
Photo 13: Below Cable Access Level, Dirty Return Air Grill.

A close up of the return air grill from Photo 12 above shows a thick lading of dust, indicating the need for an increased frequency of housekeeping measures.

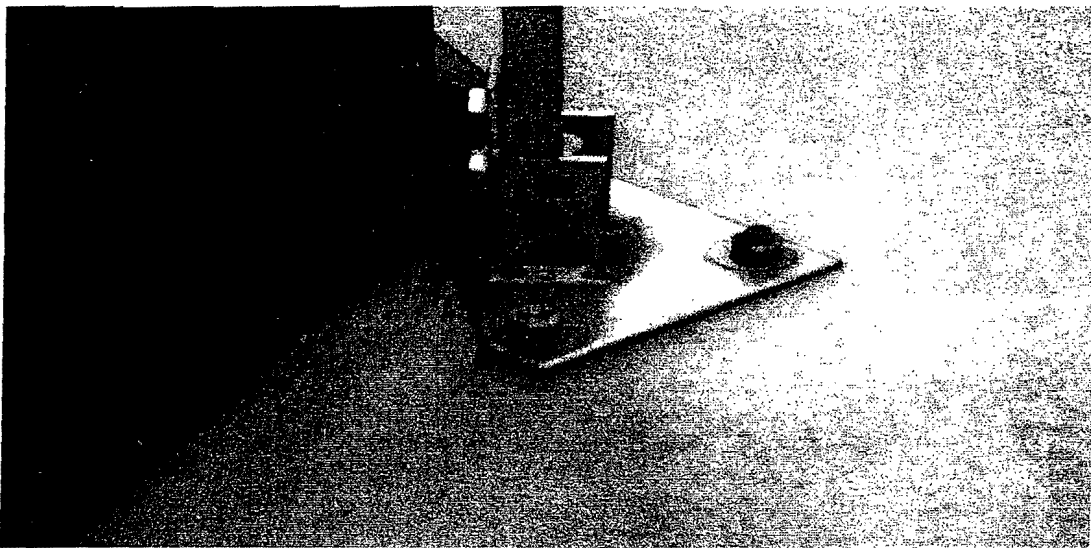
Photo 14: Cab Level Walkway, Penetrations in Floor.

The roof system on the walkway consists of a waterproof membrane on top of the structural concrete deck. The membrane is covered with a concrete topping slab that is coated with a waterproof deck coating. The membrane is installed utilizing typical roofing details and is the primary waterproofing component. The membrane terminates at the drains and is clamped in place at the drain bodies as shown above. In this type of system, the drain bodies have seepage holes to allow any water that gets through the waterproof deck coating and concrete topping slab, to follow the membrane and drain from the roof through the seepage holes into the storm drain piping. If the membrane is not fully compressed under the clamping collar into the drain body, a leak can occur.

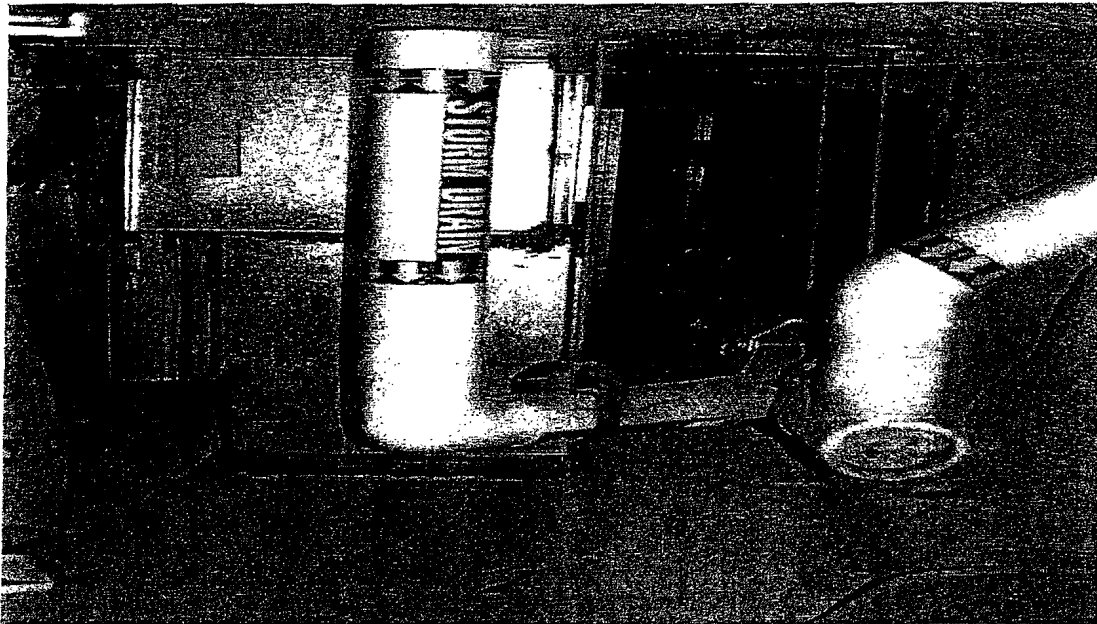
Photo 15: Cable Access Room (CA1).

One of the storm drain pipes in Room CA1, directly beneath the drain body, had water stained insulation as shown above. The stained insulation could be caused by a leak getting under the membrane and following the structural concrete slab to the opening around the drain body, a leak at the connection between the drain body and drain pipe, or possibly from condensation due to a damaged vapor barrier jacket on the insulation.

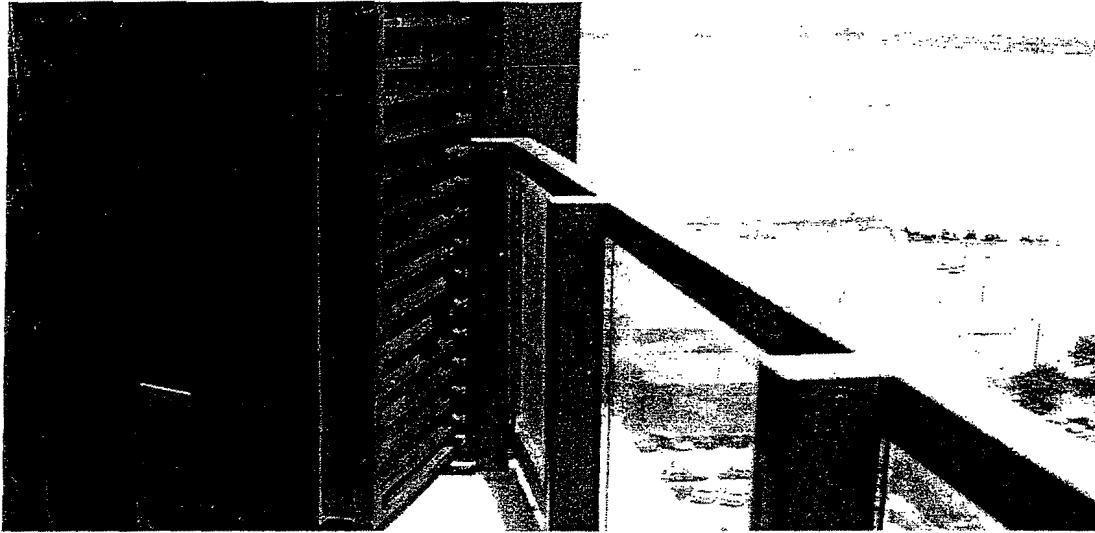
Photo 19: Junction Level, Holes in Hand Rail Post.

Each of the railing posts on the walkways has a hole in the side near the top that could allow rather small quantities of water into the tube and down into the building as shown above. The holes appear to be vent holes from when the posts were hot dip galvanized during fabrication. The holes may allow water to enter the building behind the walls of the SubJunction Level.

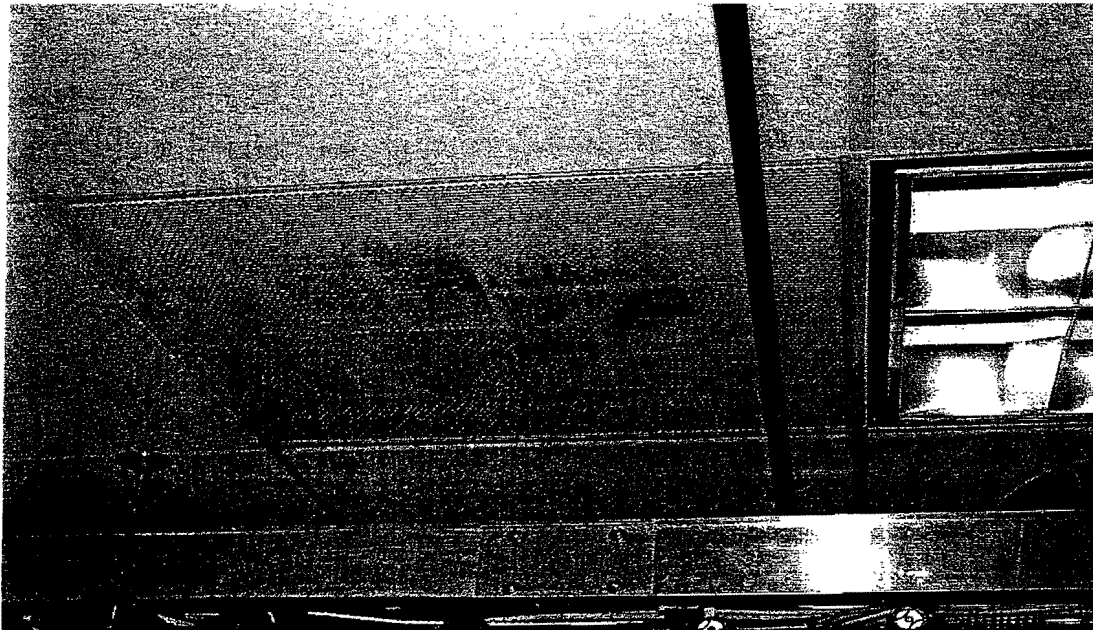
Photo 30: Sub Junction Level, Room SJ1, Dirty Diffuser.

A dirty diffuser is shown in Room SJ1. Diffusers and grilles must be cleaned as the dust provides a food source for mold.

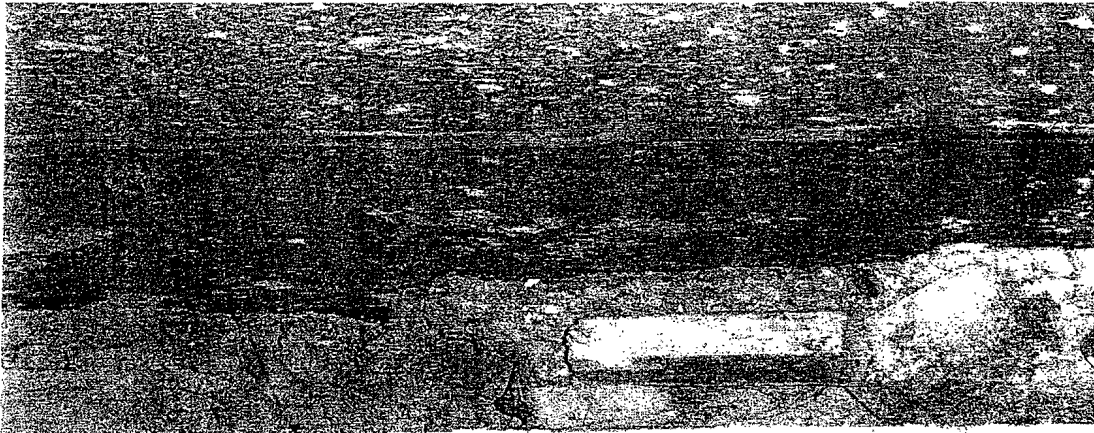
Photo 31: Debris found in 11th Floor Outer Ring.

A large quantity of scrap gypsum board was found in the void between the edge of the floor slab, precast exterior walls, and perimeter fire rated gypsum board walls as shown above.

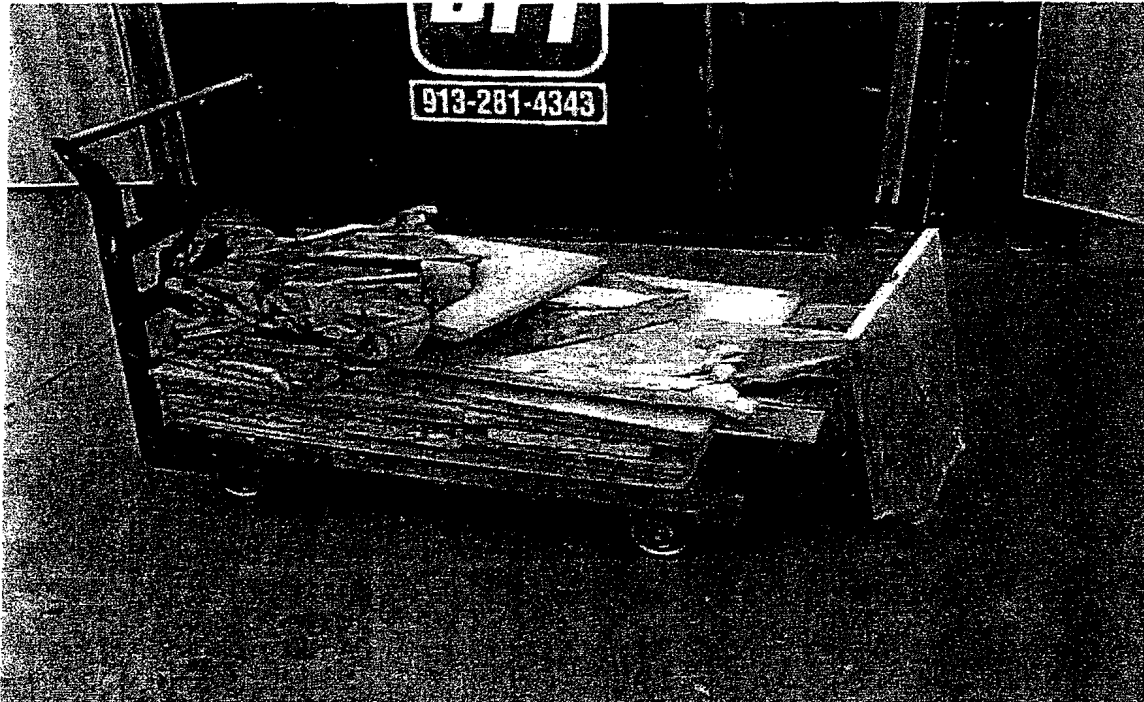
**Photo 32: Construction Debris found in 11th Floor Outer Ring,
Back of the West wall of 11TS5.**

This debris was found in the same location as the material shown in Photo 31. Much of this material appears to be left from the building's initial construction.

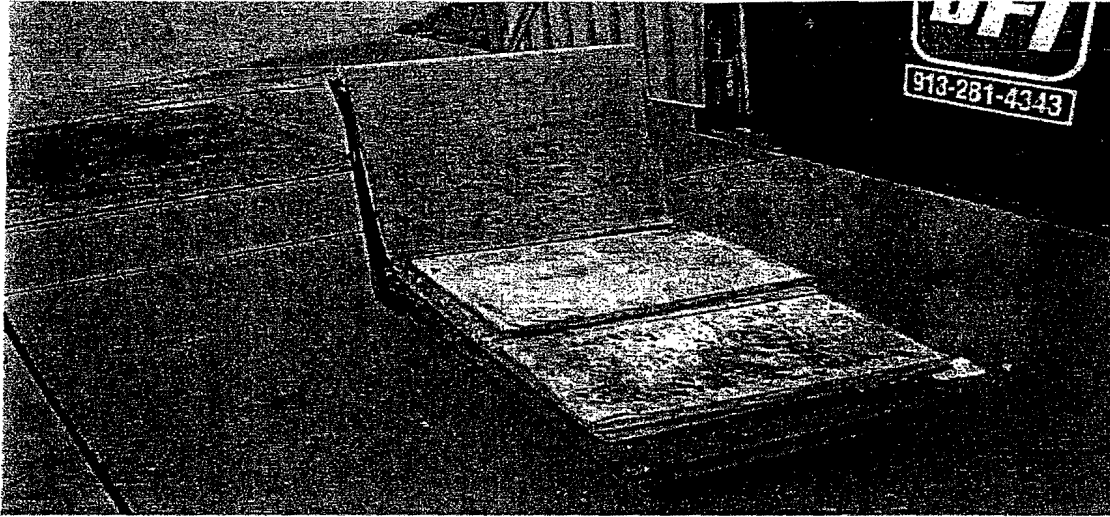
**Photo 33: Moldy Construction Debris found in
11th Floor Outer Ring, Back of the West wall of 11TS5.**

This construction debris was found in the same location as the material shown in Photos 31 and 32. Much of the scrap had large quantities of mold.

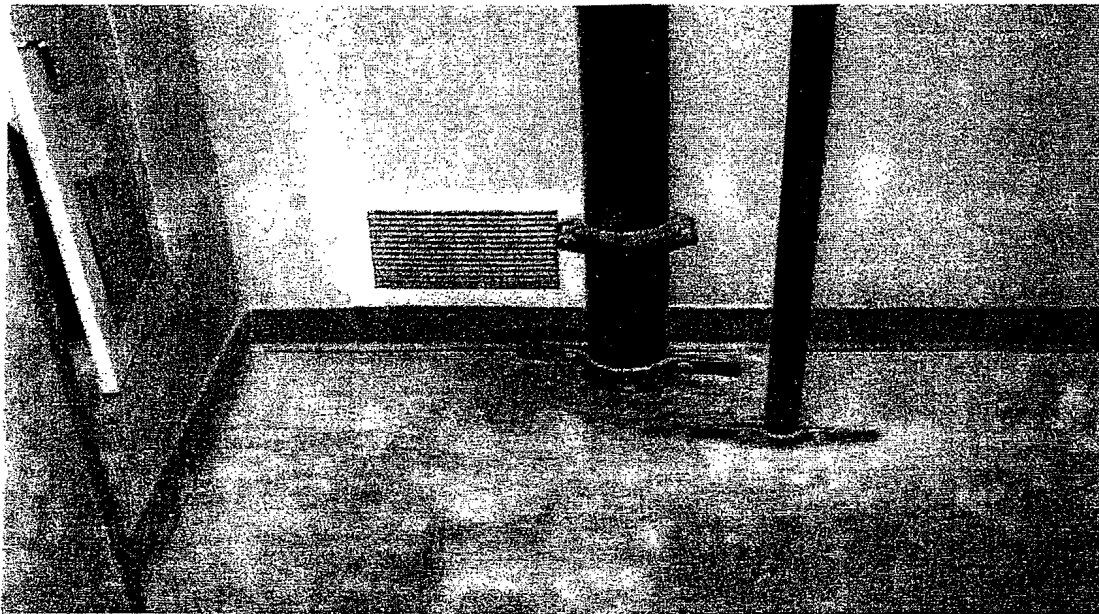
Photo 36: 11TS6, Southwest corner.
Water stains and discoloration were found on the concrete floor and gypsum board wall of stair vestibule 11TS6. A union and short section of pipe in the fire sprinkler line was unpainted and had been replaced after the tower was constructed. It was confirmed that this pipe had leaked and as repaired. Peeling back the vinyl base revealed visible mold.

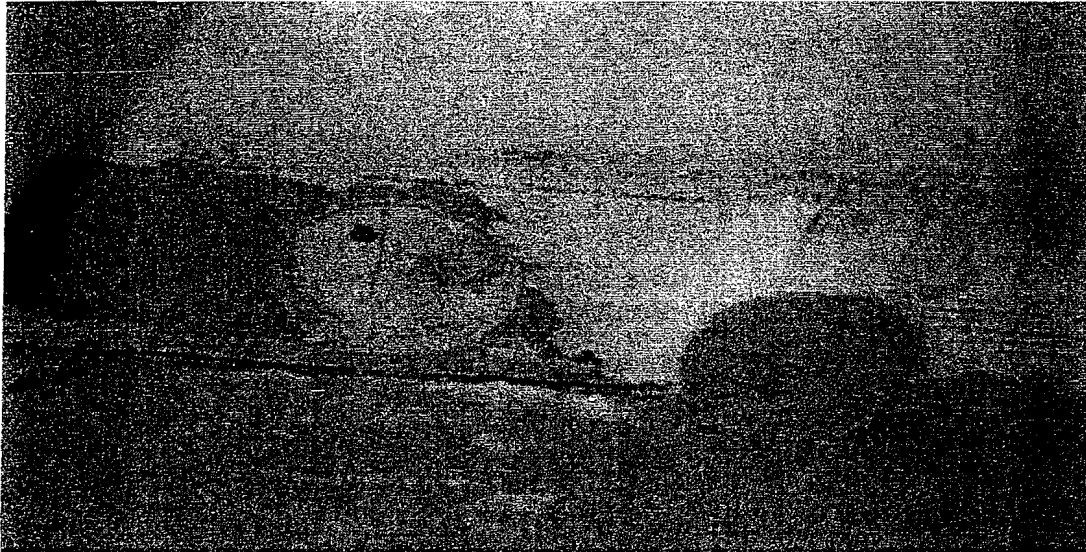
Photo 37: 11TS5, West Wall, Drilled Core South of Door.

Mold is shown on the back of the 1st layer of sheetrock and on the front of the concealed layer in Room 11TS5. This area was known to have had water leaks, therefore the base was pulled and cores were drilled in order to evaluate the possible presence of mold.

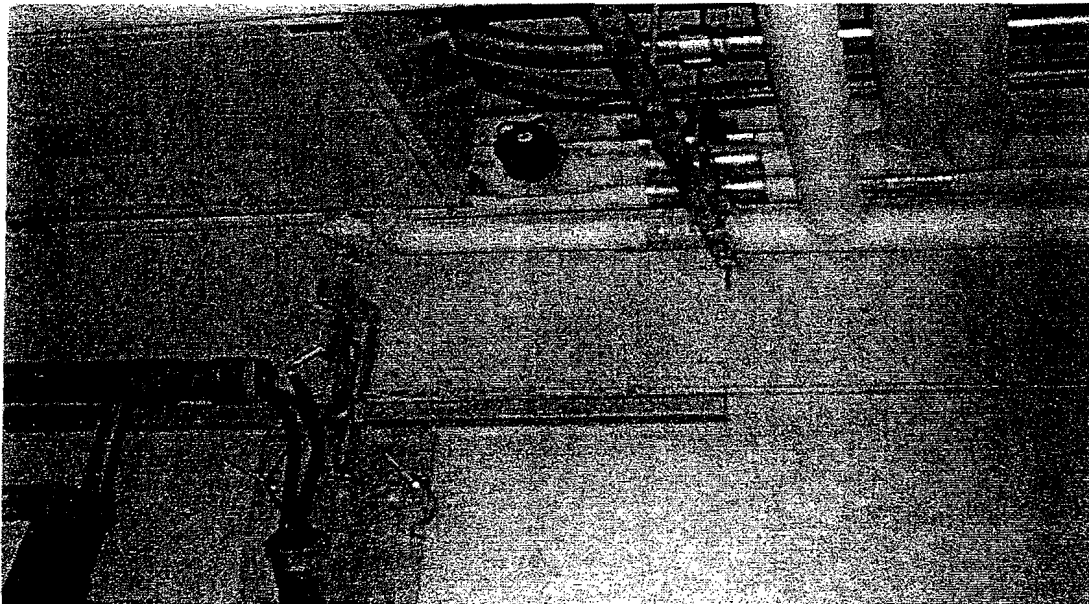
Photo 38: 11TS5, East Wall Fan Coil Unit.

Pipe insulation is shown with visible water stains in Room 11TS5. Water stained insulation should be checked regularly if in close proximity to sheetrock.

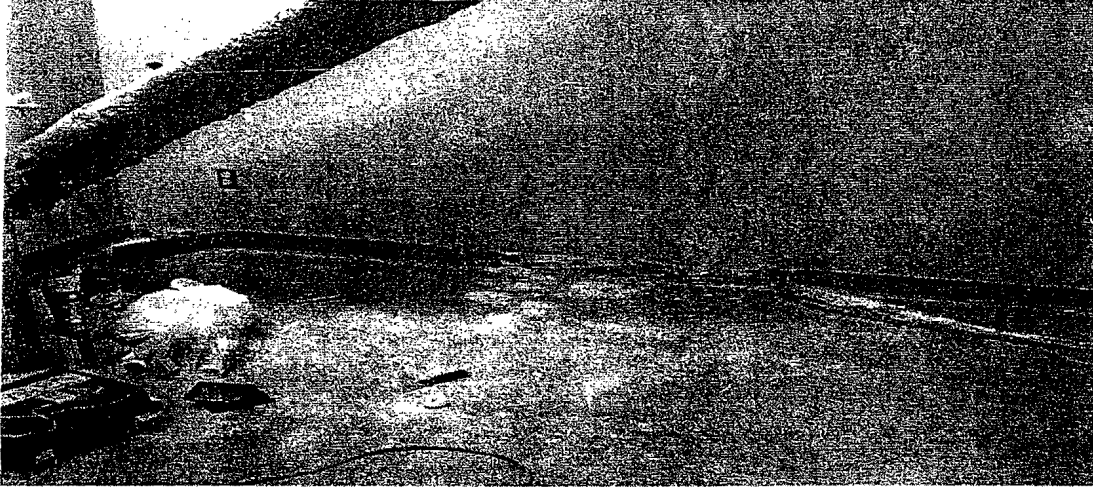
Photo 39: 10TS5, NW Corner.

Mold was found behind the vinyl base in this location of Room 10TS5. The core openings shown in the upper left corner and middle of the photo provide an example of how holes are drilled to estimate total quantities of mold for the subsequent remediation. It appears that all mold found on this level was the result of water damage from the clogged floor drain on the Sub Junction level.

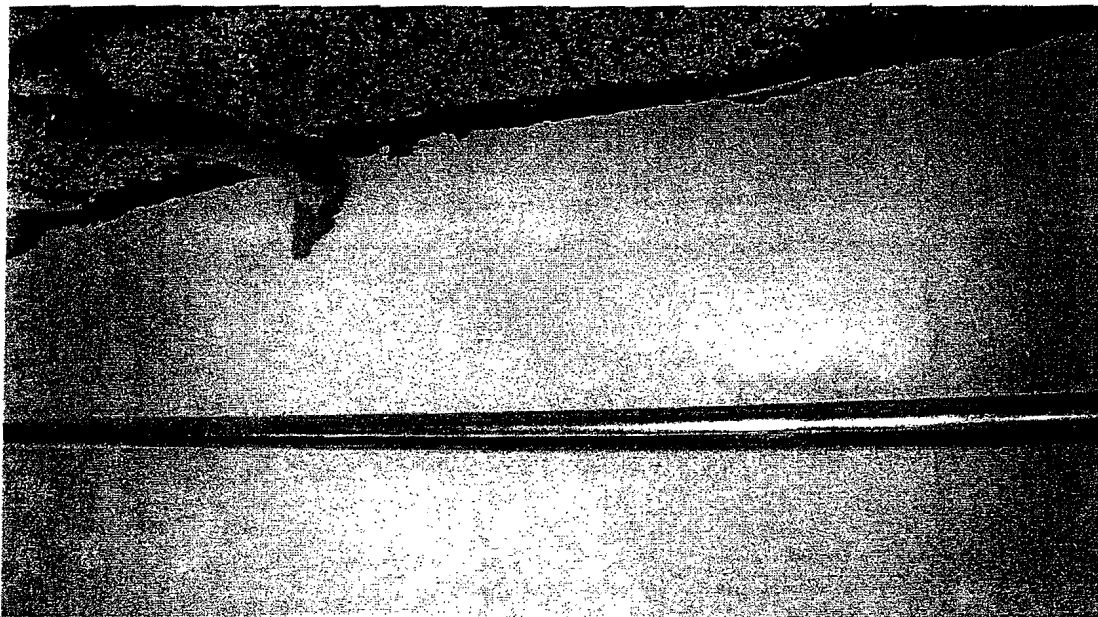
Photo 40: Yellow stained South Wall (Elevator Shaft) of 10TS5.

The yellowed areas shown on the sheetrock in Room 10TS5 often indicate the initial stage of underlying mold growth. In this case, however, the core sample obtained was negative.

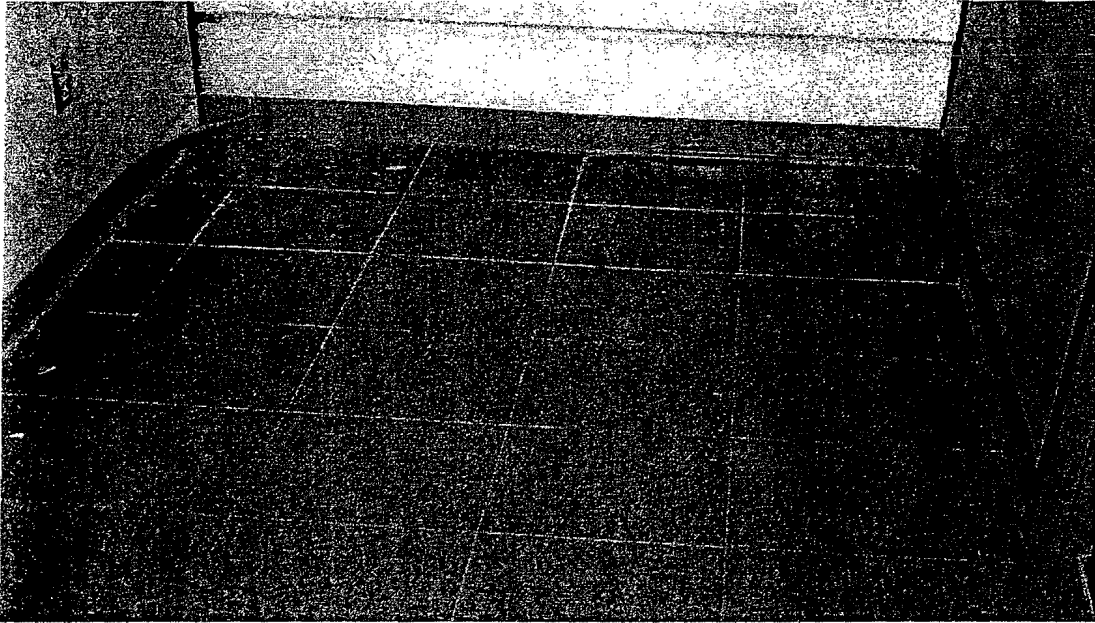
Photo 43: 9TS1, West Wall.

The floor tile at the west end of the corridor had water stains and white residue especially between the tiles as shown above. The base was pulled away for an evaluation but no mold was found. There are visible water stains on the ceiling and wall directly above this area, as shown in Photo 41.

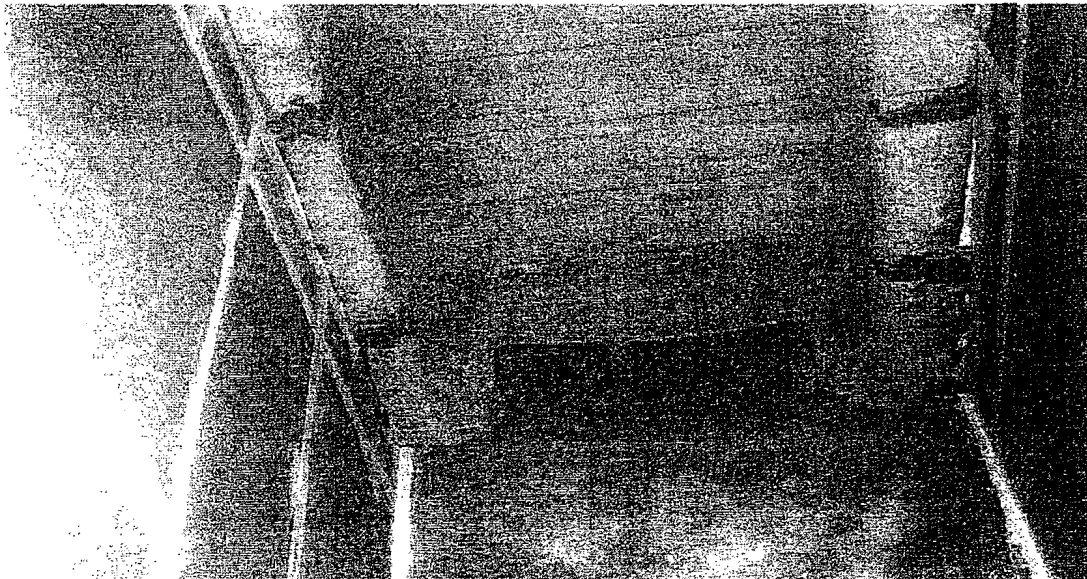
Photo 46: Underside of 9th Floor Deck, West End, Above 8TS1.

A visual inspection conducted by looking through the access panel in the ceiling of corridor 8TS1 revealed discolored and water stained fireproofing on the underside of the 9th floor metal deck as shown above.

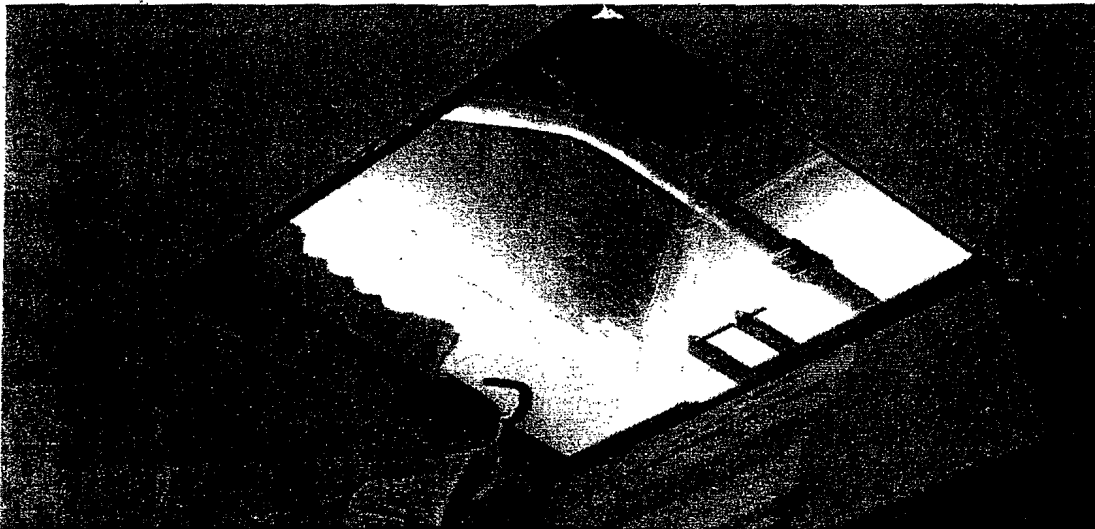
Photo 48: 8TS6 12" by 12" Access Panel Above Ceiling.

Further investigation through the access panel in the ceiling of the stair vestibule 8TS6 revealed a larger area of mold on the west wall of the fire taped gypsum board wall as shown above. This wall intersects the south wall above the corridor ceiling where the mold was found above the ceiling of 8TS1.

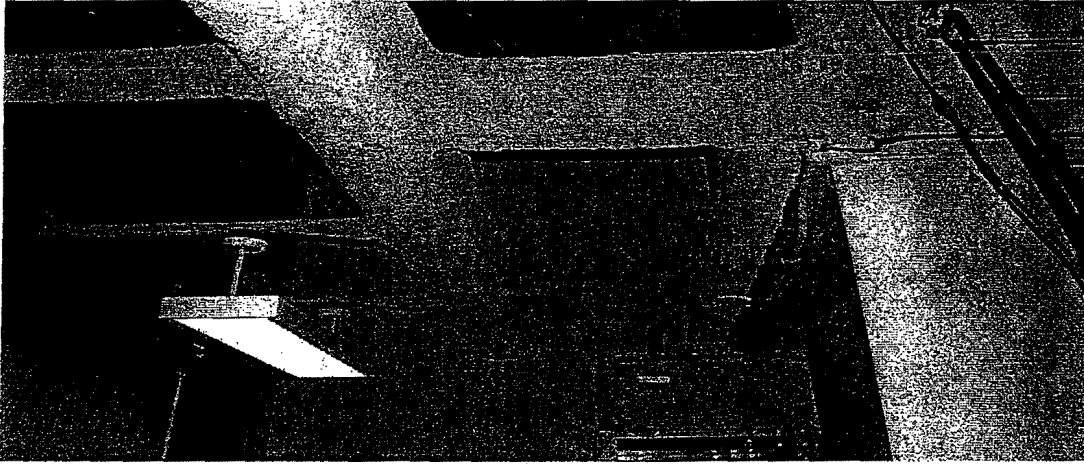
Photo 49: Yellowed Fireproofing, Intermediate Level Beam, 7TS5.

Aspergillus (3704 counts/gram) was detected in 7TS5, in a yellowed fireproofing sample. Similar yellowed fireproofing samples were collected in 7TS5 in the center of the room; in 7TS5 at the ceiling level; in 7TS5 on the metal deck; in 7TS5 on the west side of the elevator shaft; in 7TS5 on the middle of the beam on the north side of the elevator shaft; in 7TS1 above the west access panel; and in 7TS4 on the lower beam, on the west side of the elevator. All contained mold spore concentrations below the limit of detection.

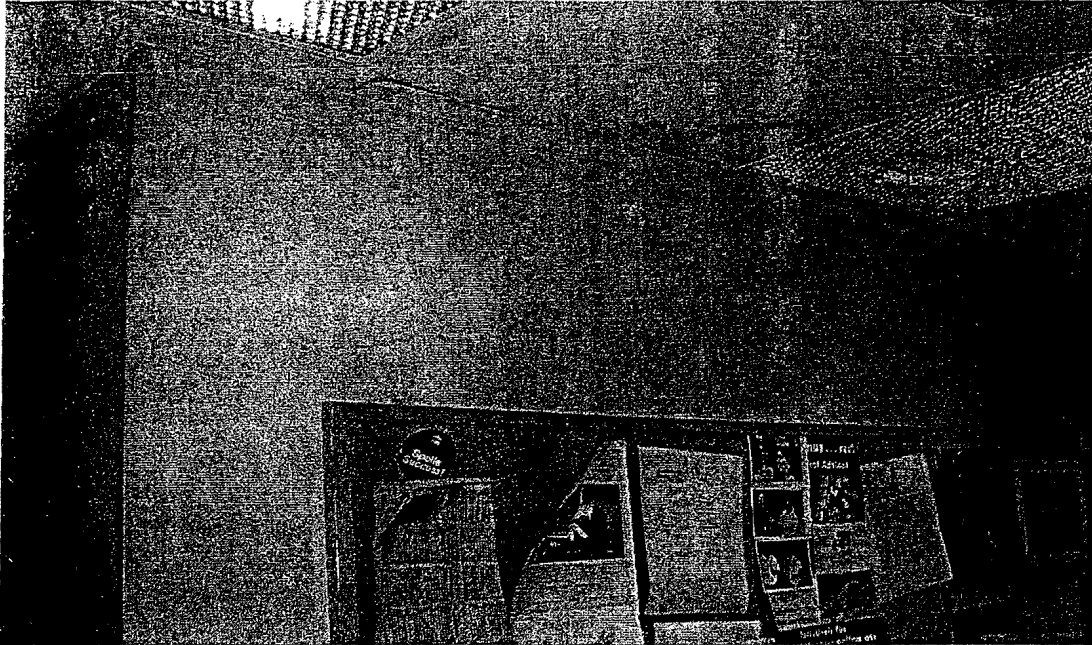
Photo 55: 2TS5, West Side of Elevator Shaft.

Several large water stains were found on the suspended acoustical ceiling in 2TS5 as shown above. Water streaks/stains were visible on the walls forming the elevator shaft and the base below was evaluated, however, no mold was found.

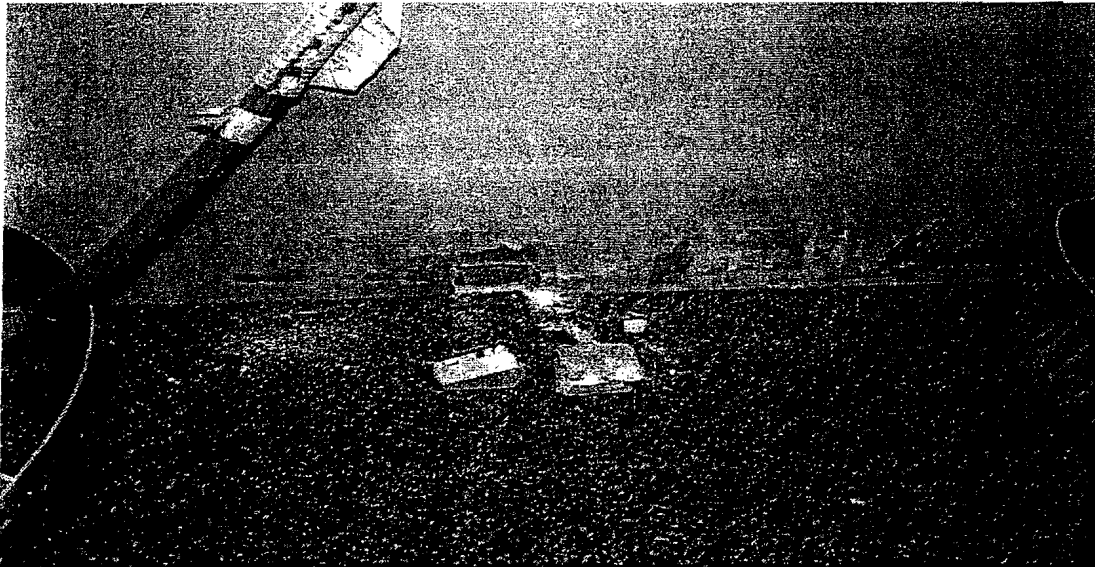
Photo 56: 2TS5, North Wall.

A small amount of mold was found behind the base on the north wall in Room 2TS5. This furred out gypsum board wall was installed adjacent to the precast concrete wall at some point after the ATCT was constructed. The source of water appears to be from old building joint leaks and water leaks from 3TS5.

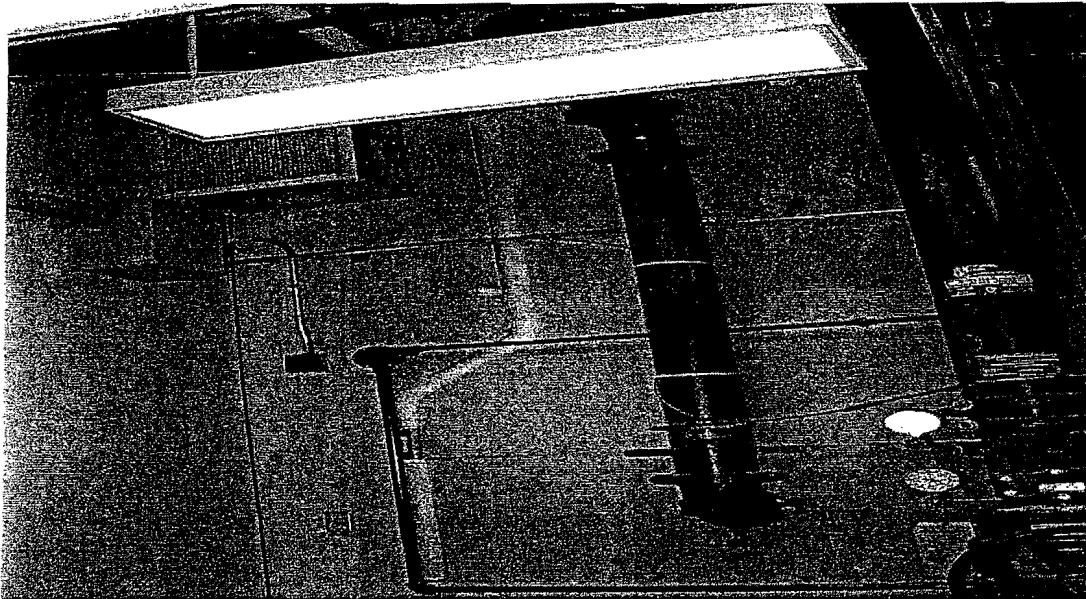
Photo 57: G4, Southwest Corner.

Water stains were visible on the unfinished gypsum board in room G4 adjacent to the outside air duct. It appears that water either leaks around or enters through the 4th floor outside air intake louver and runs down the inside, or exterior of the vertical duct run to the ground floor. This gypsum board serves as a thermal barrier over foam insulation and is not taped, finished, or painted.

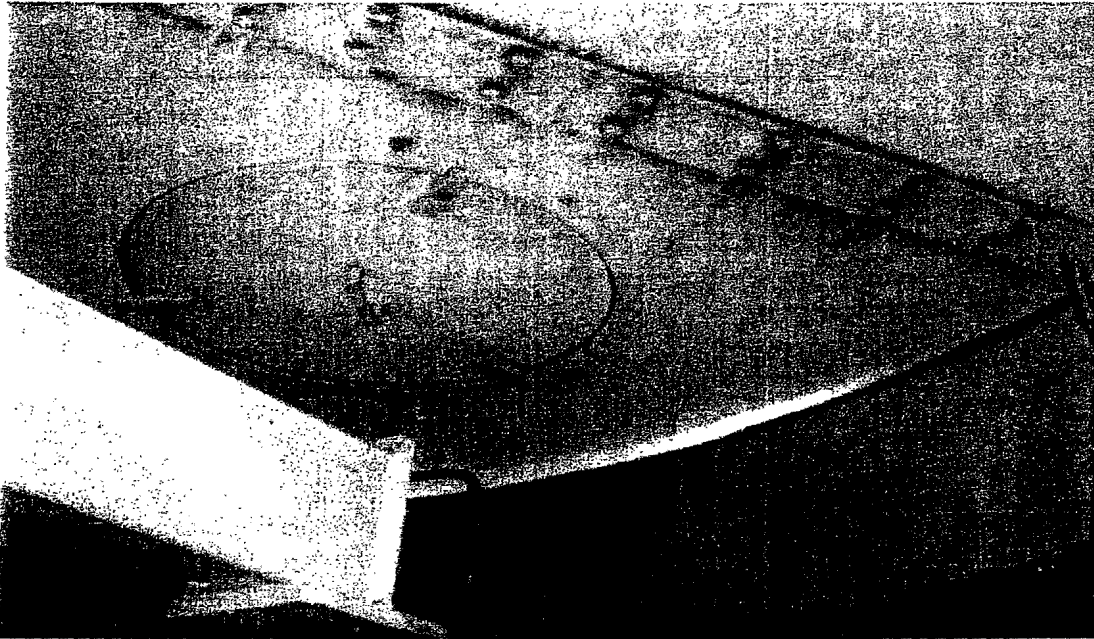
This photo shows the structural steel ring or curb beneath the ASDE antenna. The application of spray-on insulation (Contract Option 5) begins at the top of the ring and covers all structural steel below as well as the 1/4" steel plate roof. A ground cable is seen at the base of the ring.

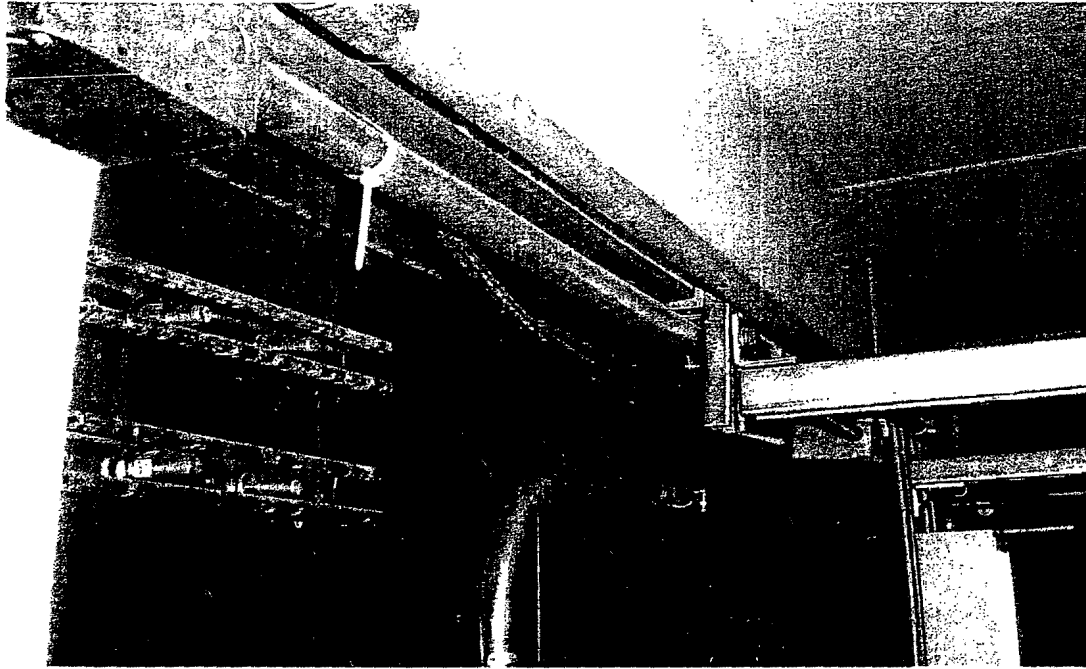
This photograph shows a typical beam at the perimeter wall insulated on one side. Junction box covers shall remain accessible after application of the insulation. Typical beam clamps and hangers can be seen.

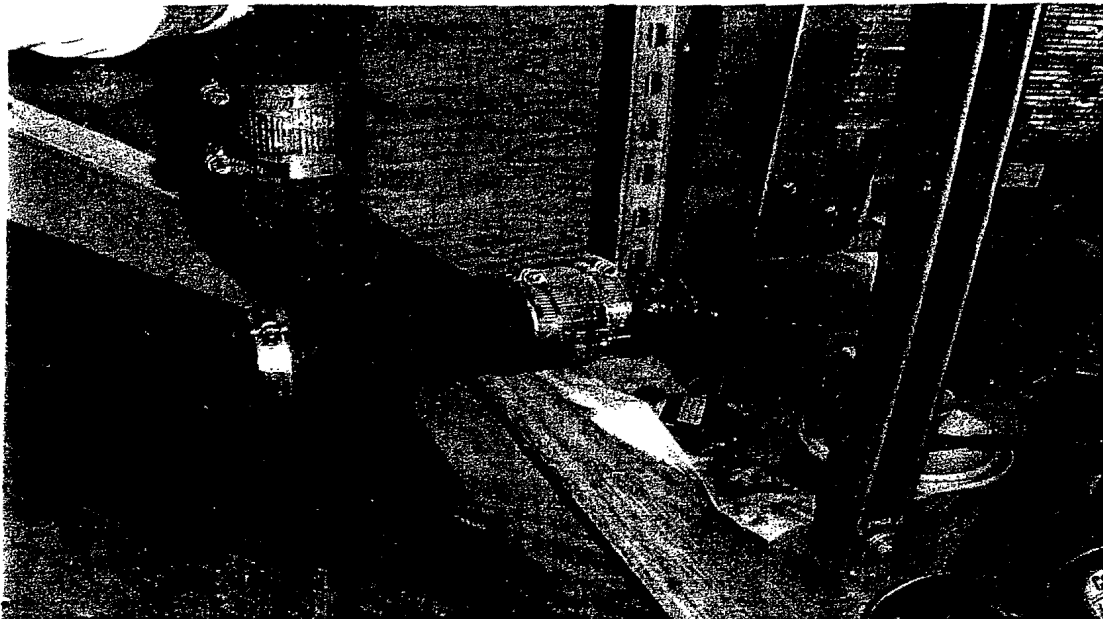
This photo shows the drain line under the Cab sink. The cast iron drain line section shall be removed and cut shorter allowing the cleanout to move to the right creating more space beneath it for a drip pan. The horizontal section of the drain line may also be moved up. A new drain line will be installed from this point to the sink.

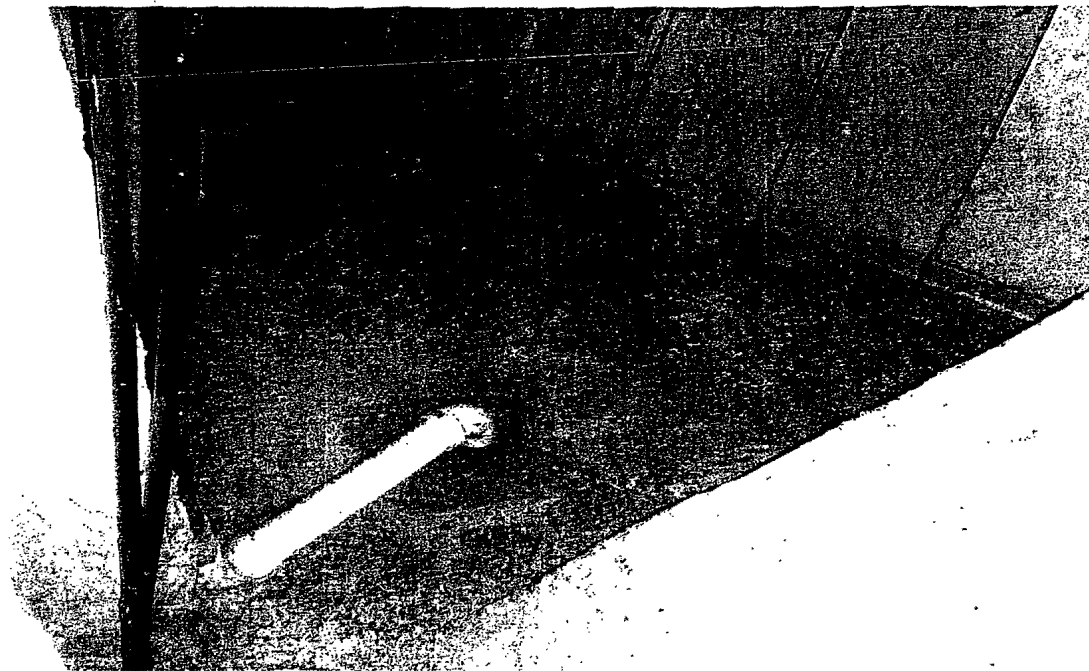
This photo shows the pigeon droppings and fire proofing to be HEPA vacuumed in one of the Subjunction Level air shafts. An angle will be installed behind the drain as a water stop to prevent water entry into the building at the column. The vertical drain line may have to be cut shorter in order to install the angle.

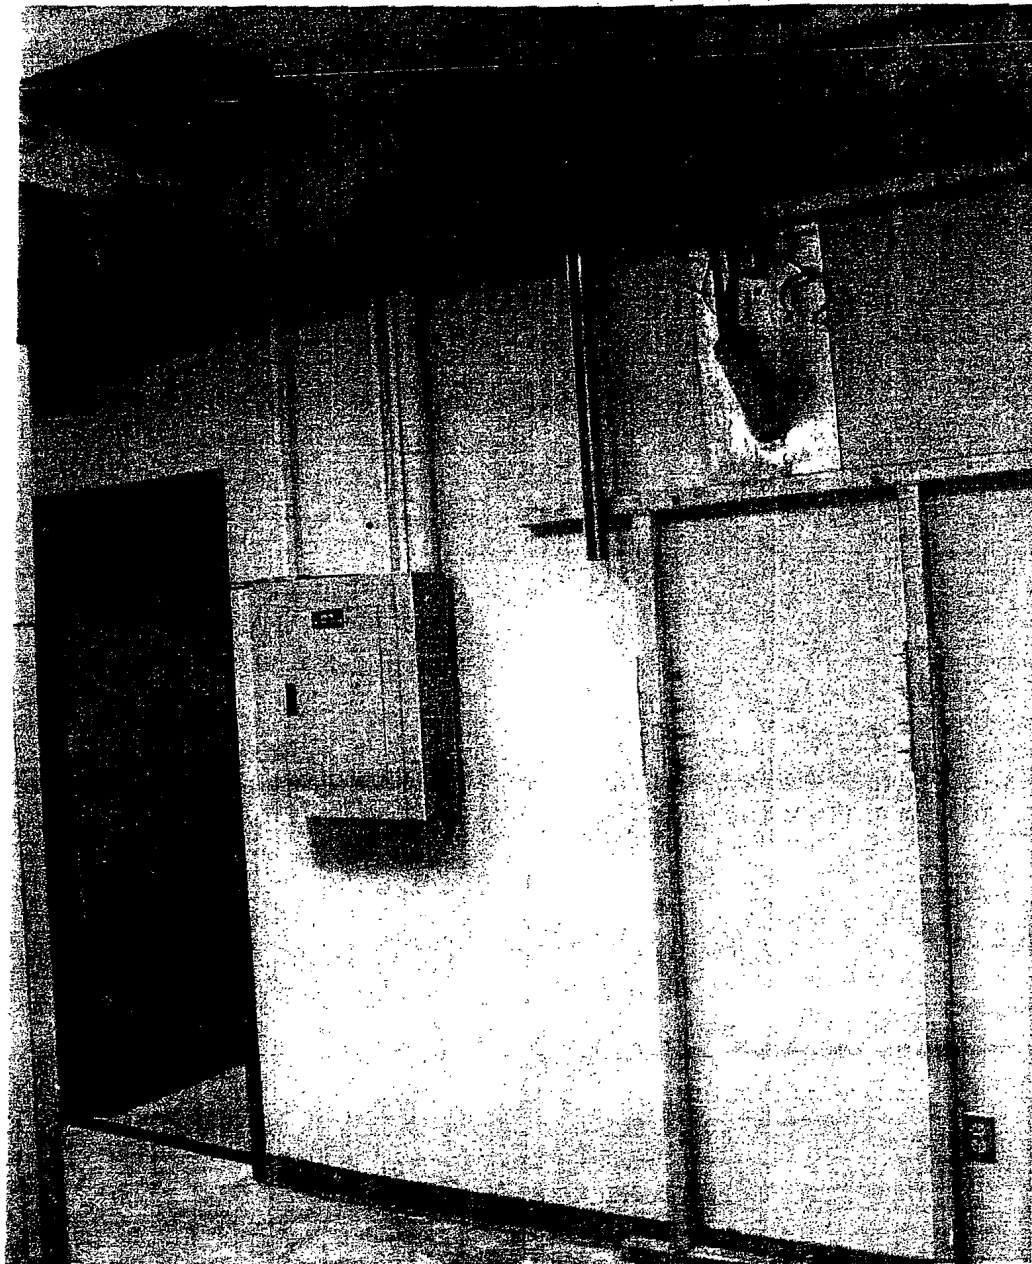
This photo shows the east wall of room 11TS5. The strut support will be temporarily removed to remove and replace gypsum board. The door and a section of wall will be removed and a header installed to support the wall above since an electric panel in the corner of room 11TS5A will prevent replacing the wall. The new gypsum board will terminate at the NW corner of the elevator shaft. A strut rack shall be installed between the floor and header where the wall is being removed.

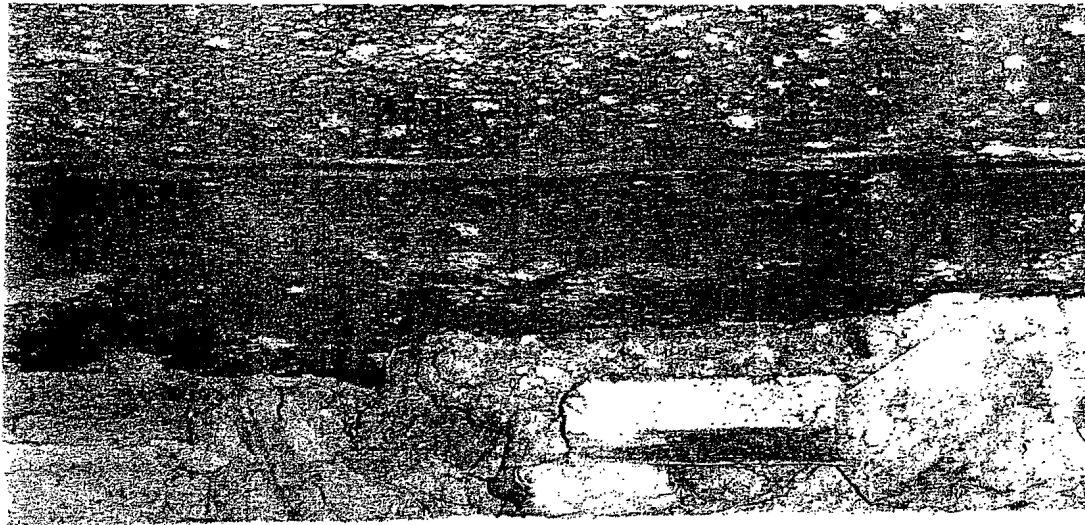
This photo shows debris and fire safing insulation in the void between the floor slab and precast panels in the 11th Floor Outer Ring. This condition is typical where gypsum board partitions are not adjacent to the exterior precast.

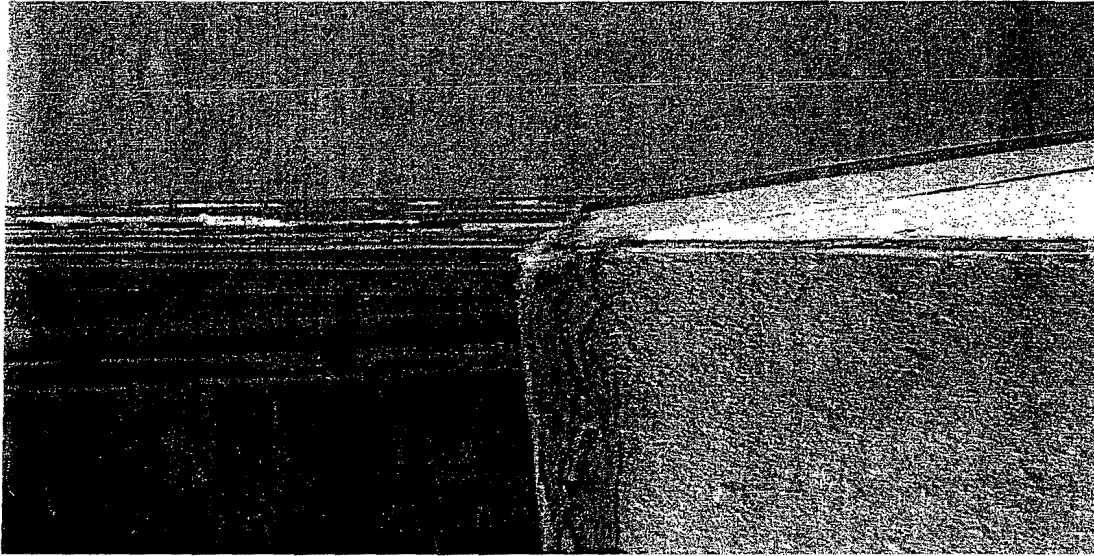
Photo 5: Cable Access Level Walkway.

During construction, it is often difficult to perfectly align the precast concrete panels to provide a uniform joint width or to control the exact width of the joint. As shown in photo 5, the vertical panel at times sits too high and can trap water on the joint sealant. Variation of the joint width can often lead to early sealant failure as the width to depth ration of the installed sealant is critical to its performance. It is not known if the joints and subsequent sealant width were designed to accommodate the anticipated movement, but the joint width and the amount of movement can lead to joint failure if they are not taken into consideration. A more permanent and long term solution than sealants and coatings to waterproof this area is recommended. The use of sealants and coatings will require recurring maintenance and frequent inspection and any leaks will not typically be seen until building materials are damaged and costly repairs become necessary.

This photo shows multiple caulk joints in the precast panels forming the interior perimeter wall of the walkway that forms the exterior wall of the Cable Access Level and the sloped precast panels forming the roof over the Cable Access Level. The joints are in poor condition and some attempt was made to provide a temporary fix for water leaks. Variation in the joint width makes it more difficult to obtain a good seal as variations in the width and thickness of the sealant can lead to premature failure of the joint. The use of separate precast panels for the sloped and vertical sections leads to a caulk joint around the perimeter of the building. The contaminated wall in the Cable Access Level (see photos 9 through 15) is located directly behind the vertical precast panels. The worst damage is located below the corners.
