| Tab Number | Document Name and Date | Document Type | Author | Recipient | Description |
|---|--|---|---|---|--|
| 1 | Investigation of Mold and Moisture at the FAA Detroit Metropolitan ATCT Facility | Report | OST | FAA | This investigation was performed to determine if mold and moisture issues still affected the DTW ATCT as was alleged by some employees. It determined that fungal growth and water intrusion still affected the building. The report contained a recommendation to perform water damage assessments at other Leo Daly ATCTs. |

**INVESTIGATION OF MOLD AND MOISTURE AT THE
FEDERAL AVIATION ADMINISTRATION
DETROIT METROPOLITAN AIR TRAFFIC CONTROL TOWER FACILITY**

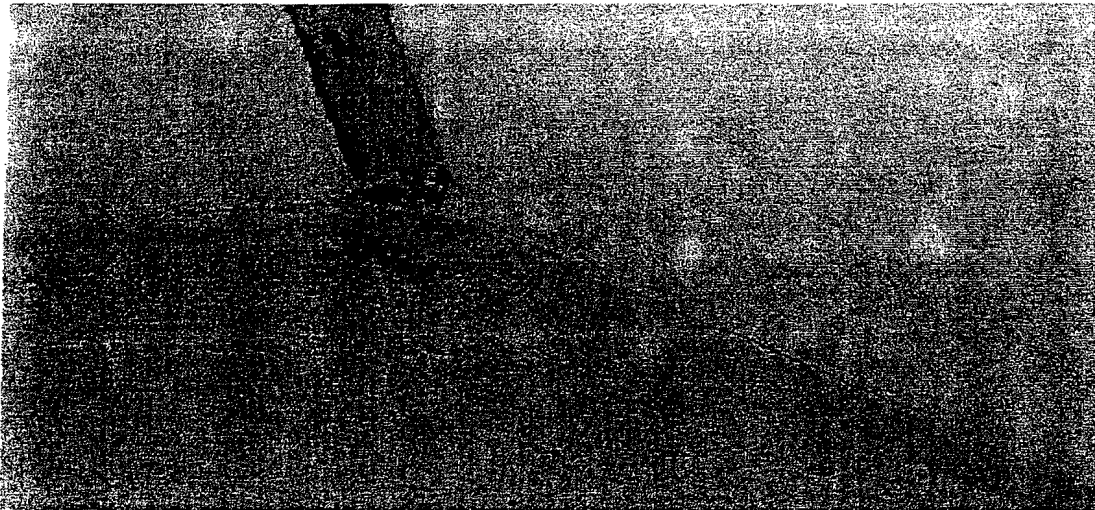
Photo 6: Cable Access Level Walkway.

This photo shows a portion of a deteriorated caulk joint between precast panels on the exterior perimeter of the walkway. The separation and crack between the waterproof coating on the concrete walkway deck and the precast wall panel can be seen to the right of the photo. Both items contribute to water infiltration into the facility.

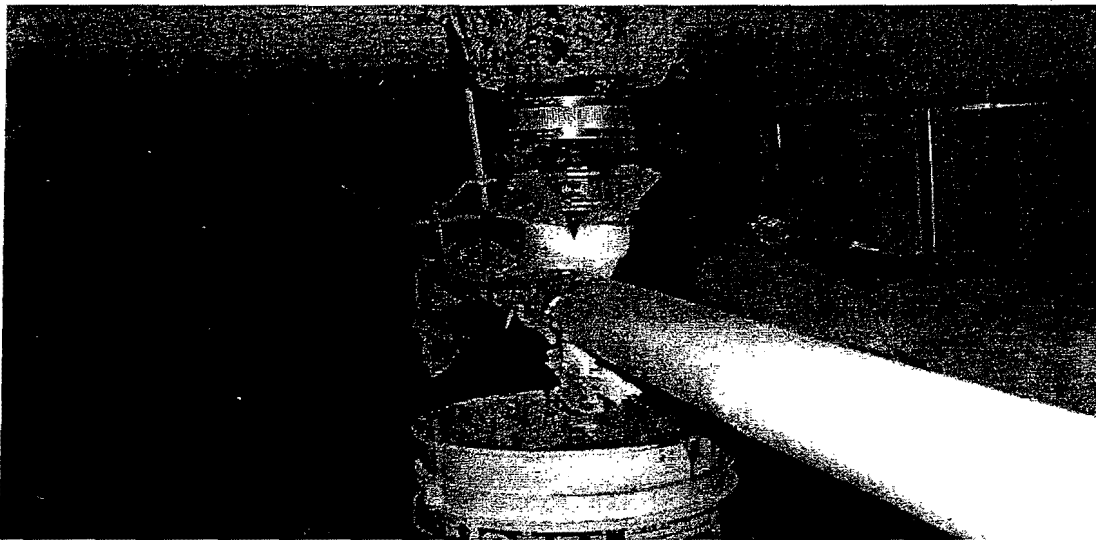
Photo 14: Unfinished Side of Wall, Room CA2.

A five gallon bucket was found under the drain on the east side of the exterior walkway at the Cable Access Level. Pipe insulation had been removed apparently to inspect the piping or connection. No evidence of an active leak was found.

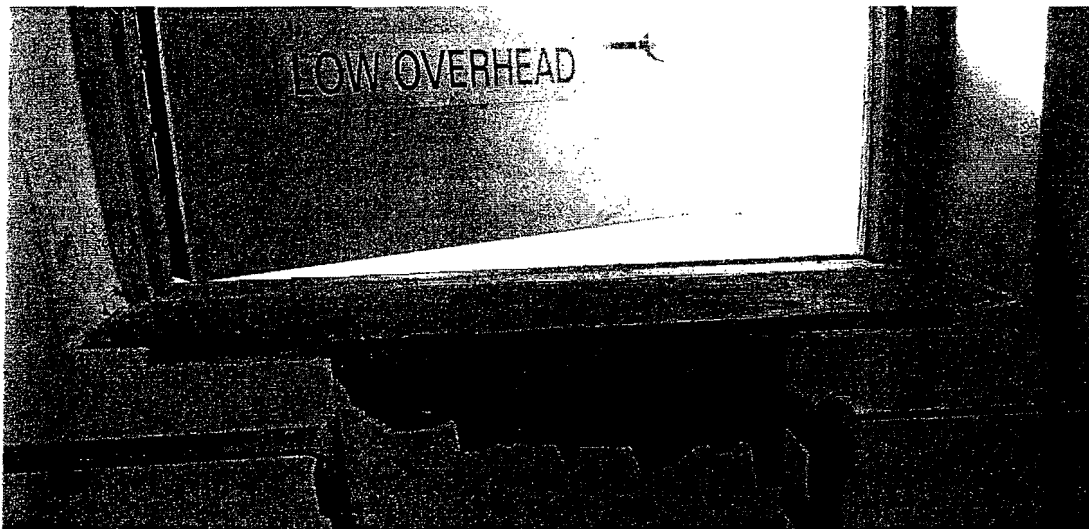
Photo 16: Room CA3, walkway door threshold.

Evidence of water infiltration can be seen by the rust on the bottom of the door frame and by the damaged gypsum board on both sides of door 707 between CA3 and the exterior walkway.

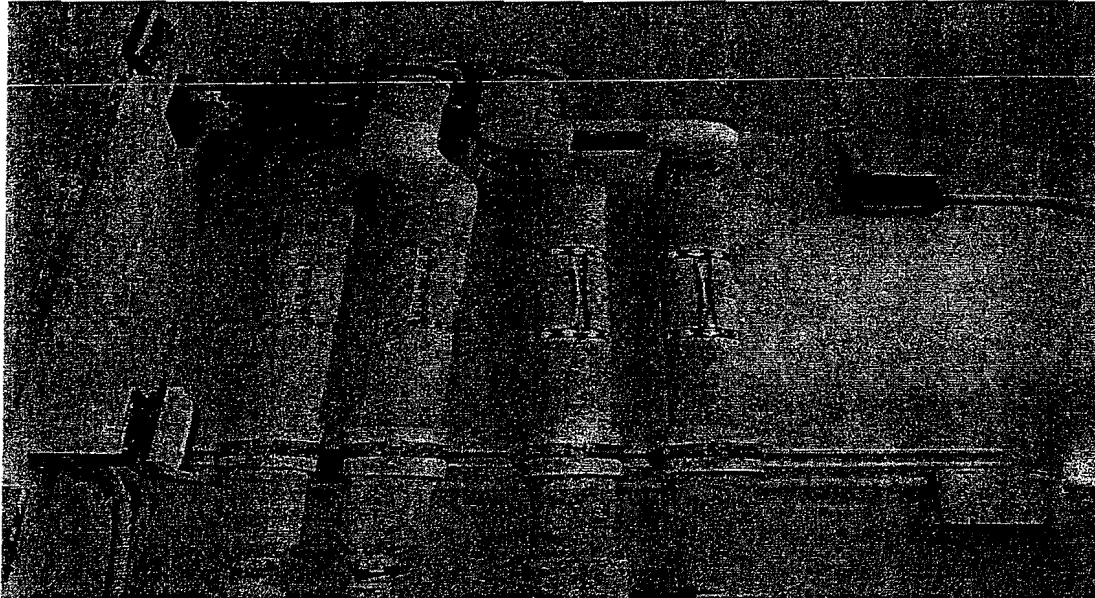
Photo 17: Room J2, West Wall.

The west wall and ceiling of the Stair Vestibule showed extensive signs of yellowing and mold contamination from recurring water exposure. Mold was found on both the chilled and heating water pipe insulation. Mold was not typically found on hot water piping in other areas of the facility. It is likely that the pipe insulation was wet due to building leaks. The room likely has high humidity as mold was also found on the fan coil unit, door 604, and both sides of door 605.

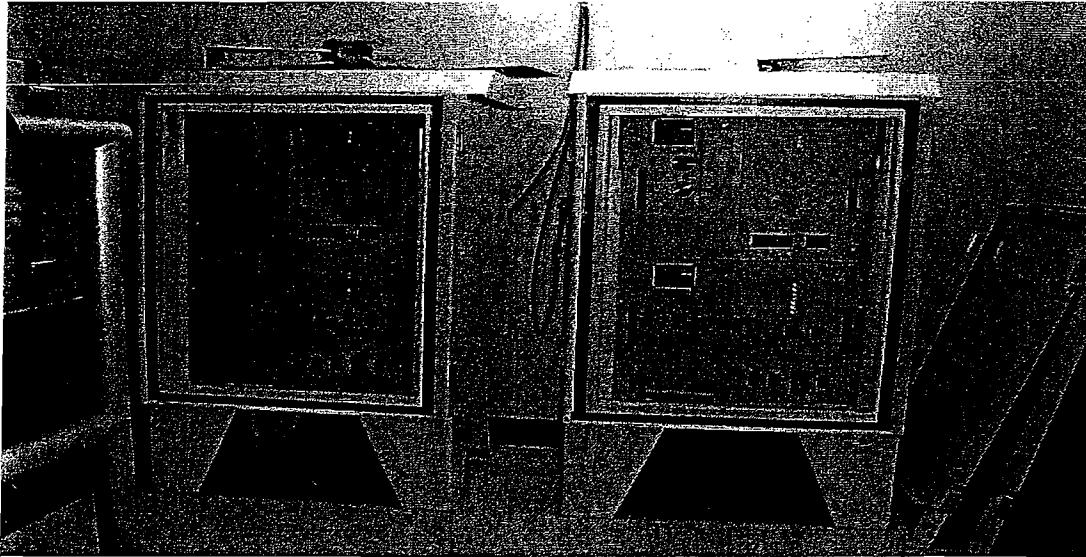
Photo 19: Room J3, East Wall Receiver and Transmitter Racks.

As indicated in photo 18, the wall behind the CPME racks and below the raised floor is water damaged or contaminated other than near the top of the wall. It will be necessary to relocate the CPME racks and remove the raised floor along the wall to perform the remediation and restoration work. The raised floor and the CPME equipment racks will complicate the remediation and add to the cost.

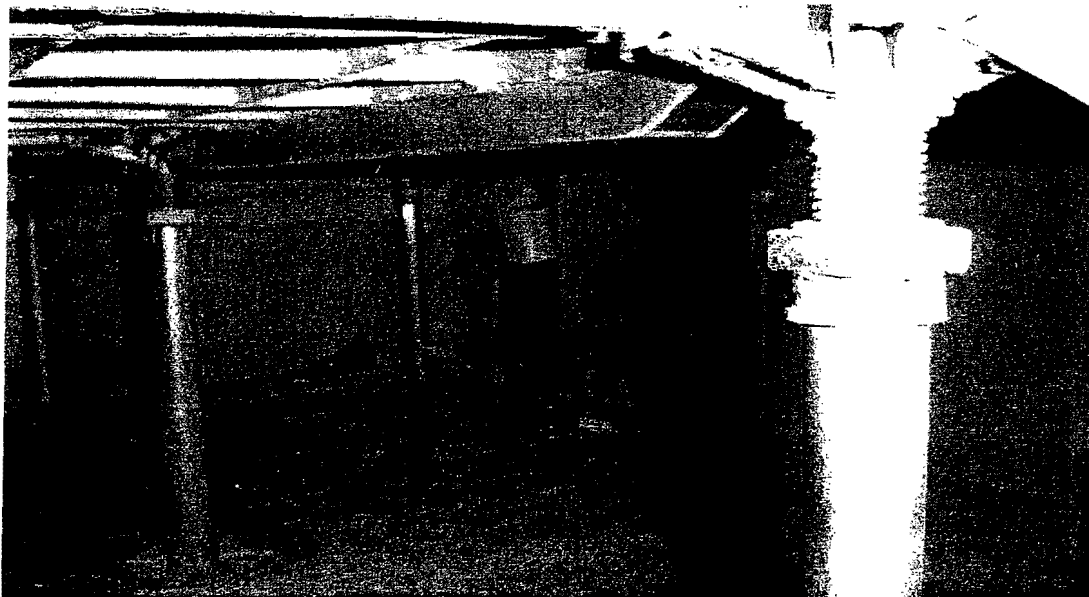
Photo 24: Room L33, North Wall under Raised Floor.

Mold can be seen at the bottom of the gypsum board at the concrete slab under the raised floor in Stair Vestibule L33. This is an outside wall. The source of water is likely building leaks due to failed caulk joints between precast panels.

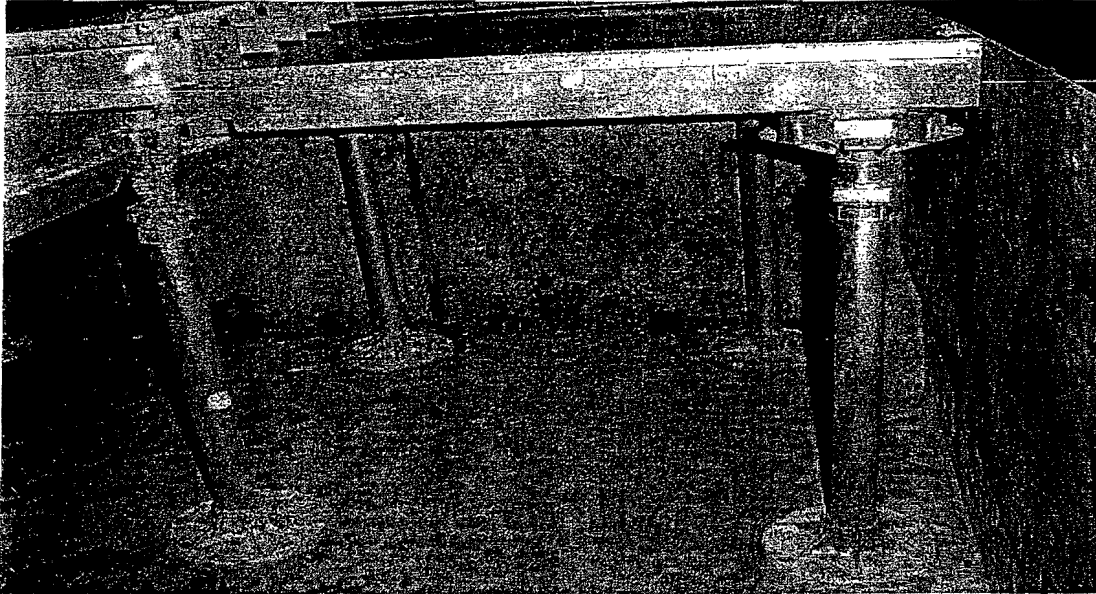
Photo 25: Room L33, South Wall under Raised Floor.

Heavy amounts of mold were found on the south wall and portions of the east wall under the raised floor in Stair Vestibule L33. The mold could be caused by the accumulation of water under the raised floor from building leaks or from high humidity levels in the facility.

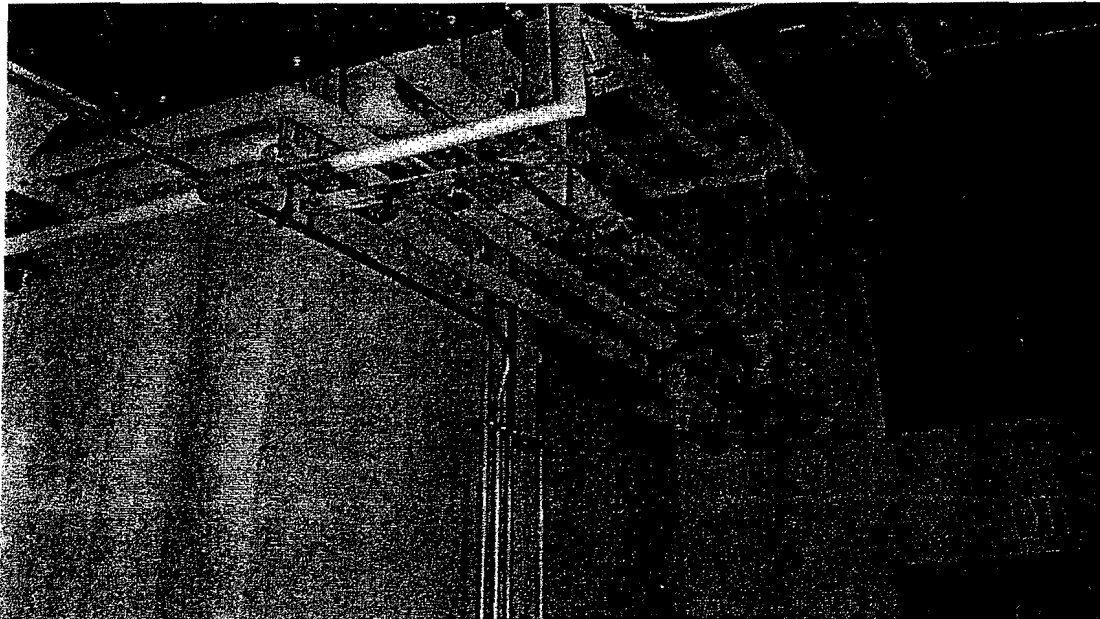
Photo 26: Room RA1, Moldy Chilled Water Piping.

Mold growth and discoloration was common on the majority of chilled water piping in the facility. The problem was more pronounced on horizontal piping insulated with the canvas type vapor barrier jacket as opposed to piping with the all-service vapor retarder jacket (ASJ). This may be due to the fact that the field applied vapor barrier is not as tight as that on the piping with the ASJ and the moisture appears more likely to accumulate in the horizontal sections of piping.

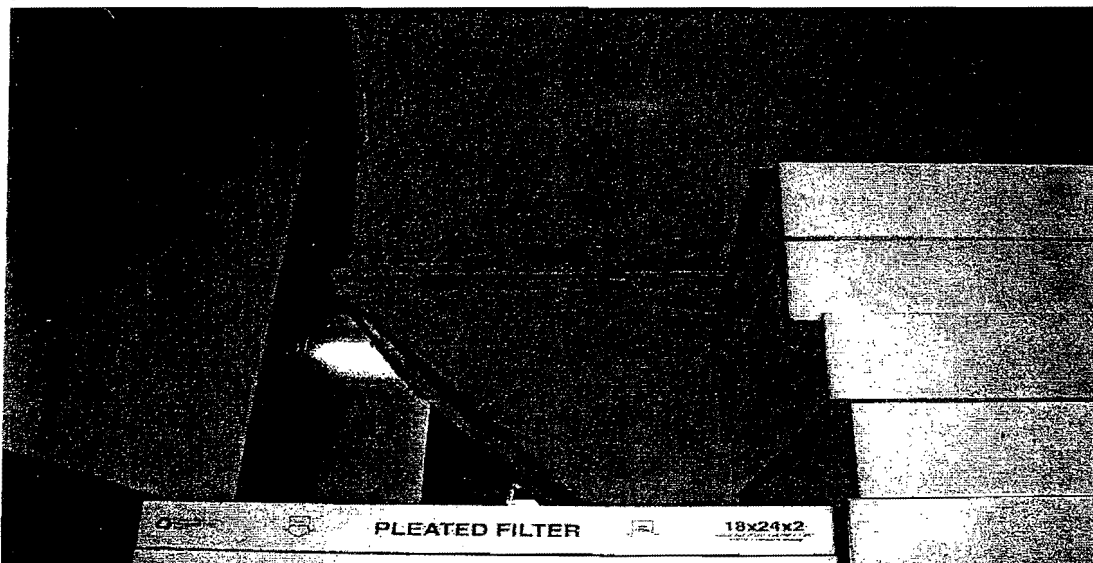
Photo 36: Room 142, Mold on HVAC Ductwork.

Mold was visible on the surface of the duct. The air filters appear to have minimal water staining on the edges. It is recommended that the air filters be kept in the box in a dry area away from any active mold growth.

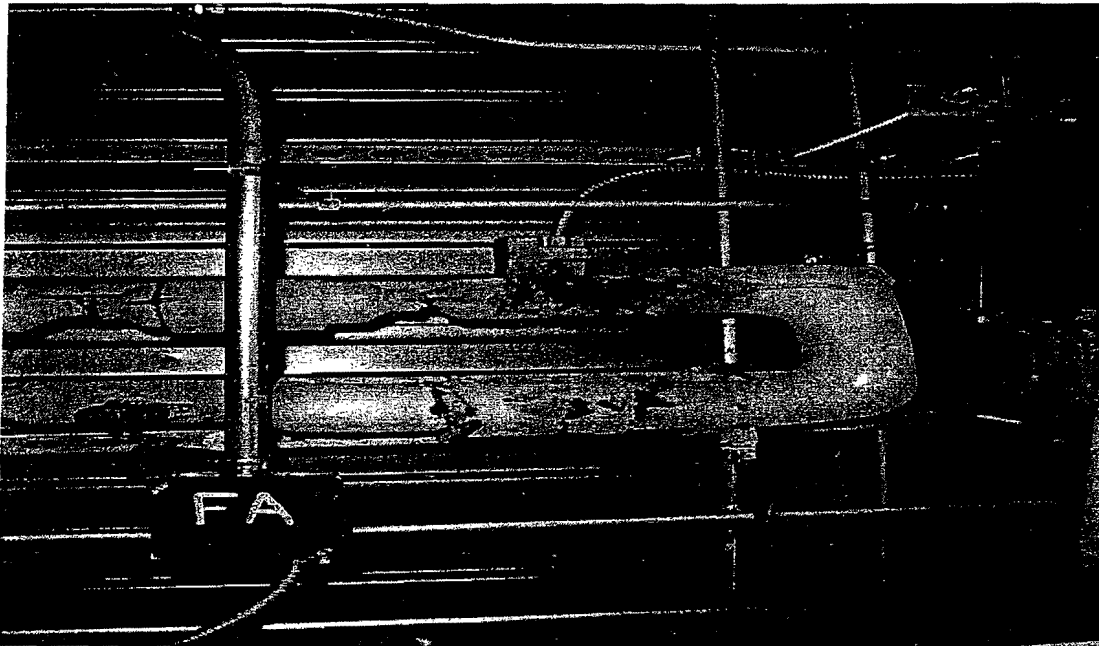
Photo 38: Room 145, Leaking Pipe above Ceiling.

The damaged pipe insulation provides evidence of leaks in the hot water (heating) supply and return piping. It was above the ceiling where a new stain was found on the ceiling tile shown in photo 39.

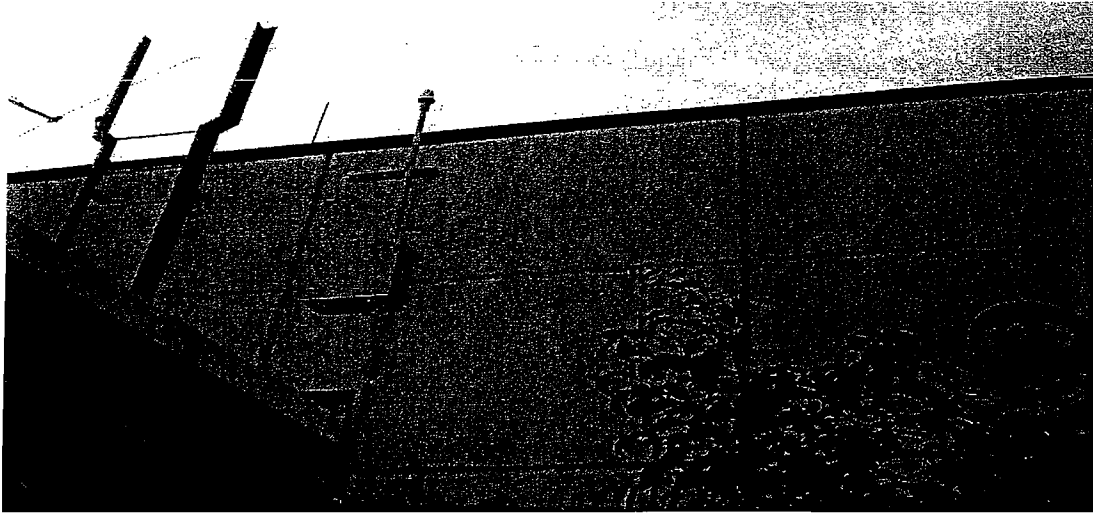
Photo 43: Base Building East Wall Above Canopy Door.

This photo shows the lack of a uniform application of sealer on the precast panels. The exposed aggregate is visible in the sections of the panels across the top of the wall. A line can be seen between the canopy roof and the surface mounted junction box where the application of sealer appears to stop again leaving exposed aggregate visible at the face of the panels. The sealer provides a uniform appearance of the panels but more importantly prevents the migration of moisture into the panels and into the building. The existing sealer is in poor condition and the quality and uniformity of the original application appears questionable.

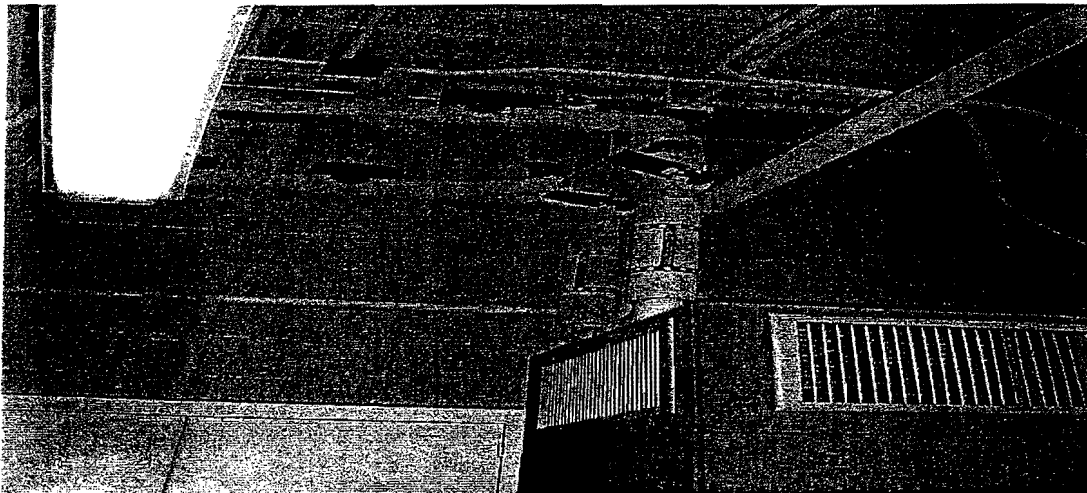
Photo 48: ESU Building, Room 104, Mold on Chilled Water Piping above CRU 5. Mold is visible on this section of chilled water piping at the valve. The vapor insulation and vapor barrier at this location are not continuous and result in condensation forming on the cold metal valve.
