# Report on Exterior Building Envelope

## And HVAC Conditions

Airport Traffic Control Tower

2006  
April 24, 2005 MK

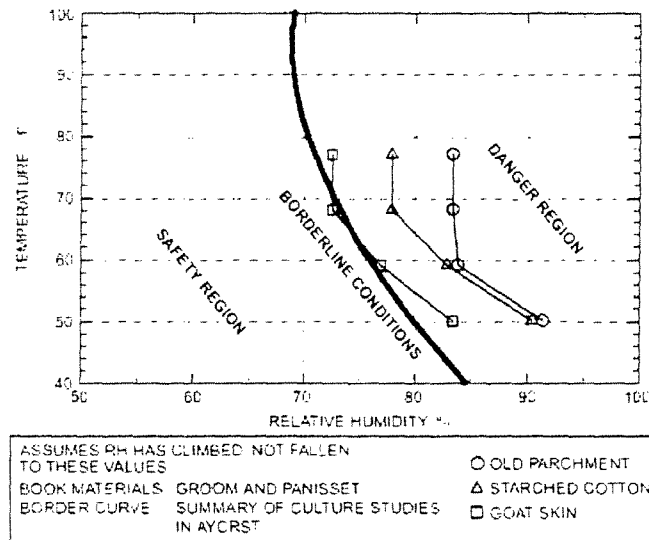
The control tower is basically an un-occupied shaft and per FAA Order 6480.7c, cooling is not recommended for most of the areas. However, in a humid climate the moisture leakage into the building through uninsulated walls, cracks or leaky plumbing may result in excessive interior humidity.

Moisture related problems typically result when the space is humid (greater than 70% relative humidity) and hot. The graph below, which has been taken from the ASHRAE Applications Handbook, illustrates this condition.

To avoid this condition, DMJMH+N recommends that specific and positive measures be taken to reduce the humidity within the ATCT shaft. Two possible options to reduce humidity are the installation of dehumidifiers or the installation of fan coil units. These options will be discussed in detail in Section 6.
